KDK Archaeology Ltd

Archaeological Observation and Recording Report

17 Tring Road
Wilstone
Hertfordshire

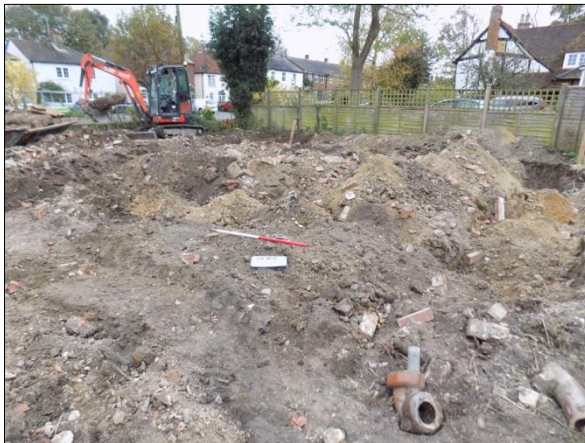
Plate 1: Overall shot during removal of original footings

Following the demolition of the original building, the old footings were removed under archaeological supervision using a 1.5 tonne machine fitted with a 0.6m toothless bucket (Plates 1-2). The new footing trenches were then excavated using a 2.5 tonne machine also fitted with a 0.6m wide toothless bucket (Plates 3-14). Six footing trenches were excavated in a footprint measuring 13.5m by 12.2m, with two central trenches in addition to the four around the edges (Fig. 5). When the footings were completed, the ground between them was levelled (Plates 15-16) and an area to the southwest measuring 13.5m by 4.1m was reduced to a depth of 0.64m in order to accommodate the proposed patios for the houses (Plate 17).

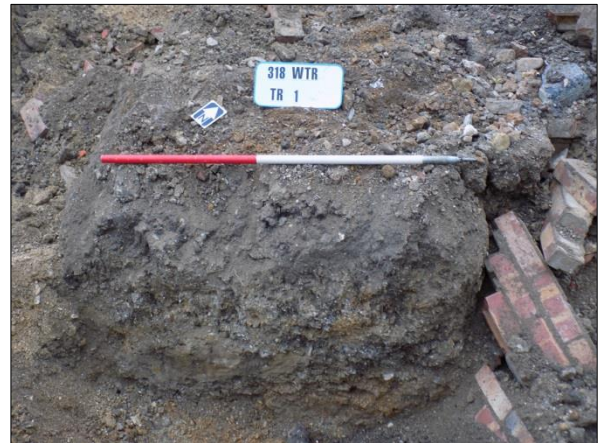
Plate 2: Site stratigraphy following demolition

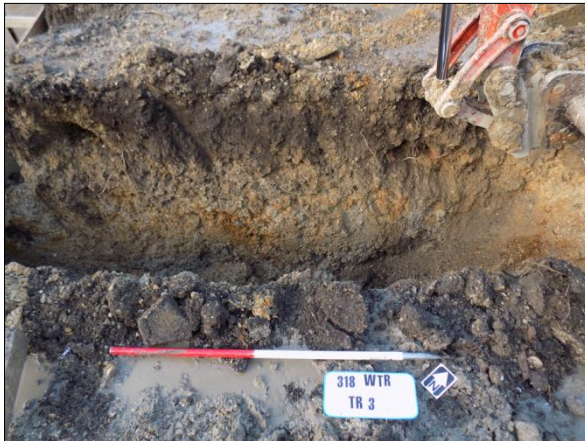
No elements of archaeological interest could be identified in any of the trenches or the reduced patio area. The materials found consisted largely of brick, tile, scrap metal and plastic, all dating to the modern period. The majority of this material was also unstratified, having been displaced by widespread ground disturbance within the footprint of the new development, which created difficulties in understanding the site stratigraphy. This was primarily caused by the removal of the foundations of the previous structure, as well as their backfilling and subsequent re-excavation. The stratigraphy was clearest in the southeast facing section of Trench 3 (Plate 3, Figure 6) and consisted of a 0.2m deep layer of mixed topsoil and subsoil deposited by the contractors after the removal of the original footings. A similar layer of darker soil was also observed in Trench 1 after the foundations were removed but before the ground was backfilled, however this also contained modern detritus and was probably a construction deposit from the previous house (Plate 2). Below the overburden in Trench 3 was a 1.2m deep layer of natural sand containing lenses of orange and yellow gravel and clay. Throughout the trenches, this layer of natural geology was disturbed by activity both from the construction of the original building and from its demolition. At the base of the trench was a light bluish grey layer of undisturbed natural clay, measuring 0.1m in depth.

Plate 3: Stratigraphy of new footings (Trench 3)

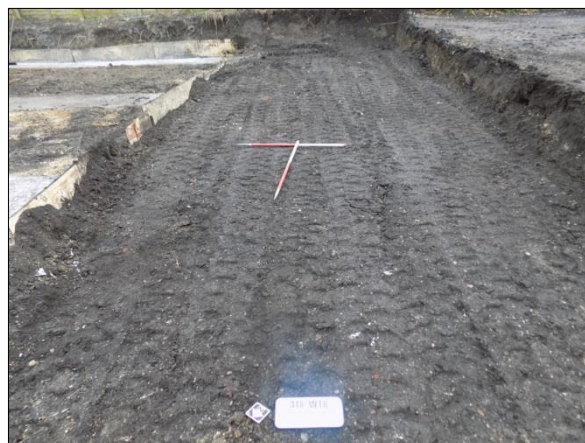
The reduced patio area also contained no recognisable archaeology. The stratigraphy was different to that of the footing trenches with a 0.47m deep layer of made ground above 0.17m of natural geology. The top layer of made ground was similar to that seen in the footing trenches and consisted of a mixture of topsoil and subsoil deposited by the contractors. Original plans for the excavation of service trenches were altered in favour of plans that would not affect undisturbed ground.

Plate 17: Reduced area for patios, view southeast
