## Archaeological Observation and Recording Report

Gardener's Cottage

The Lordship

Much Hadham

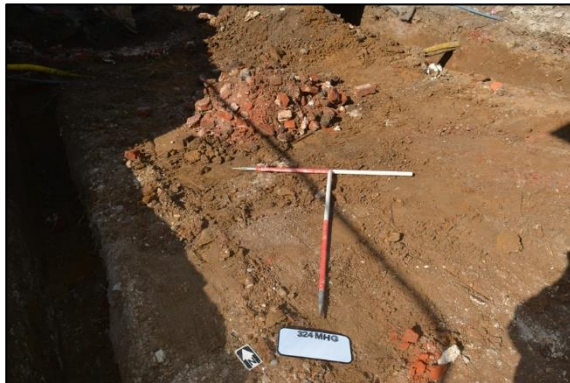
The foundations for the single storey extension were excavated to the north of the existing cottage and comprised three footing trenches and two service trenches (Fig. 5; Plates 1-9). The footings comprised two north-south orientated trenches (measuring 6.70 x 0.50 x <1.45 m (L X W X D)) and one east-west orientated trench (measuring 4.88 x 0.50 x <1.45 m (L X W X D)). The ground level within the footings was also reduced by 0.45m. The service trenches abutted footing Trenches 1 and 2.

**Plate 1:** Ground reduction between the footing trenches

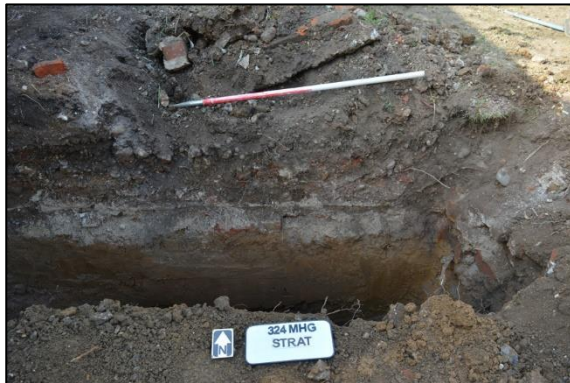
- Topsoil (05): Mid-greyish brown, clayey silty sand with occasional rounded stones and angular flint throughout. This layer was very friable and reached a depth of 0.11m.
- Subsoil (06): A mid-greyish brown similar to the topsoil but composed of sandy clay. The subsoil was fairly malleable and contained occasional sub-angular stones and angular flints throughout. This layer was 0.30m deep.
- Made ground (07): This layer was situated adjacent to the cottage and beneath the retaining wall. It comprised a mixture of subsoil (006) and basalt and contained frequent gravel and building detritus. It reached a depth of >1.10m.
- Natural (09): A dark brownish orange, friable and soft sandy clay which contained occasional angular flints throughout. Chalk was also noted within this layer.

**Plate 5:** Footing stratigraphy, looking north

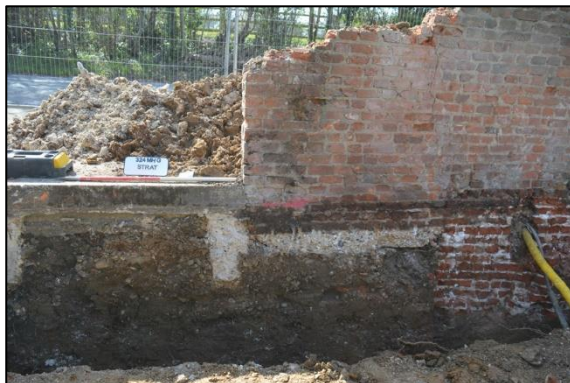
**Plate 6:** West wall foundation, looking west

A section of the surviving wall that formed part of the western boundary of the site was removed prior to the construction of the extension; though much of the wall has been preserved *in situ*. The foundation of this wall is, in places, considerable, as it was 12 courses, or 1.10m deep. The depth may suggest that the post-medieval ground was terraced in this area. Where the foundations were at their shallowest, the brickwork had been underpinned with hard stony cement. A large hole had been made in recent times for the installation of a gas pipe and it had been repointed with cement above the modern ground level. The excavation of the footing and service trenches exposed more of this boundary wall. Wall [08] was observed within Footing 2 and is shown on the Tithe map to be a boundary wall which spans the width of the modern garden. As the masonry ties into the boundary wall to the west and appears to have been built using identical materials and construction methods it was a return for the existing western boundary wall.

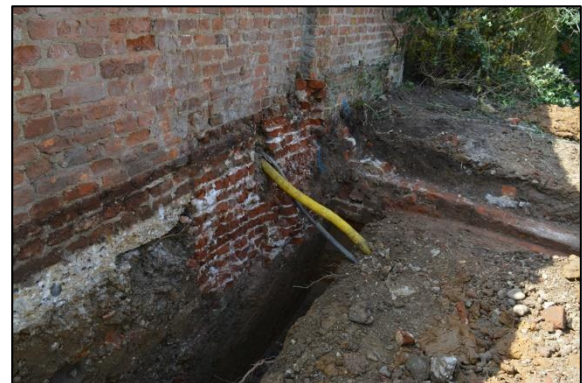
**Plate 7:** West wall foundation showing return, Looking northwest

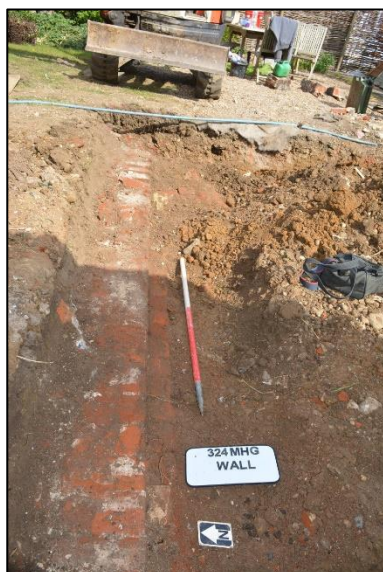
An east-west orientated brick wall [08] was located within Trench 2, to the north of the main building (Fig. 7; Plates 8-9). The wall was at least two bricks wide and constructed of handmade made with bricks measuring 22.5 x 5.5 x 10.5cm, which were well-puddled with Spanish and had occasional stone inclusions. They were set in a white, hard, lime mortar that also contained small stones. Seven courses of brick were visible, which reached a depth of 0.50m. A total of 4.88m of the wall was visible within the trench. Some collapse was evident to the east of the footing trench.

**Plate 8:** Wall [08], looking east

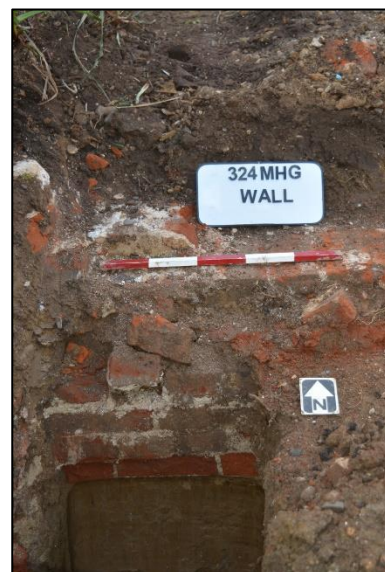
**Plate 9:** Wall [08] foundation

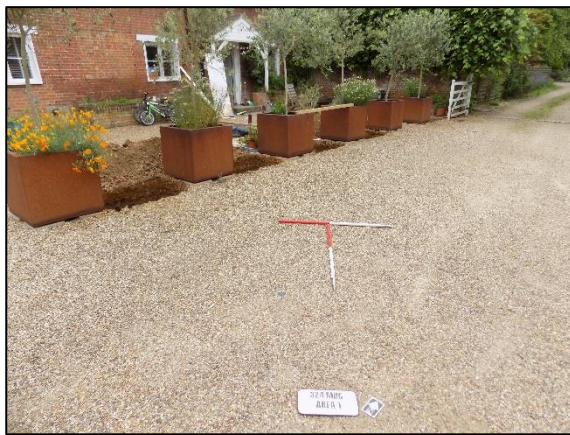
A total of 12 pits were excavated (Fig. 5; Plates 10-15). Six of these were designated as planter pits (P1-5) and situated within the courtyard to the east of the Gardener's Cottage. Each planter pit was between 1.05-1.20m in length x 0.70m in width and dug to a depth of c.0.50m. The natural geology was not reached within any of these pits. A new perimeter fence was constructed along the north-western border of the site, parallel to the main road. The postholes (P6-12) were dug at regular intervals and measured 0.60 x 0.60m in size and dug to a depth of 0.65m. Again, the natural geology was not reached in any of these postholes and no finds, features or deposits were encountered within P1-12.

**Plate 10:** Planters P1-5, looking northwest

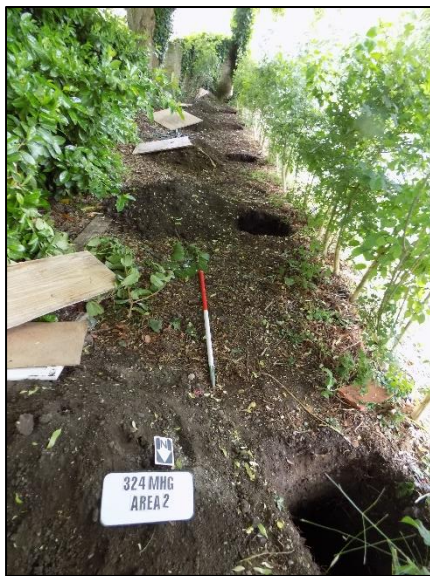
Plate 13: Postholes P6-12, looking south

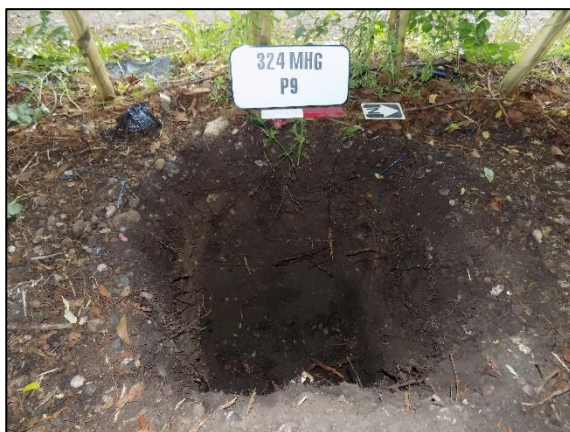
- Gravel (01): A layer of shingle 0.10m deep that covered the entire courtyard to the east of the cottage
- Builders sand (02): Dark brownish orange sand situated beneath gravel (01); 0.18m deep.
- Disturbed topsoil (03): A dark orangey brown, loose silty sand which contained a moderate number of rounded and sub-angular stones and occasional sub-angular flint nodules <50mm. Contained tile and brick debris. It reached a depth of 0.20m.
- Heavily bioturbated topsoil (04): Located where the postholes were dug in an area dominated by trees and vegetation. It comprised a loose, dark greyish brown sandy silty loam, which contained frequent rooting (especially P10), and occasional round and sub-angular stones. The base of this layer was not reached, but it exceeded 0.65m in depth.

Plate 15: P9 stratigraphy, looking west
