KDK ARCHAEOLOGY LTD

Archaeological Observation and Recording Report

Garden House
Cottered
Hertfordshire

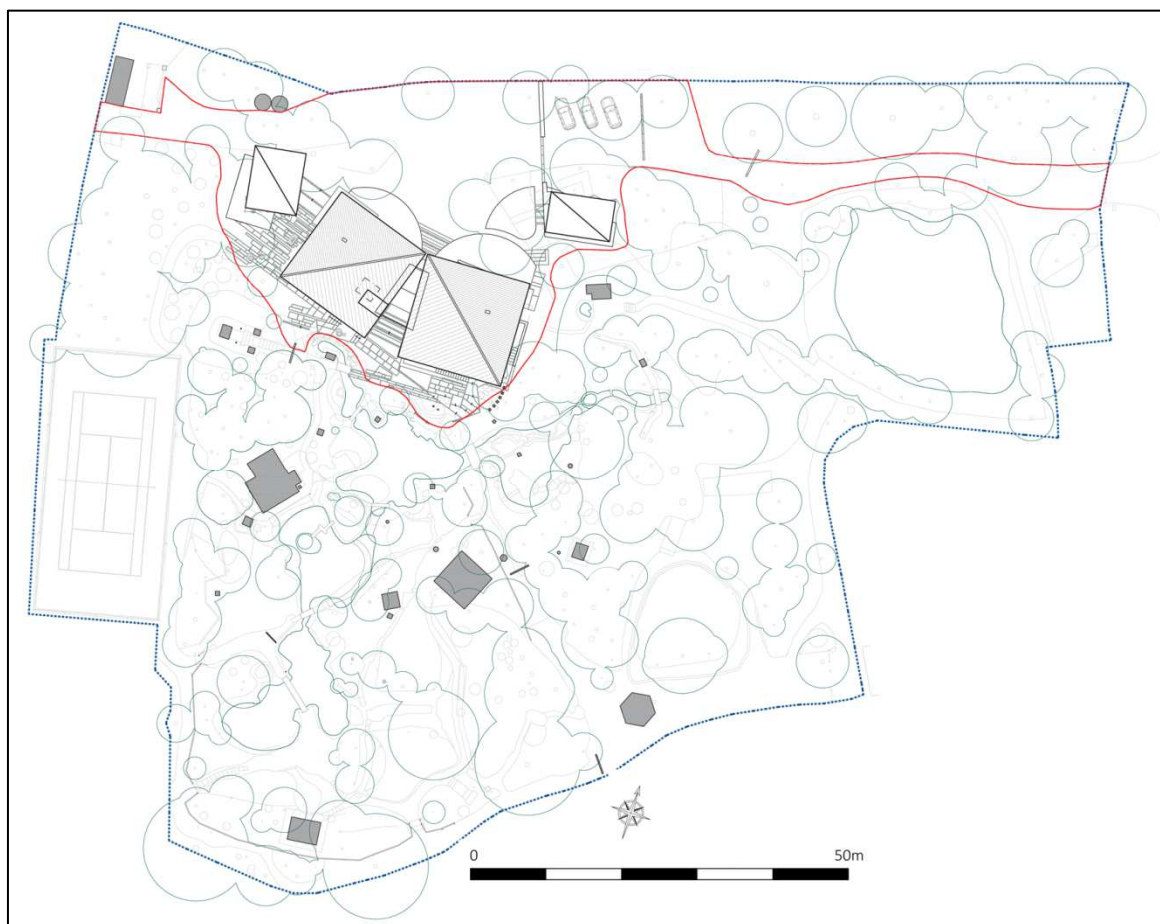
Figure 3: Proposed development (scale as shown), with external, new landscaping pending further planning submissions

The proposed development involves the demolition and replacement of the existing house with a bespoke house with two outhouses (Fig. 3).

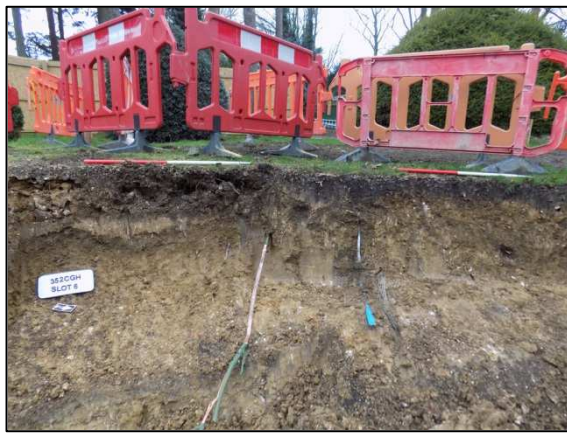
Plate 1: Slot 6, looking west

Slot 6: Slot 6 was located to the north of Slot 5. The section was excavated to a depth of 0.79m to expose the natural geology. Within the section a shallow gully measuring 0.69m wide and 0.12m deep could be seen (Fig.5; Plate 1-3). No datable material was recovered from the fill. A single sherd of possible medieval pottery was recovered from possible subsoil layer (607), and was therefore not associated with any dateable cut feature. The stratigraphy for Slot 6 comprised:

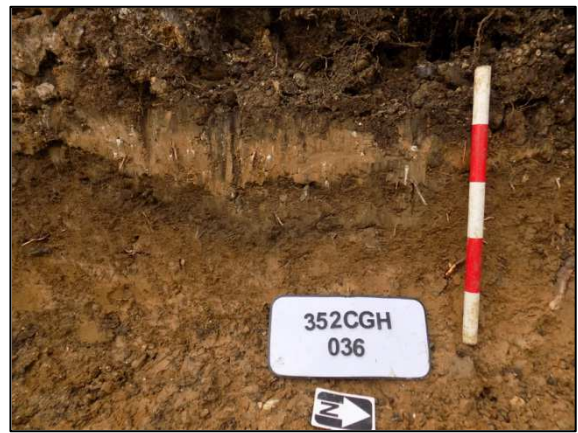
Plate 2: Possible gully [036], looking west

Two features were identified within the excavated sections. The first, possible posthole [013/810], was exposed within Slot 8 to the northeast of the site. The second feature was a suspected gully, [036/605] which was observed to the west of the site in Slot 6. The latter feature may be visible in the artist studio which was beneath the impact level of the grading for the raft, and yet to be excavated, and could therefore be fully investigated at a later date.

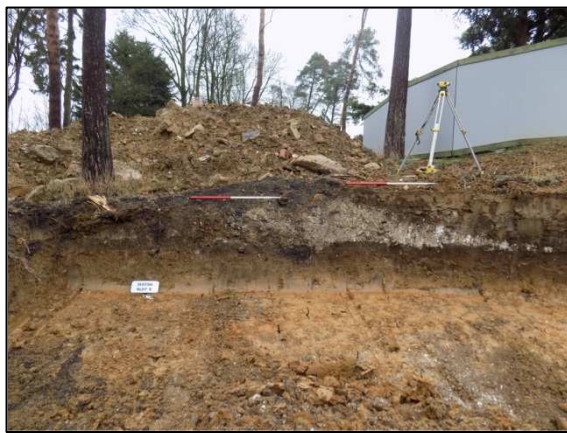
Plate 3: Slot 8, looking northeast

Slot 8: Slot 8 was located in the northeast portion of the site at the base of a mound known as Mt Fuji. Several trees were situated close to the slot and the topsoil had been heavily disturbed by rooting. A possible posthole measuring 0.57m wide and 0.31m deep was observed in the section (Fig. 6; Plate 3-4). The stratigraphy for Slot 8 comprised:

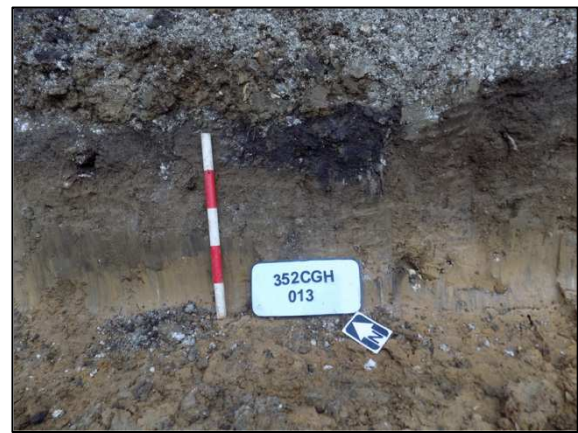
Plate 4: Possible posthole [013/810], looking northeast

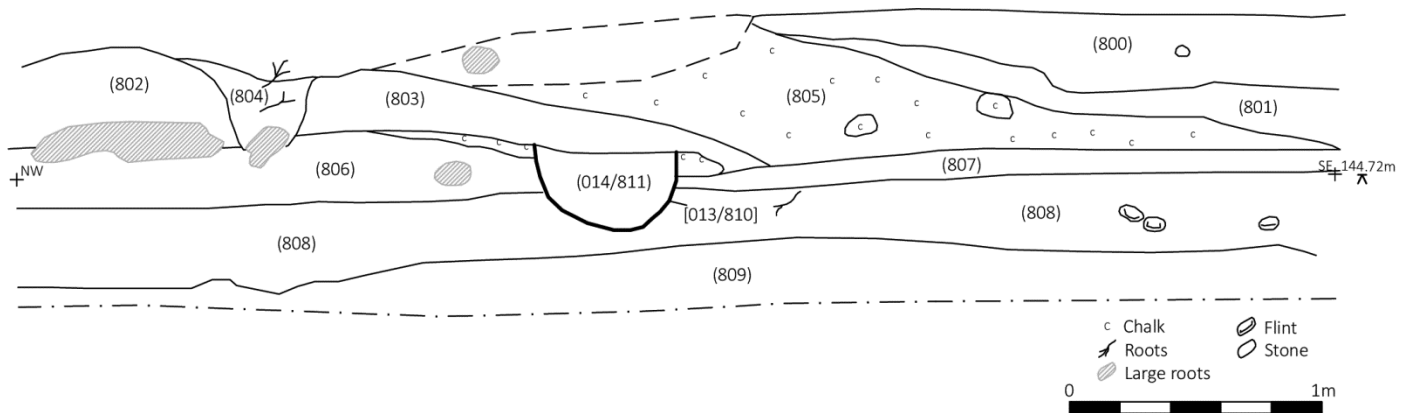
Figure 6: Southwest facing section of Slot 8 (scale 1:30)

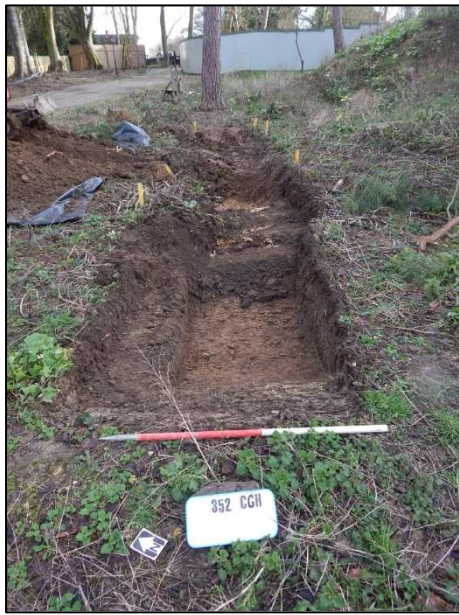
Plate 5: Stripped portion of Staff House footprint, looking northeast

The ground reduction for the Staff House did not breach the topsoil layer and effectively consisted of grading, rather than reducing over the footprint. The deepest impact was a 1m wide strip on the southern edge, where the reduction reached a depth of 0.30m, but even this did not breach the topsoil. A small sondage was excavated in this area to assess the stratigraphy (Plate 5). The suspected gully, which was observed within slot 6 of the house footprint, was beneath the impact level and was not observed within the Staff House area.

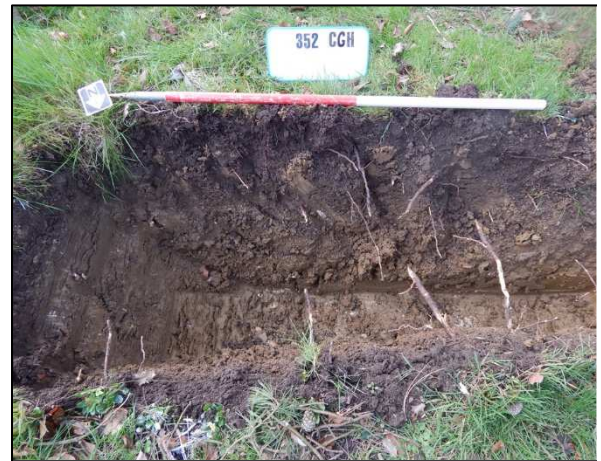
Plate 6: Test Pits 3 and 4, looking south southwest

As part of the current programme of groundworks, the makeup of the ground along the line of the proposed drainage run was also tested. Initially seven pits were excavated using a 1.5 tonne excavator fitted with a 0.75m toothless ditching bucket, carried out in conjunction with arboreal and archaeological investigations. The test pits housed the inspection chambers and once they were complete the pipe run was pulled between them. Nothing of archaeological origin was identified within any of the pits (Plates 6-10).

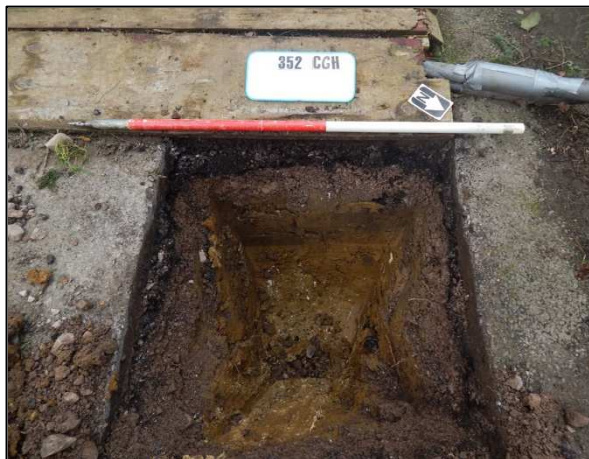
Plate 7: Test Pit 9, looking southwest

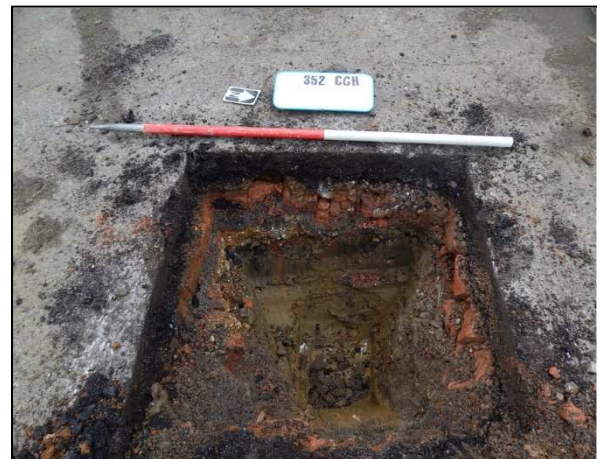
Plate 8: Test Pit 11, looking west

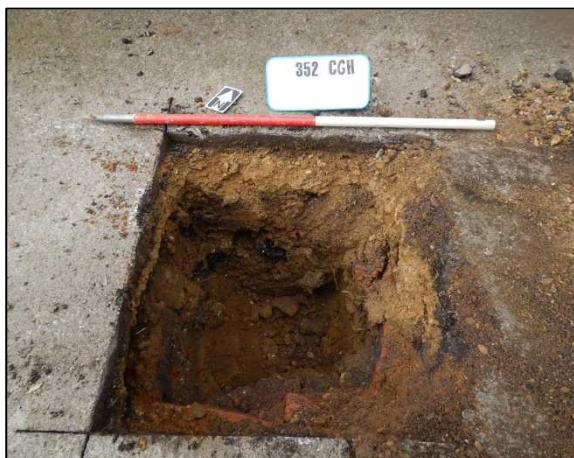
Plate 9: Test Pit 13, looking northwest

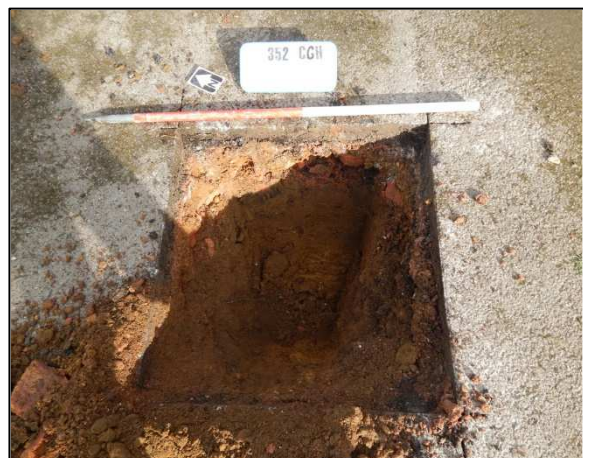
Plate 10: Test Pit 15, looking northeast
