## Archaeological Evaluation Report

Land adj. Rose Cottage

Chapel Lane

Akeley

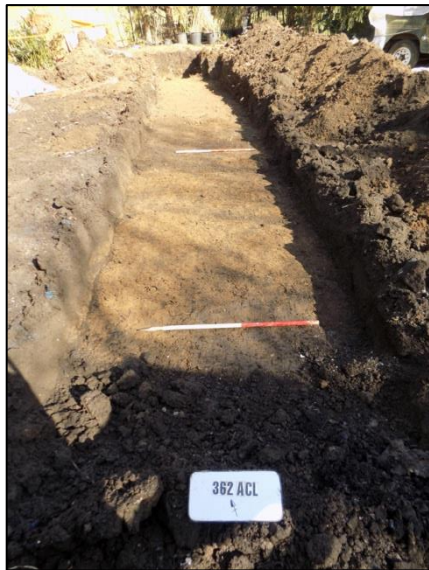
Plate 1: Overview of trench looking north northeast

A single trench was excavated within the footprint of the new building using a 2.5 tonne machine fitted with a 1m toothless ditching bucket. The trench was orientated north northeast- south southwest and measured 16.2m in length, 2.10m in width and was up to 0.90m deep (Figs. 6-7; Plates 1-2). A sondage was excavated to the north northeast of the trench. The stratigraphy of the site comprised:

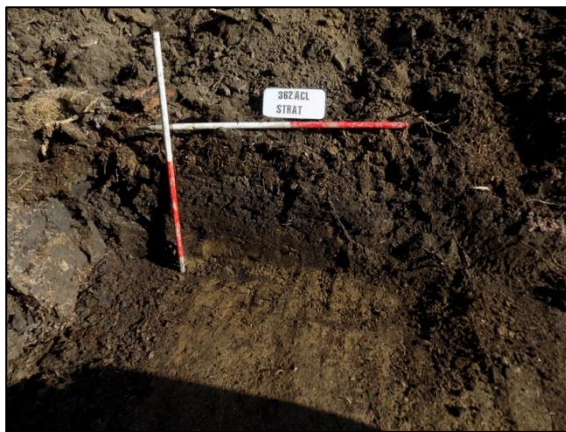
Plate 2: Stratigraphy. Northeast end of trench, looking southeast

- Topsoil **(01)**. Dark greyish brown clayey silt between 0.20m and 0.60m in depth.
- Allotment topsoil **(02)**. Dark greyish brown worked clayey silt containing a high proportion of well-rotted manure and straw 0.30m deep. Contained brick and modern building detritus. This was observed to the north northeast end of the trench.
- Subsoil **(03)**. Mid greyish brown soft clayey silt which reached a depth of 0.16m. Clay pipe, iron pieces, animal bone and pottery were within this layer.
- Natural **(04)**. A light yellowish orange firm silty clay

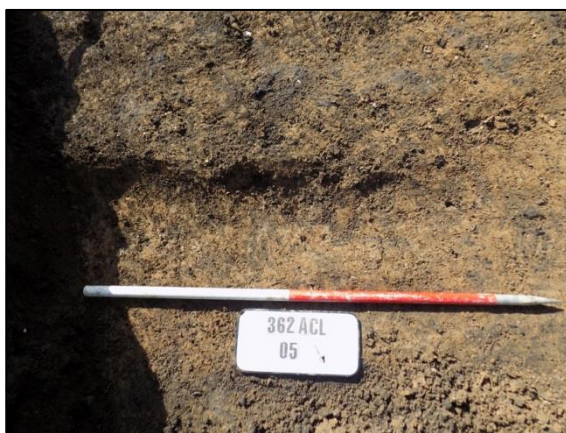
Plate 3: Feature [05] looking southwest

The features observed within this evaluation were all late post-medieval/modern. Towards the southwestern end of the trench were two linear features **[05]** and **[07]** which appeared to be plough marks (Figs. 9-10; Plates 5-8). These features cut through the subsoil, were orientated southeast-northwest and ran parallel to each other. They appeared to be backfilled with identical fills containing late post-medieval/modern material.

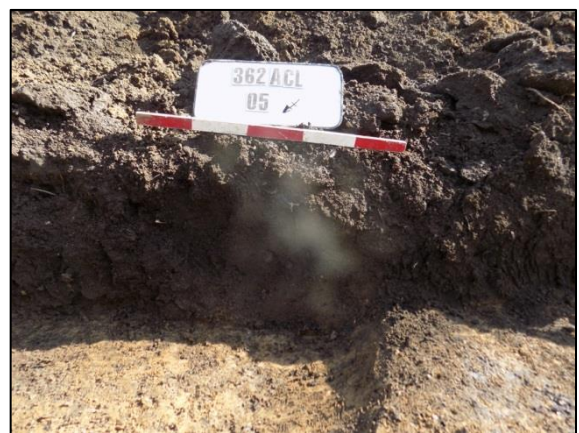
Plate 4: Northwest facing section of [05]

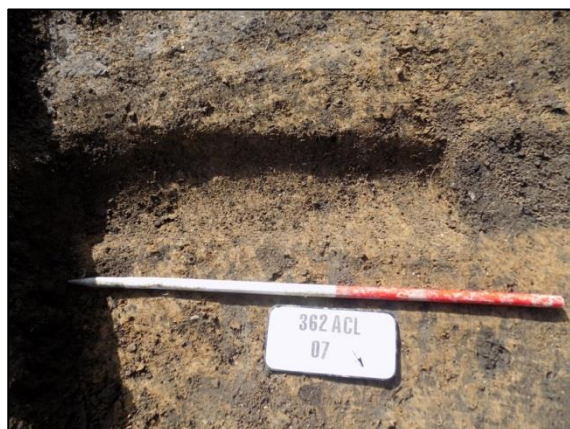
**Plate 5:** Feature [07] looking southwest

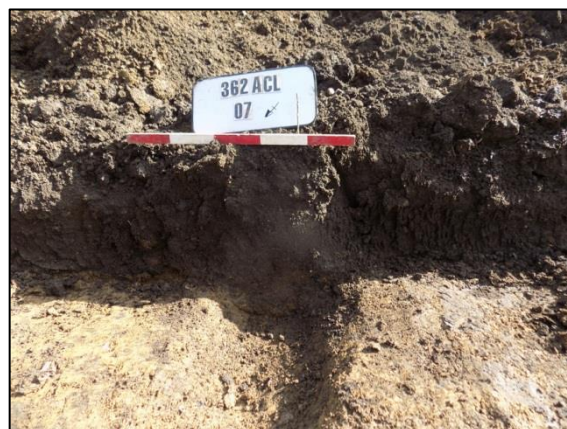
**Plate 6:** Northwest facing section of [07]

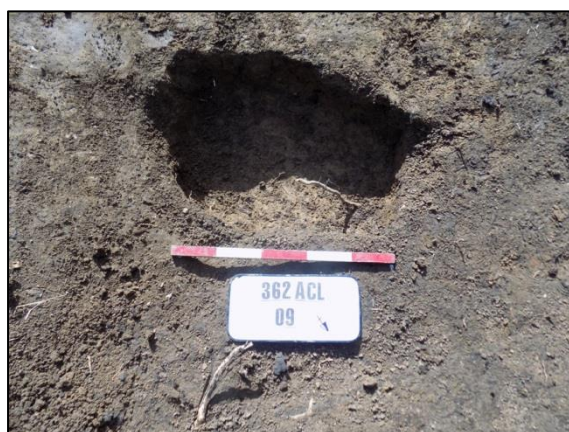
**Plate 7:** Pit [09] looking southwest

Pit **[09]** was also modern. It was densely packed with wine, beer, Codd, Torpedo and medicine bottles along with other modern material such as plastic, pottery and iron objects (Figs. 11-12; Plates 7-8).

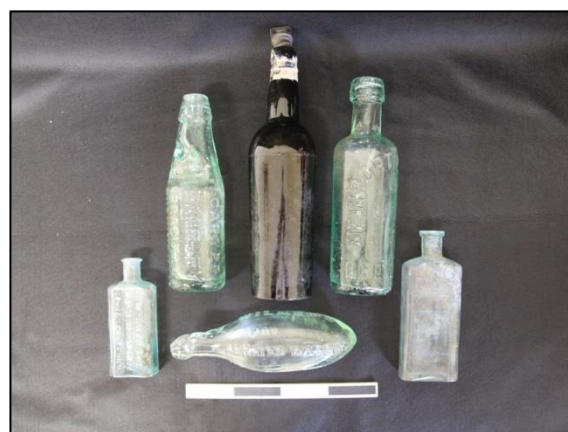
**Plate 8:** Example of bottles found in pit [09]
