KDK ARCHAEOLOGY LTD

Historic Building Watching brief

St Mary's Church

Northchurch

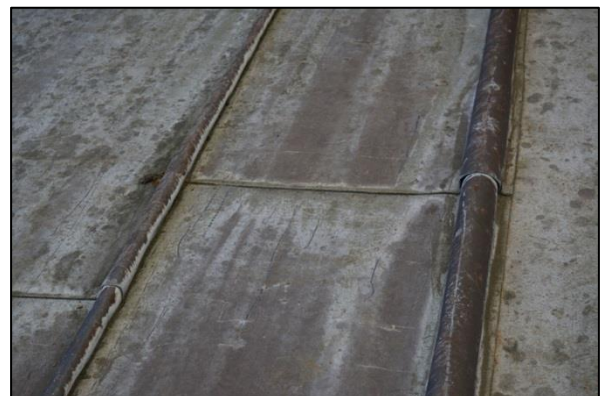
Plate 6: Hollow roll to the left of a timber roll joint

Not all of the lead sheets had been applied in the same way. There were instances where an earlier method of fixing the edges, known as a hollow roll, had been applied (Plate 6). The edges of the lead sheets were simply rolled tightly, which provides a smaller strip than the timber rolling. The locations of the hollow rolls are shown on Figure 7. Interestingly none were found on the nave roof.

The north aisle was constructed in 1882 although the use of narrow boards, as opposed to the wide boards set on the diagonal as on the nave roof, makes it appear younger than the nave roof. The use of hollow rolls as well as timber rolls for joining the lead sheets would suggest fairly large scale repair work, possibly executed in the 1980s re-leading programme, but the uniformity of the timber boards beneath show no sign of having been replaced. Be that as it may, repair patches were observed along some of the joins, at the feet of some of the rolls and on the westernmost lead sheet. The nave roof had needed more repairs to the main body of the sheets, no doubt because it was so thin.

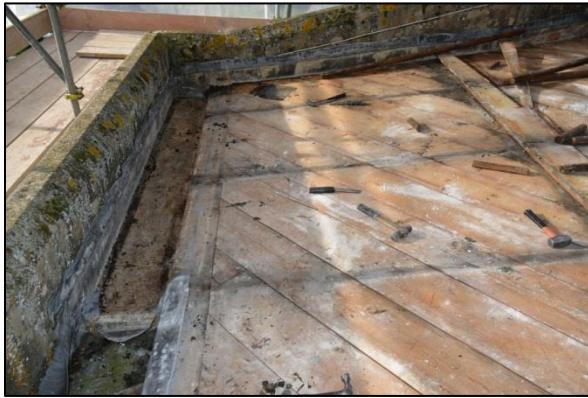
Plate 7: Nave roof timbers and valley gutter detail

The valley gutters had been screeded and it was intended to build them up to the height of the tallest section to make a deeper sump (Plate 7).

The timbers on the nave roof were 27cm (10½inches) wide and set on the diagonal (Plate 7). The timbers at the western end above the organ were rotten and had to be completely replaced. A number of repairs to the leadwork varying in size between 7x7cm and 110x38cm were noted. There are more per square metre on the nave roof than the north aisle, although there did not seem a great discrepancy in age between them. Most of the ends of lead overlying the timber battens had been repaired (Plate 5), and a number of patches were noted along the joints of the lead sheets. Random isolated patches of various sizes and shapes were also noted on both roofs (Plates 8-9).

The screeding to the valley gutters and blockwork along the north wall of the north aisle are clearly later 20th century repairs as are, no doubt, some of the repairs to the lead work.

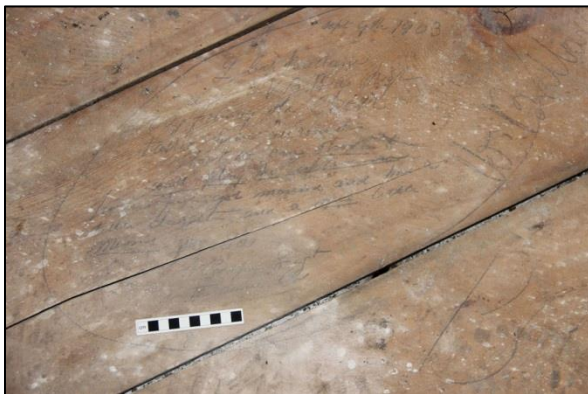
Plate 11: Graffito 2 of 9th September 1903

The second (Plate 11) is clearly dated September 9th 1903 and mention a L. Cap. Ballam. Most of the text is indecipherable but there is mention of a marriage and having a little daughter.

The nave roof was clearly re-laid and re-leaded in 1903 by a local builder, R.J. Matthews, and his colleagues Ginger Warren, Fred Sear, M Cooper and L Geary. Other individuals named on the roof include L. Cap Ballam, who cannot be more closely identified, although a Mervin Ballam is noted in the 1929 Kelly Directory as being a manager with the waterworks Company and living on the High Street in Berkhamsted. Edward Harris Ballam is recorded as living at 13 Upper King Street Berkhamsted in 1898 (Kelly's Essex Directory) and the banns were read for William George Ballam and Alice Mead three times in October 1901. Of the three the most likely candidate is Edward Harris Ballam who was also the sergeant instructor of volunteers (ibid).

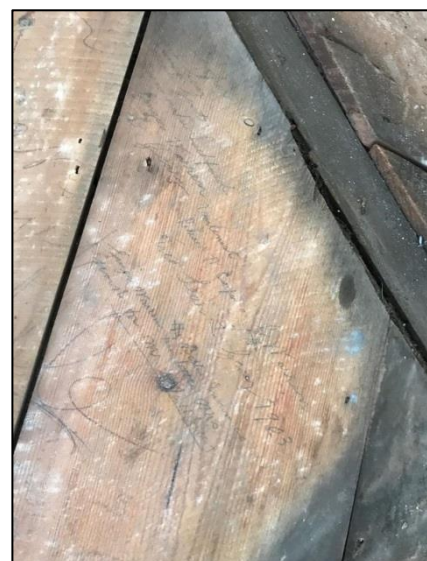
Plate 12: Graffito 3 dated 1903
(courtesy of Mark Weston)

The names Ginger Warren, Fred Sear and L Geary are seen again on the opposite side of the roof towards the western end of the building (Plate 12).

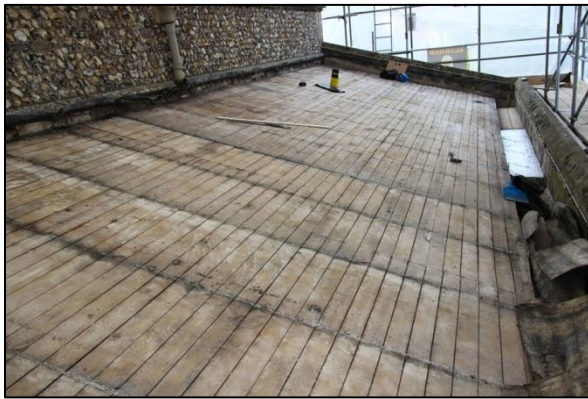
Plate 13: North aisle roof timbers looking west

The timbers on the north aisle roof were 10cm wide and aligned E-W along the entire north aisle (Plate 13). No graffiti or other points of interest were noted. However, when the lead had been removed, a section of brickwork between the top of the timber boards and the string course on the north nave wall was exposed (Plate 14). It was also noted that the west and south walls had blockwork beneath the render (Plate 15).
