KDK ARCHAEOLOGY LTD

Archaeological Summary Report

St Mary's Churchyard

Luton

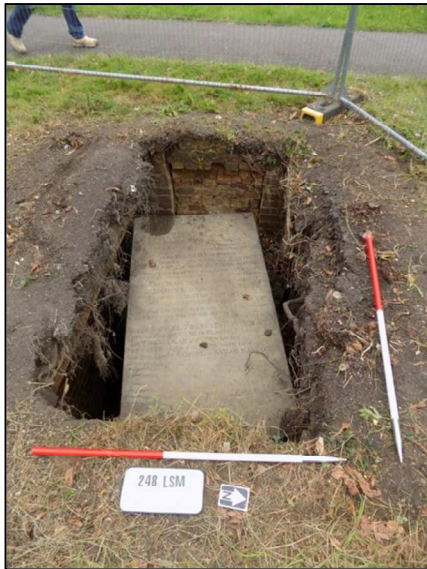
Plate 1: Ledger in situ looking west

The stone ledger had fallen to a depth of 0.72m below ground level (Plates 1-2; Fig 4). The slab, which was of York stone, measured 1.98 x 1.06 x 0.11m and was orientated east-west with the top of the ledger to the west. The stone was in excellent condition and the inscribed text was clear and legible (Fig. 5). Slight damage had occurred on the southern side of the stone but this only affected the surface and there was no visible loss elsewhere (Plate 6).

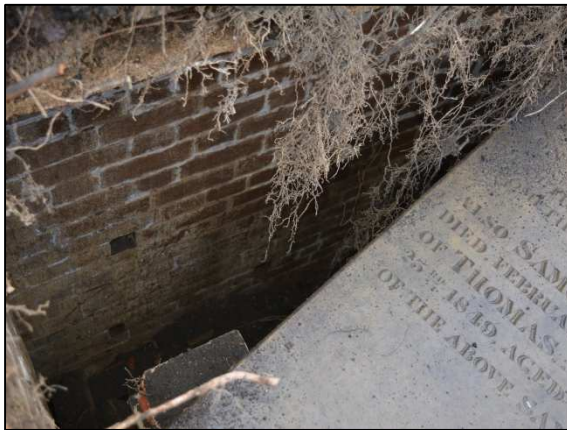
Plate 3: View into the vault (2016) looking southwest

Bricks possibly from the vaulted roof were observable in the initial site visit in 2016 but had silted over by the time the grave slab was lifted. Leaf litter and other debris had fallen into the vault further obscuring the view of the vault base (Plate 3).

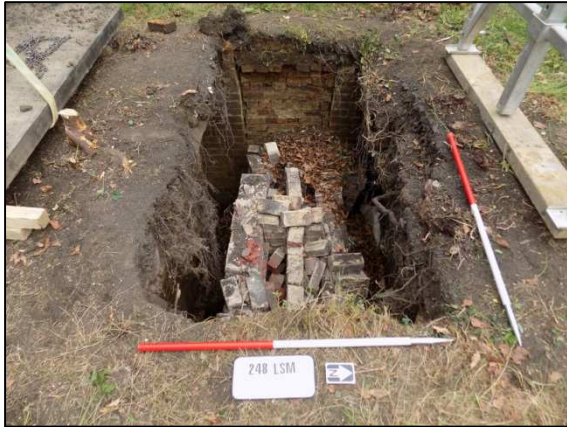
Plate 7: The chest tomb looking west

The removal of the slab exposed the collapsed chest tomb below (Plates 7-9: Fig. 6).

The chest tomb measured 1.95m long by 0.86m wide and was approximately 0.80m deep. It was roughly 15 courses high and had a large flat worked stone slab in the north and south sides, framed above and below by a course of lipped bricks. The standard bricks, which measured 22.5 x 11 x 7cm (9 x 4¼ x 2¾ inches) were frogged and some had horizontal skintlings.

The bricks had been heavily disturbed by the fall and many had become displaced, particularly to the west. Visibility was restricted beyond the top few courses of brick and due to the limited space and unsecured floor surface entrance into the vault itself was not possible. The internal measurements of the vault were 2.26 x 2.09m and the vault floor was approximately 1.80m below ground level. The bricks used in the vaults construction were well made, measured 22.5 x 11 x 6.5cm (9 x 4¼ x 2½ inches) and were set in a friable lime mortar. Some repointing in a yellowish white firm mortar was visible on the east and south walls (Plates 11-12).

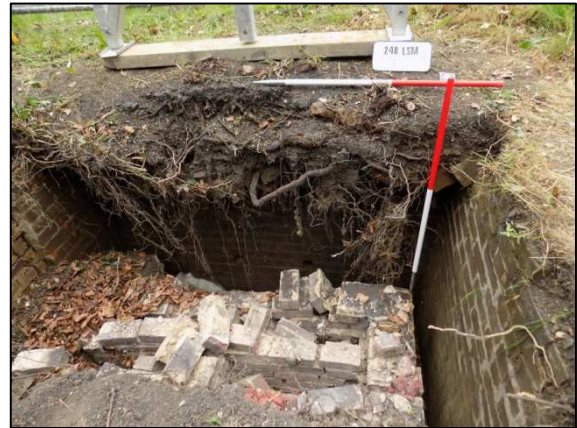
Plate 10: Rooting damage looking south

This Watching Brief was undertaken in response to the collapsing of a grave monument which occurred in October of 2016. The tomb was located approximately 13m to the north of the church (Fig. 3). The collapse occurred due to the presence of a large rose bush whose roots had destabilised the monument. Heavy rains in the lead up to the collapse proved to be too much causing the structure to drop into the vaulted tomb below. The lifting of the ledger stone was monitored under archaeological supervision. The vault beneath was then recorded and the void was backfilled with approximately 12 tonnes of topsoil. Once the area had been filled, the stone ledger was placed back on top of the tomb (Plates 1-5 & 15-16).

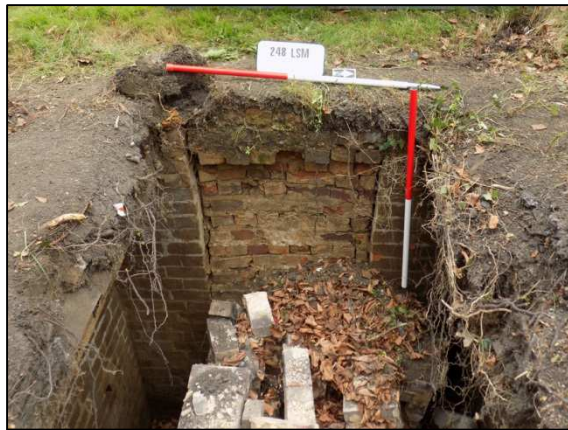
Plate 13: Bricked up vault entrance looking west

To the west of the vault was a bricked up entrance way (Plate 13). This measured 0.87m wide by 1m deep and had been bricked up with 15 courses of frogged Fletton bricks set in an orangey yellow lime mortar. The bricks measured 22.5 x 11 x 6.5cm (9 x 4¼ x 2½ inches)

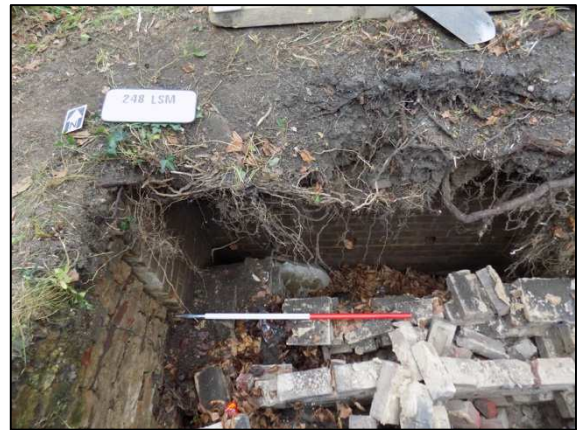
Plate 14: Displaced gravestone in northwest corner looking north

Regular holes in the wall of the vault may suggest that there had been or was intended to be, shelves to hold individual coffins; however no coffins were observed within the vault. In the northwest corner a displaced headstone was exposed. The headstone had become pinned between the chest tomb and the vault wall. No inscription could be seen on the stone and no measurements or further investigation could be undertaken due to the vault being inaccessible (Plates 15-16).

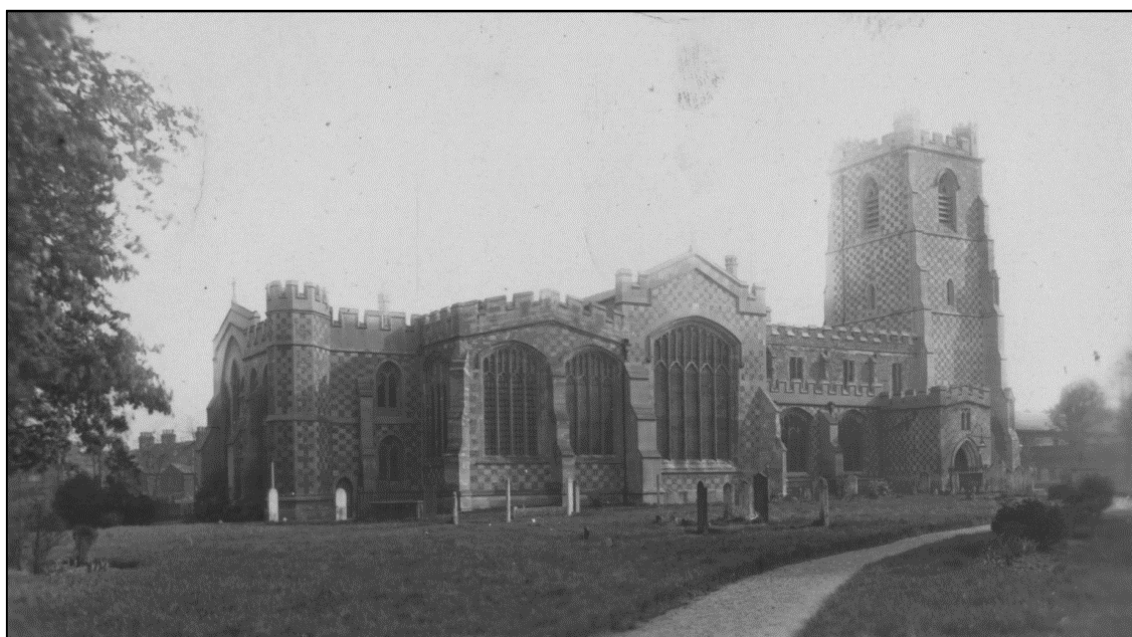
Plate 18: Early 20th century Photo of St Mary's

It is difficult to determine the process of the collapse of the tomb. It appears that the collapse was a single instantaneous event with the tomb and the vaulted roof falling and crushing any burials that may have been beneath. The collapse of the brickwork and the subsequent silting over of the vault floor may have obscured any human remains or funerary furniture from view. The rosebush, the roots of which seemed to have been assisting in holding up the tomb is noted to have been on the site as early as the Second World War and perhaps earlier (Orrin *pers comm*). A postcard from the beginning of the 20th century shows the chest tomb intact and free of any vegetation. Although taken from a distance, a rectangular structure can be seen on the Haydon family plot (Plates 18-19).
