KDK ARCHAEOLOGY LTD

Historic Building Impact Assessment

37a Market Place
St Albans
Hertfordshire

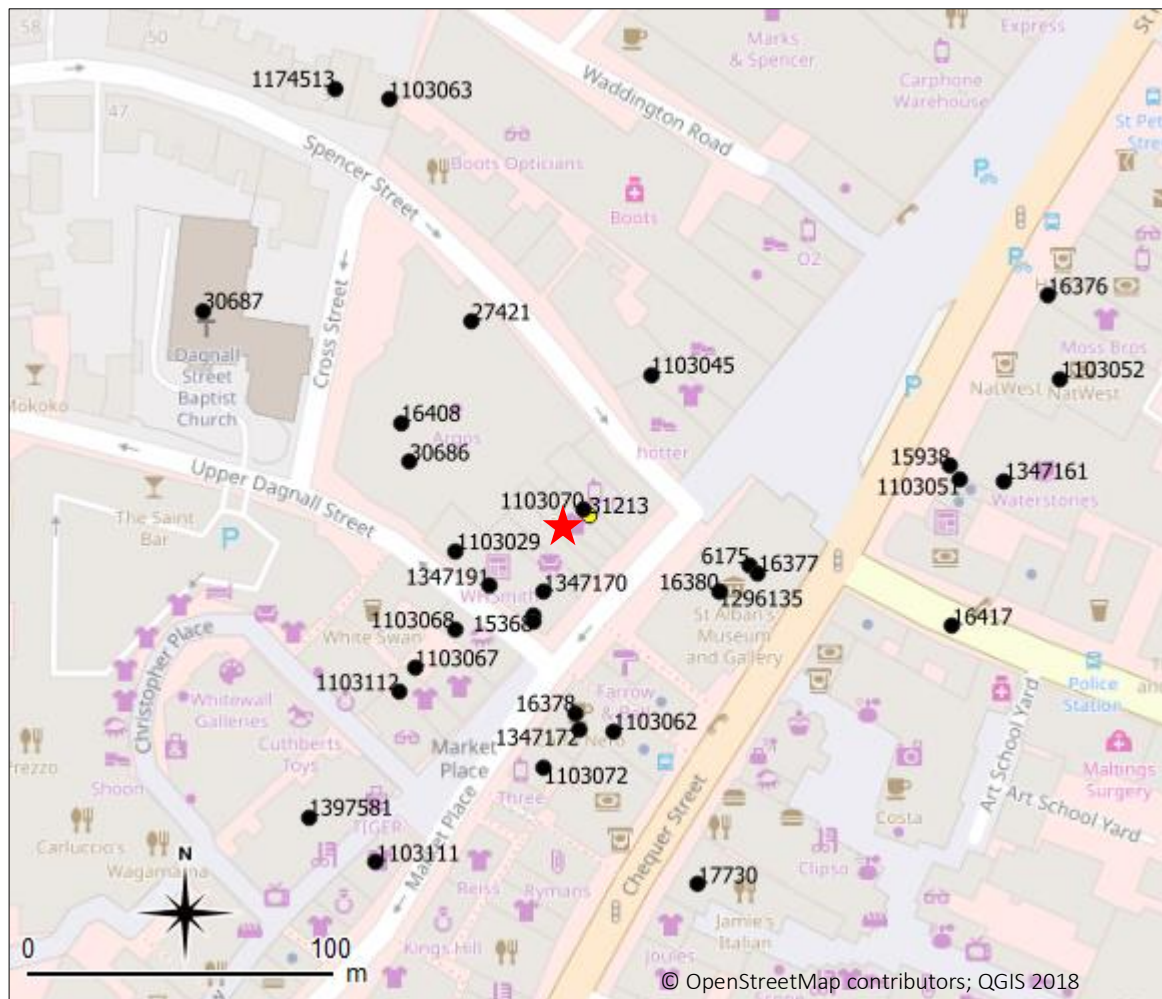
Figure 5: Listed and other historic buildings in the Historic Environment Record (scale 1:2500)
Number 37 is marked by a red star

Number 37a Market Place is located on the western side of the market, in an area which was laid out at the end of the 12th century (Niblett & Thompson 2005:275). The burgage plots on either side of the market square are still evident on present day mapping (Fig. 2), although considerable alterations have occurred within the plots themselves. Nonetheless, there are a considerable number of listed buildings within the immediate vicinity of Number 37 as can be seen in Figure 5 and Table 1 below.

There are some 20 historic buildings within 250m of the property, which are shown on Figure 5 and detailed in Table 1.

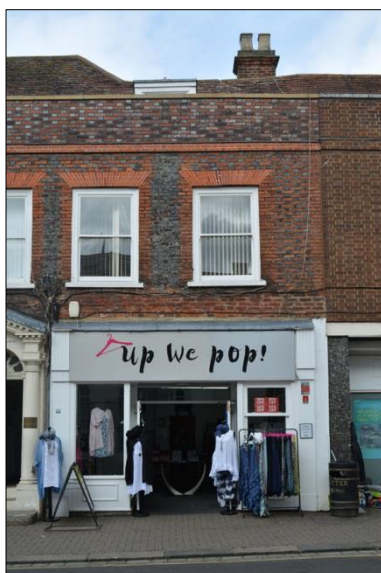
Plate 2: Detail of shop frontage

The shop front is a very rudimentary early – mid 20th century feature with a three light sash to the right of the recessed doorway and a single pane to the left (Plate 2). The fascia above the door is unadorned, but the entire architrave is likely to have once been the same as that to the left of the main door into the building. The brickwork above is typical of late 17th and early 18th century work with rubbed bricks surrounding the windows, a brick plat band above the first floor windows and, in this instance, a flat topped parapet obscuring the double pitch of the structure beyond.

The shop front has been described above and has no further details of interest on the interior aspect. It is clear, however, that it is in need of some attention.

The proposed alterations have been designed to have a minimal impact on the historic fabric. The recessed shop entrance will be retained but the window to the north of the door will be replaced with a single light to match the other shop windows within the building as a whole. This will have minimum impact on historic fabric as the shop frontage is no earlier than the first half of the 20th century and is currently in poor repair. The proposal can therefore be considered to have a neutral or even positive impact

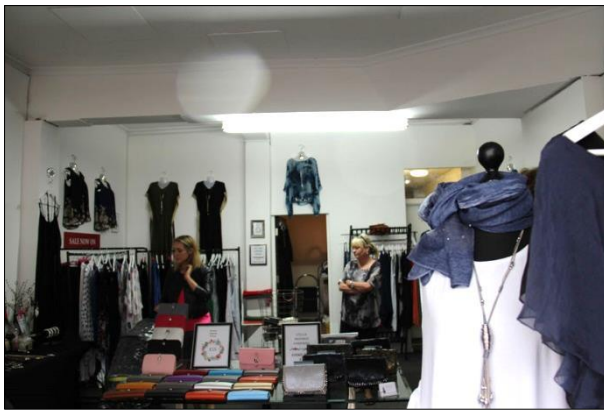
The interior of the shop has been completely lined so no original features are exposed (Plates 5-9). That there may be some historical fabric left of the ceiling is hinted at by the small extent of cornice that has not been covered by the lining and the hooks that would have supported lights or cables for lights (Plate 9).

The interior of the shop will be relined to allow for new tiling, lighting, heating, plumbing and air conditioning. In order to assess the impact of these proposals inspection areas were opened within the present lining to the walls and the ceiling. It was found that the northern wall is simply plastered brickwork whereas the wall to the south has lath and plaster behind the modern plasterwork (Plates 18-19). The means of fixing the new lining has been described as follows:

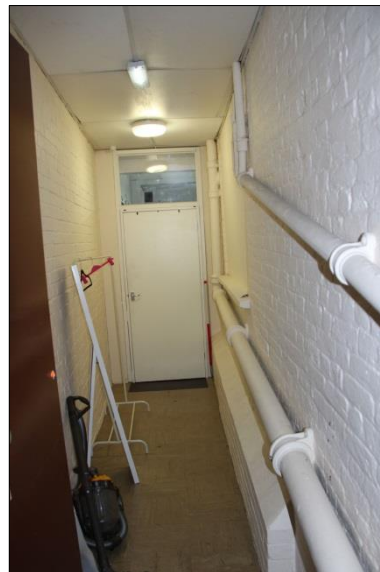
The door to the right opens into a passage that extends the full length of the building and opens into the enclosed yard to the rear (Plates 12-13). At the far end of the passage is a sink and tea making station. The wall to the left is clearly part of the original house as an original window with queen closers to either side survives at the eastern end although it has now been blocked (Plates 13-14). The bricks in the south wall are similar in size and form to those in the front and rear walls and some have diagonal skintlings (Plate 15).

An HVAC unit is also intended to be fitted in due course, the associated pipework for which would run along the modern wall in the passage, having avoided historic material within the shop, to the yard where the unit would be attached to the modern wall to the right of the passage door.

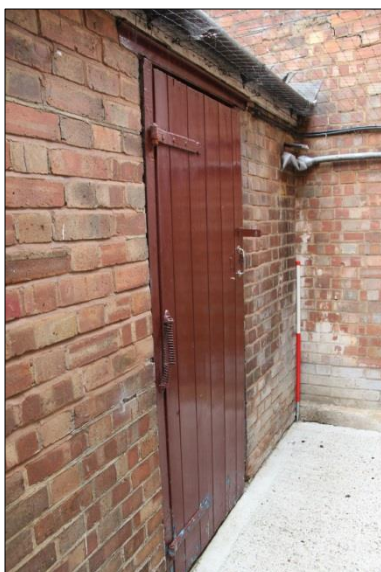
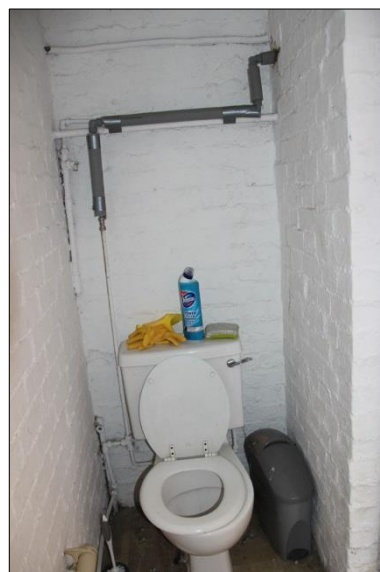
The WC is in a separate building at the far end of the enclosed yard, built in the late 20th century in Fletton Brick (Plates 16-17).

The tea station and external WC will simply be redecorated, which can only have a positive impact.
