## Archaeological Observation and Recording Report

The Lodge Wall

RSPB

Sandy

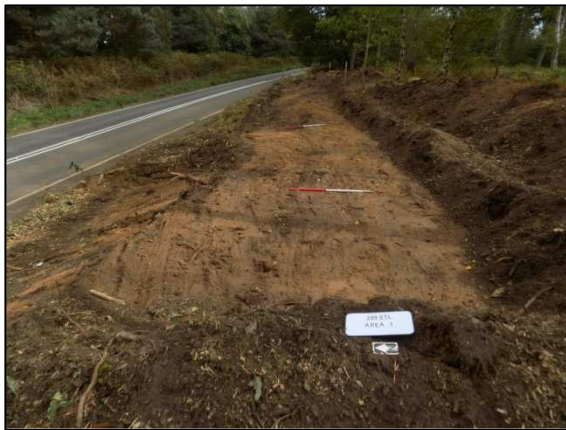
**Plate 1:** Area 1, looking east

Areas 1 and 2 were located at the eastern end of the site (Fig. 3; Plates 1-3). The excavation entailed the stripping of a large area south on top of a steep gradient. The area was stripped down to the natural geology under archaeological supervision before being reduced further at a later date. Although the areas are joined, they were stripped independently of each other; the first, Area 1 to the east, followed by Area 2 to the west covering a combined space of 391.39 sq m. Within Area 1 was a single linear feature [003] (Figs. 4-5; Plates 5-6). This comprised a shallow cut with irregular sides and a U-shaped base which had been greatly affected by rooting. The entire feature measured at least 8m in length and continues beyond the limit of excavation at both ends. The feature is a possible ditch which was orientated northwest-southeast across the trench. It contained a single fill (004) which was void of any datable material.

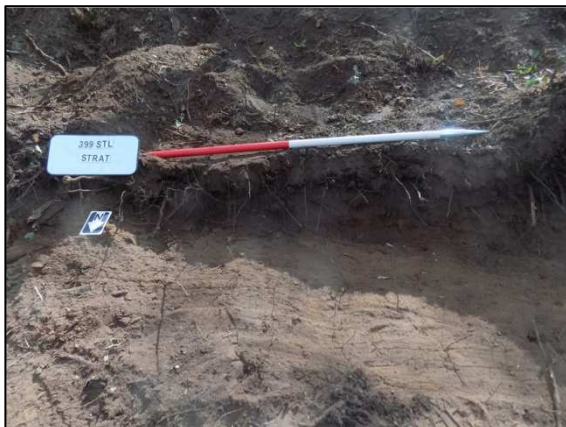
**Plate 3:** Site stratigraphy

<i>Context no.</i>	<i>Type</i>	<i>Dimensions (max)</i>	<i>Description</i>
001	Layer	D<0.42m	Topsoil found throughout the excavated area. Mid greyish brown, very loose silty sand containing occasional rounded stones. Heavily disturbed by roots and there were several established trees in the vicinity. The soil was sterile of any finds though modern detritus was visible on the surface.
002	Layer	-	Natural geology found throughout the site. Mid brownish orange very loose silty sand. Sandstone appears in patches and can be found beneath the sand in large bands. Heavily affected by rooting.
003	Cut	L: >8.00m W: 0.36m D: 0.13m	Linear feature with irregular sides and a U-shaped base which was heavily affected by rooting in places. Orientated NW-SE. Filled by (004). Ditch or root run, located in Area 1
004	Fill	L: >8.00m W: 0.36m D: 0.13m	Fill of [003]. Mid greyish brown, very loose silty sand which contained occasional rounded stones. Rooting present throughout in great quantity. No datable material recovered from the fill.

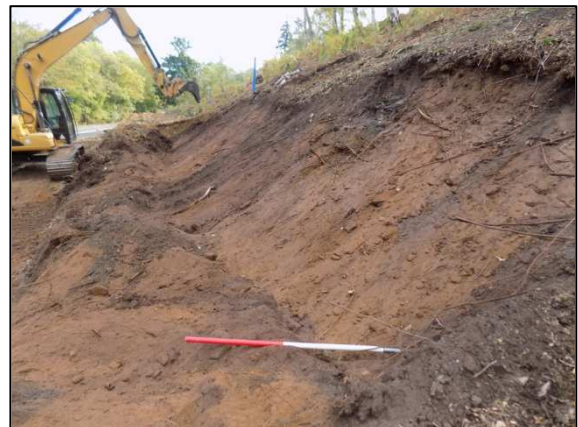
**Plate 4:** Area 3, looking northeast

Area 3 was situated at the western end of the development site (Fig. 3; Plate 4). A large 55m area was reduced along the gradient and at the base of the slope to the required depth. The area was heavily rooted and no archaeological features or deposits were exposed. After discussion with CBCAT, it was decided further monitoring visits were not needed.

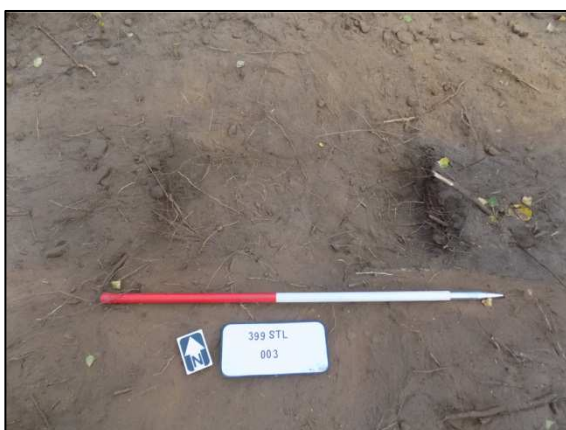
**Plate 5:** Ditch/root run [003]

During this investigation, only a single ditch orientated northwest-southeast was observed in Area 1. The function of this feature is unclear but it appears to have been filled by natural processes before the subsequent rooting had taken place.

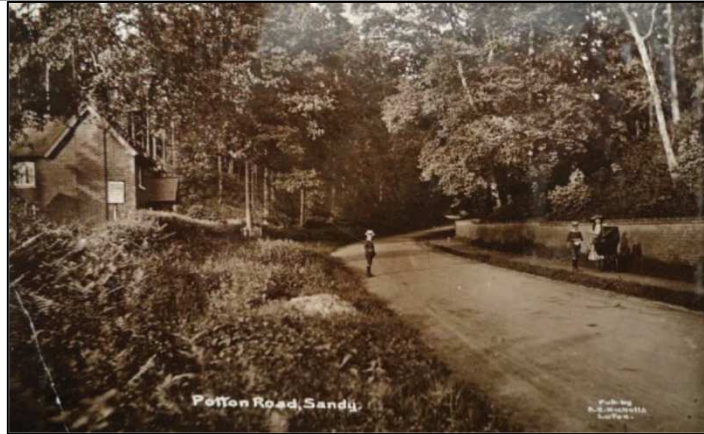
Captain Peel also paid for major agricultural improvements across the estate, the planting of new trees and construction of a wall enclosing the estate “each side the Potton road” (1857). But what exactly the latter refers to is unclear. The extent of the wall along the Potton road is not known – how far it extended east towards Potton has not yet been discovered. It is presumed that this wall was built of brick, as was the house, and capped with freestone slabs. But a postcard printed c1900 of the Potton Road and the wall along its south side is the earliest record of its form that has so far come to light.

*Figure 3: Postcard that includes the brick wall along the south side of the road to Potton*

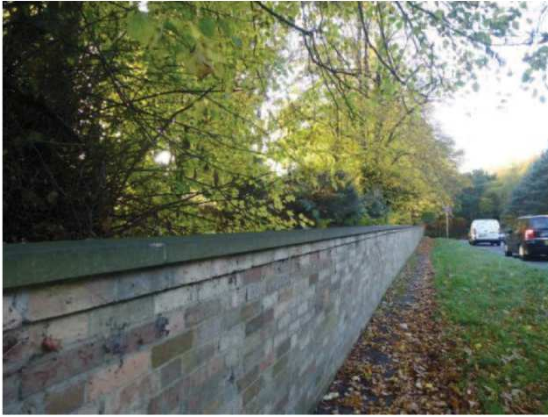
*Figure 4 (above): Part of the wall rebuilt by the RSPB in 2009*

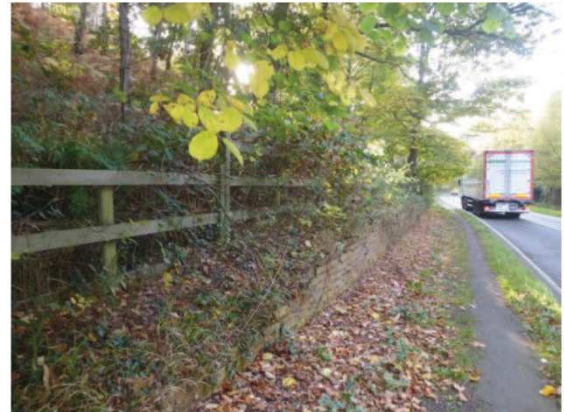
The remainder of the brick wall was already in a very poor condition, suffering from damage caused by people wanting to acquire the capping stones, by hill creep, and by the catastrophic effects of car and lorry accidents. These factors have resulted in the destabilisation and collapse of lengths of the wall through the dry valley. Originally 20 bricks high plus its stone capping, none of the wall survives to its full height through the combe. Parts are reduced to less than 6 bricks high.

*Figure 5 (right): An upstanding stretch of the remains of the wall in the combe*

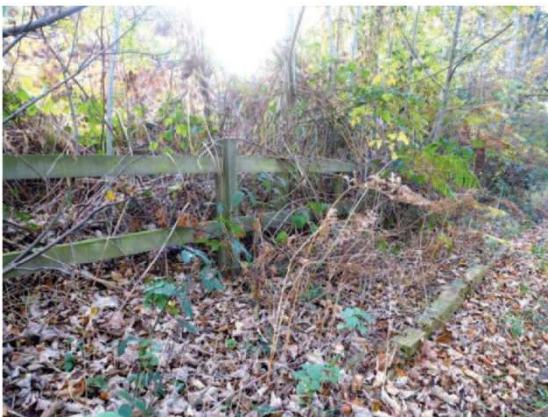
*Figure 6 (above): In places the wall hardly survives above the level of the pavement*

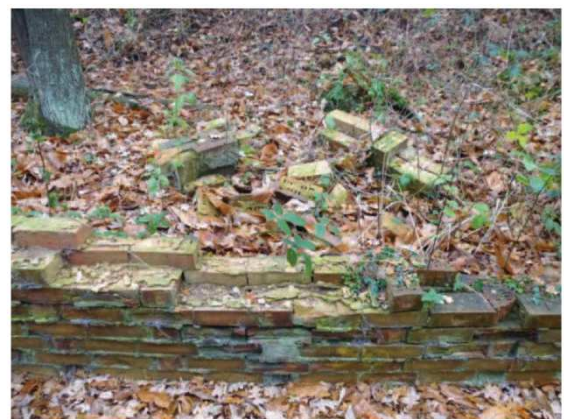
*Figure 7 (right): The result of a car crash in 2016*

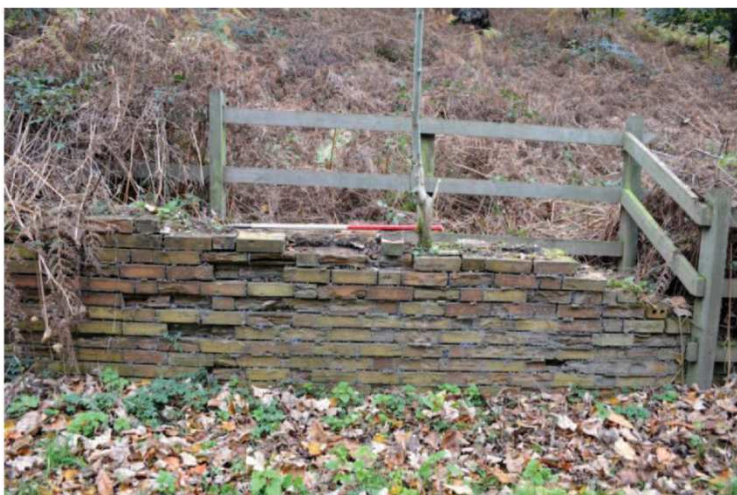
Figure 8: W1 West end (Sandy end)  
NGR TL 18424856

Photographs of the wall (digital jpeg and RAW files as well as 35mm B&W film) were taken every 50m along the length of the site (Figures 8–15 below, pp8–10). These record the external face and 'top' of the wall. No photos were taken of the internal face at this stage as it was masked along its length by slumping of the hill slope. A sketch plan identifying the location of these photos was produced and notes were made of the brick size, type and bond.

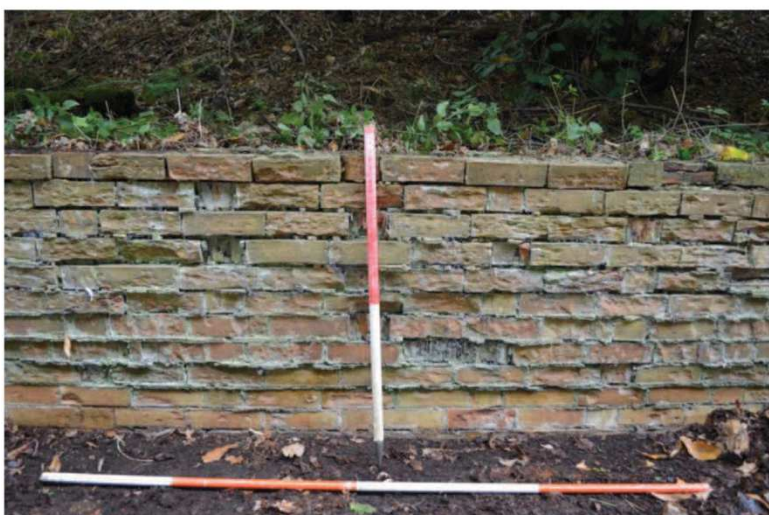
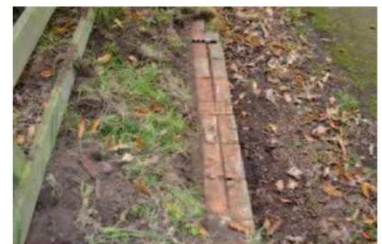
Figure 13: W6 @ 250m  
NGR TL 18654861

Three brick piers, 1.25m high from the base of the wall and 0.12m wide, keyed into the wall at 11.2m intervals were found in September 2018 to either side of W6. The upper two courses of the piers use bevel-design bricks to provide a 'finished' look. Two others were recorded at TR3 and TR1. To ensure the stability of the wall, they would have been built along its length. When this recording work was undertaken the piers were not visible along the other sections of the wall due to soil slippage, trees and scrub growth but they are to be seen along the rebuilt wall length to the east.

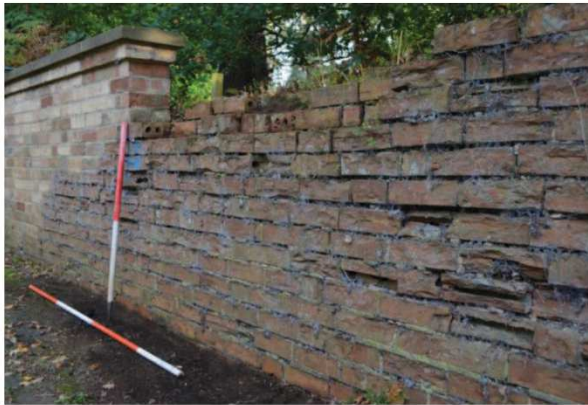
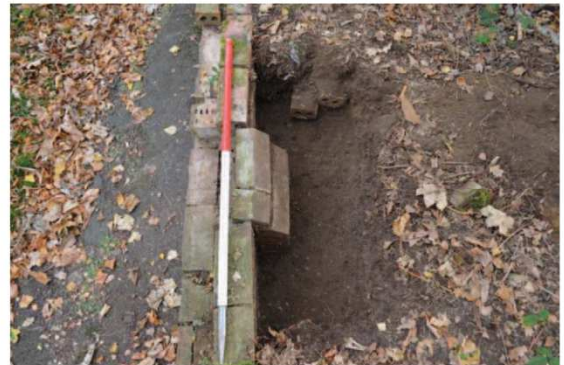
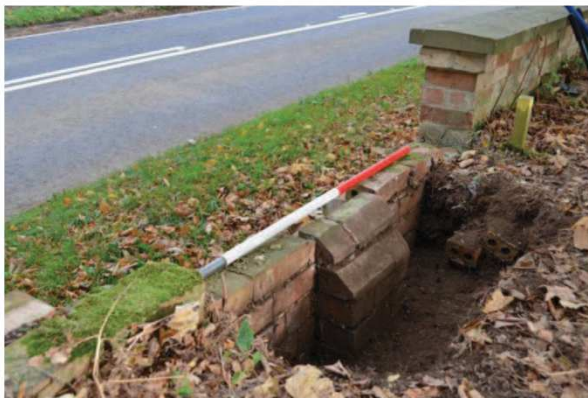
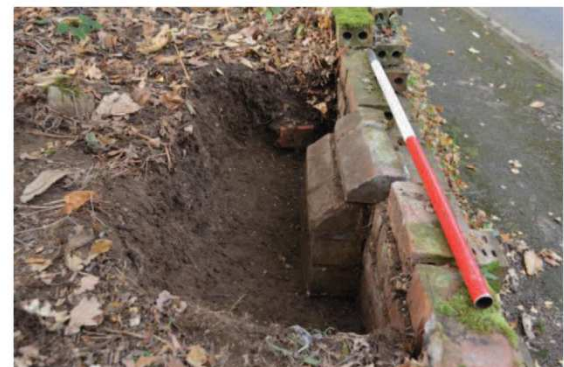
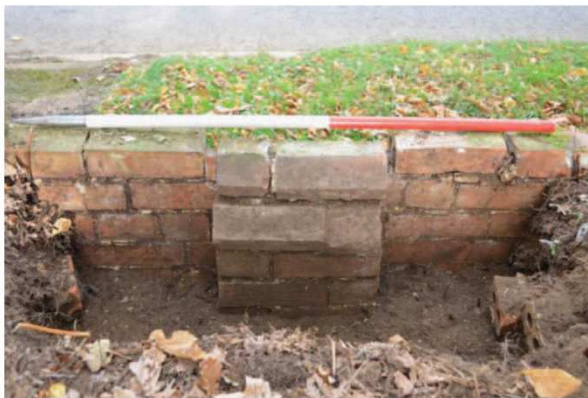
Today, the wall only survives intermittently along the site, but when built it was 1.6m high from the base of its lowest course (ie 20 courses high plus the slab capping). It is c0.23m wide (the length of a brick), with the uppermost brick course overhanging by up to 0.02m on both faces. The stone slabs that used to cap the wall overhung this course by around 0.02m on both sides. There was no clear evidence of any building repairs to the wall.

Figure 19: Composite sections / profiles across the brick wall in Trench 1 and Trench 2
