KDK Archaeology Ltd

Historic Building Watching Brief Report

37a Market Place

St Albans

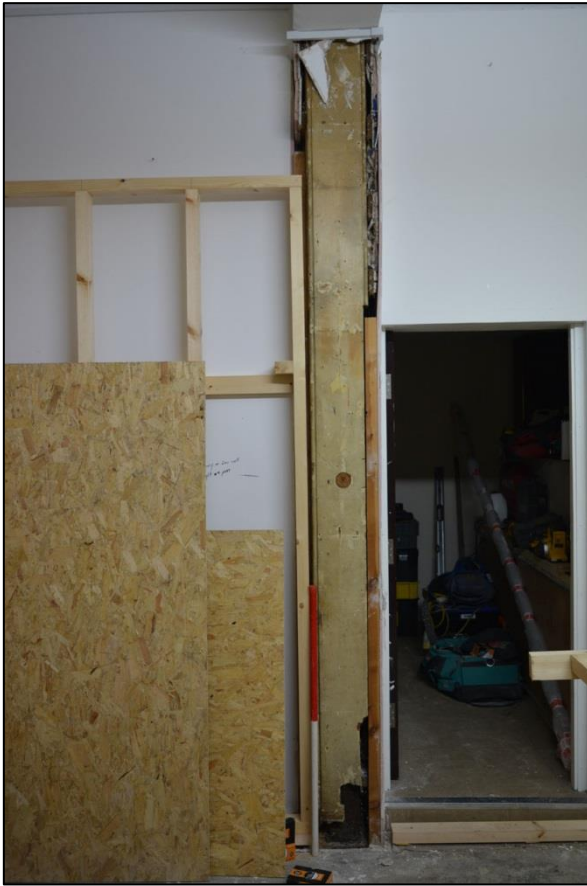
Plate 1: North wall

A single site visit was undertaken to record the works to the shop. As the works had been planned to impact as little on the existing building as possible the only freshly exposed building fabric was the concrete floor, the steelwork in the north and east walls and a very small area of brickwork next to the eastern steel (Plates 1 & 2). This was too slight to be able to take any measurements or fully assess the fabric of the bricks. The only feature of note associated with the steel in the north wall was a length of skirting board that had been attached to the front of it to provide a flush finish. The frame on which the new wall lining as well as the suspended ceiling was to be constructed was partially constructed and no further areas of the shop were to be exposed.

SITE NO/CODE: 426/SAM			Site Name: 37a Market Place, St Albans
Shot	RAW	JPEG	Subject
1	x	x	Exposed steel in the north wall
2	x	x	Exposed steel and brickwork in the east wall
3	x	x	View to the northwest showing the new frame

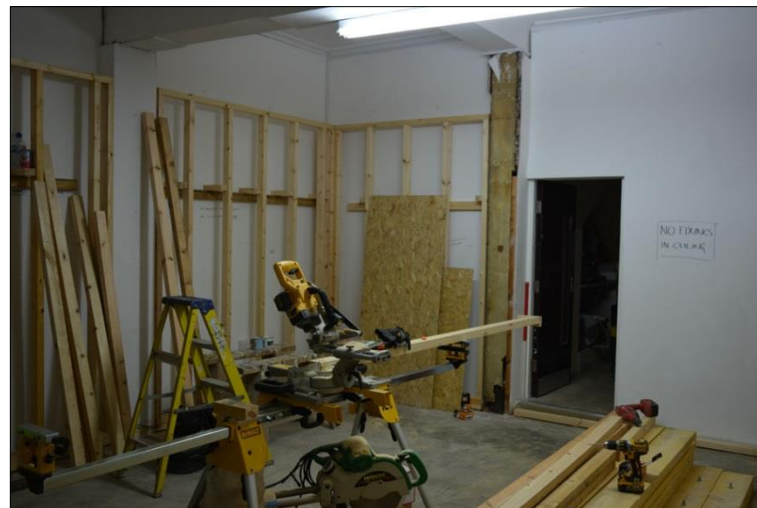
Plate 3: Northwest corner of the shop showing the frame for the new wall and ceiling lining
