KDK ARCHAEOLOGY LTD

Archaeological Evaluation Report

65 St Johns Road
Moggerhanger
Bedfordshire

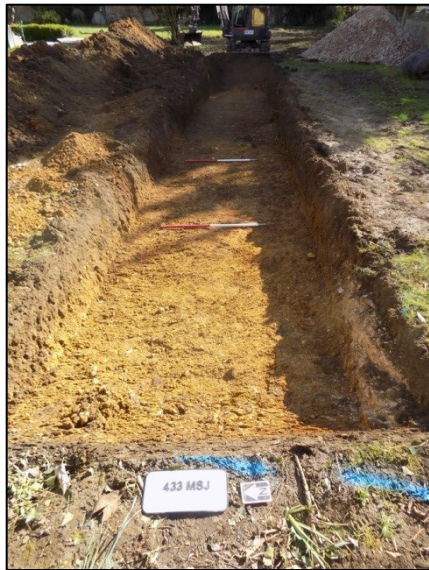
Plate 1: Trench, looking east

A single trench was excavated in the footprint of the new development, to the south of the 19th century Gardener's House (Fig. 6; Plate 1-2). The trench measured 15 x 2m, was orientated east-west and was excavated using a 2.5 tonne machine fitted with a 1.20m toothless ditching bucket.

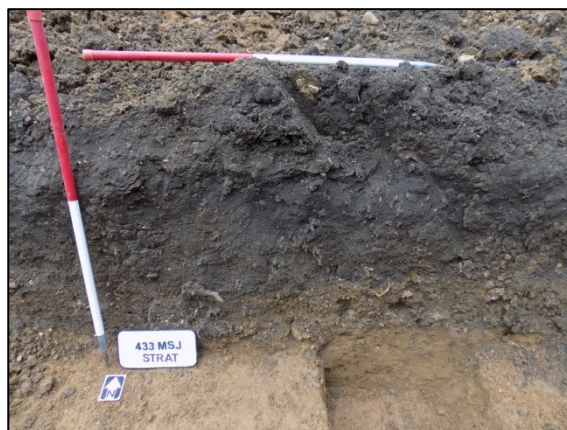
Plate 3: Trench stratigraphy, looking north

The stratigraphy encountered comprised:

- Topsoil (001). A dark brownish grey, friable, very silty sand which contained occasional sub-angular stones as well as small flint pieces. Red and white bricks were also visible in this layer. The topsoil reached a depth of 0.30m

- Subsoil (002). A mid brownish grey, fairly firm, very clayey silty sand. This layer was 0.18m thick, but was not present in the far west end of the trench.

- Interface (003). Just above the natural geology was a mixed brown-orange clayey silty sand which reached a depth of 0.24m. This layer had been heavily affected by rooting and animal activity. Archaeological features were observed cutting into this layer.

- Natural geology (023). Although observed intermittently throughout the trench, it is to the east that the natural strata was completely visible. The natural geology comprised a vivid brownish orange silty sand which was very loose. No inclusions were visible within this layer.

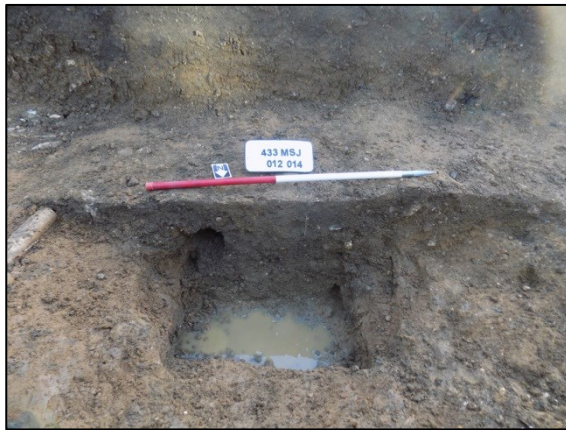
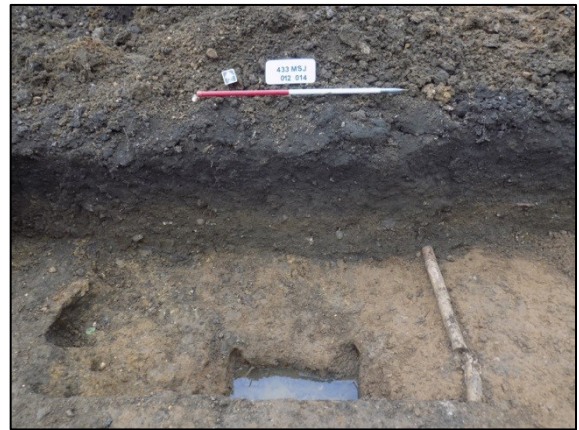
Plate 4: North facing section of Ditch [012] and Pit [014]

Ditch [012] and Pit [014] (Figs. 7-8; Plate 4-5): Close to the east of the trench was a wide, but shallow ditch, [012]. This feature was orientated north-south and measured 2.17m wide and 0.25m deep. The ditch continued to the north and south beyond the limit of excavation. Along the eastern extent of the ditch was a ceramic service pipe, although a separate cut was not visible. It is likely that the ditch was for land drainage purposes and was re-used for the route of pipe when the system was upgraded. It is also possible that the Ditch is the remains of a furrow as ridge and furrow has been noted within the village. A high proportion of post-medieval material was recovered from the fill (013) of the ditch along with a single sherd of Anglo-Saxon pottery. Cut through that single fill was Pit [014] whose sole fill also contained a high proportion of artefacts. The pottery included, tin glazed earthenware and red earthenware pottery, sherds of a stoneware bottle, all of which appear to be Victorian in date. In addition, brick, iron nails, clay pipe and bottle glass were recovered from the fill. The area had been considerably affected by animal activity but a large portion of the feature was visible in plan. The pit measured 1.11m wide and reached a depth of 0.60m. A total length of 0.50m was observed; however, the features full extent continued beyond the excavated section and was not visible in plan.

The archaeological features recorded on the site were probably all post-medieval in date and are probably associated with the Gardner's House which was constructed in the mid-19th century, or agricultural activity nearby. It is likely that function of the largest of these features, Ditch [012], is related to drainage. The feature was shallow, relatively wide, with a single fill and the presence of the service pipe to the east of the ditch with no visible cut suggests the feature was backfilled once the pipe was laid, probably superseding the ditch's drainage function. High concentrations of artefacts were recovered from the fill, enough to suggest that the ditch was used to purposely dispose of unwanted detritus. Square Pit [014] was dug into the ditch. This also contained a high proportion of post-medieval artefacts and was almost certainly used as a rubbish pit.

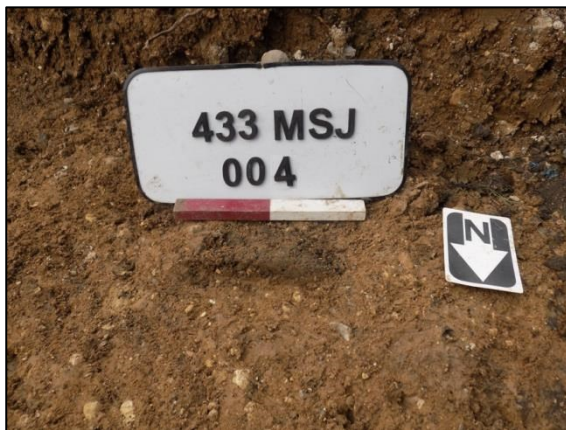
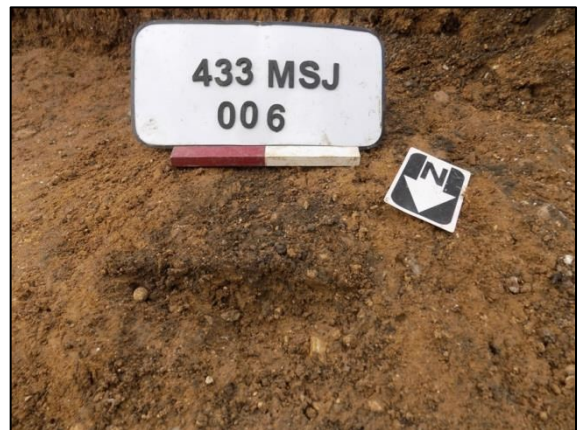
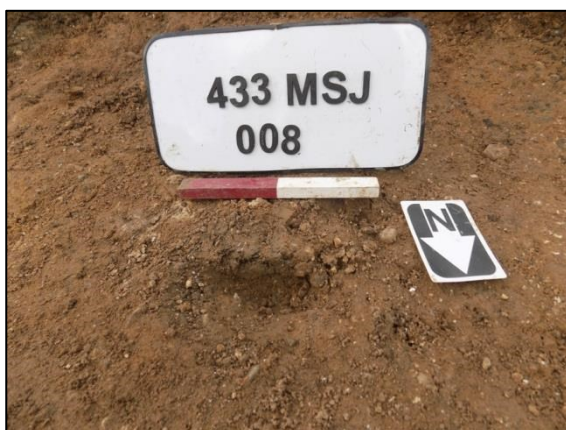
Figure 9: Plans and sections of Stake holes [004], [006], and [008] (scale 1:10)

Stakeholes [004], [006] and [008] (Figs. 7 & 9; Plate 6-8): At the western end of the trench were three stakeholes aligned roughly east-west. They were spaced apart at regular intervals but could not be observed beyond [008]. This may be due to the level of bioturbation towards the centre of the trench. The stakeholes measured c.0.17m in width, between 0.13m - 0.28m in length and between 0.04m - 0.24m in depth and probably represented part of a fence line.

The row of stake holes situated to the west of the trench did not produce datable material. Maps dating to the late 19th century show a rectangular structure in the close to the location of the stakeholes but is no longer recorded in the Ordnance Survey map of 1974. Although not big enough to support a large structure, the stakeholes may well have formed a boundary fence or animal pen in the southwest corner of the site.

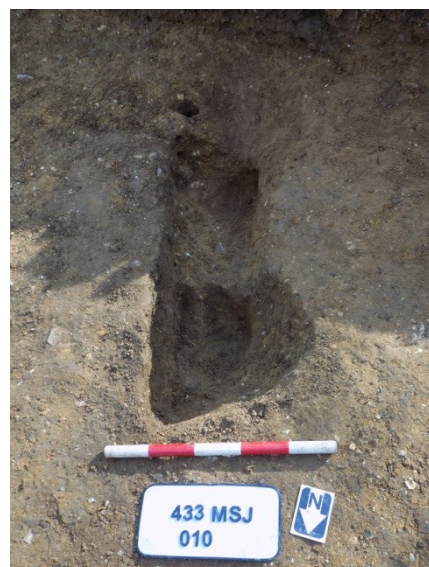
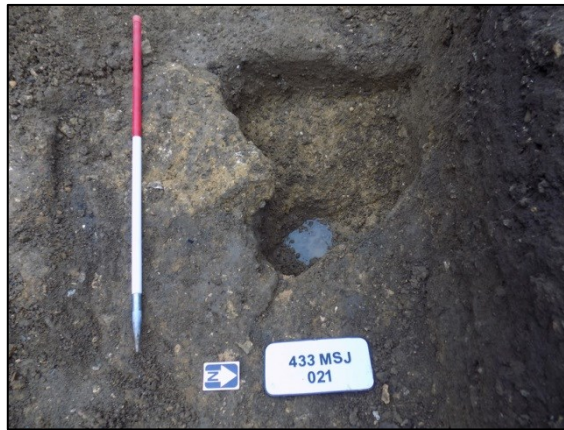
Plate 9: Rooting [010], looking south southeast

Natural forming features [010], [016], [018], [021] and layer (020) (Figs. 7; Plate 9 & 10): The final features exposed comprised large irregular disturbances caused by rooting and animal action. Artefacts were present in the majority of these features which would have been dragged down or fallen in as a result of these activities. These artefacts were all post-medieval in date with the exception of a sherd of Anglo-Saxon pottery which was recovered from the base of tree throw [010]. The other vessels were probably Victorian in date and comprised sherds of red earthenware and tin glazed earthenware. Layer (020) appears to be the extent of another tree throw as which covered rooting [021]. Close to [021] was a roughly square shaped feature which is also believe to be the result of bioturbation.
