KDK ARCHAEOLOGY LTD

Historic Building Watching Brief and Archaeological Watching Brief

14 George Street
St Albans
Hertfordshire

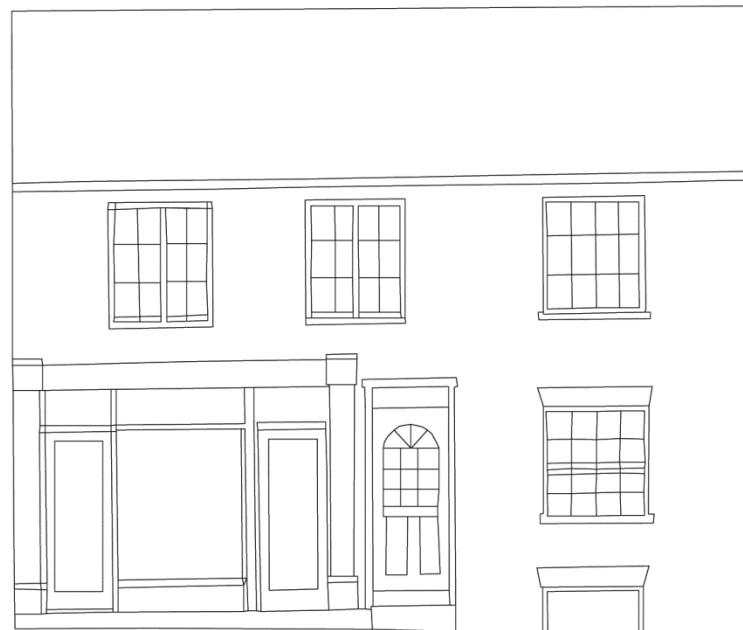
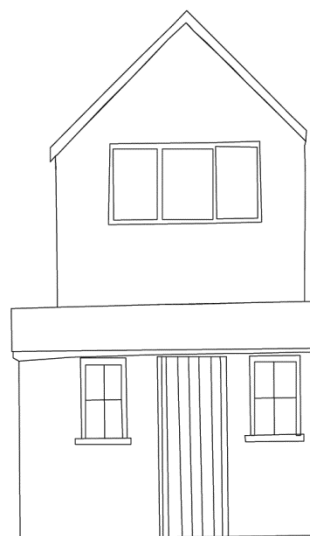
Figure 8: Front and rear elevations (scale 1:100)

The front elevation is built of red brick in Flemish bond. It has an early 20th century shopfront with a glazed door to either side of the large window. The door to the left leads directly to the first floor, which contains offices. There are two timber casement windows with queen closers lighting the first floor.

The rear elevation as a modern single storey brick built extension behind which is a 2-storey extension with a large 3-light window at first floor level. The ground floor has a centrally located door and timber casements to either side.

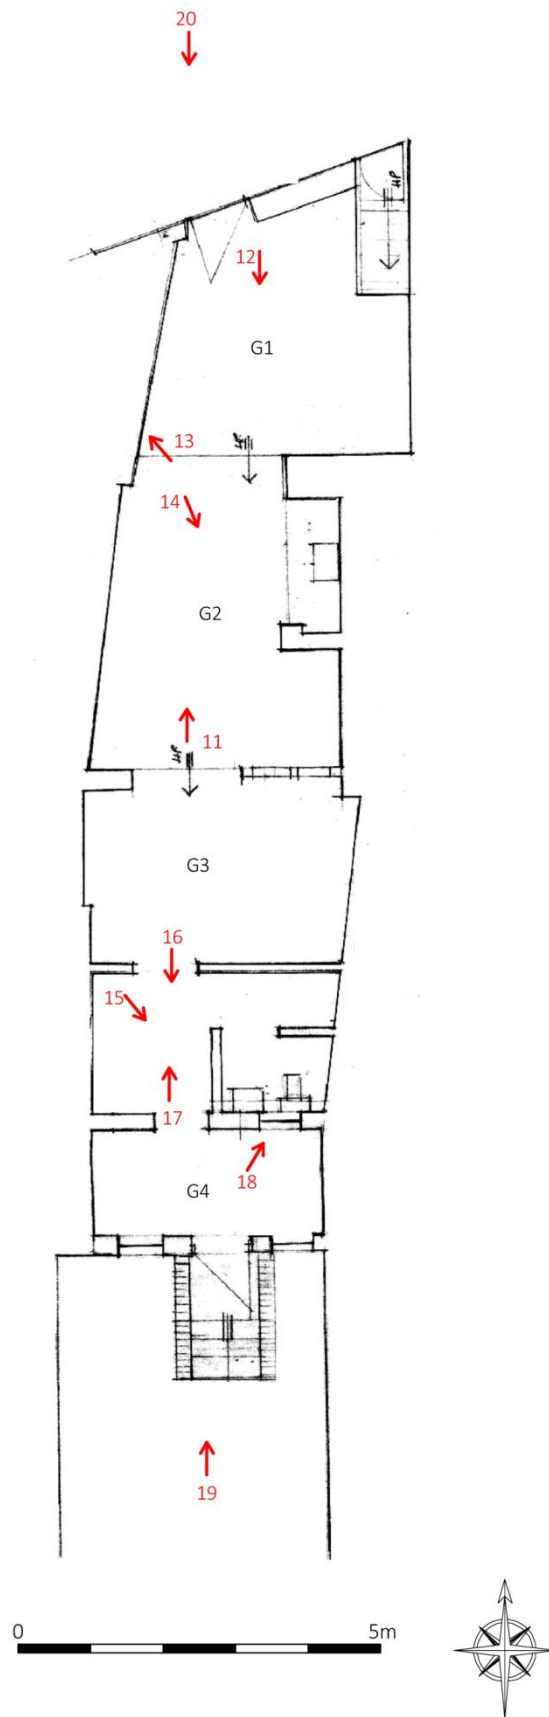
Figure 9: Ground floor plan (scale 1:100)

Much of the ground floor had been stripped prior to the initial survey. The room at the front of the building, G1 had a hatch in the floor to the cellar and was open to Room G2 to the south. Historical joists could be seen above the modern ceiling in G1 and an exposed post in the west wall had a redundant mortice and stave hole. The floor was of north-south aligned timber boards.

There was a step up to Room G2, which had an inglenook fireplace with a salt hole and shelf in the east wall. This had original brickwork in the back but appeared to have been added to in the 18th century. Later repairs and additions were also evident, primarily the hearth and flue which were 20th century. The wall around the fireplace was brick, but the west wall was painted plaster.

A step led up to Room G3, which had been subdivided into four rooms during the previous ownership. There was a 50cm wide, half height wall dividing the western ends of Rooms G2 and G3, but the remaining walls were of painted plasterboard. The floor was tiled and the modern joists were exposed in the ceiling. There was a small window in the south wall, lighting what was formerly the WC. That this was a 19th century extension to the building is suggested by the brickwork in the south wall, which was fully exposed in Room G4.

Room G4 was a 20th century addition and served as little more than a covered yard (Plate 10). The downpipe on the north wall had not been concealed or diverted, and the brickwork remained bare.

In summary, the ground floor had been considerably altered and modernised. The only features of interest were the inglenook fireplace and historical joists in Room G2 and the post in G1.

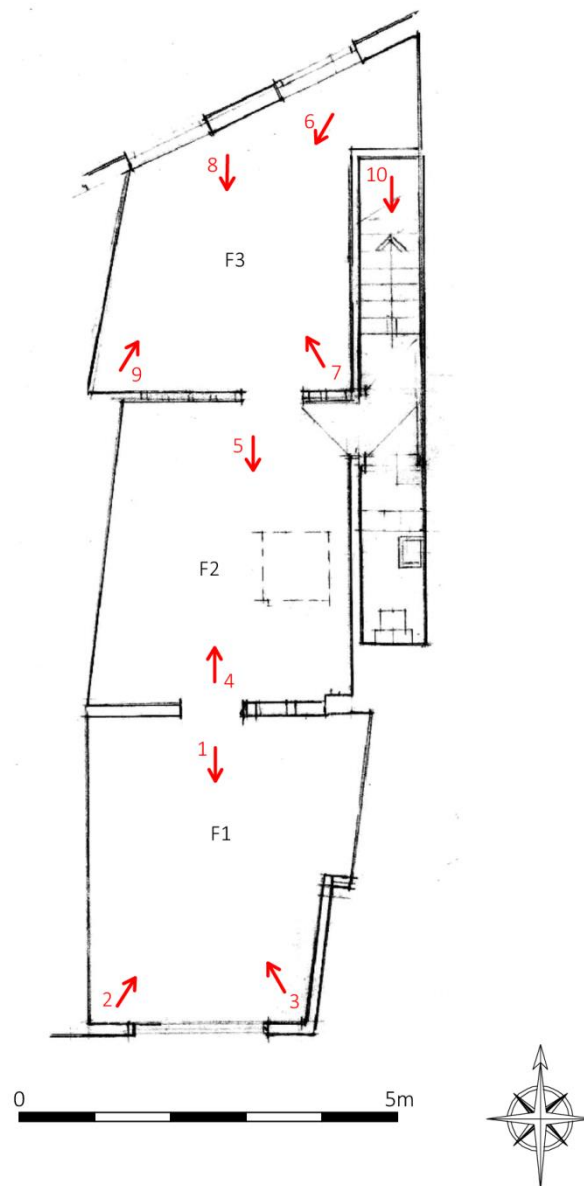
Figure 10: First floor plan (scale 1:100)

A number of historical features survived on the first floor, particularly in the room overlooking the road (F3). Jowlposts survived in the northeastern and southwestern corners of the room, and the timber frame forming the west wall had a centrally located blocked door. The spinal beam was exposed, as were the few timbers in the east wall. The north wall was plain other than the two casement windows.

Room F2 had exposed timberwork in the north wall with an opening in the east to access Room F3. A ledge and braced door in the east wall gave access to the stairs and WC beyond. Some timberwork remained exposed in the east and west walls, and the room was lit by a skylight.

The timber frame making up the north wall of Room F1 had been modernised to house a glazed screen and door. The room was largely modern, but timbers in the junction of the ceiling and walls and posts to either side of the window allowed it to fit in with the neighbouring rooms. A feature of interest in F1 was a slight recess in the east wall.

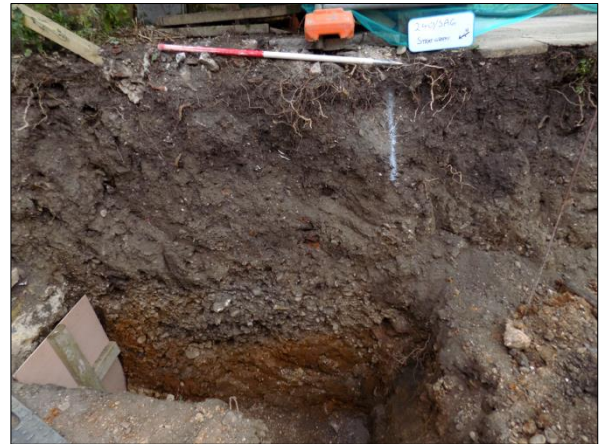
The site stratigraphy was recorded in Trench 1 as this trench had the largest and clearest section. It consisted of topsoil overlying made ground (101) and (102) respectively. These two layers contained a large number of finds including animal bone, pottery, oyster shell and clay pipe components. The ground was clearly disturbed as archaeological finds were uncovered above modern material in some instances. As a result, the finds could not be stratified and the majority were not retained, with the exception of five fragments of pottery from (102) and two examples of clay pipe from (101).

Plate 2: Trench 1 stratigraphy, facing southeast

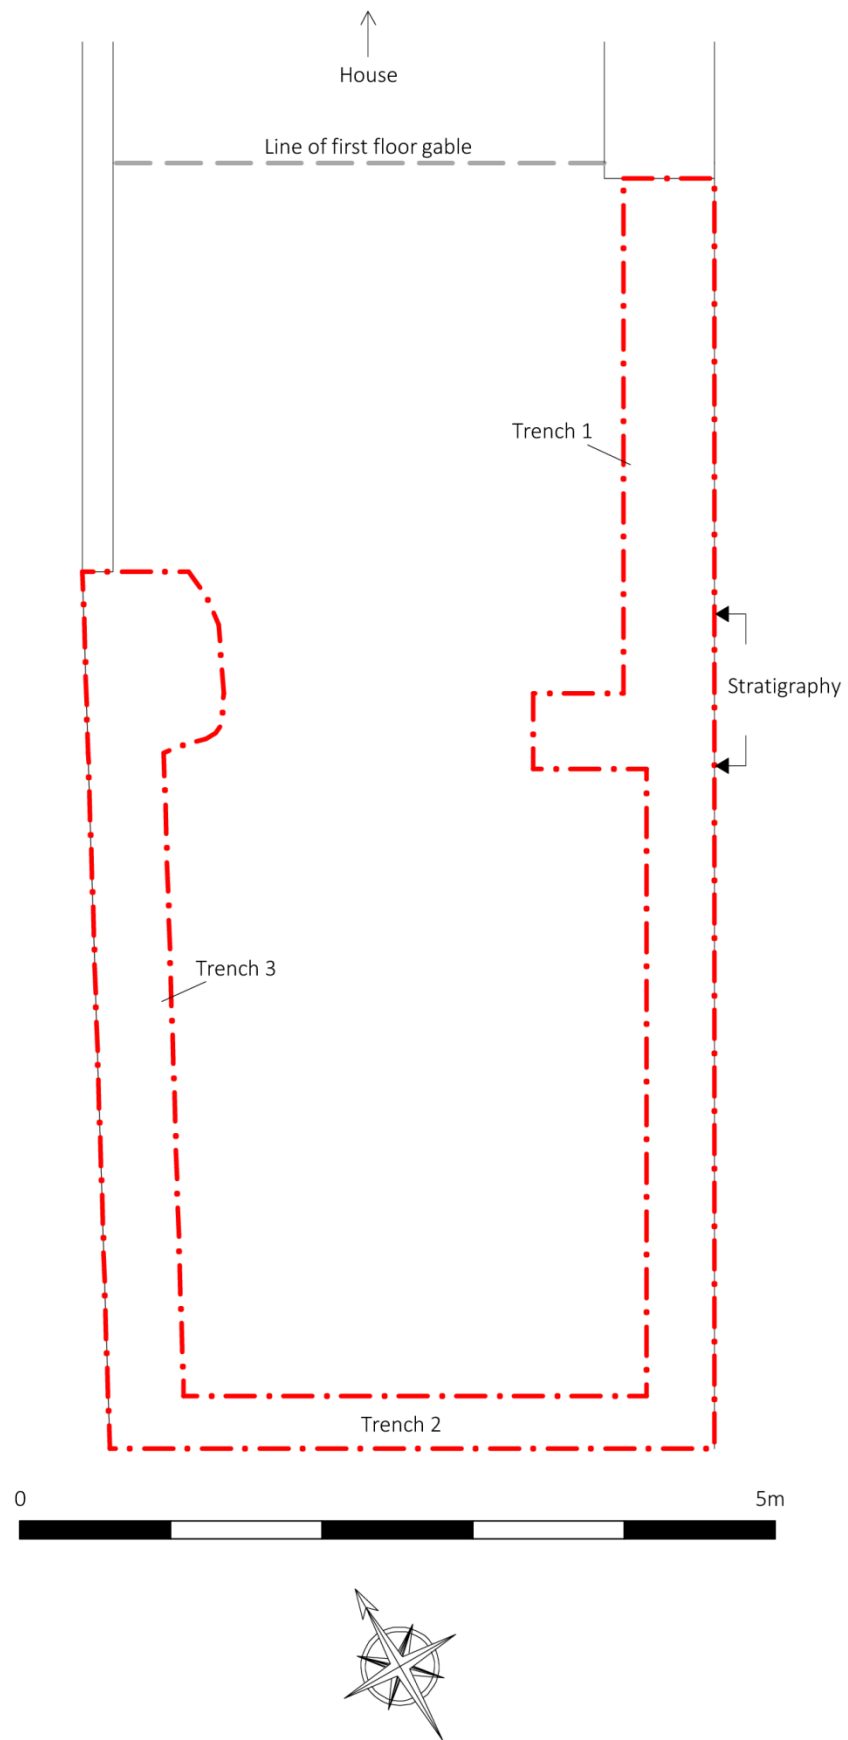
Figure 11: Trench plan (scale 1:50)

This portion of the works involved monitoring the excavation of footing trenches for the proposed garden wall (Fig. 4, Plates 2-8), as well the reduction of the ground surface in the garden in preparation for the installation of a patio (Plate 1). The ground reduction was completed using a 0.8 tonne machine fitted with a 0.75m toothless bucket, the footings were mainly excavated using the same machine but fitted with a 0.45m toothed bucket, although much of Trench 2 was hand-excavated due to space constraints. Trench 1 was 8m in length but varied in width from 0.45m to 0.6m, with a section half way along that was 1.2m wide. Trench 2 was 4m in length and 0.35m wide; Trench 3 was 5.8m in length and 0.5m wide for the most part, except for the north end, which was excavated wider at 0.9m. The trenches varied in depth from 0.3m to 0.7m, although Trench 1 had a much higher section on the southeast side, caused by the higher ground level in the neighbouring garden and the ground reduction that was completed before the trenches were started.

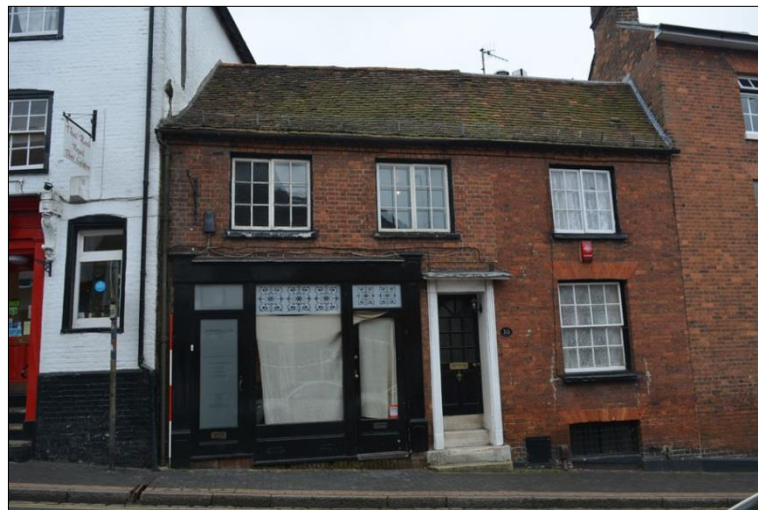
Project No: 240/SAG	Project: 14 George Street St Albans	Elevation: North
Description:	<p>Brick built in Flemish bond under a clay tiled roof. Early 20th century shopfront with a fully glazed door with rectangular light above to left and right of window. The door to the left opens onto staircase leading to first floor as this is a separate unit.</p> <p>Two 2-light timber casements to the first floor with queen closers to either side.</p>	
Recorder: KK	Survey Date: 27.09.2016

Plate 1: North elevation (20)

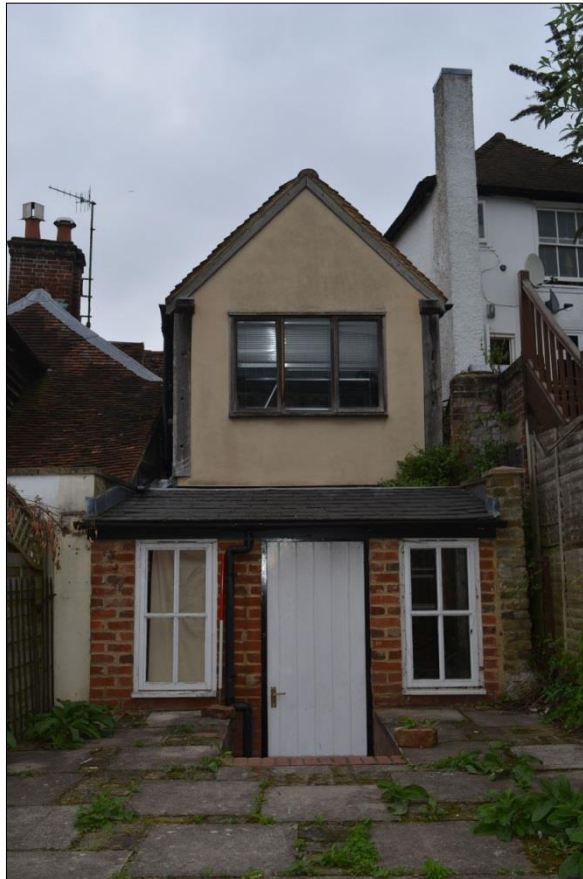
Project No: 240/SAG	Project: 14 George Street St Albans	Elevation: South
Description:	Single storey extension under a slate roof. First floor has been largely rebuilt with machine cut posts and modern timber window. The wall has been rendered and painted. The roof is of clay tiles.	
Recorder: KK	Survey Date: 27.09.2016

Plate 2: South elevation (19)

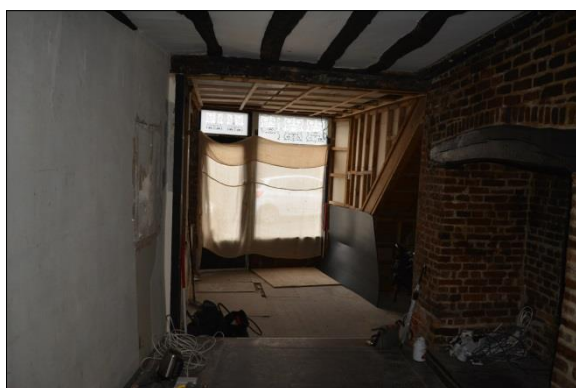
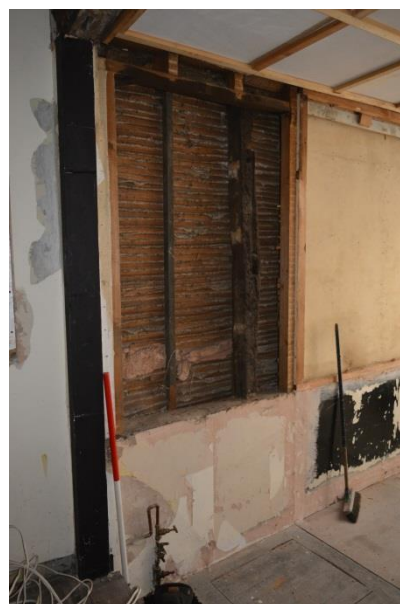
Project No: 240/SAG	Project: 14 George Street St Albans	Room no: G1
Location: On street frontage		Function: Shop
Wall form & decor: Timber studwork with redundant mortice and stave hole partially exposed in the west wall behind plasterboard. Partition wall to east, shop front to north and wall removed to south		
Ceiling / roof structure: Historical joists above modern ceiling		
Windows: Full height shop window to north		
Doors: Fully glazed door with rectangular light above to north to west of window		
Floor: North-south aligned boards with repairs in plywood boards in front of the door		
Fireplace:		
Staircase: Step up to G2 to the south		
Other architectural details: The staircase, which is access by its own front door, is partitioned off to the east of the room. There is a hatch in the southwest corner to the cellar, which was not accessible during the survey.		
Recorder: KK		Survey Date: 27.09.2016

Plate 3: Room G1: view to north (11)

Plate 4: Room G1: view to south (13)

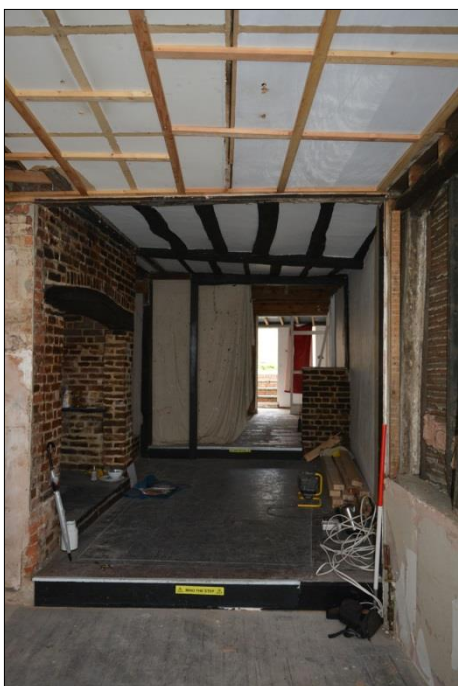
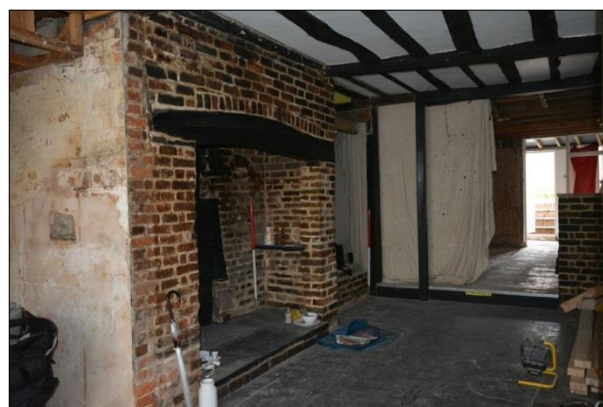
Project No: 240/SAG	Project: 14 George Street St Albans	Room no: G2
Location: South of G1		Function: Shop
Wall form & decor: Brick to east, painted plaster to west. Wall removed to south other than the studs. Open to north		
Ceiling / roof structure: Exposed beams aligned north-south		
Windows: -		
Doors: -		
Floor: Timber		
Fireplace: Brick built inglenook fireplace in east wall. Brickwork to the back is original but it has been added to in the (?) 18 th century and has later repairs and additions including the 20 th century hearth and flue. Original bricks measure 23 x 7-8 x 6.5cm. Salt hole and shelf to the right. Arched timber lintel above.		
Staircase: Step down to G1 and up to G3		
Other architectural details:		
Recorder: KK	Survey Date: 27.09.2016

Plate 5: Room G2: view to south (12)

Plate 6: Room G2: fireplace (14)

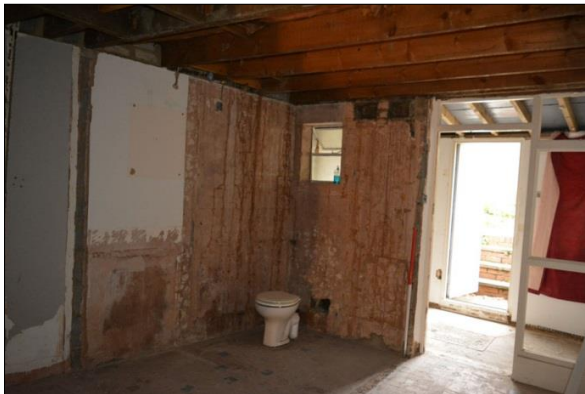
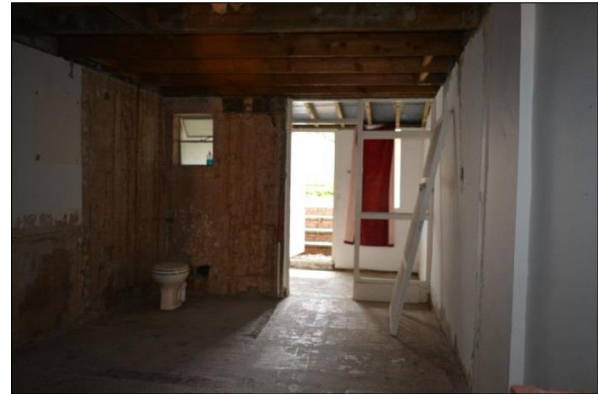
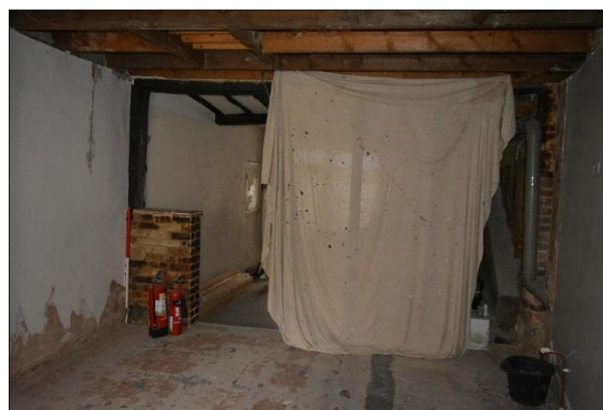
Project No: 240/SAG	Project: 14 George Street St Albans	Room no: G3
Location: south of G2		Function: -
Wall form & decor: Half height brick wall c.50cm wide dividing the western end of Rooms G2 and G3. Otherwise painted plasterboard		
Ceiling / roof structure: Modern joists		
Windows: Small single light window to south		
Doors:		
Floor: Tiled		
Fireplace:		
Staircase: Step down to G2		
Other architectural details: This was recently subdivided into 4 rooms.		
Recorder: KK	Survey Date: 27.09.2016

Plate 7: Room G3: view to southeast (15)

Plate 8: Room G3: view to north (16)

Plate 9: Room G3: view to south (17)

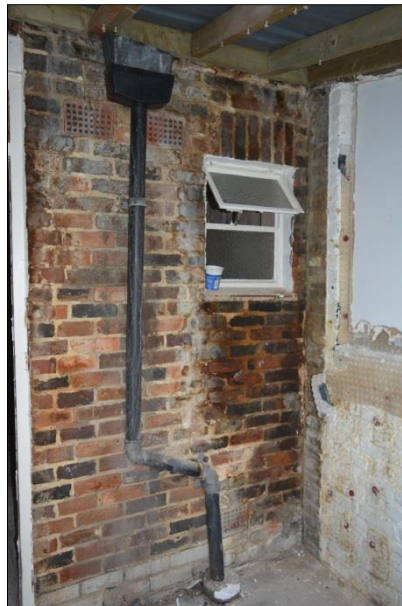
Project No: 240/SAG	Project: 14 George Street St Albans	Room no: G4
Location: Southern end of the building		Function:
Wall form & decor: 19 th century brickwork		
Ceiling / roof structure: Modern joists		
Windows: Two casements to south. Small top hung to north		
Doors: Door between the window to the south		
Floor: Concrete		
Fireplace:		
Staircase:		
Other architectural details: Single storey extension		
Recorder: KK	Survey Date: 27.09.2016

Plate 10: Room G4: northeast corner (18)

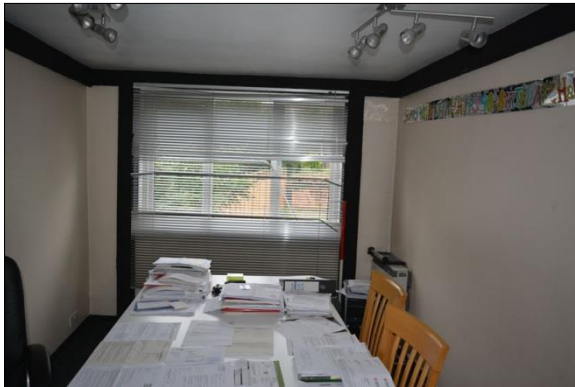
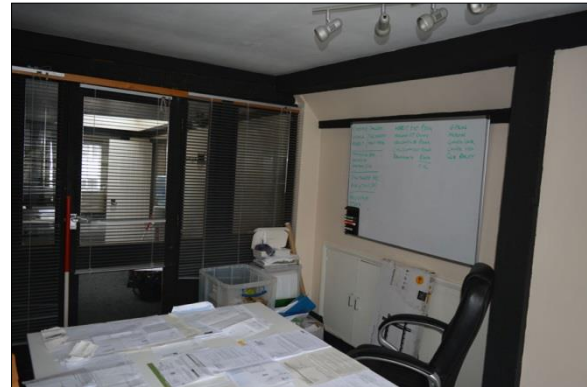
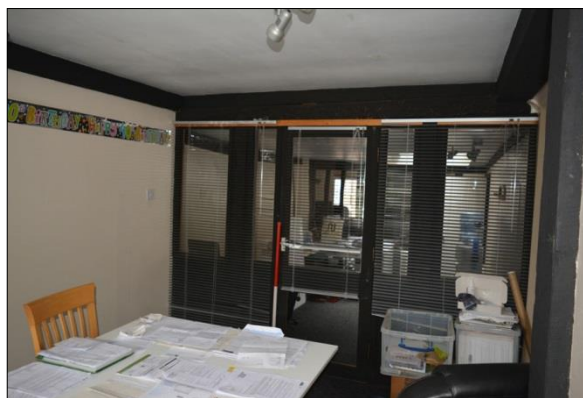
Project No: 240/SAG	Project: 14 George Street St Albans	Room no: F1
Location: Southern end of the building		Function: Office
Wall form & decor: Timber frame to north modernised to house glazed screen and door. Mostly painted plaster but with some exposed timbers including posts to either side of window and beams at junction of the ceiling.		
Ceiling / roof structure: Painted plasterboard		
Windows: Modern to south		
Doors: Glazed door to north		
Floor: Carpeted		
Fireplace:		
Staircase:		
Other architectural details: Slight recess in east wall with built in cupboards at the bottom.		
Recorder: KK		Survey Date: 27.09.2016

Plate 11: Room F1: view to south (1)

Plate 12: Room F1: view to northeast (2)

Plate 13: Room F1: view to northwest (3)

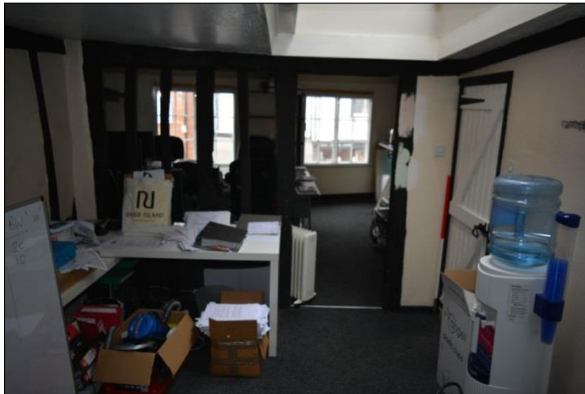
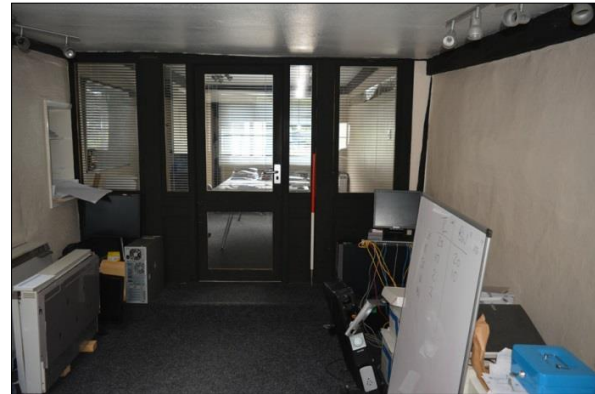
Project No: 240/SAG	Project: 14 George Street St Albans	Room no: F2
Location: Between F1 and F3		Function: Office
Wall form & decor: Painted plaster with some exposed timberwork to E & W. Exposed timberwork to north with an opening in the eastern end for access to F3		
Ceiling / roof structure: Painted plasterboard		
Windows: Skylight		
Doors: Ledge and braced door to east, Glazed door to F1 in screen to south		
Floor: Carpet		
Fireplace:		
Staircase:		
Other architectural details:		
Recorder: KK		Survey Date: 27.09.2016

Plate 14: Room F2: view to north (4)

Plate 15: Room F2: view to south (5)

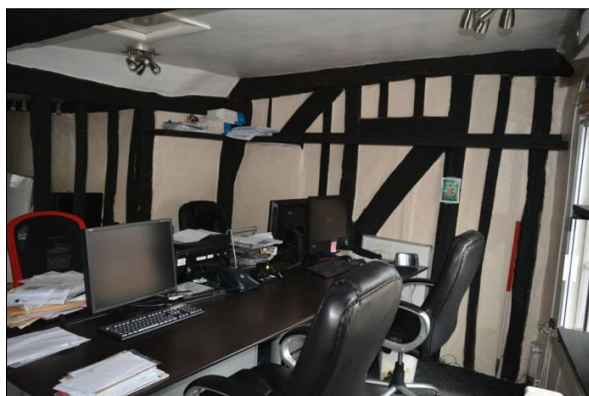
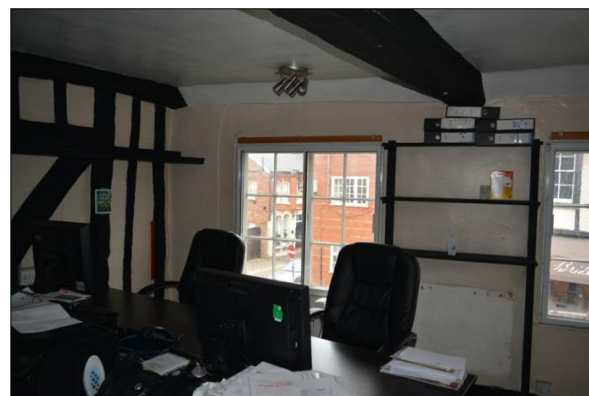
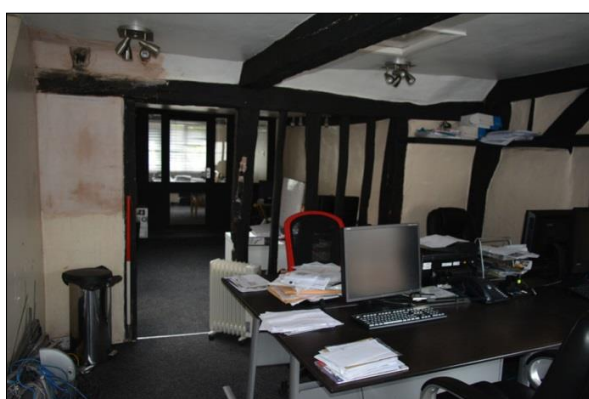
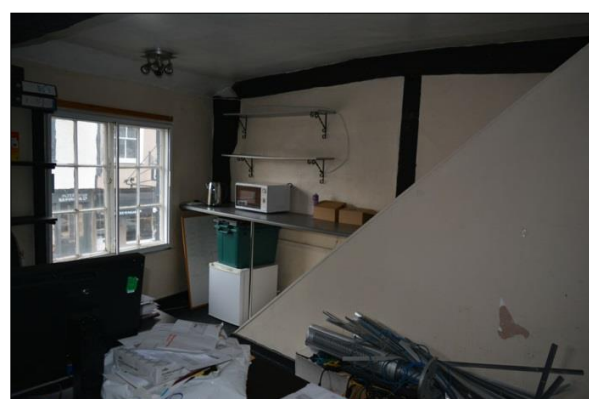
Project No: 240/SAG	Project: 14 George Street St Albans	Room no: F3
Location: Northern end of the building		Function: Office
Wall form & decor: Timberwork to west with former door now blocked and braced. Jowlposts to northeast and southwest		
Ceiling / roof structure: Axial beam and one exposed rafter to the south		
Windows: two 2-light casements with secondary glazing to north		
Doors:		
Floor: Carpet		
Fireplace:		
Staircase:		
Other architectural details: Hatch to roof space.		
Recorder: KK		Survey Date: 27.09.2016

Plate 16: Room F3: view to southwest (6)

Plate 17: Room F3: view to northwest (7)

Plate 18: Room F3: view to south (8)

Plate 19: Room F3: view to northeast (9)

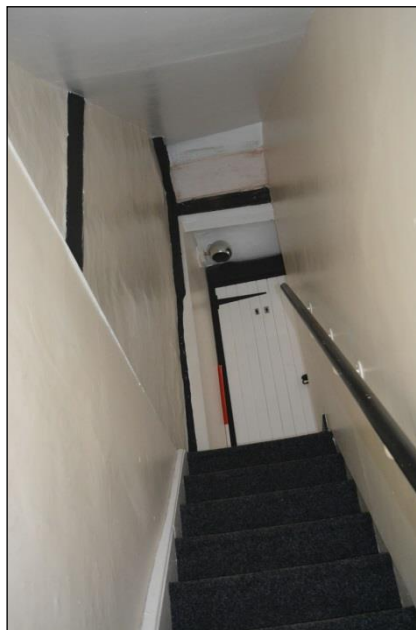
Project No: 240/SAG	Project: 14 George Street St Albans	Room no: F4
Location: Eastern end of the building		Function: Staircase
Wall form & decor: Some timberwork to the east otherwise painted		
Ceiling / roof structure: Painted		
Windows:		
Doors: Fully glazed door to the north		
Floor: Carpet		
Fireplace:		
Staircase: Enclosed stair with handrail to the west		
Other architectural details:		
Recorder: KK		Survey Date: 27.09.2016

Plate 20: Room F4: view to south (10)
