KDK ARCHAEOLOGY LTD

Archaeological Observation and Recording & Strip, Map and Record Report

The Old Town Hall

St Albans

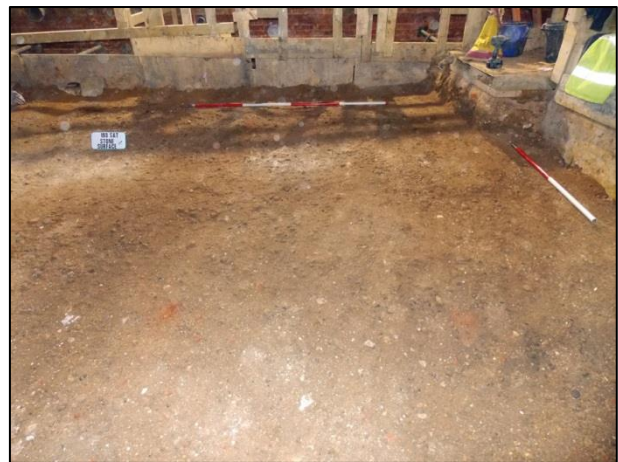
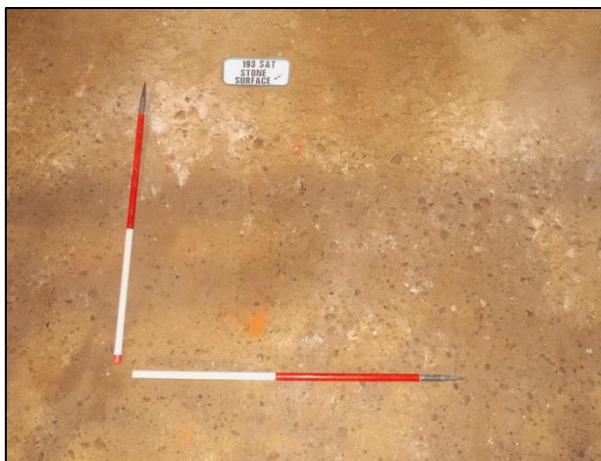
Plate 14: Stone surface [025], facing northwest

Plate 15: Stone surface [025] detail

The largest and most significant feature recorded during the ground reduction was a rough but densely compacted cobbled stone surface [025] (Plates 13, 14 & 15). Its full extent was not recorded as it underlay the extant brick footings of the northwestern wall (9.6m), and 3/4 of the northeastern wall (15.8m), continuing beyond the site limits. To the southwest it extended along approximate 1/3 of the extant basement wall (6.5m) which had truncated the surface at that point. Its depth was at its maximum immediately beneath the brick footings where it measured up to 0.35m (Plate 16). However, its thickness appeared to taper towards the southeast and it had a slight camber in the same direction. The edge of the cobbling coincided with that of chalk surface [024], though this may have been coincidental as the construction of a modern concrete beam had truncated the chalk at that point. Further fragments of what was almost certainly the same stone surface were recorded in Underpinning Pits 13, 21, and 23 on the southeastern side of the site, also underlying the extant footing. It was probably present in Pit 6 as well but the first 2m were excavated without archaeological supervision. The extent of this surface appears to coincide with the edges of the Almshouses depicted in the map of 1822 (Fig. 16)
