## Archaeological Observation and Recording Report

Church of St Mary the Virgin

Great Brickhill

Buckinghamshire

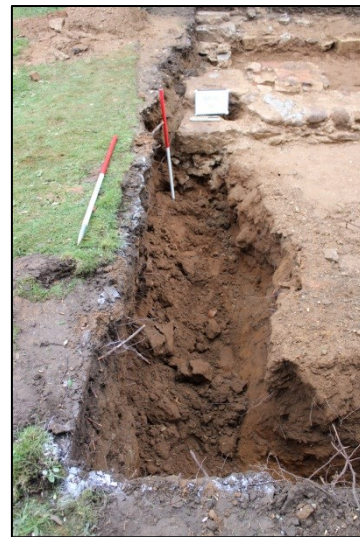
**Plate 10:** Trench 1, facing east

The base of the west wall [104] was revealed in Trenches 1 and 3, and the visible portion was formed of large blocks of clunch (Fig. 8; Plates 10 & 14), with underlying concentrations of angular ironstone (c.0.20) that may have acted as a 'hard-core' foundation for the structure. It was apparent that structure [104] was also intended to be load bearing as two 'post-pads' [106, 107] were formed by hollows in the stone blocks 2.15m apart on the western side (Fig. 8; Plates 29 & 30). The northern end of structure [104] was fully revealed within the footing trenches, though the southern end may have extended farther south as a block of clunch was exposed in the section of Trench 3 at the limit of excavation.

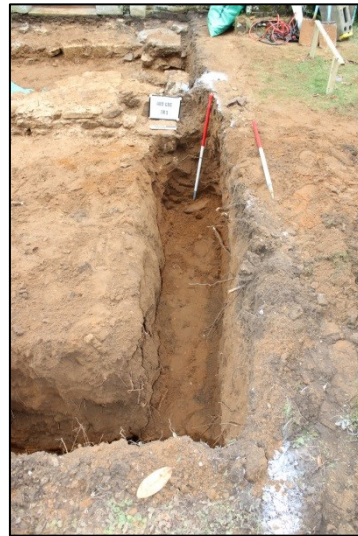
**Plate 14:** Trench 3, facing east

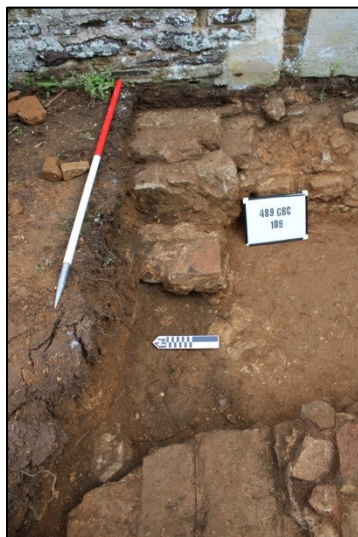
Plate 27: Northern return wall[109], facing east

The remains of two return walls (109, 110), measuring (L) 0.35-0.5 x (W) 0.30-0.4 x (H) 0.28-0.55m, built of roughly hewn/dressed clunch and tile linked wall [104] to the church foundations [108] (Figs 7-8; Plates 27-28). The north wall [109] was predominantly clunch built with a little brick/tile and ironstone. The presence of cement mortar indicates 20<sup>th</sup> century work of some form having taken place on or impacting the wall. A 0.66m wide gap had been created in [104] level with the outer edge of the northern buttress, although the building fabric had not been taken out in its entirety; the basal level was still intact. In contrast, a gap in the southern return wall [110] was only 0.33m wide, but all of the historic fabric had been removed, and the wall itself had collapsed. A sample of tile from each structure [104, 109, 110] were examined and dated by its fabric and manufacture to the post-medieval period, probably 16<sup>th</sup> – 17<sup>th</sup> century (Blinkhorn, this volume).

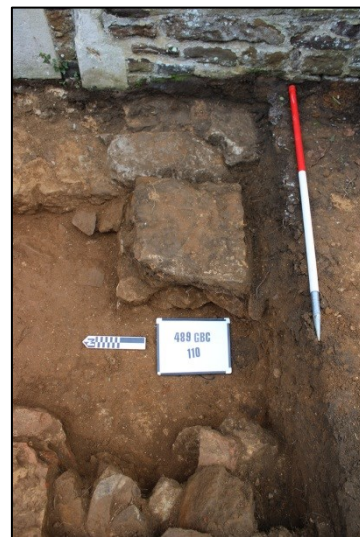
Plate 28: Southern return wall[110], facing east

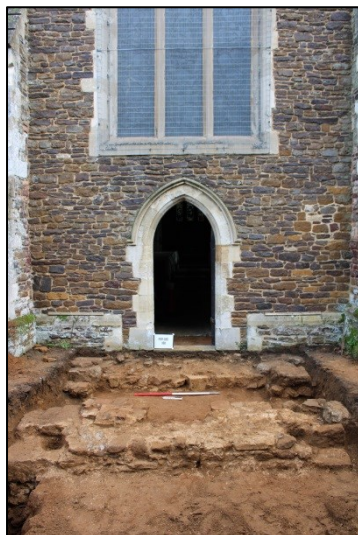
Plate 35: Church foundations [108], facing east

The foundations [108] of the church were revealed at the eastern extent of the excavated area (Fig. 9; Plates 35-37). The area revealed measured 3.40mL x 0.5mW x 0.3mH and was built from dressed clunch that was almost completely covered with, and set into lime mortar: the southern half consisted of one course of large clunch blocks *c.* 0.20m wide x 0.18m high, whereas the northern end was constructed from smaller blocks of clunch, *c.* 0.1m wide x 0.5-0.13m high, and undressed iron stone. The clunch pieces had relatively fine and widely spaced, diagonal toolmarks on them, and were almost certainly reused from the west wall when it was extensively rebuilt in 1826. This section of building fabric appears to all intents and purposes to have been additional to the foundations of the church *per se* and provided a solid base for the ledger slab that had been placed in front of the west door to form a step.

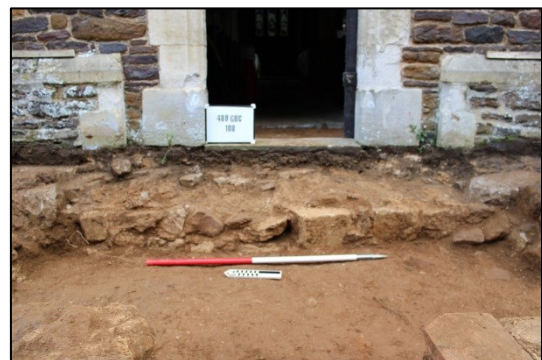
Plate 36: Church foundations [108], detail, facing east

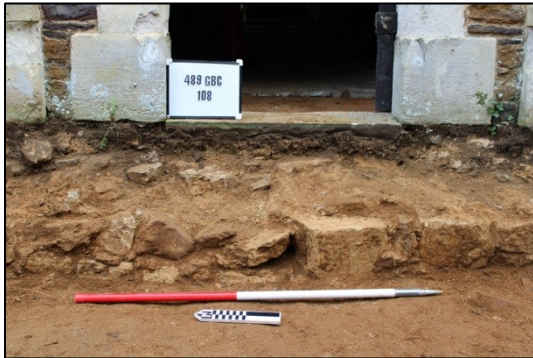
**Plate 37:** Church foundations [108], detail, facing east

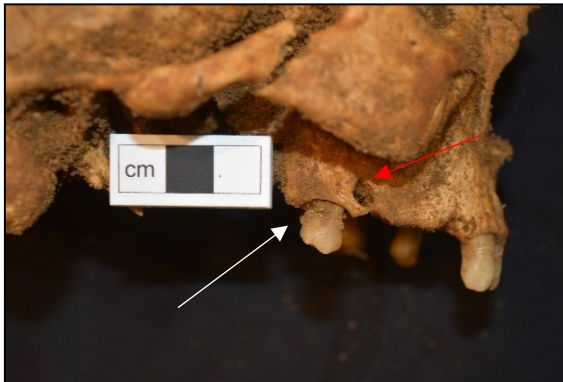
Fig 1. SK1. Dental abscess above second right molar (red arrow). N.B Periodontal disease and dental calculus (white arrow)

Most of the sockets of this individual appeared fully healed, although the socket that would have held the right M2 shows signs of minimal healing meaning that the tooth was lost shortly before death. The reason for this loss may have been caused by an abscess located near to where the root would have been (Plate 1). Although abscesses can be a result of periodontal disease, dental abscesses can also develop as a direct result of dental caries, attrition or trauma exposing pulp cavity which in turn allowing bacteria to infiltrate the cavity. Here micro-organisms accumulate in the pulp cavity, inflammation occurs and dead cells and bacteria (pus) collect. This builds up of pus and pressure can eventually create a hole or sinus in the jawbone allowing the pus to escape, an in turn may also lead to ante mortem tooth loss (AMTL; Roberts and Manchester 2005:70). The abscess was 5.12mm in diameter and had rolled and thickened rim.

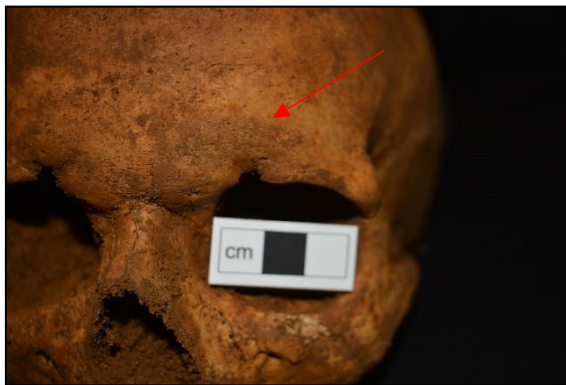
Fig 3. SK1. Periostitis above the left eye socket

Evidence of mild periostitis over the left eye socket of this individual is shown in Plate 3. Periostitis is a non-specific inflammation of the bone initially seen as fine pitting and longitudinal striation that leads to plaque-like new bone formation on the cortical surface. Such reactions are frequently associated with infection and trauma and are among the most common abnormalities encountered on human remains (Roberts and Manchester 2005: 172-174; Waldron 2009:172). It is possible that this lesion may have been the result of a localised infection around the left eye, but it is also possible that the individual received a strike to the head prior to death, whether this is an accidental bump or the result of interpersonal violence cannot be determined.
