KDK ARCHAEOLOGY LTD

Archaeological Observation and Recording Report

Church of St Lawrence
Nettleden
Hertfordshire

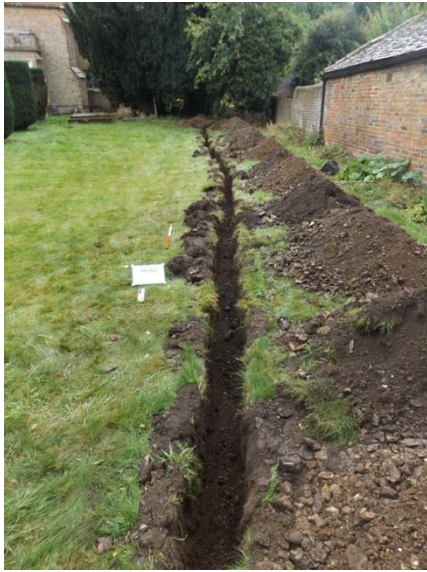
Plate 1: Pipe trench, facing south

The trench ran from the south side of the church tower northwest to the boundary then north northeast to the Nettleden Road. The pipe trench was c. 55m metres long x c. 0.40m wide, and excavated to a depth of c. 0.70m, though this was reduced to c. 0.20m at the rear of the church tower. The trench curved around a small copse of trees adjacent to the western end of the church, and a shallow trench c. 3m long was excavated along the edge of the northern wall of the tower, where a French drain had been emplaced during previous works adjacent to the exterior southern wall.

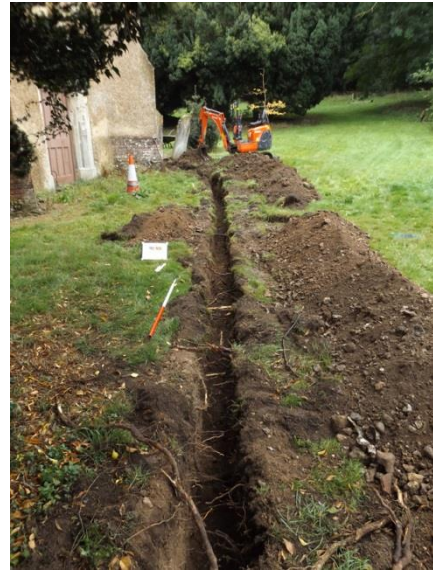
Plate 2: Pipe trench, at western end of church

The water pipe trench intersected with an electrical services trench near the western end of the church, where a proximal human tibia was emplaced in an upright position adjacent the electrical cable, and 2 fragments of human pelvis were found in the fill. It is evident that these elements had previously been disturbed by the excavation of the cable trench. No *in situ* human remains were encountered during this project. All of the archaeological materials were re-buried within the trench.

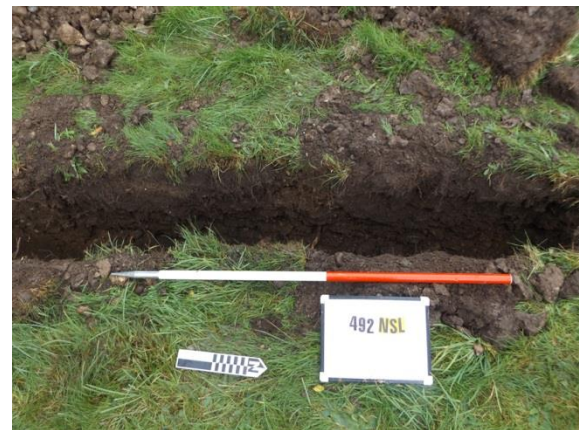
Plate 4: Detail of pipe trench stratigraphy

The remaining 46m of the trench, to where it connected with the church, contained 63 fragments of CBM, mostly roof tiles, a large ceramic handle, 5 brick fragments, 3 fragments of blue & white porcelain, 2 fragments of animal bone, and small metal horse shoe. All of this material appears to date from the post-medieval to modern periods. The stratigraphy within this area comprised darker brown clayey silt topsoil, though occasional glimpses of different geological strata were revealed at the base of the narrow trench.
