Historic Building Recording

Organ Hall Farm
Theobald Street
Borehamwood
Hertfordshire

In January 2020, KDK Archaeology Ltd carried out Historic Building Recording of two pre-fabricated dwellings at Organ Hall Farm, Theobald Street, Borehamwood, Hertfordshire.

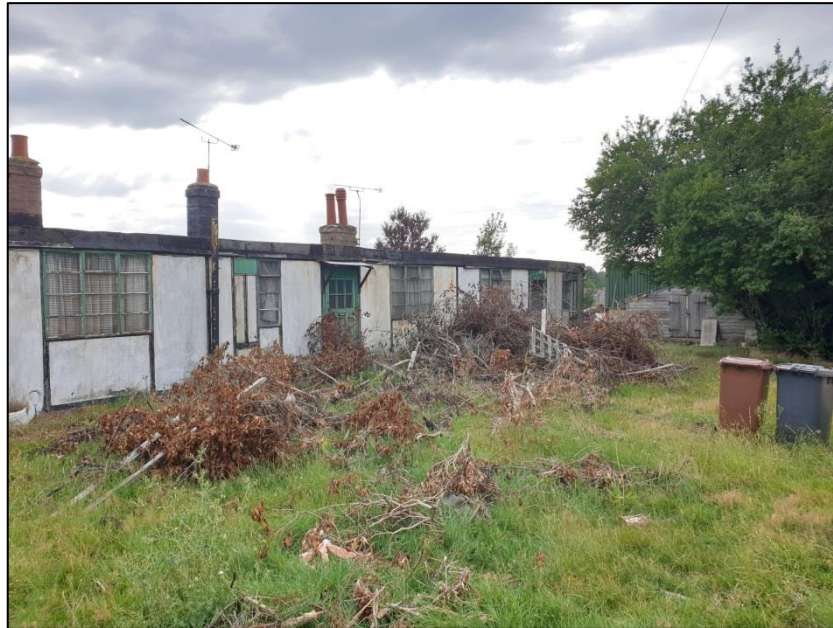
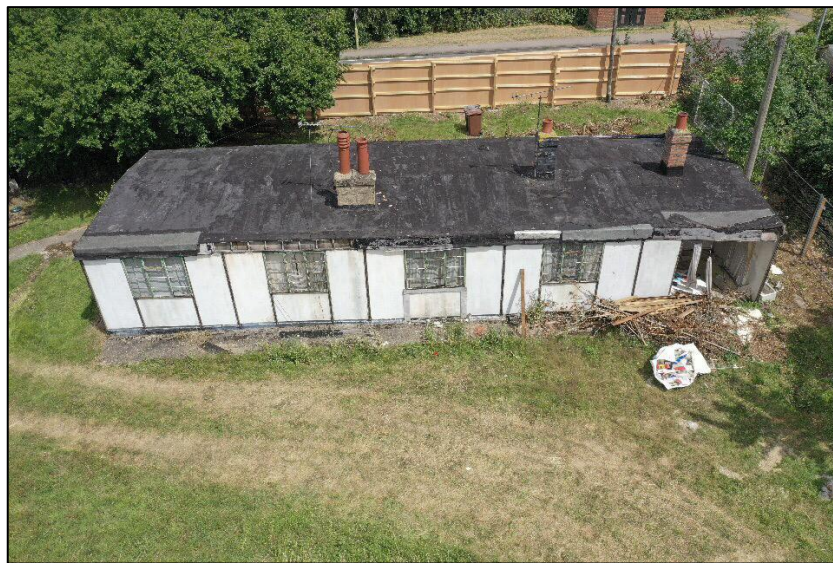
Figure 3: Front and rear elevations taken before the roof was removed
(Courtesy of Griggs)

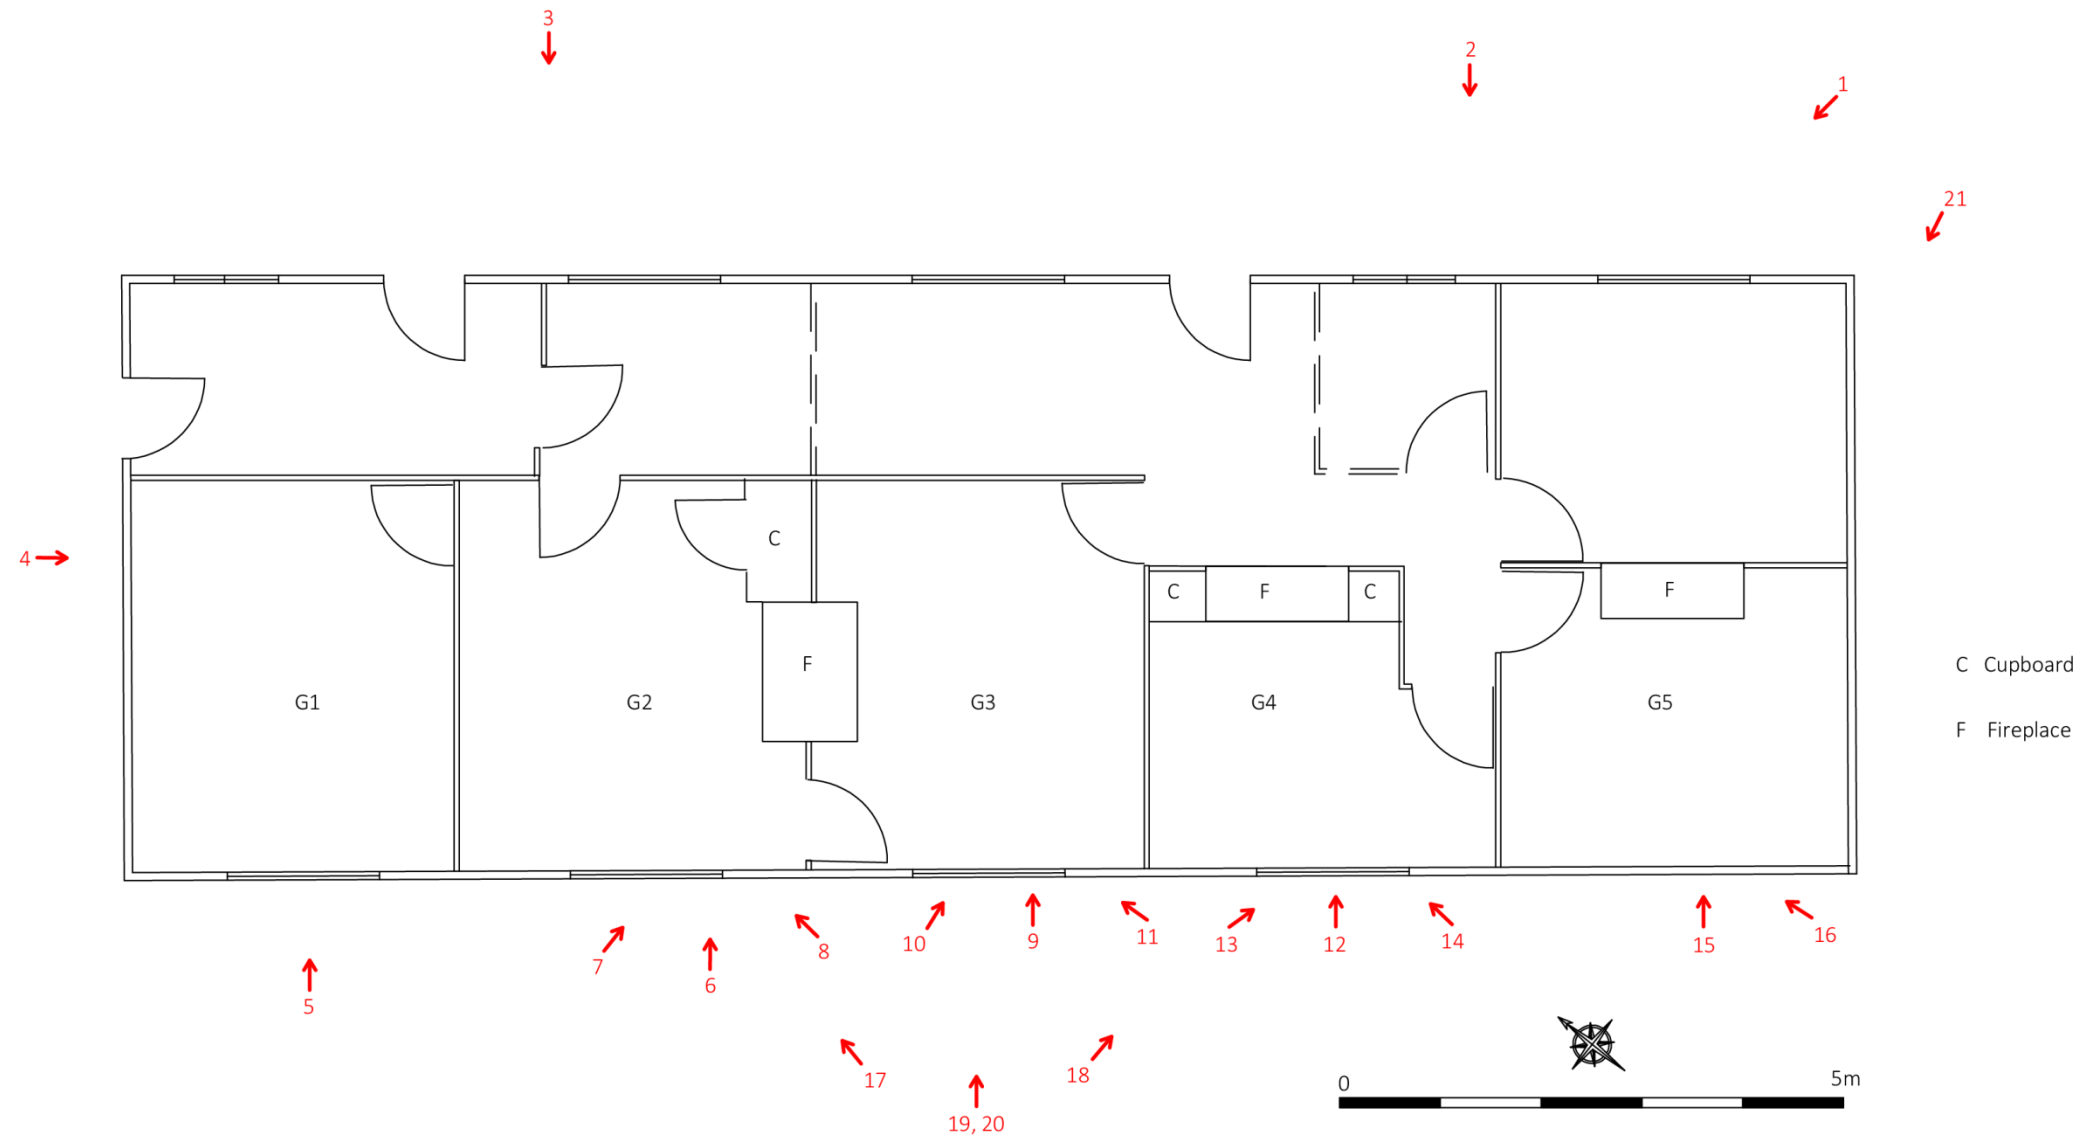
Figure 14: Photo plan (1:75)

The roof had been removed prior to the survey commencing, as a result of which the rear (south) wall and part of the west wall had collapsed. It was therefore possible to record the rooms to the rear of the buildings, although the presence of asbestos and the general dilapidation of the surviving structure allowed only very limited access within. The rooms to the front, which included the entrance hallway(s) and bathroom(s), were completely inaccessible because of the instability of the structure and because the front of the building was too overgrown to allow any visibility through the windows. However, it was possible to see a little of these rooms through adjoining doors that had been left ajar, and the location of the walls that could be glimpsed this way are shown as dashed lines in Figure 14.

4.3 Interior (Fig. 14, Plates 8-21)

Of the five rooms that could be clearly recorded to the south of the buildings, two could be identified as living rooms (Rooms G2; Plates 10-12 & G3; Plates 13-15) as they had back to back fireplaces, although that in G3 had been blocked. Room G5 (Plates 20-21) was a bedroom heated with a tiled fireplace, and it is possible that Room G1 (Plates 8-9) was also a bedroom, albeit unheated. Room G4, with its fireplace in the north wall and cupboards on either side was clearly a kitchen (Plates 16-19), but this appeared to be the only one in the two buildings. The rooms that lay to the north of Rooms G1 – G4 were just short of 2m wide and housed the entrance hallways and at least one WC, notably behind the kitchen. The room to the north of G5 was of a similar size to G5, but its function was not clear. The lack of a second kitchen, which should be identifiable by its size, the presence of fitted cupboards and its location

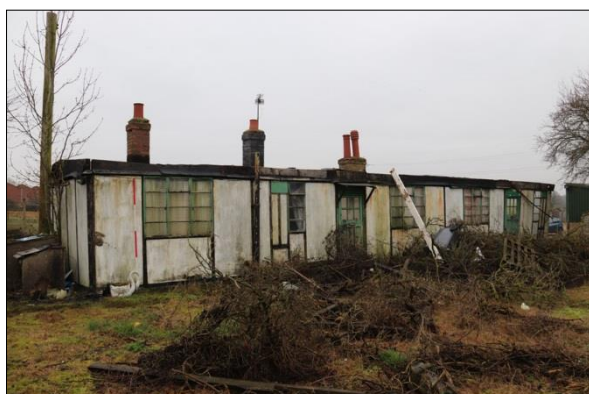
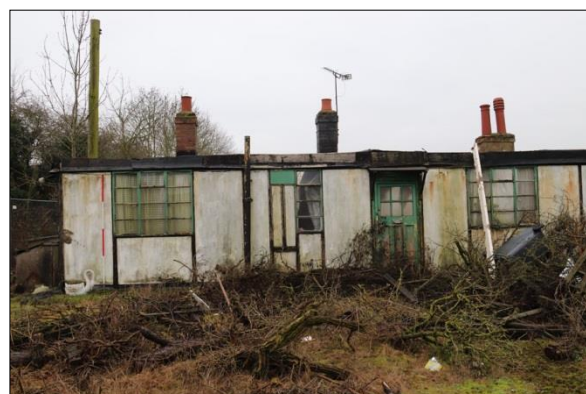
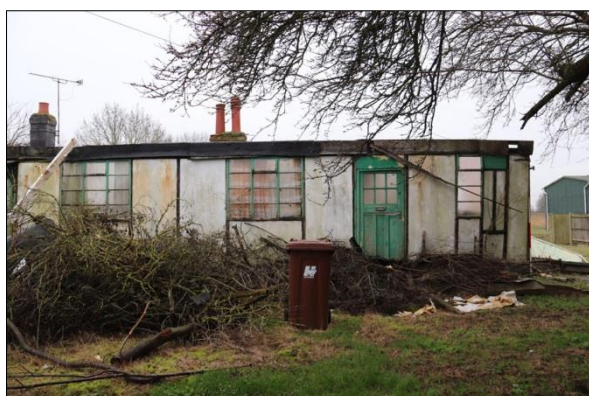
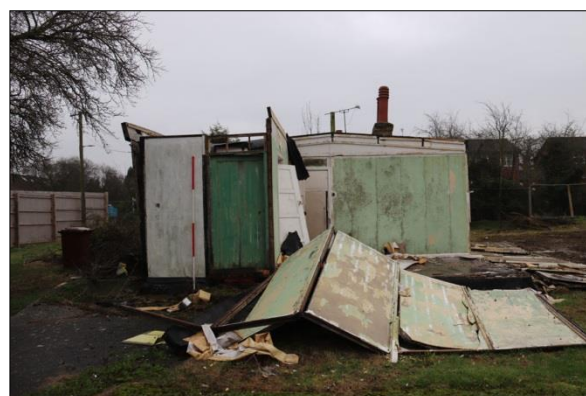
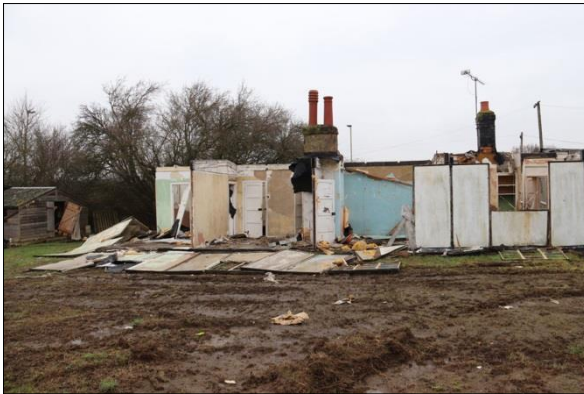
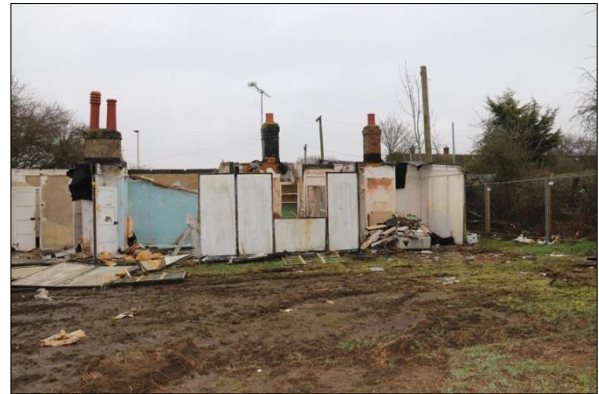
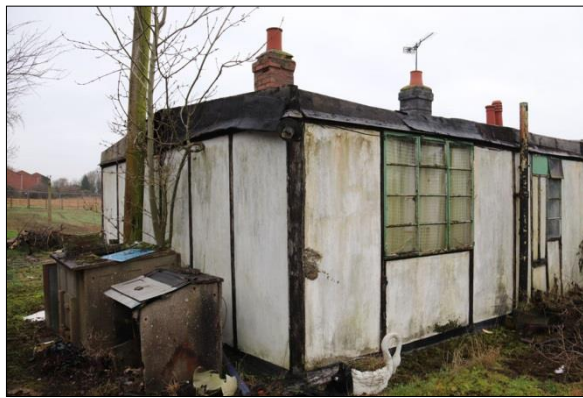
Project No/code: 506/BTS	Project: Organ Hall Farm, Borehamwood	Elevations
Doors: Two half glazed timber doors		
Windows GF: Three 3 light and two single light Crittal type windows with horizontal glazing bars. The side lights in 3 light windows are casements, and the central light has a top hung window in the uppermost upper pane		
Walling material: Asbestos boards with wood chip filling. The foundations are brick built		
<p>Other Architectural Features: Three chimney stacks; the western one has two pots serving fireplaces on either side of the internal wall. One of the other chimneys is for the fireplace in the kitchen and the other for a bedroom. The latter are both to the east of the double stack.</p> <p>The single light windows have a decorative panel to one side and the 3-light windows have side opening casements to either side and a top hung single pane opening in the centre.</p> <p>The west wall has a timber door with rectangular light above. The base of the door now lies behind low level brickwork.</p> <p>The south wall has collapsed, but no doors were present, just a metal framed window for each room.</p> <p>The east wall has no openings.</p>

Plate 1: North elevation from the northeast (1)

Plate 2: North elevation: east end (2)

Plate 3: North elevation: west end (3)

Plate 4: West elevation (4)

Plate 5: South elevation: west end (17)

Plate 6: South elevation: east end (18)

Plate 7: East elevation (21)

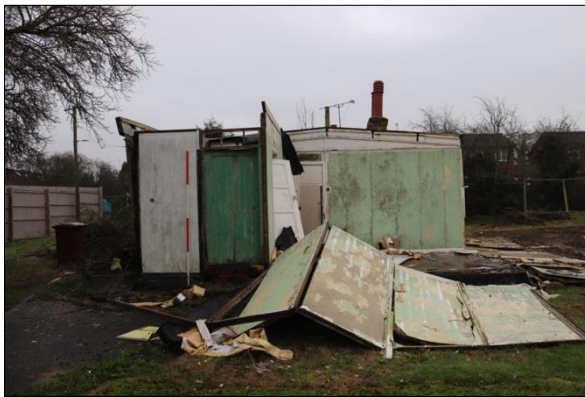
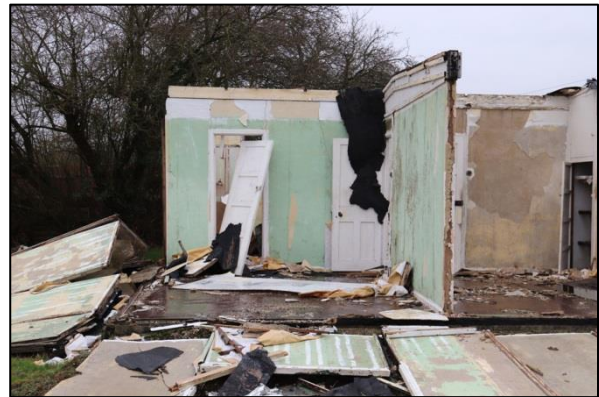
Project code: 506/BTS	Project: Organ Hall Farm Borehamwood	Room no: G1	
Location: Southwest corner		Function: Uncertain	
Dimensions (m):	Length: 3.88	Width: 3.186	Height: -
Wall form & decor: Papered asbestos panels with simple skirting boards			
Ceiling / roof structure: Removed prior to survey			
Windows: 3-light metal framed casement window to south.			
Doors: 4 horizontally panelled timber doors to north and east			
Floor: Removed prior to survey. Sub floor uniform throughout the building but material could not be identified			
Fireplace:			
Other architectural details:			
Recorder: KK		Survey Date: 24.01.2020

Plate 8: Room G1 from the west (4)

Plate 9: Room G1 from the south (5)

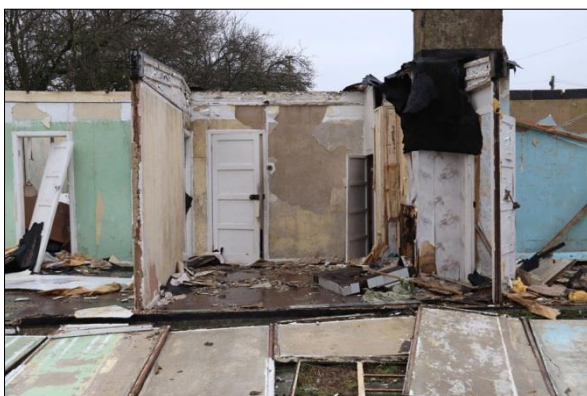
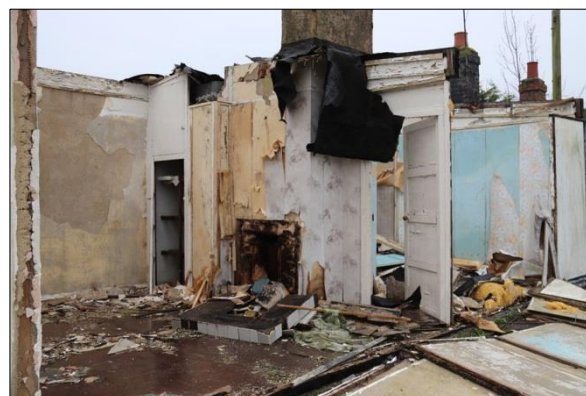
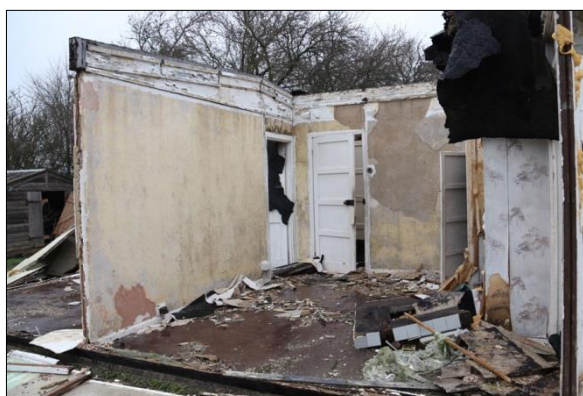
Project code: 506/BTS	Project: Organ Hall Farm Borehamwood	Room no: G2	
Location: East of G1		Function: Possible living room	
Dimensions (m):	Length: 3.87	Width: 3.43	Height: -
Wall form & decor: Papered asbestos panels with simple skirting boards			
Ceiling / roof structure: Removed prior to survey			
Windows: 3-light metal framed casement window to south.			
Doors: 4 panelled door to north and in SE corner to G3. A similar door gives access to a cupboard in the east wall			
Floor: Removed prior to survey. Sub floor uniform throughout the building but material could not be identified			
Fireplace: Collapsed tiled fireplace to east, south of the built in cupboard			
Other architectural details:			
Recorder: KK		Survey Date: 24.01.2020

Plate 10: Room G2 from the south (6)

Plate 11: G2: view to the northeast (7)

Plate 12: G2: view to the northwest (8)

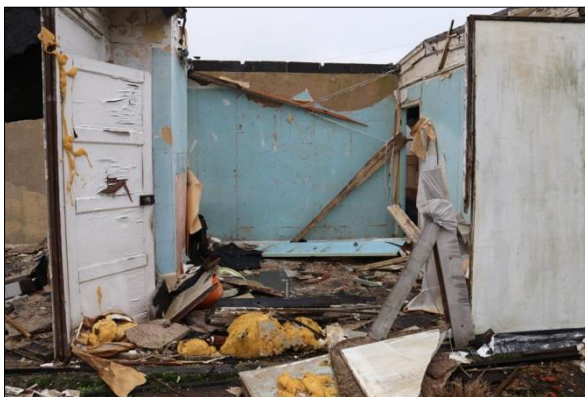
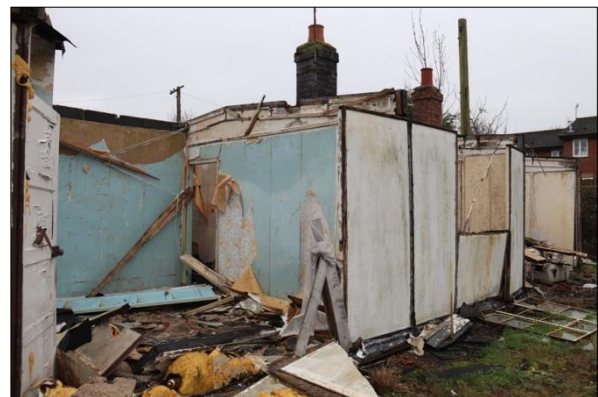
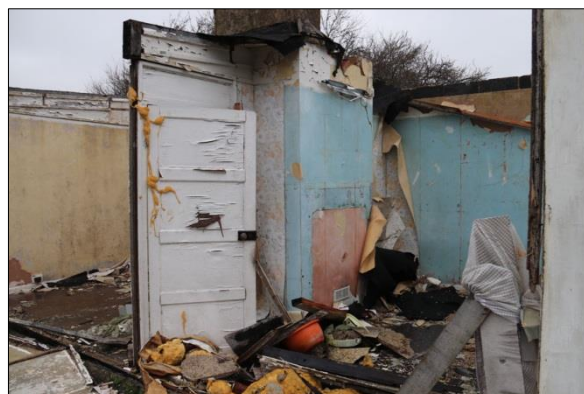
Project code: 506/BTS	Project: Organ Hall Farm Borehamwood		Room no: G3
Location: East of G2		Function: Possible living room	
Dimensions (m):	Length: 3.86	Width: 3.3	Height: -
Wall form & decor: Papered asbestos panels with simple skirting boards			
Ceiling / roof structure: Removed prior to survey			
Windows: 3 light Crittall-type window to south			
Door: 4 panelled door in the southwest corner to G2 and the northeast corner to passage			
Floor: Removed prior to survey. Sub floor uniform throughout the building but material could not be identified			
Fireplace: Blocked fireplace in west wall			
Other architectural details:			
Recorder: KK		Survey Date: 24.01.2020

Plate 13: Room G3 from the south (9)

Plate 14: Room G3: view to the northeast (10)

Plate 15: Room G3: view to the northwest (11)

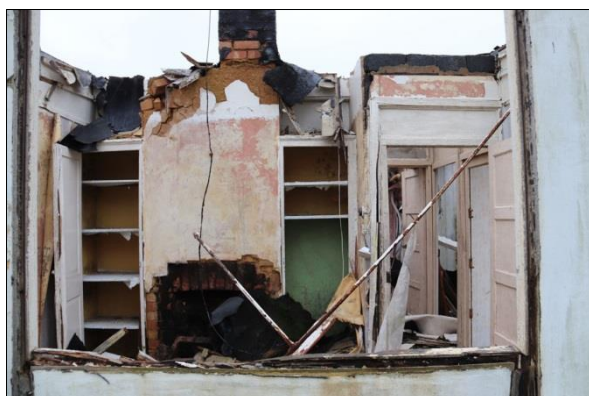
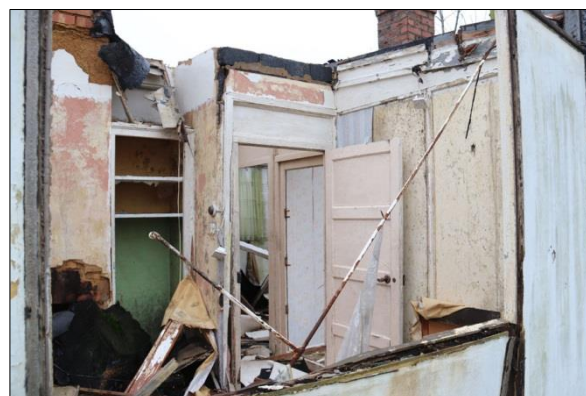
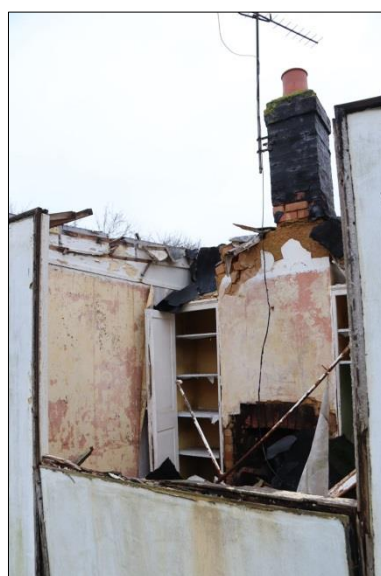
Project code: 506/BTS	Project: Organ Hall Farm Borehamwood	Room no: G4	
Location: West of G6		Function: Kitchen	
Dimensions (m):	Length: 2.95	Width: 3.44	Height: -
Wall form & decor: Papered asbestos panels with simple skirting boards			
Ceiling / roof structure: Removed prior to survey			
Windows: 3 light Crittal type window to south			
Door: 4-panelled timber door In dog leg wall to east of fireplace			
Floor: Removed prior to survey. Sub floor uniform throughout the building but material could not be identified			
Fireplace: Brick built fireplace in north wall flanked by cupboard on either side			
Other architectural details:			
Recorder: KK		Survey Date: 24.01.2020

Plate 16: Room G4 from the south (12)

Plate 17: Room G4: view to the northeast (13)

Plate 18: Room G4: view to the northwest (14)

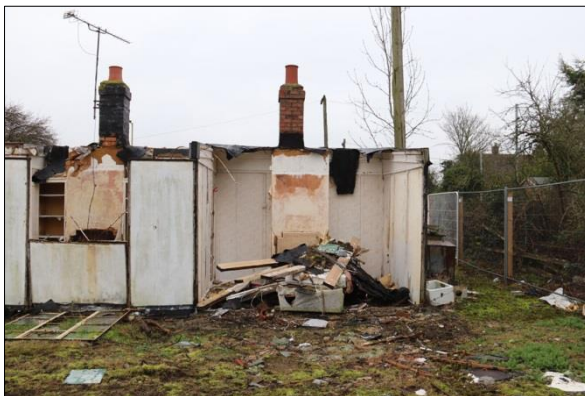
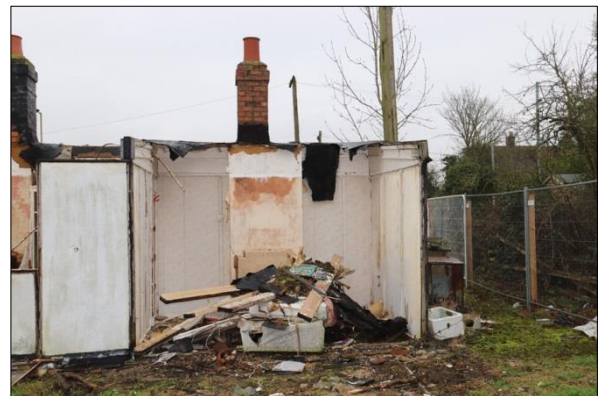
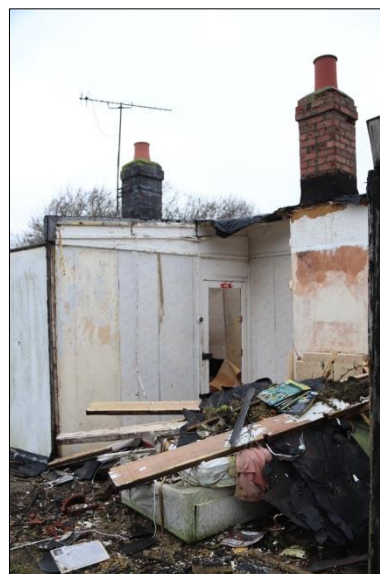
Project code:n 506/BTS	Project: Organ Hall Farm Borehamwood	Room no: G5	
Location: SE corner of the building		Function: bedroom	
Dimensions (m):	Length: 2.97	Width: 3.44	Height:-
Wall form & decor: Papered asbestos panels with simple skirting boards			
Ceiling / roof structure: Removed prior to survey			
Windows: 3 light Crittal type window to south			
Door: North end of the west wall			
Floor: Removed prior to survey. Sub floor uniform throughout the building but material could not be identified			
Fireplace: Tiled fireplace to north			
Other architectural details:			
Recorder: KK		Survey Date: 24.01.20

Plate 19: Rooms G4 & G5 from the south (19)

Plate 20: Room G5 from the south (15)

Plate 21: Room G5: view to the northwest (16)
