Historic Building Recording

Market Cross Market Square Leighton Buzzard Bedfordshire

Scheduled Monument Ref: 1005429

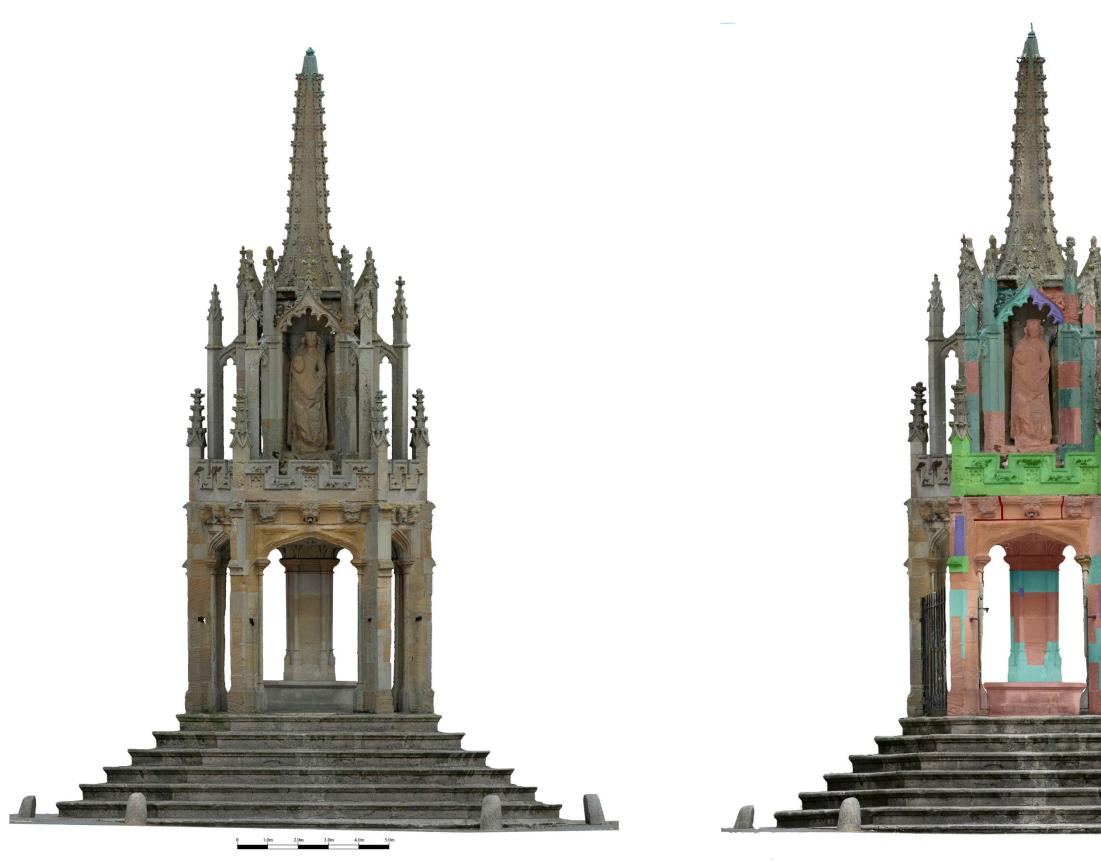
Figure 23: The Madonna building phases

The most photographed elevation over time is that facing the length of the High Street and contains the statue of the Madonna. The statue stands on the original plinth although the cinquefoiled tracery in the head of the niche is a 20th century replacement (Fig. 23). Both original stonework and the 1850s repairs are visible in the jambs. The spandrels below the grotesques as well as the spandrels themselves have a slightly micaceous appearance, and some render appears to have survived on some of the heads of the grotesques. The parapet also appears to be rendered, although the quatrefoils and the course of stone below are not.

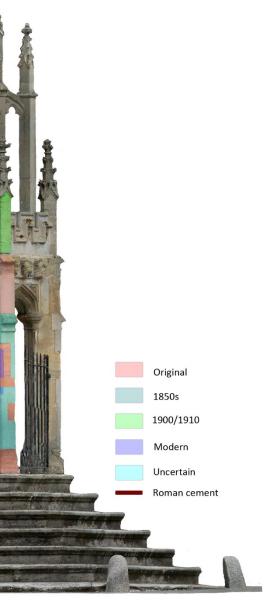
Spire restored/rebuilt 1910

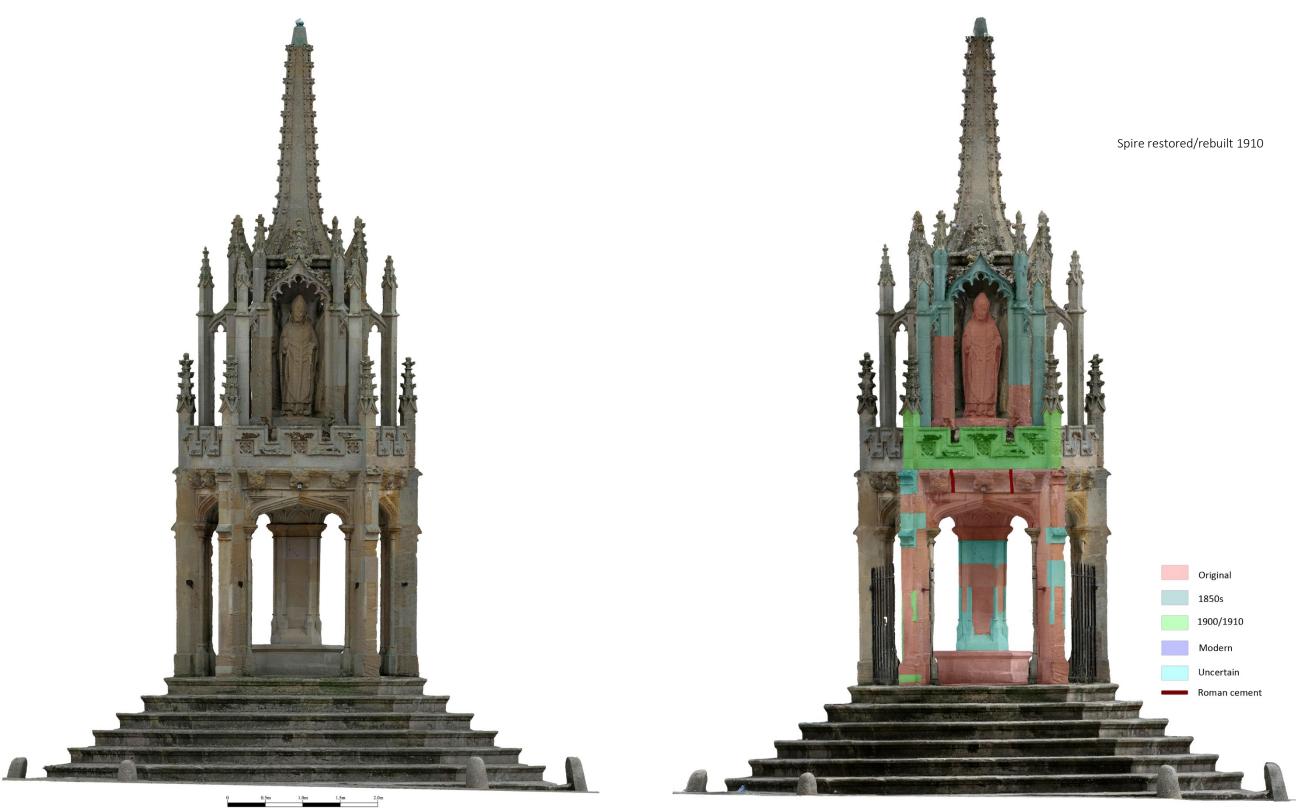
Figure 21: The Bishop building phases

The niche housing the bishop to the left of the Madonna is little changed since the works completed in the 1850s, but later repairs and replacements were noted in the lower section of the elevation (Fig. 24).

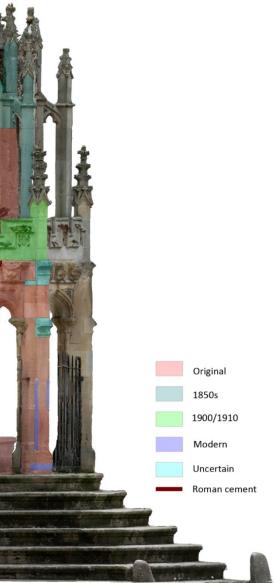
Figure 25: St John building phases

Spire restored/rebuilt 1910

To the left of the bishop is the statue of St John (Fig. 25). The alterations to the upper levels of this face of the Cross are similar to that housing the bishop.

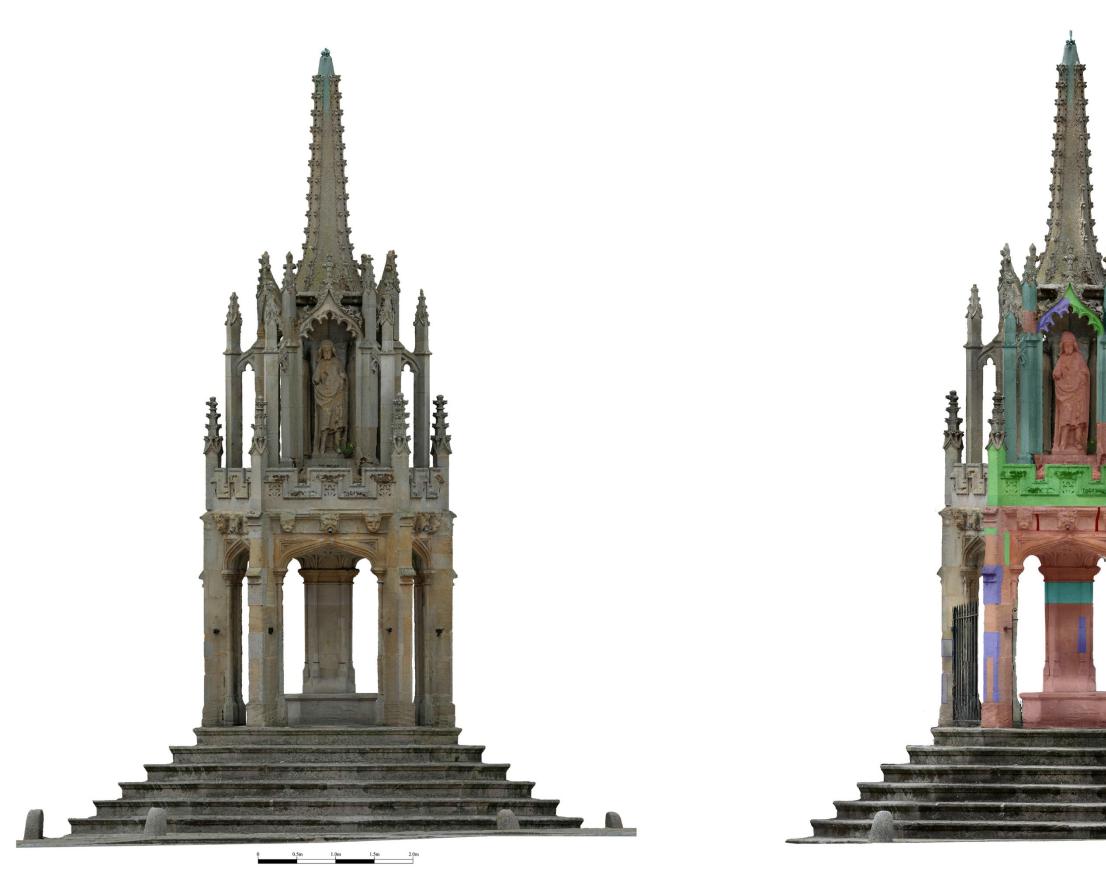
Figure 26: Christus building phases

The most significant alteration on the side housing the statue of the Christ risen is that the left side of the canopy above the statue (as one is facing it) is a modern replacement/repair (Fig. 26).

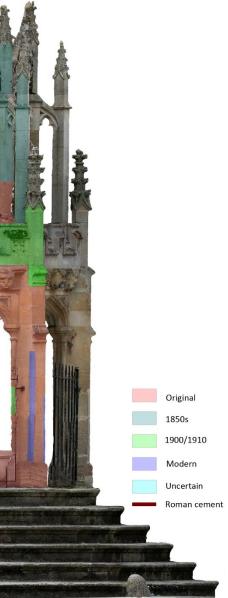
Spire restored/rebuilt 1910

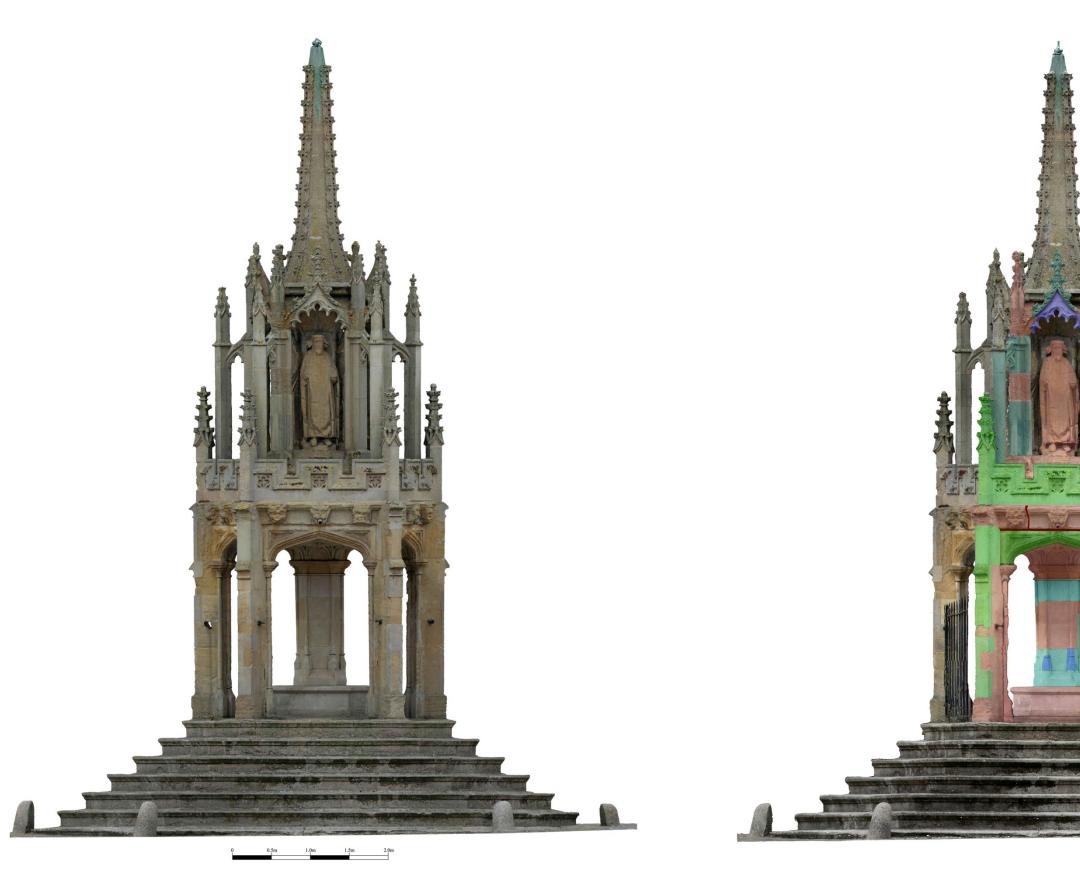
Figure 27: The King building phases

The elevation housing the statue of the king, has had extensive repair work to the canopy, which appears to be recent work. The spandrels beneath the frieze of grotesques appear to date from the the early 20th century (Fig. 27). Between the frieze and the spandrels is also a course of tiles covered with Roman cement. Further repairs are evident in the pillars, which also have some shell surviving within the mortar layers.

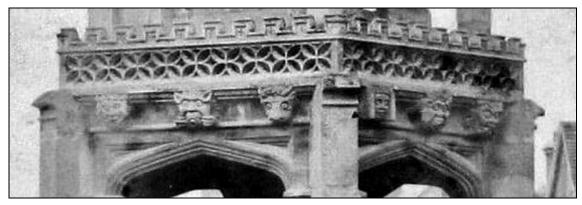
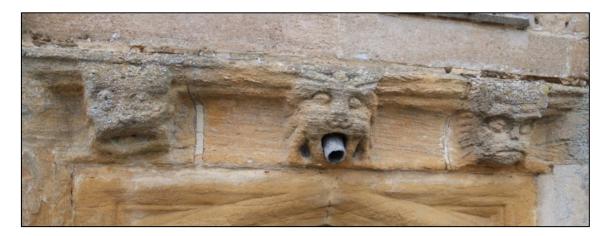
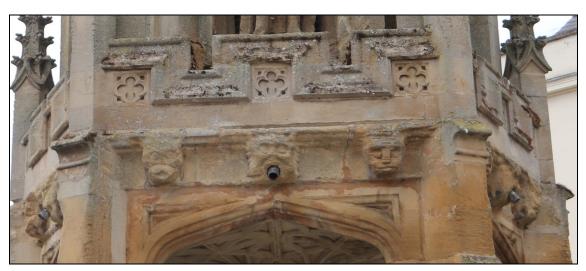
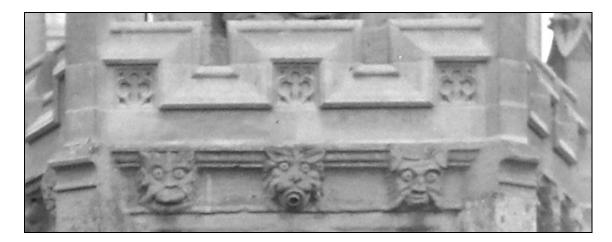
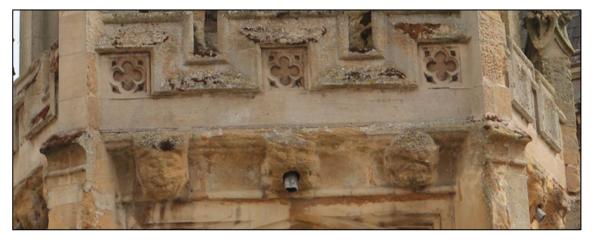
Figure 28: Grotesque details

stone courses, has survived in some of the columns. Later tile repairs behind a mortar coloured to resemble the adjacent stone was noted beneath the grotesques on the south and southwest elevations. Roman cement repairs were also present on either side of the central grotesque on all five elevations.

Christus grotesques 1851

Bishop grotesques to the left and Madonna grotesques to the right 1851

Madonna grotesques 2021

Christus grotesques 2021

Madonna grotesques 1905

Bishop grotesques 2021

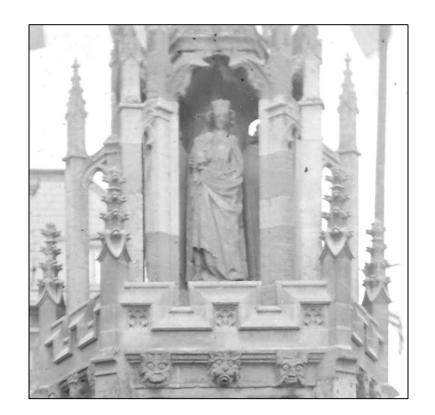
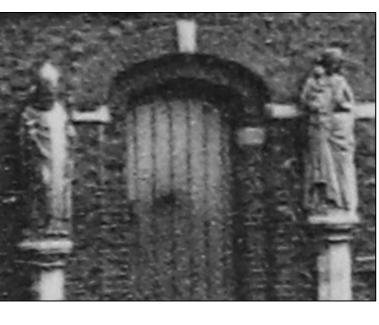
Figure 29: The Madonna and Bishop statues

A key query was to determine whether the statues within the niches are those originally made in the medieval period or are 19th century replacements. That these are the originals can be confirmed by studying the historic photographs of the 19th century, which show the 1850s statue of the Madonna with a well-defined Christ child in the niche (Fig. 29). This same statue, which was put on a plinth in front of the Old Town Hall in 1900, can be seen in a low resolution photograph of 1910, and can be identified as the 1850s statue by the shape of the child's head. In contrast, the statue of the Madonna in the 1905 photograph by Delafield is very weathered and the head of the Christ child lacks definition of any form and so can only be the original figure.

The replacement Madonna & Bishop on the cross, 1851 - 1905 (Z465/3)

The original Madonna back on the cross in 1905(Z15241/1)

The replacement Madonna and Bishop on the Old Town Hall plinths post 1910 (21306/72/11/5)

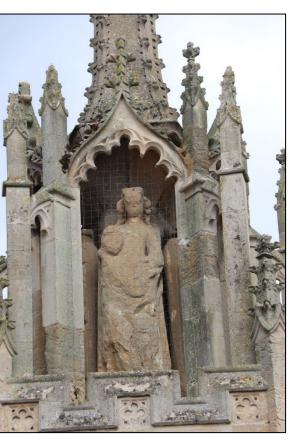
Figure 30: Stone use and later repairs

Examples of the various building/repair episodes are shown in Figures 30 and 31, where the differential weathering is also very clear to see.

The Madonna August 2021

Pinnacle & canopy above the Madonna

Madonna statue & adjoining column

Parapet detail

Column below Christus

Column below the Madonna

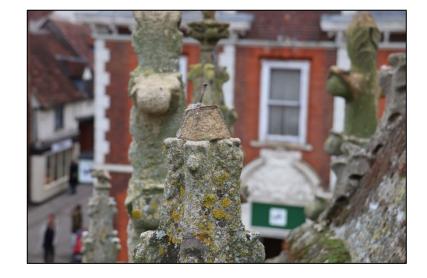
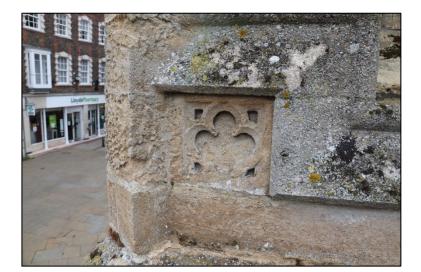
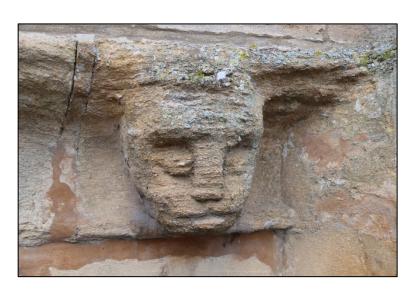
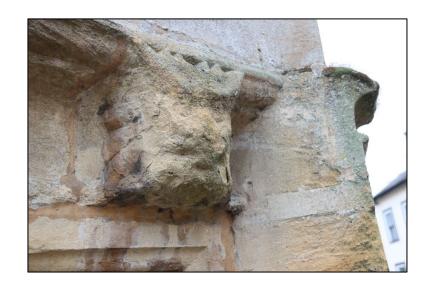
Figure 31: Stone deterioration

Loss of top of pinnacle

Detail of frieze (Weldon stone)

Loss of facial detail (Carstone)

Banded weathering (Carstone)

General erosion (Carstone)
