Archaeological Observation and Recording Report

Church of All Saints
Winwick
Cambridgeshire

NGR: TL10474 80700
Event number: ECB6333

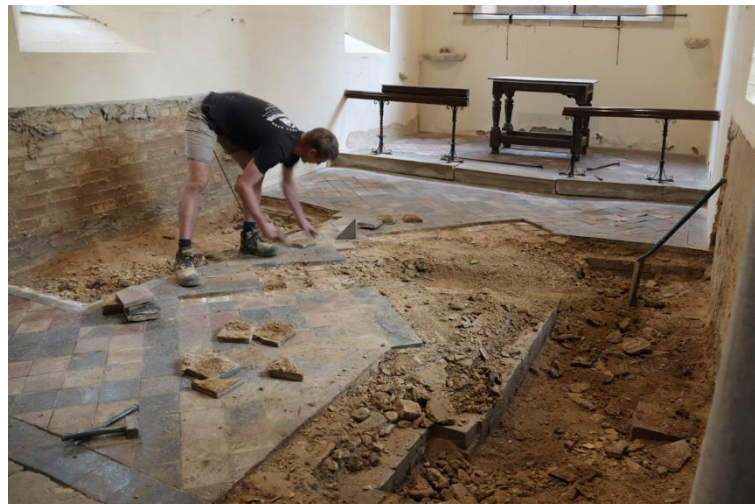
The floor tiles were plain black and red, and measured 15 x 15 x 2.6cm (6 x 6 x 1 inches). These had been set in a hard, sandy mortar up to 6cm thick. Although they all initially appeared to be 19th century in date, some lacked the distinctive groove on the back, and were more likely to be medieval.

Plate 1: The tiles being removed

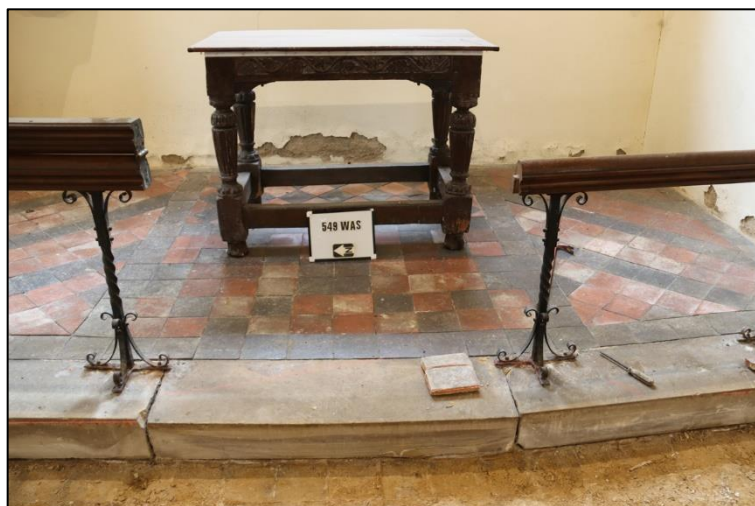
Plate 2: Sanctuary step

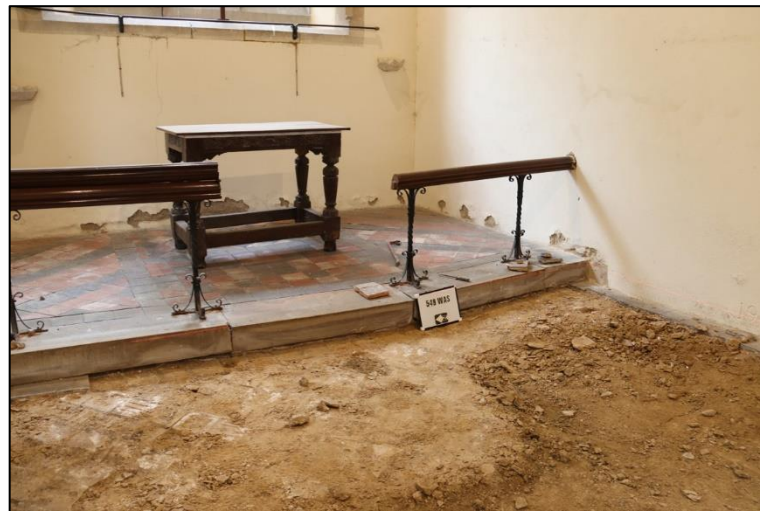
The reduction of the floor level was insufficient to reveal any features other than the pew bases.

Plate 3: The partial reduction of the floor at the altar end

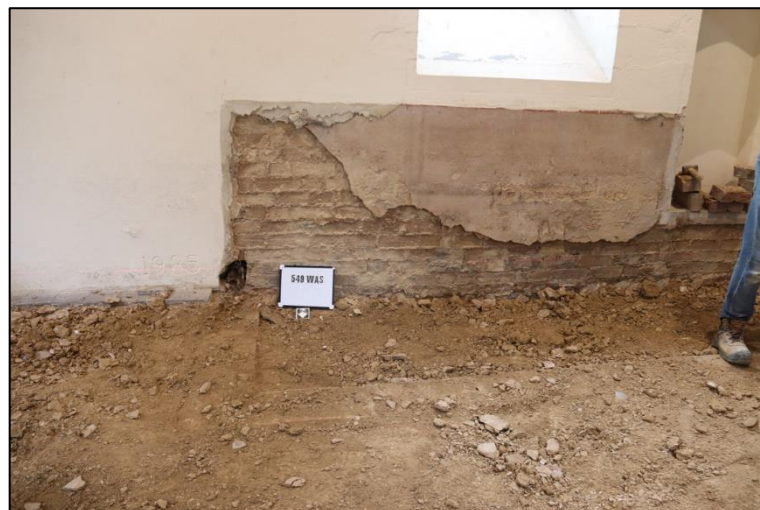
The brick joists for the pew bases appeared to be relatively modern. Modern works were evident in the south chancel wall, which internally was constructed of handmade bricks with horizontal skintlings, and set in cement mortar. The lime render over the bricks was about 2cm thick, and areas of reworking in cement-based render were evident. Indeed, the date 1985 had been inscribed into the south wall.

Plate 4: Detail of the south wall showing the old and new render over the brickwork and the date 1985

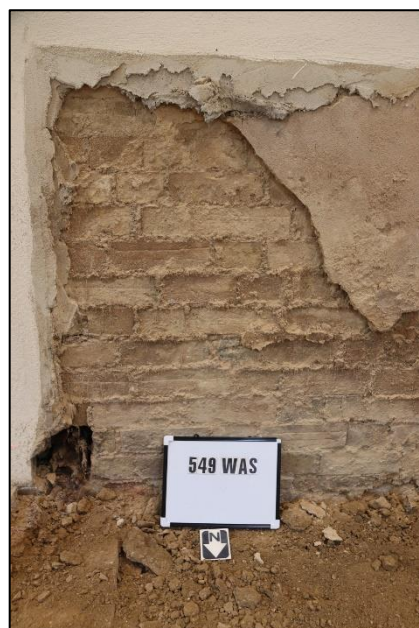
Plate 5: Detail of the brickwork in the south wall

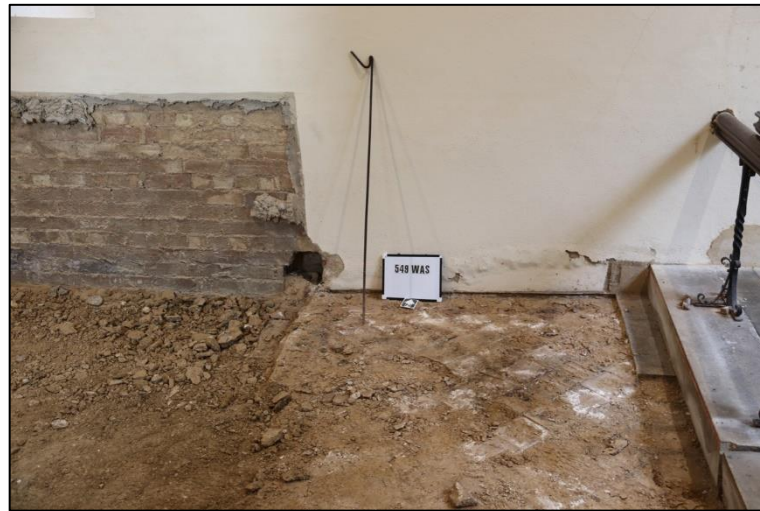
Plate 6: Floor reduction at the eastern end of the north wall

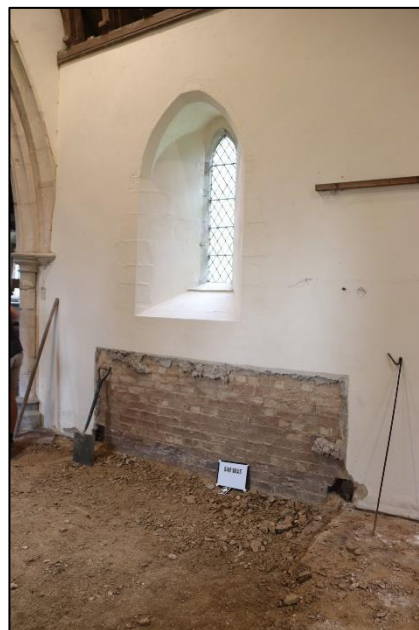
Plate 7: The lancet window and 19th century brickwork in the north wall

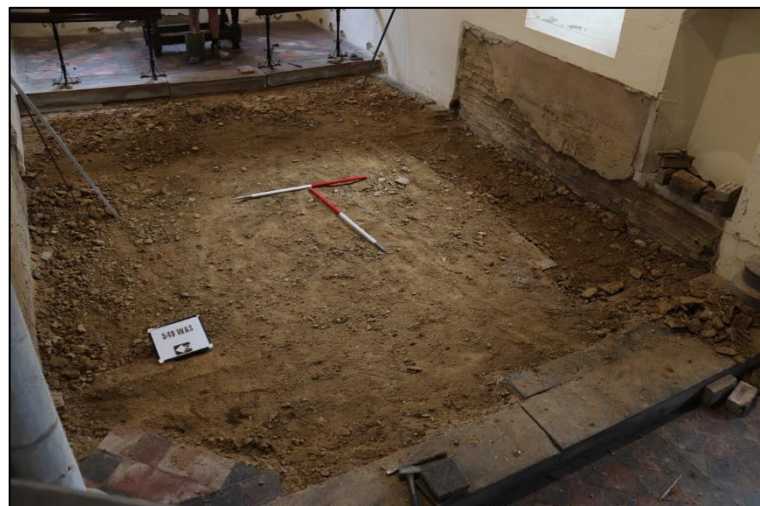
The floor was lowered by c.100mm, which did not breach the hard, sandy mortar that formed the base for the floor tiles. No archaeological features were exposed other than 19th and 20th century building and repair works behind the pews in the north and south walls.

Plate 8: The chancel floor after ground reduction
