KDK ARCHAEOLOGY LTD

Archaeological Observation and Recording Report

Langley Lodge Farm Barn
Kings Langley
Hertfordshire

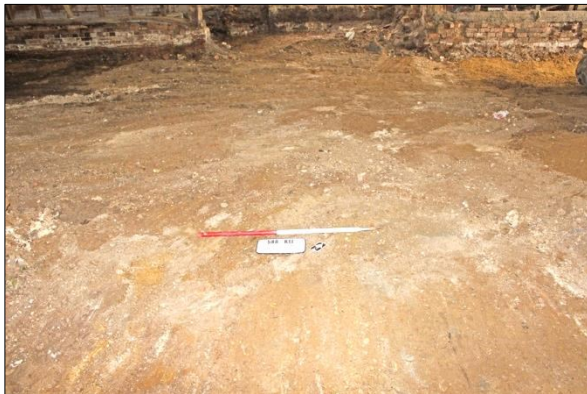
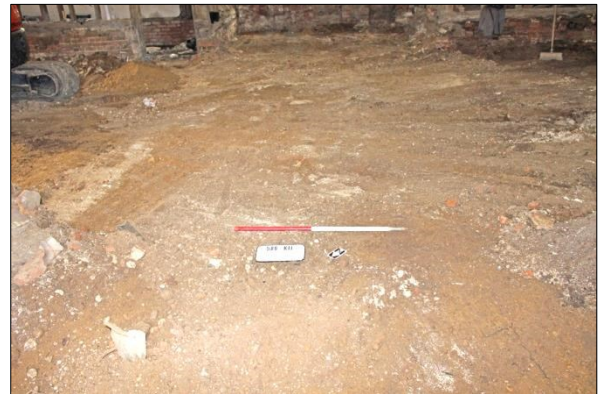
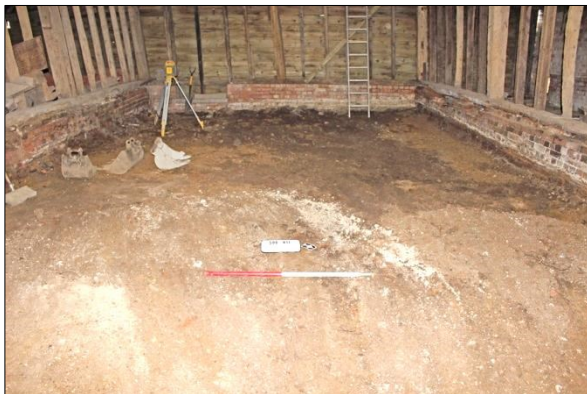
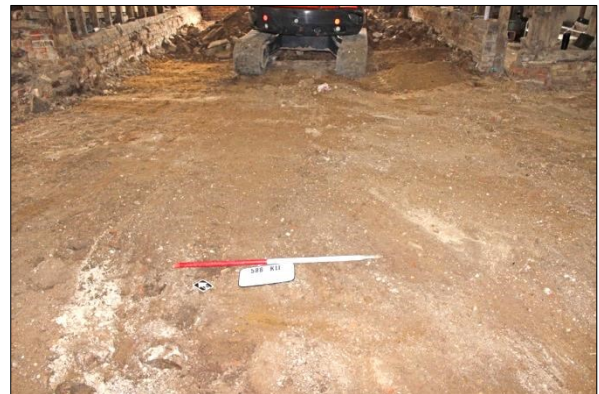
After removal of the concrete floor, a stage of ground reduction was carried out inside the barn. This entailed the lowering of all interior dirt floors by 20cm (Fig. 6, Plates 1-4). This work revealed two red brick piers running either side of the central threshing bay, between the opposing gabled sections to the southeast and northwest. The piers were 34cm in width and 5.5m in length, but only the depth of a single course remained. The individual bricks appeared to be predominantly frogged and measured 22 x 10 x 6.5cm (8½ x 4 x 2½ inches). They were bonded with lime mortar and had been disturbed in places by later demolition (Plate 5). Between the brick piers was a thin layer of chalk, mostly measuring no more than 5cm deep except for near the northwest wall, where the layer became 20cm thick. The chalk was patchy but stretched across the entire central threshing bay, from northwest to southeast, a length of 11.7m and a width of 4m (Plate 6).

Plate 1: Main barn floor reduced, view NW

Plate 2: Main barn floor reduced, view SE

Plate 3: Main barn floor reduced, view SW

Plate 4: Main barn floor reduced, view NE

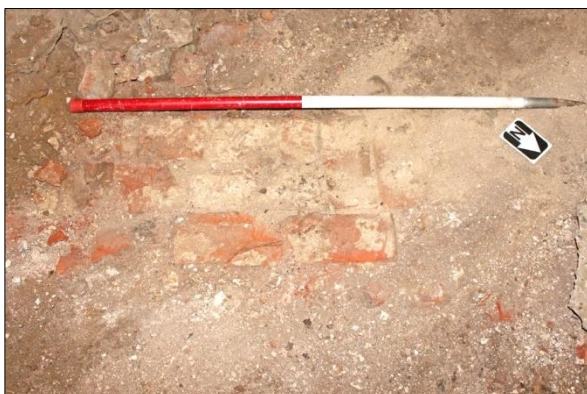
Interior ground reduction revealed the presence of brick piers described in the Historic England list entry, which once supported a raised timber threshing floor. In between these was a layer of chalk that may have been all that remained of an earlier threshing floor, although its date could not be ascertained. No other features of archaeological interest were identified, although service trenches and footings pads were subsequently excavated inside the barn.

Plate 5: Surviving brick pier, view SW

The varied excavations required for the development of Langley Lodge Farm Barn, Kings Langley revealed generally little in the way of archaeological interest, save for the brick piers and chalk floor uncovered during interior ground reduction. Examination of the bricks suggested that they were 19th century in date and would seem to be the same red brick piers mentioned in the National Heritage List entry. These originally supported an raised timber threshing floor that was demolished after 1978, which would explain the poor condition of the brick piers. Nothing remained of the timber floor at the time of the archaeological monitoring.

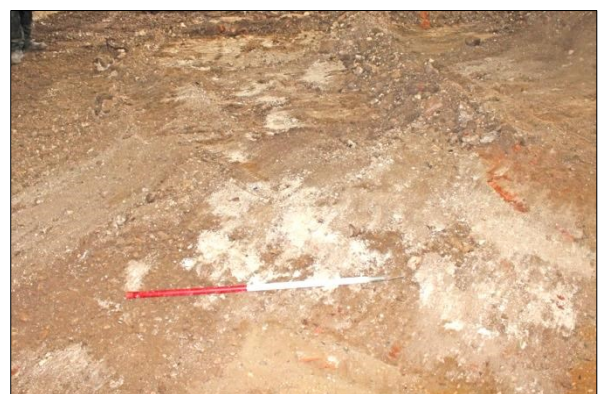
Plate 6: Central chalk floor, view N

A chalk floor is not mention in the list entry. However, the floor identified on site would have been located beneath the raised timbers, so may be the remains of an earlier threshing floor that occupied the entire central bay. It extends into the opposing gables so must have been deposited following their construction.

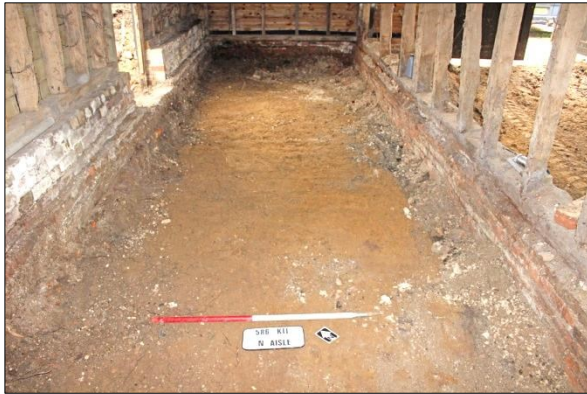
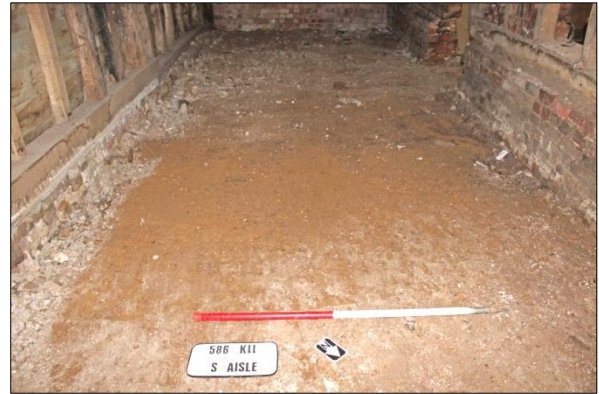
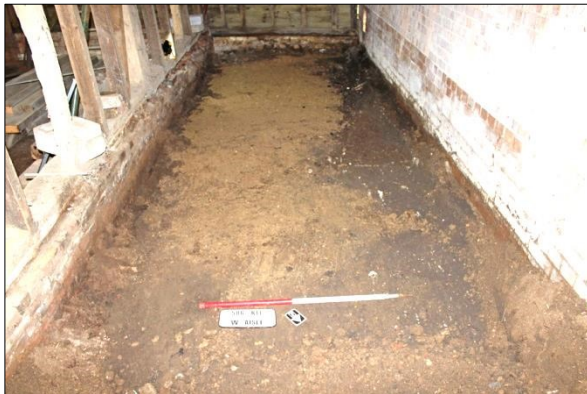
The internal ground reduction also included the floors of the more modern side aisles at the corners of the barn, except for the aisle in the east corner, which did not need to be reduced (Plates 7-9). All reduction of the internal made ground revealed natural gravelly sand. This had been disturbed in places by pockets of modern disturbance and a patch of topsoil at the edge of the west aisle, but the natural soil was otherwise ubiquitous and lay beneath the central chalk floor and brick piers.

Plate 7: North aisle reduced, view NE

Plate 8: South aisle reduced, view SW

Plate 9: West aisle reduced, view SW

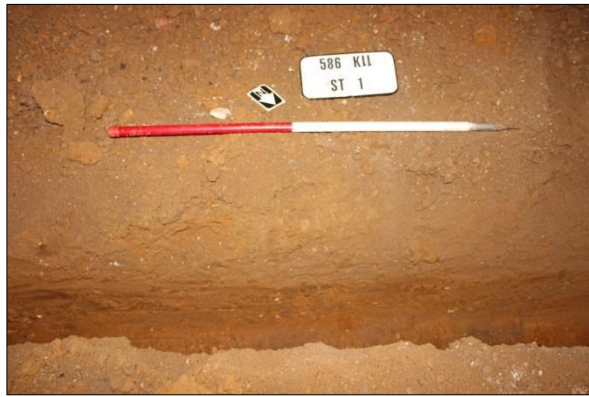
Four internal service trenches were monitored following the internal ground reduction (Fig. 7), but these revealed only natural soil with a thin layer of made ground above in places (Fig. 8). All trenches measured 0.3m wide but varied in depth from 0.9m deep in Service Trench (ST) 1 and only 0.3m deep in ST 2 and ST 3 (Plates 10-16). Ten pits were excavated around the central section of the barn in order to accommodate concrete footings pads for a mezzanine floor. Each pad was 0.7m long, 0.5m wide and 0.4m deep at the deepest point. All pads showed only natural soil (Plates 17-26).

Plate 12: Service trench 1 stratigraphy

Figure 8: Service trench 1 stratigraphy (Strat 1)

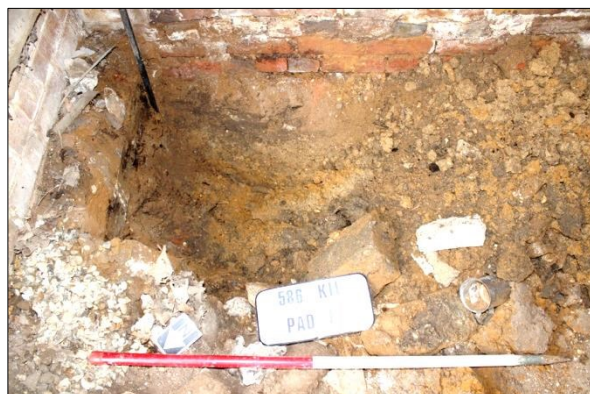
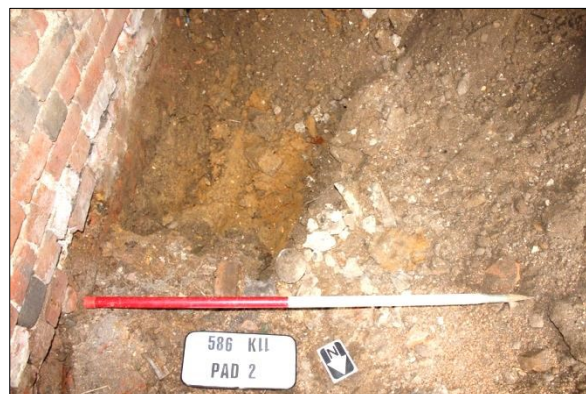
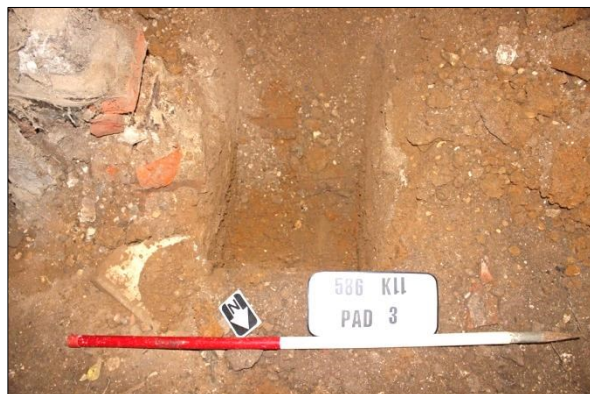
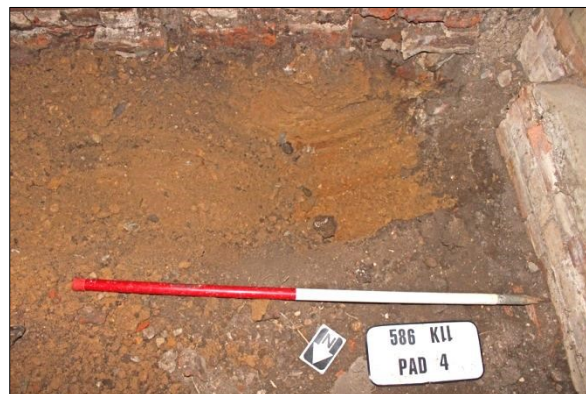
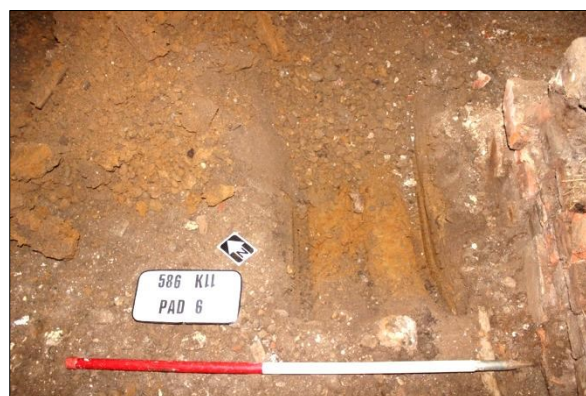
Plate 17: Pad 1, view SE

Plate 18: Pad 2, view SW

Plate 19: Pad 3, view SW

Plate 20: Pad 4, view SE

Plate 21: Pad 5, view NE

Plate 22: Pad 6, view NE

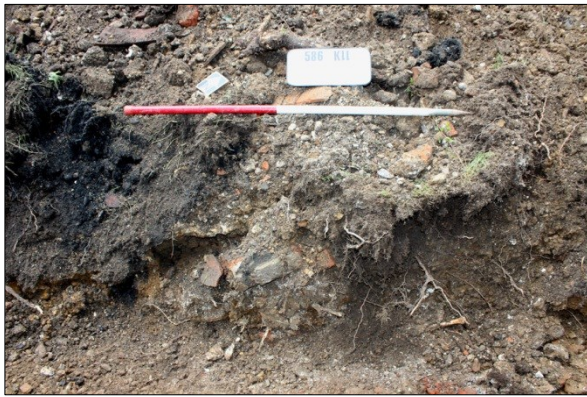
Ground reduction also took place to the exterior building. The largest area reduced measured 1.8m wide and ran 20m along the full length of the barn. The reduction was 0.65m deep and revealed made ground containing large amounts of modern CBM and other materials to the southwest, but did not breach below the topsoil at the northeast end (Plates 27-28). 0.55m of topsoil was visible in section prior to the reduction of the patio area, but this gave way to made ground near the base of the excavation (Fig. 9, Plate 29). It appeared in section that there had been past ground reduction at the southwest end of the garden, followed by the deposition of topsoil, although this certainly occurred in the modern period. Service Trench 5 was excavated within the area of ground reduction, also along the edge of the barn. This was 0.3m wide and 0.4m deep and revealed natural soil below 0.05m of made ground and topsoil (Plates 30-31). Two further service trenches of similar dimensions were excavated to the exterior. ST 6 connect ran from the reduced area to the soakaway and ST 7 connected to the LPG tank. These were also 0.3m wide, although ST 6 was slightly deeper at 0.6m and showed made ground and some

Plate 29: Exterior ground reduction stratigraphy

Figure 9: Exterior ground reduction stratigraphy (Strat 2)

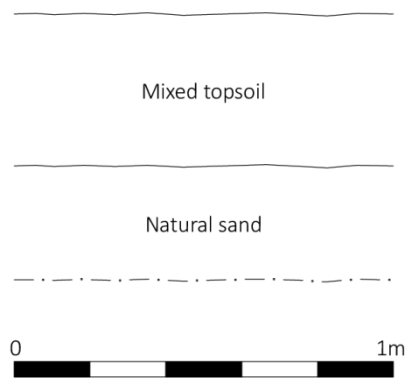
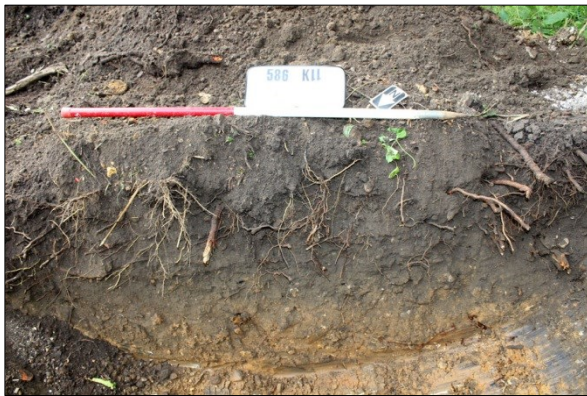
natural soil, whereas ST 7 was only 0.3m deep and did not breach the topsoil (Plates 32-33). The patio area was excavated to adjoin the area already reduced, this measured 5.5m long by 2.5m wide and 0.4m deep. It showed made ground to the northeast and topsoil to the southwest (Plate 34). A soakaway was excavated in the west corner of the garden measuring 2m by 1.6m and 0.7m deep (Plate 35). The stratigraphy showed 0.4m of mixed topsoil over 0.3m of visible natural sand (Fig. 10, (Plate 36)). The LPG tank was excavated 14m to the northeast and measured 2.8m by 1.6m (Plate 37). It was 0.8m deep and the stratigraphy showed 0.3m of topsoil over 0.3m of modern chalky made ground, below which was 0.2m of natural clayey sand (Fig. 11, Plate 38).

Plate 36: Soakaway stratigraphy

Figure 10: Soakaway stratigraphy (Strat 3)

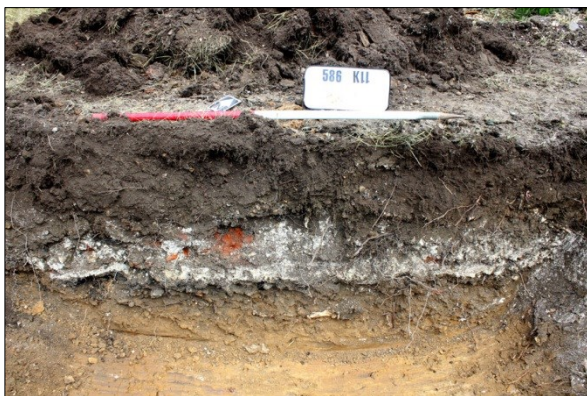
Plate 38: LPG tank stratigraphy

Figure 11: LPG tank stratigraphy (Strat 4)
