Archaeological Summary Report

Stone Feature at Upper Alders

Sandy Smith Nature Reserve

Chicksands

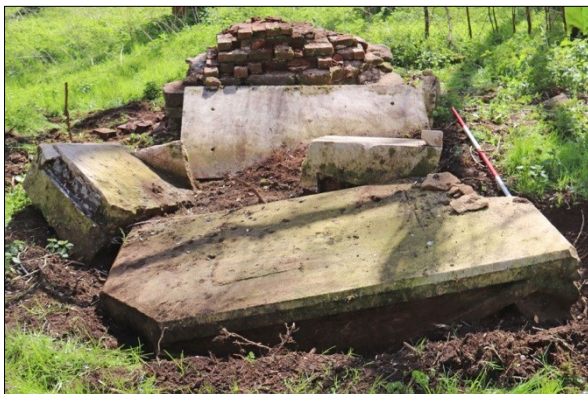
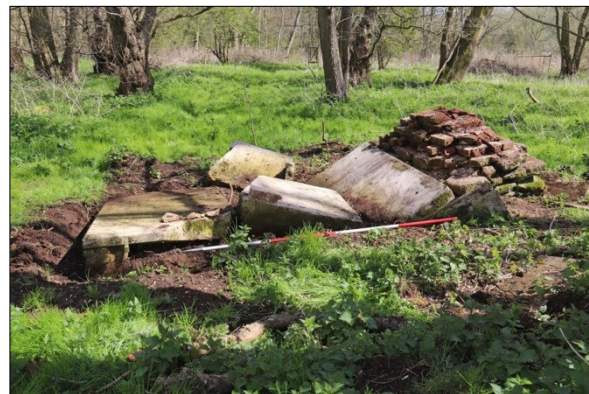
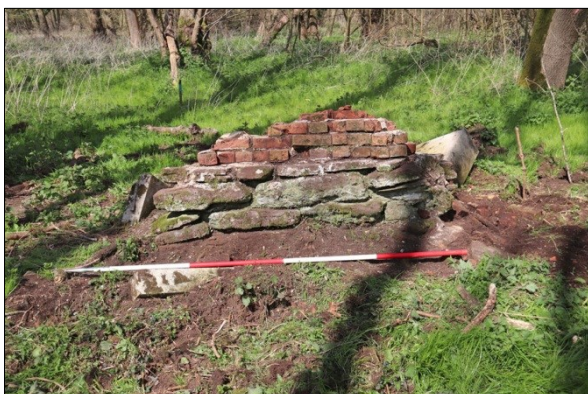
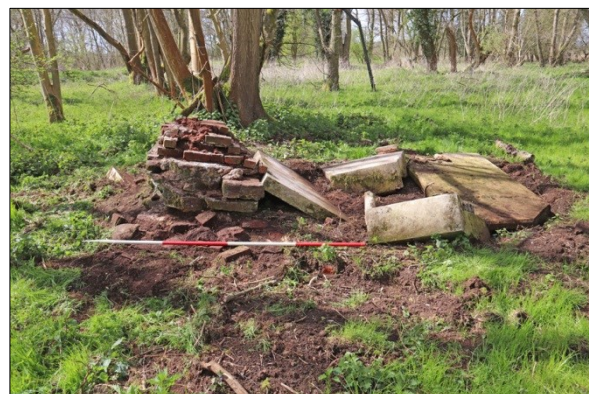
The feature consists of a stone and brick plinth that was initially overgrown with vegetation. Around the plinth is a scatter of at least eight stone components, mainly concentrated to the west. The plinth also leans to the west, suggesting that this is the direction in which the feature collapsed. Most of the stones were at least partially buried prior to recording, although they were not deeper than the topsoil. It is possible that other pieces are buried deeper, but only those immediately accessible were uncovered (Plates 1 – 4).

Plate 1: Entire feature, facing east

Plate 2: Entire feature, facing north

Plate 3: Entire feature, facing west

Plate 4: Entire feature, facing south

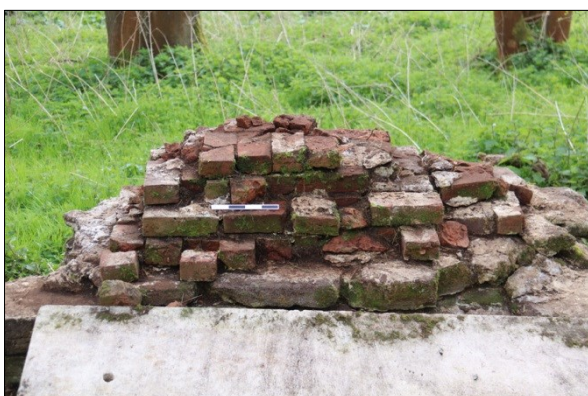
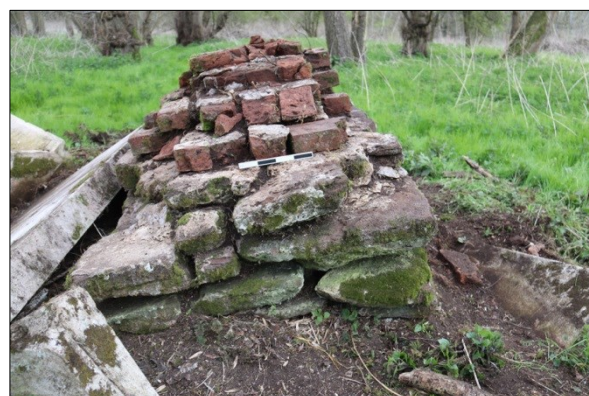
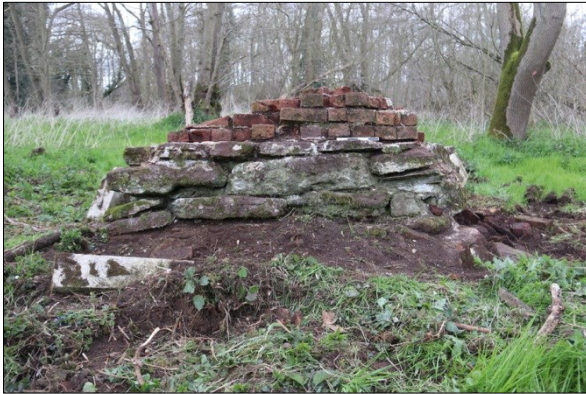
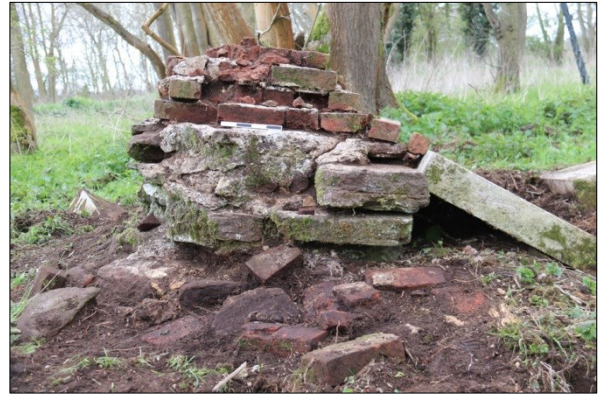
The entire feature is scattered over an area measuring 5.2m north-south, by 4.85m east-west (Fig 3). The plinth is positioned on the east side and measures 2.06m long, 1m wide and approximately 0.75m high. The lower portion of the plinth consists of ironstone courses 56cm high, roughly finished in an irregular bond. This has the outward appearance of dry stone joints but it has been constructed with lime mortar, which survives in the interior of the masonry. The north side has a harder sand-based mortar. The ironstone pieces vary significantly in size, up to 63cm long and 20cm wide, laid generally flat in courses. Above this are four courses of handmade red brick approximately 30cm high. The bricks mostly measure 22 x 10 x 7cm, but some are 23 x 10 x 6.5cm. Some of the bricks are lightly frogged and most are poorly puddled with few inclusions. They have been bonded with the same hard lime mortar found on the ironstone (Plates 5 – 8).

Plate 5: Stone and brick plinth, facing east

Plate 6: Stone and brick plinth, facing north

Plate 7: Stone and brick plinth, facing west

Plate 8: Stone and brick plinth, facing south

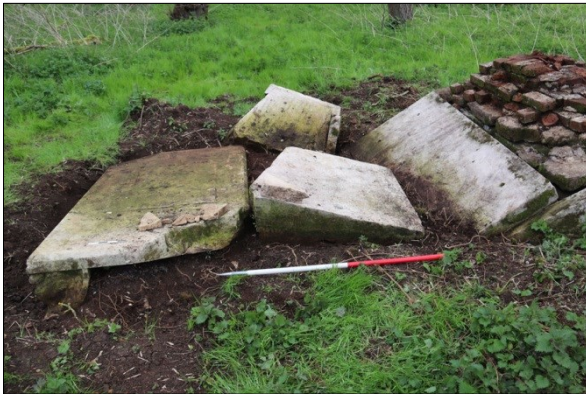
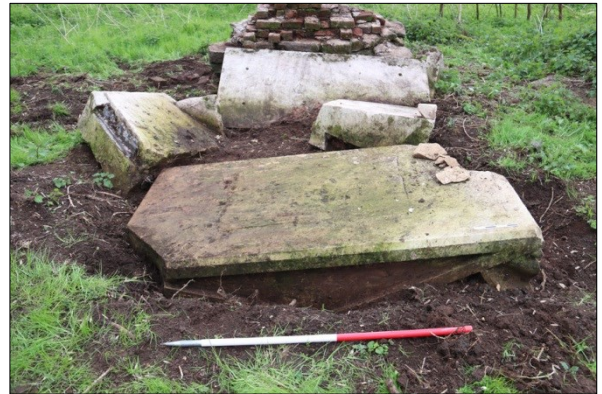
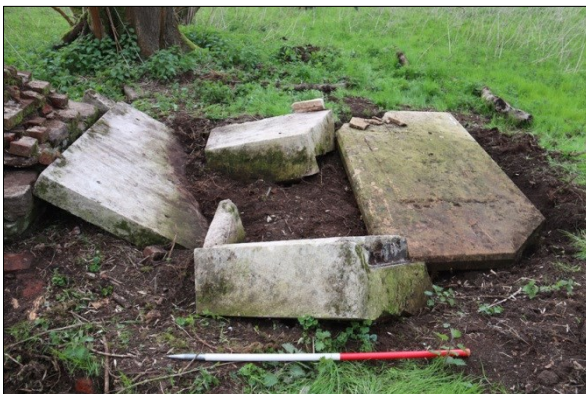
Plate 9: Scattered stones, facing north

Plate 10: Scattered stones, facing east

Plate 11: Scattered stones, facing south

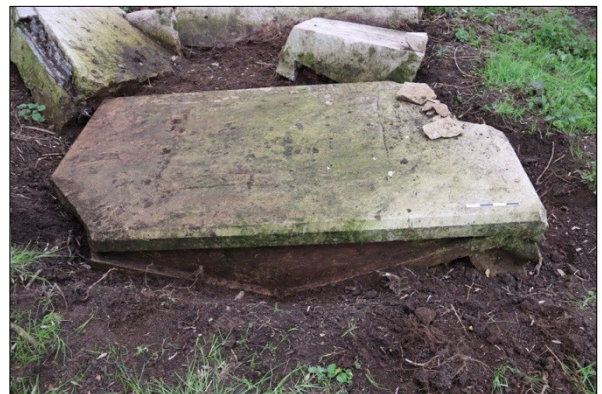
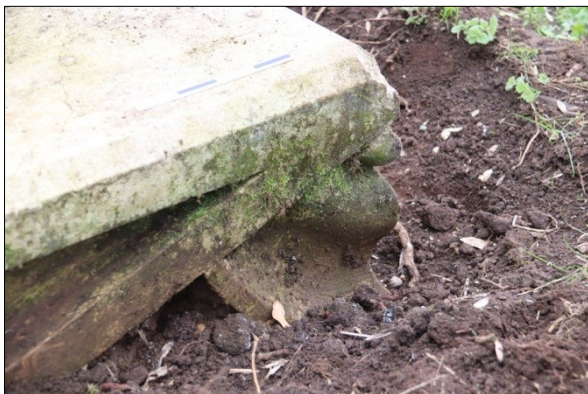
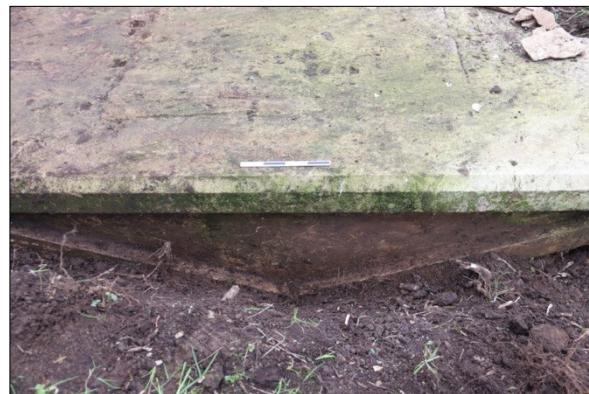
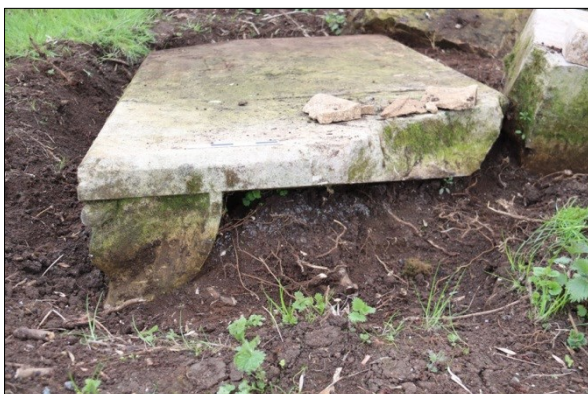
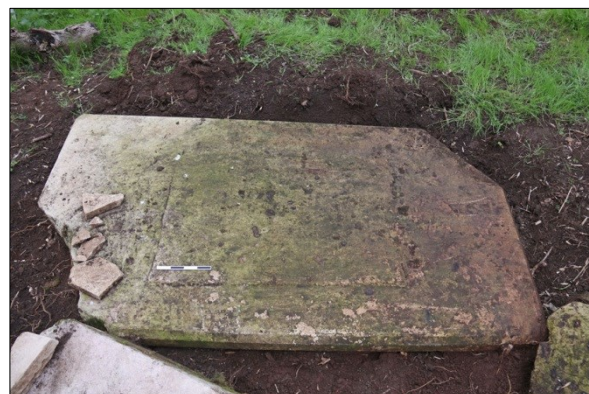
The upper portion of the feature is scattered primarily to the west and consists of several large moulded pieces that appear to have lain in situ since the structure collapsed. The stones are all oolitic Lincolnshire limestone, possibly from the Weldon quarries (Plates 9 – 11). Stone 1 is the largest of these, measuring 2.07m in length and 1.13m wide. It is currently lying upside down but is evidently the top piece the structure. It has a pediment and a decorative corner moulding, only one of these is visible as two corners are damaged and a third is obscured, however it is likely that all corners sported this moulding. The protrusion is in the shape of a quarter sphere with a curved cyma recta moulding. On the underside currently facing upwards is a raised marking for slotting against other pieces 95cm long by 66.5cm wide. The bottom edge is also chamfered (Plates 12 – 16).

Plate 12: Stone 1, top piece, facing east

Plate 13: Stone 1 corner decoration, facing east

Plate 14: Stone 1 pediment, facing east

Plate 15: Stone 1 side, facing north

Plate 16: Stone 1 underside, facing west

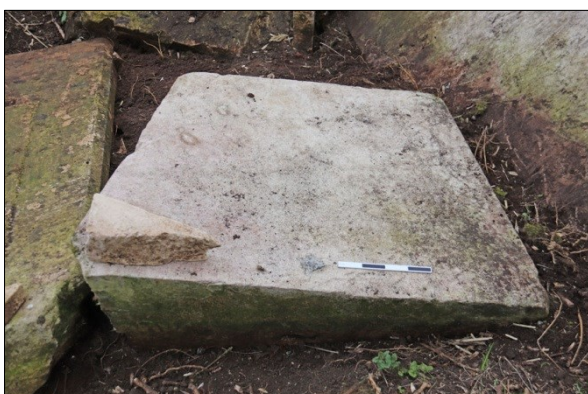
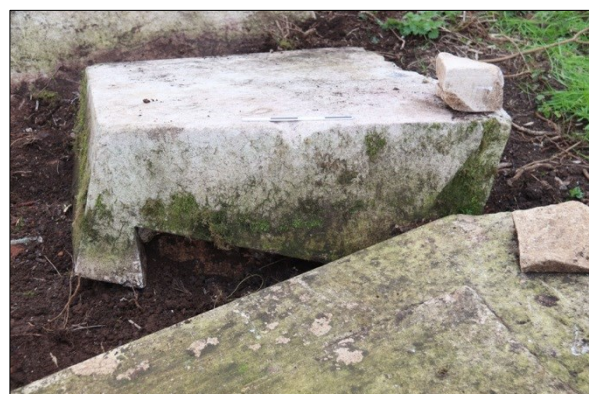
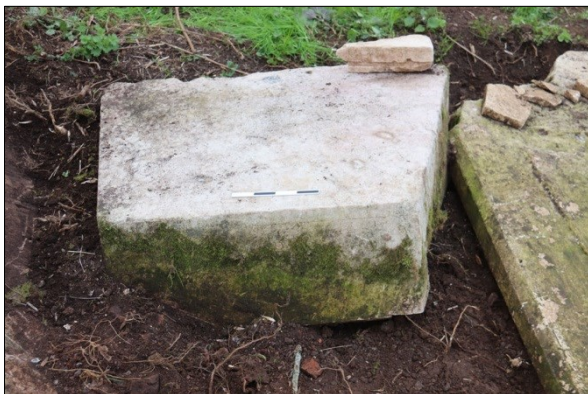
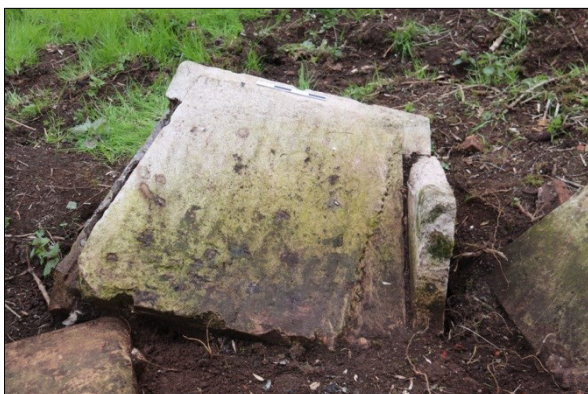
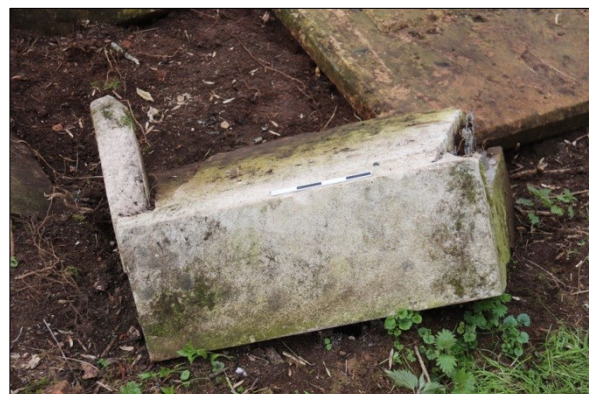
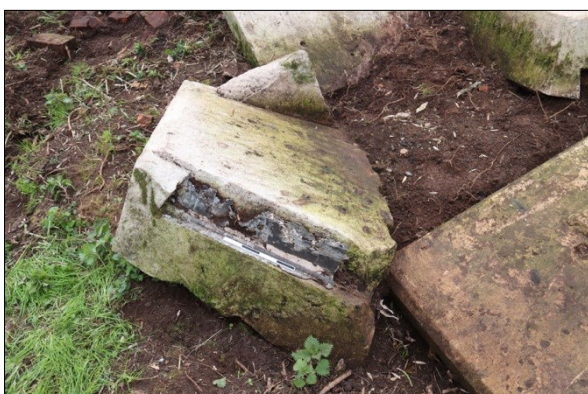
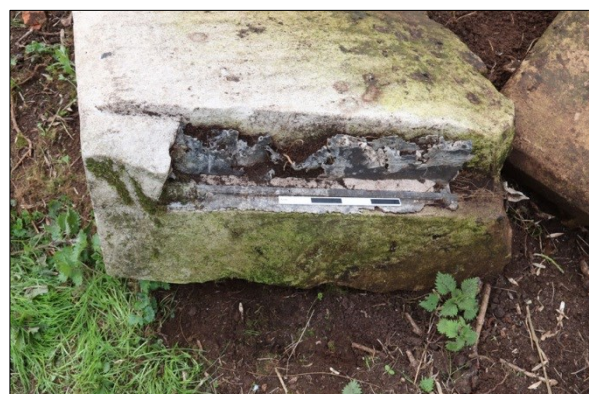
Stones 2 and 4 are opposite counterparts that likely sat on the base and supported the top piece (Plates 17 – 19, 21-24). They are trapezoidal in shape and have dovetail grooves filled with lead flashing that likely acted as mortices. However it is not immediately obvious which way up they were positioned in the feature. It may be that a front section that slotted into these joints is missing. Stone 3 is the base slab that sat directly onto the brick part of the plinth, it has four pilot holes arranged in the top side (Plate 20).

Plate 17: Stone 2, side support, facing north

Plate 18: Stone 2 side, facing east

Plate 19: Stone 2 top, facing south

Plate 21: Stone 4, side support, facing north

Plate 22: Stone 4 top, facing south

Plate 23: Stone 4 side, facing east

Plate 24: Stone 4 lead flashing, facing east

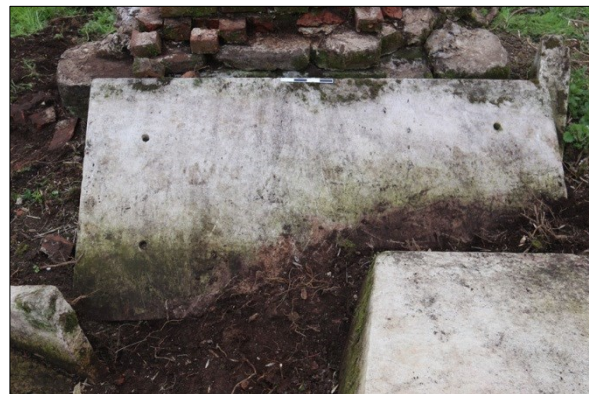
Plate 20: Stone 3, base, facing east

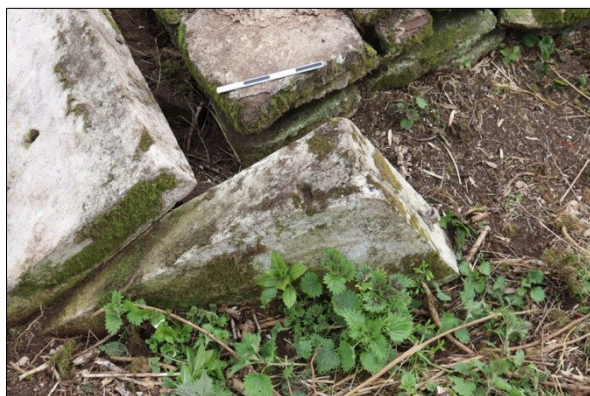
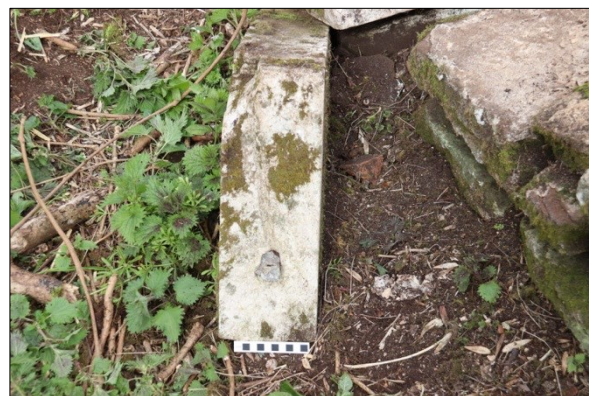
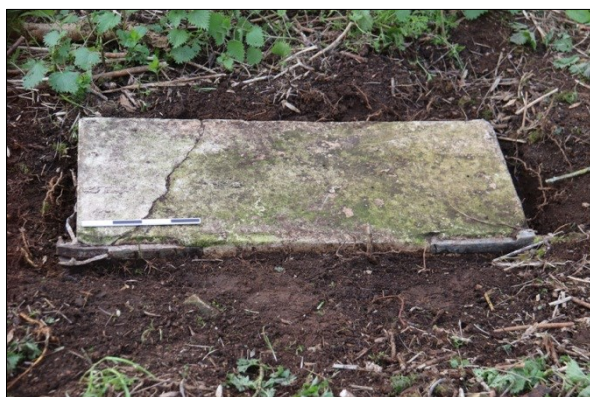
Stones 5 and 6 are both located to the south side of the plinth and both were partially buried. They are rectangular slabs of the same size with iron or lead pins at one end for fixing in place (Plates 25 – 27).

Plate 25: Stone 5 partially buried, facing north

Plate 26: Stone 5 partially buried, facing west

Plate 27: Stone 6, facing southeast

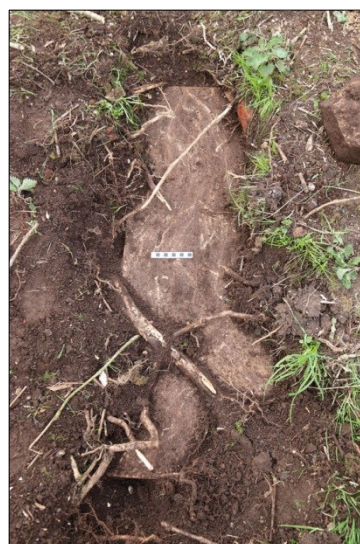
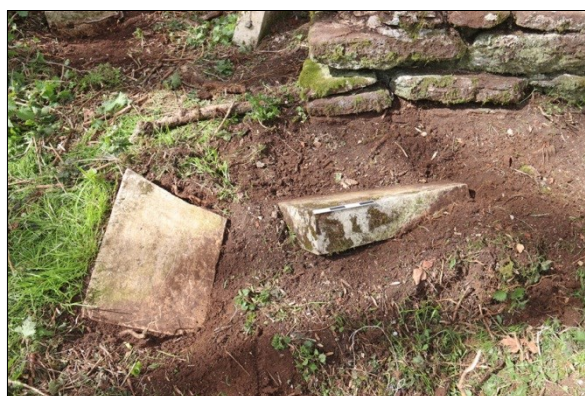
Stones 7 and 8 are also identical slabs, approximately 30cm longer than Stones 5 and 6. Stone 7 is located to the north of the assemblage and was entirely buried. Stone 8 was found to the east of the plinth and has been broken into two pieces. These appear to have been side panels (Plates 28 – 29).

Plate 28: Stone 7, partially buried side panel, facing southeast

Plate 29: Stone 8, broken side panel, facing west

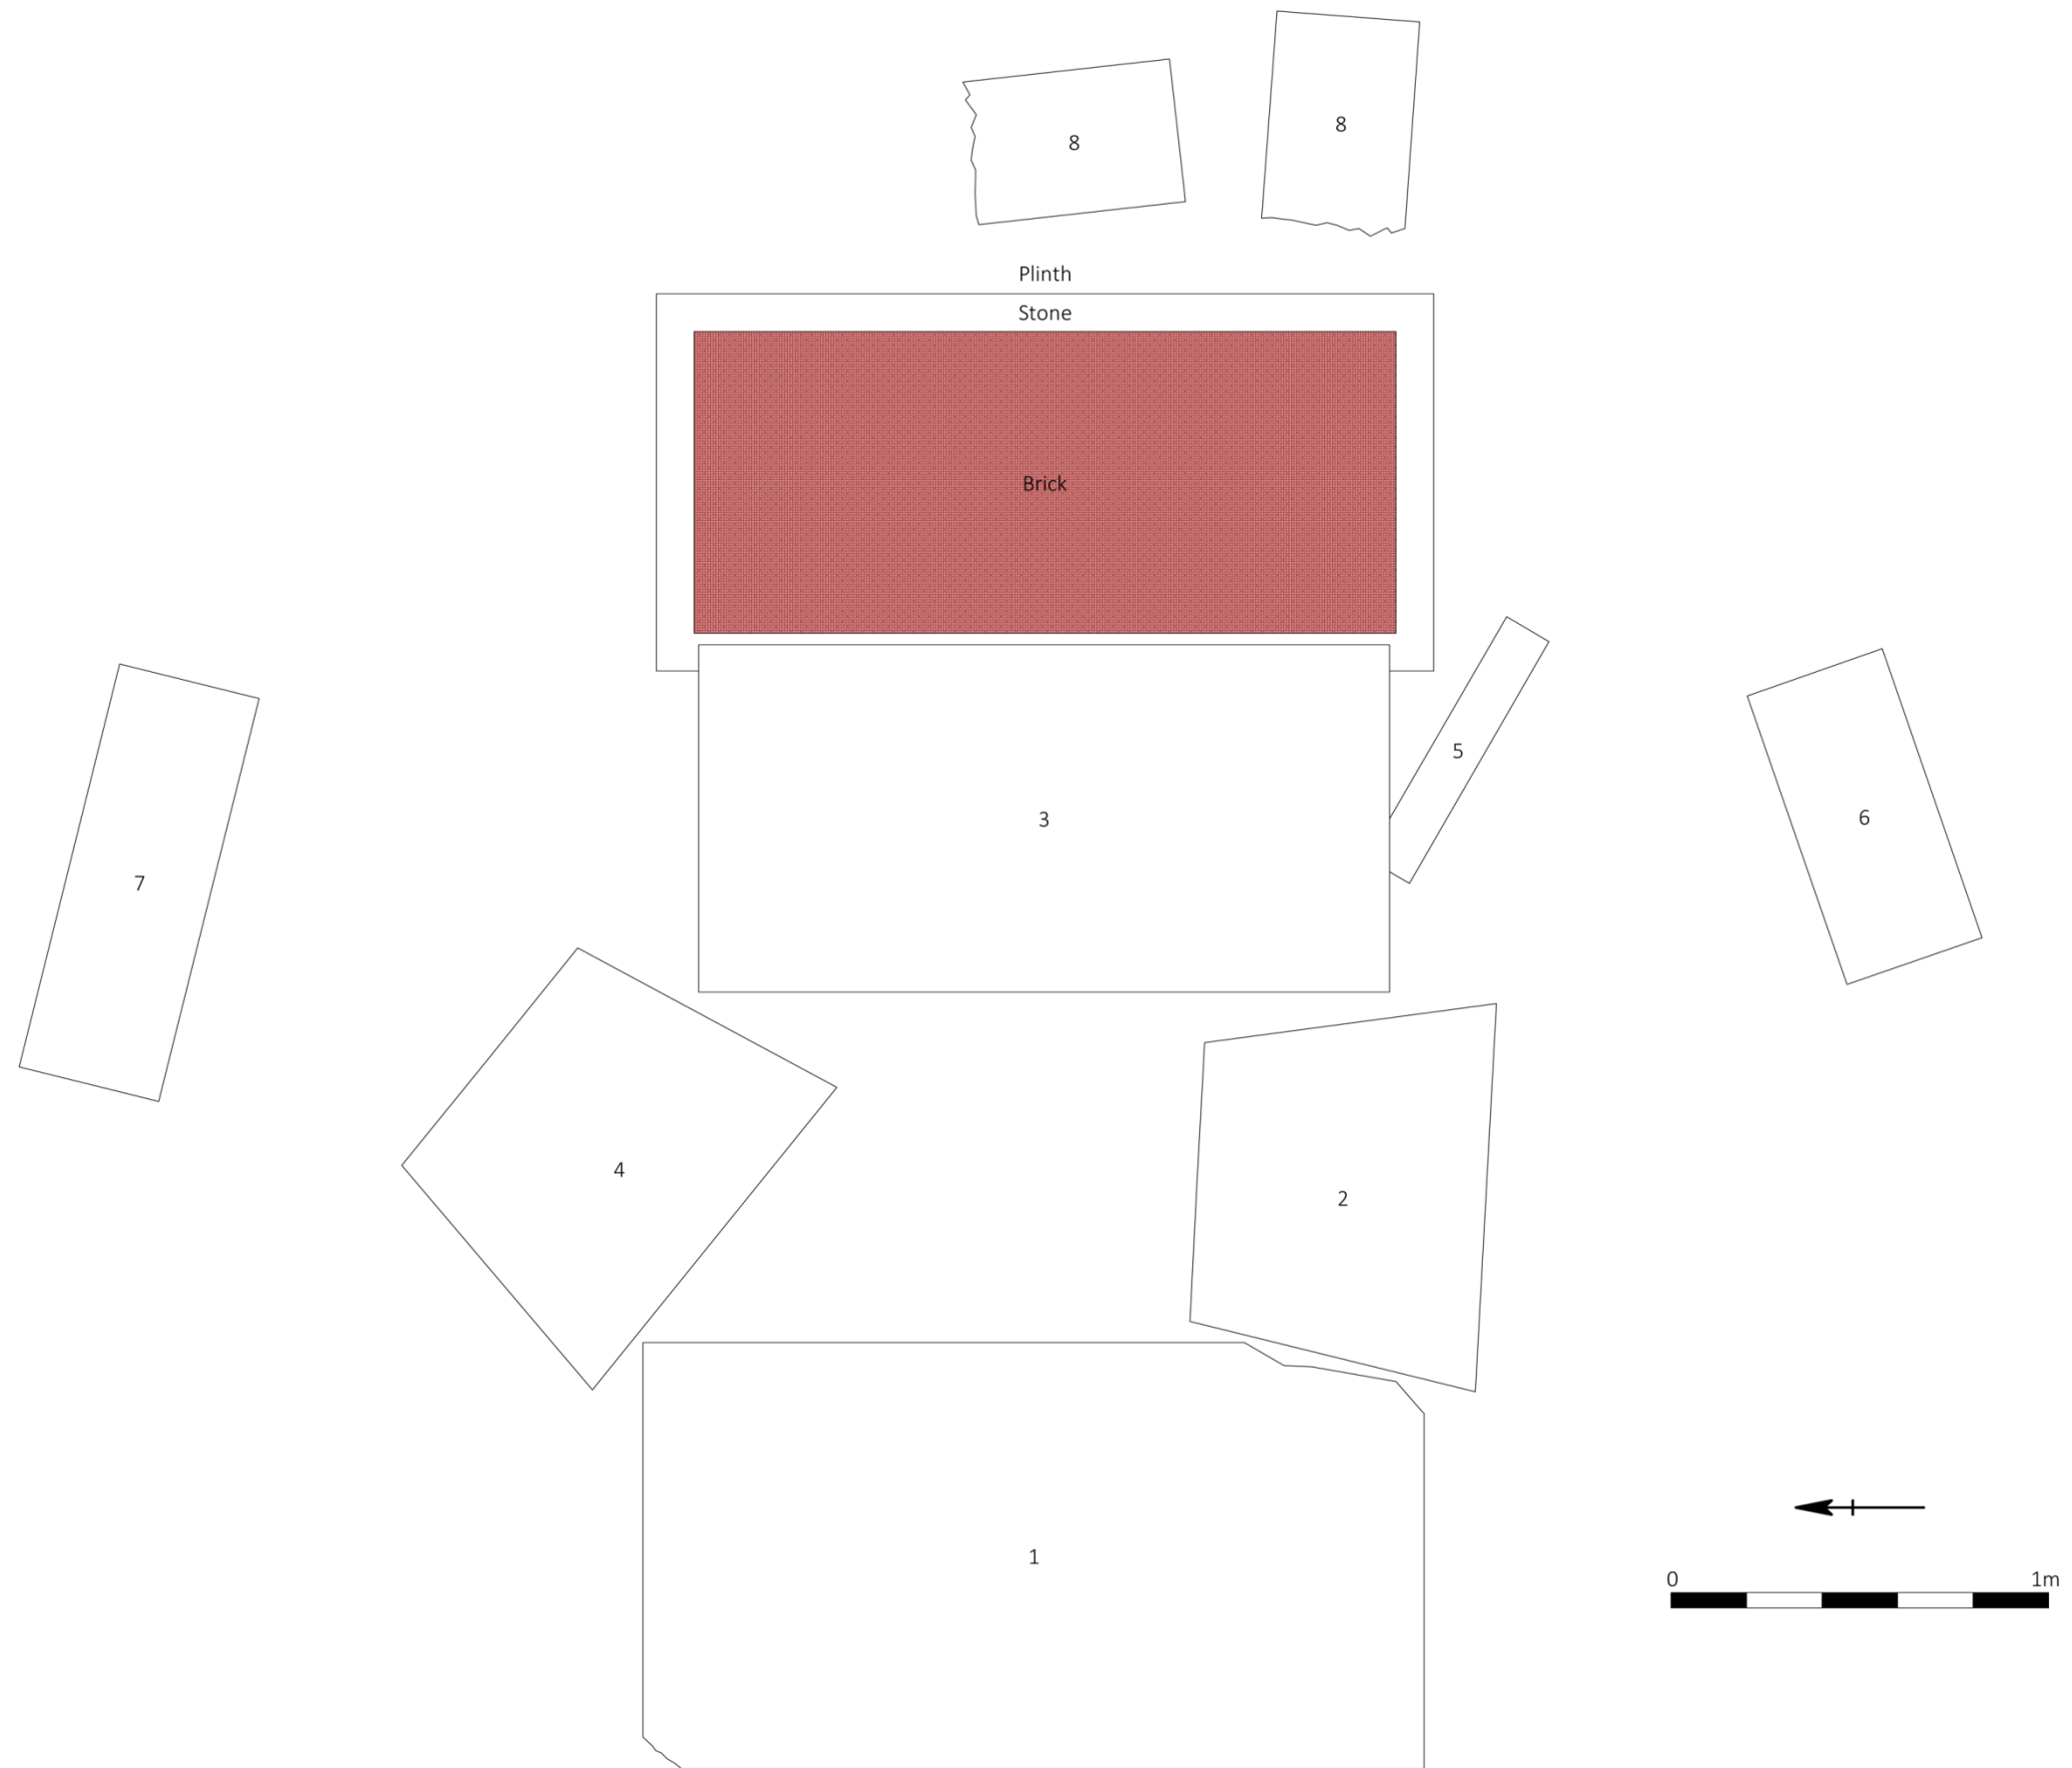
Figure 3 shows a plan view of the feature in situ, as it as when found. Figure 4 is a speculative reconstruction of the feature's west elevation. It shows what the feature may have looked like using all available data and estimating the positions of various pieces, while also allowing for the fact that some elements may not have been discovered yet.

Figure 3: Plan of feature in situ (scale 1:20)
