KDK ARCHAEOLOGY LTD

Archaeological Observation and Recording Report

Church of St Lawrence
Church Street
Bovingdon
Hertfordshire

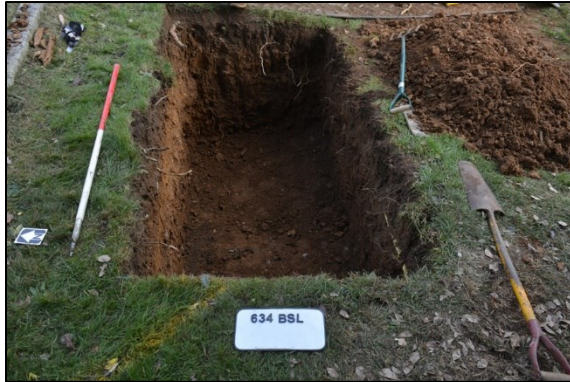
The soakaway was located to the south of the church, just beyond series of tombs and graves belonging to the Ryder family (Plates 1 & 2). It measured 2.10x1.10m and was excavated to a depth of 1.10m. The stratigraphy comprised:

Plate 1: Soakaway, looking east

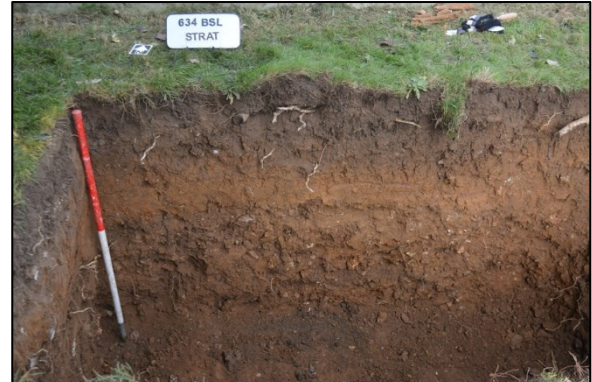
- Topsoil (001). Mid greyish brown, slightly clayey silty sand. Friable with occasional angular flints. Heavy rooting was noted, particularly to the west of the soakaway. This layer reached a depth of 0.28m.
- Made ground (002). Mid orangey brown sandy clay containing occasional flint pieces. Rooting was present throughout. The depth of this layer was 0.22m.
- Cemetery soil (003) Mid brown sandy clay. Fairly malleable with a moderate number of angular flints. Large roots were present within this layer. It contained a number of finds including disarticulated human remains. The base of this layer was not reached and the natural geology below was not exposed anywhere on the site.

Plate 2: Site stratigraphy, taken within the Soakaway. Looking north

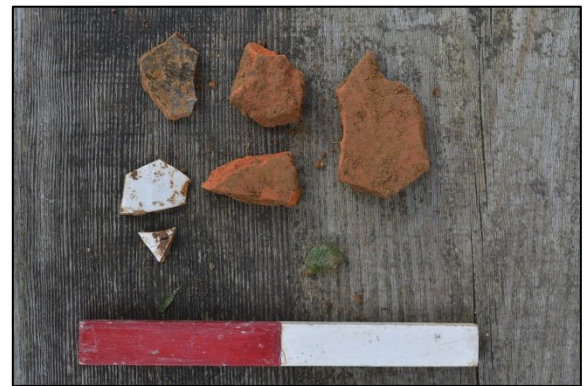
Plate 3: Representative assemblage of finds from cemetery soil (003)

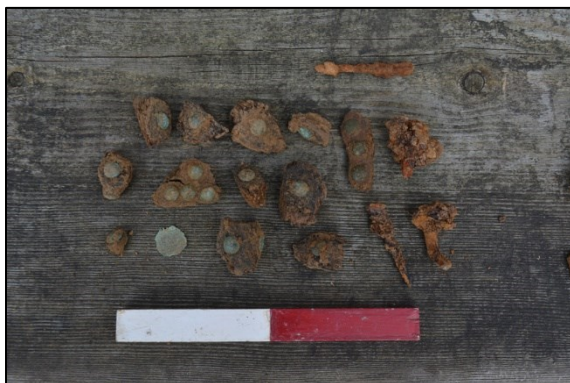
No articulated burials were encountered during this investigation; however, several fragments of disarticulated bone were noted. These included, the mid shaft of a right tibia, four pieces of skull (parietal bone) and two metatarsals. No grave cuts or cut features were observed within the soakaway. Artefacts recovered from the cemetery soil included glass, tile, brick, pottery (Plate 3). In addition, there were a number of objects associated with coffins observed. These included; fragments of wood, copper alloy studs and iron coffin nails (Plate 4).

Plate 4: Coffin wood, nails and studs found within the soakaway

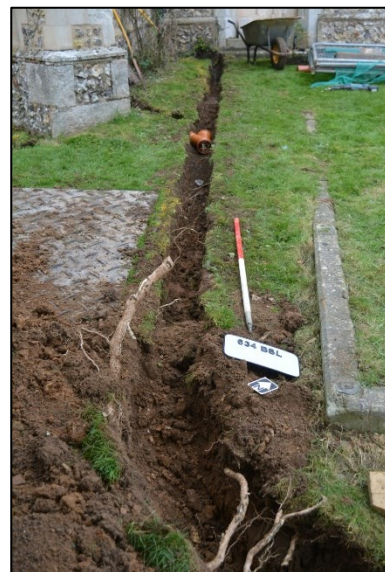
The service trench was excavated between the existing down pipes connected to the church roof and the newly dug soakaway (Plate 5). The trench, which measured 3.77x0.25m, was excavated parallel to the south porch and close to a number of 20th century cremation burials, although these were not exposed during this investigation. A depth of 0.60m was reached within this trench, exposing an identical stratigraphical composition to the soakaway. Similar finds were also recovered from the service trench as well as clunch and limestone fragments. A York stone slab 0.47m wide was observed within the trench, 2.40m to the south of the church wall (Plate 6). Its full length could not be determined as it continued beyond the limit of excavation to the east and west. As the stone was at the required depth for the installation

Plate 5: Service trench, looking north northeast

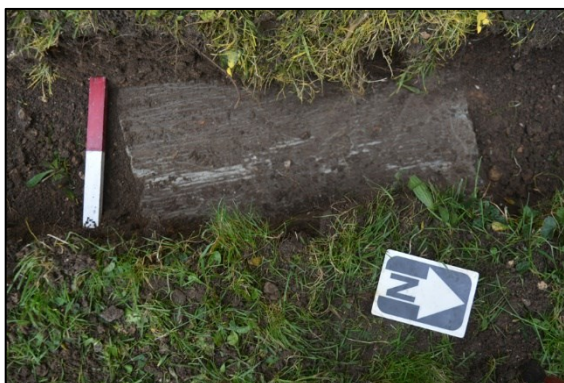
of the service, it was deemed unnecessary to disturb the stone itself, and what could potentially be beneath it, any further and it was left *in situ*.

Plate 6: Stone found within service trench, looking south southwest

The finds mainly consisted of modern and post-medieval building material. Coffin fragments and fixings were also noticed which, due to their preservation, were likely also late post-medieval/modern in date. A York stone slab was exposed in the service trench near to the church. No inscription was noted on the stone and it was left *in situ* to avoid damaging it or disturbing what may lie beneath.
