KDK ARCHAEOLOGY LTD

Historic Building Recording

1 The Green

Islip

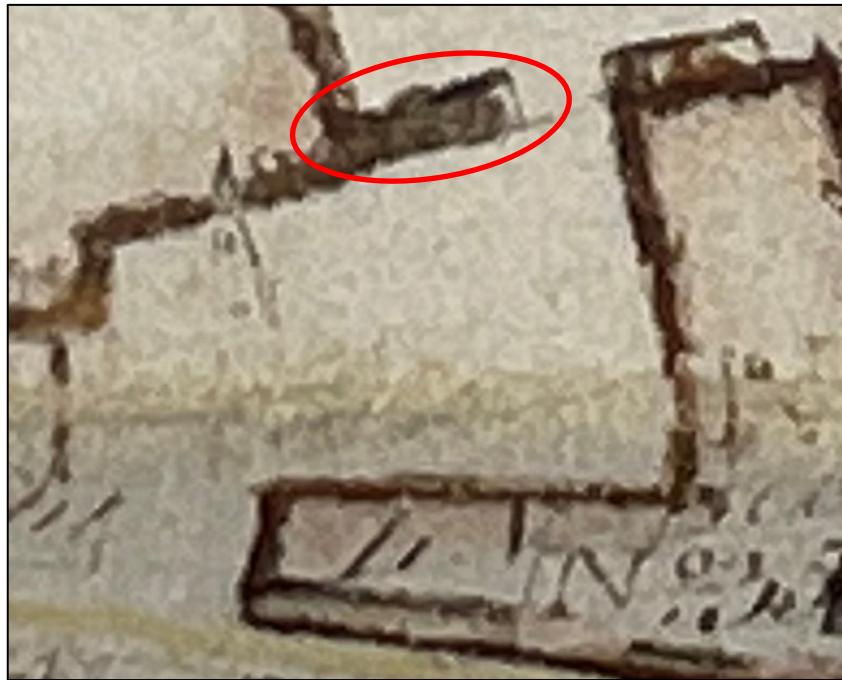
Figure 4: Extract from the 1800 Inclosure Map (not to scale)

The earliest readily available map is the Inclosure Map of 1800, which shows the church and the cottage only very faintly (Fig. 4). In contrast, the 1886 Ordnance Survey map shows both in some detail, and the cottage had already been subdivided into 3 units by this time (Fig. 5). By 1900 the central unit had been further subdivided and it stayed that way until at least 2003 (Figs. 6&7).

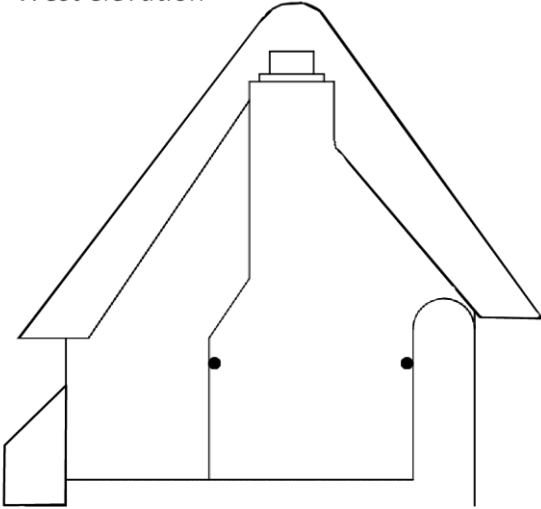
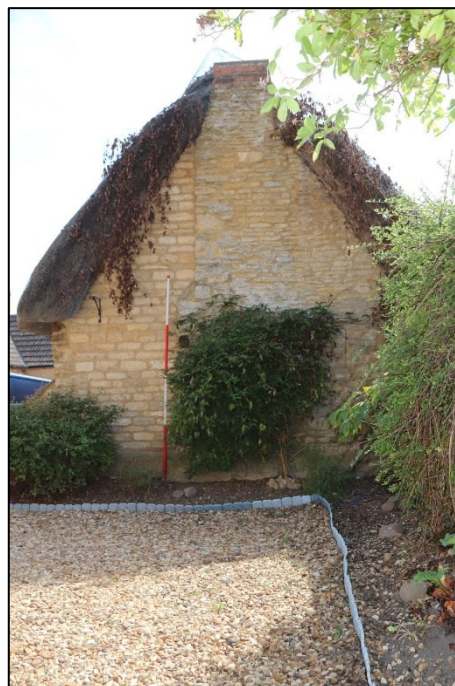
Plate 6: West end

There is an external chimney stack on the west elevation constructed of smaller rubble pieces than in the adjoining wall. The end of a timber pole can be seen on either side of the stack. The elevation is built of well coursed, roughly worked limestone pieces including Ketton, Weldon and Blisworth type stone. The wall has been repointed in a cement-based mortar, and has a small concrete plinth at the base.

The upper floor of the west elevation is of brick infilled timberwork, although this does not appear to be of any great age. The studs are machine cut and the bricks have horizontal skintlings, a feature that date the bricks to no earlier than the mid 18th century. In this instance, the bricks are possibly reclaimed or even reproduction and have been set in a cement-based mortar. There is a timber casement window at first floor level and a leaded window in the floor below, above which is a chamfered timber lintel.

| Other Architectural Features: | External chimney stack also built of limestone rubble but smaller pieces than the main wall. Brickwork at the top of the stack, but the chimney pot has been removed. On either side of the stack is the end of a timber pole. The wall has a concrete sill. | |

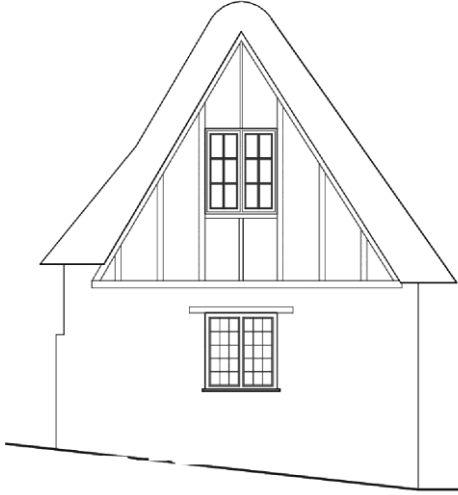
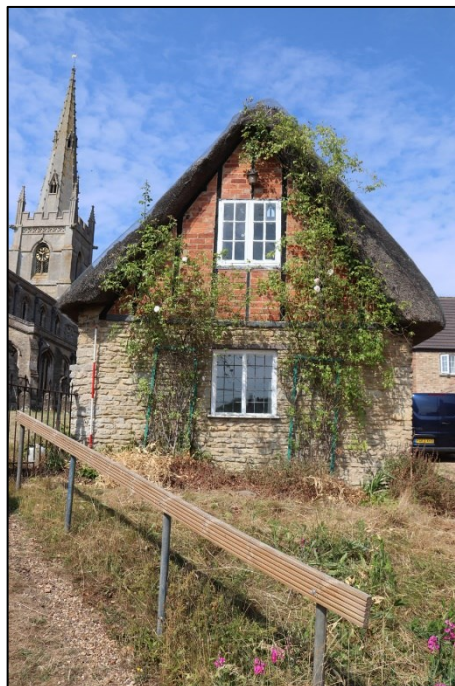
Plate 7: East elevation

| Windows GF: | 2-light timber casement with leaded lights under a machine cut chamfered lintel | |

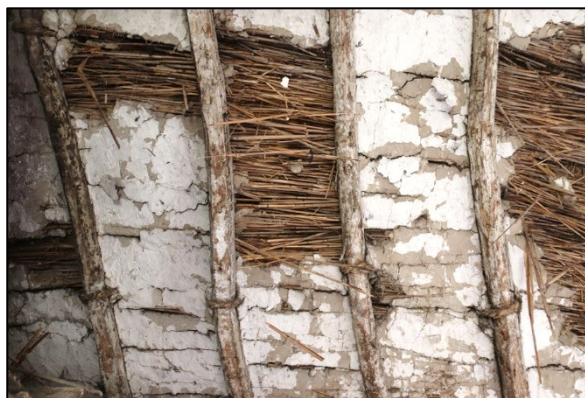
Plate 25: G1: thatching detail in north wall

The roof has clearly been reworked on more than once accession. At 6cm wide, the rafters exposed in the western end of Room G1 are more likely to be of 18th or possibly 19th century date. The rafters and battens beneath the dormer window in the eastern part of the same room are modern. The truss is rather rudimentary, with an adzed principal rafter and machine processed collars added at a later date. The purlins are only roughly worked and the joints are not scarfed together. The thatch has been tied to the rafters.

| Ceiling / roof structure: Lath and plaster. Rafters 6cm wide on 35cm centring exposed in north wall. Thatch seen to be tied to the rafters. Modern rafters and battens noted beneath the dormer window. | | | |

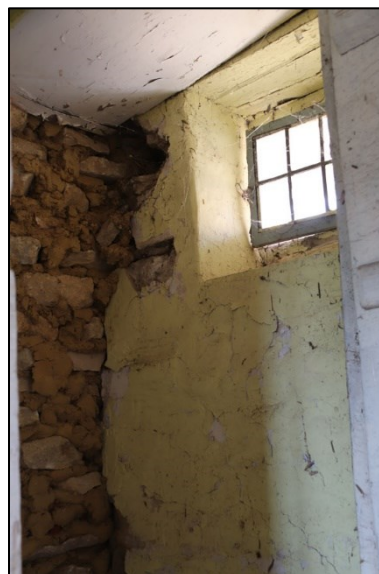
Plate 26: G1: cupboard to north of fireplace

| Other architectural details: Walk in cupboard to north of fireplace | | | |
