KDK ARCHAEOLOGY LTD

Archaeological Evaluation Report

Land r/o 115 Station Road
Lower Stondon
Henlow
Bedfordshire

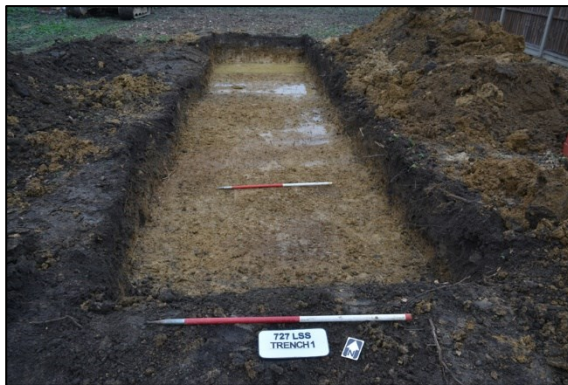
Plate 1: Trench 1, Looking north northwest

The topsoil and over burden was removed in spits under constant archaeological supervision. The natural geology was uncovered at a depth of 0.49m (Fig.6; Plate 1-2). The stratigraphy comprised:

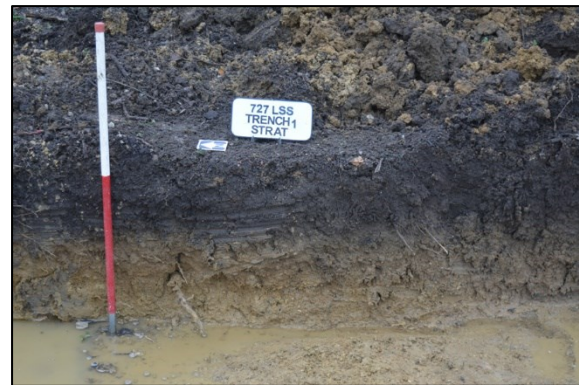
Plate 2: Site stratigraphy, looking east northeast

- Topsoil (100). Dark grey slightly clayey silt. Friable with occasional small angular flints and rounded stones. This layer was 0.17m deep.
- Subsoil (101). Mid brownish grey silty clay 0.13m in depth. Very malleable. Contained occasional sub-angular stones. Rooting was present within this layer
- Subsoil (102). Mid brownish orange slightly sandy silty clay with occasional stone and flint gravel inclusions. The depth of this layer varied between 0.19m to the north and 0.09m to the south. Rooting had also penetrated this layer.
- Natural geology (110). Mid yellowish brown slightly sandy silty clay with occasional stone and flint gravel inclusions and a moderate number of chalk pieces.

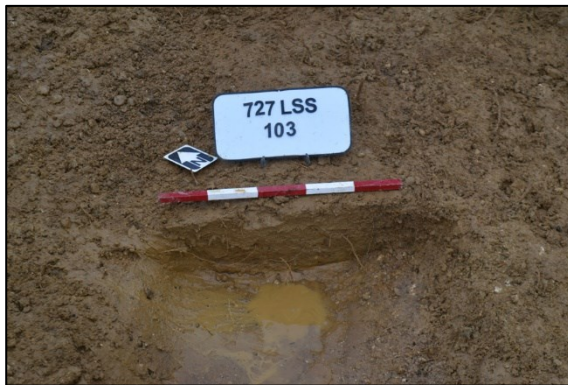
Plate 3: Southwest facing section of Ditch [103]

Near the centre of the trench was a northeast-southwest orientated ditch, [103]. The feature was 0.71m wide, 0.21m deep and a length of 2.91m could be observed before both ends were obscured by the limit of excavation. The ditch contained two fills; lower fill (104), a gravelly sand located to the southern half of the feature, and an upper naturally silted fill (105). No artefacts were recovered from the fill; however, (105) contained occasional small flecks of charcoal.

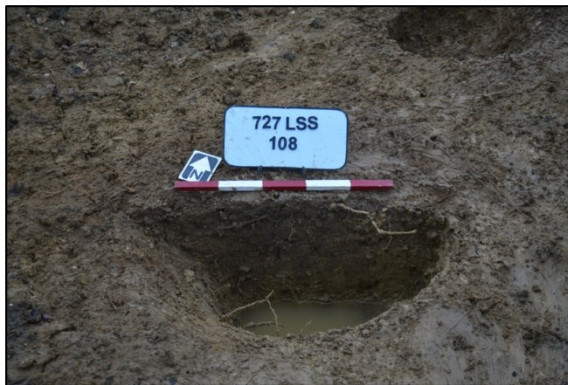
Plate 5: Southeast facing section of Pit [108]

To the south of Ditch [103] was small Pit [108]. The pit was round in shape, had steep side and measured 0.73 x 0.70 x 40m in size (L X W X D). The fill appeared to be the result of natural processes meaning that the pit was left open once it went out of use. Occasional chalk and charcoal flecks were observed within this pit but no dateable material was recovered. It is possible that this feature was used for storage purposes.

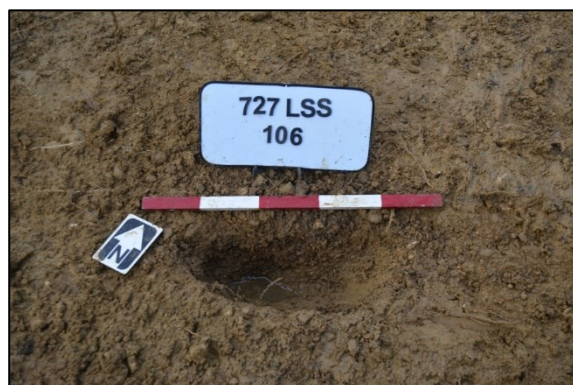
Plate 7: Southeast facing section of Posthole [106]

Between Ditch [103] and Pit [108] was a large steeply sided posthole. The feature measured 0.42m long, 0.39m wide and 0.27m deep and was filled with a single hard packed gravelly fill, (107). Once more, no artefacts were recovered and no further postholes were identified within the trench.
