KDK ARCHAEOLOGY LTD

Archaeological Evaluation Report

Land to the rear of 29-33 Clophill Road
Maulden
Bedfordshire

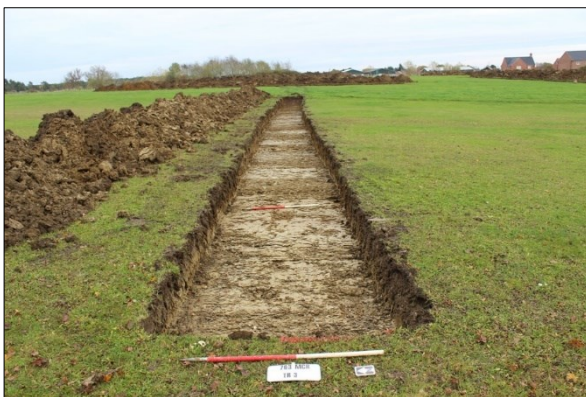
Plate 3: Trench 3 facing east-southeast

Trench no	3	Length (m)	40	Width (m)	1.82	Depth (m)	0.40-0.90
Co-ordinates	506207, 237879					Area (sq m)	72.80
Description	Trench severely waterlogged, no archaeological features.						
Context No.	Type	Depth (m)	Description				
300	Topsoil	0.12	Mid greyish brown silty clay				
301	Subsoil	0.17	Light greyish brown slightly sandy clay				
302	Natural	>0.61	Grey clay with chalk inclusions

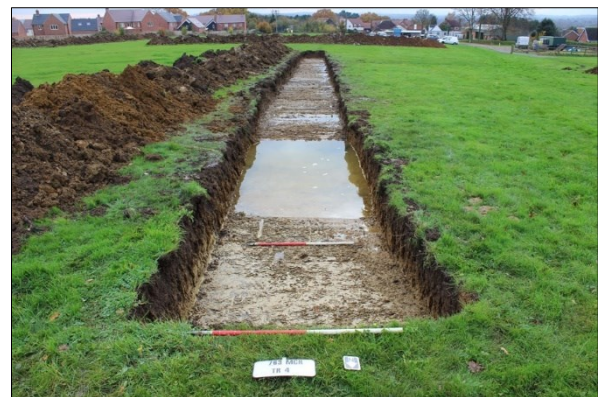
Plate 4: Trench 4 facing south-southwest

Trench no	4	Length (m)	40	Width (m)	1.90	Depth (m)	0.51-0.76
Co-ordinates	506246, 237882					Area (sq m)	76.00
Description	Trench severely waterlogged, no archaeological features.						
Context No.	Type	Depth (m)	Description				
400	Topsoil	0.12	Mid greyish brown silty clay				
401	Subsoil	0.18	Light greyish brown slightly sandy clay				
402	Natural	>0.40	Grey clay with chalk inclusions

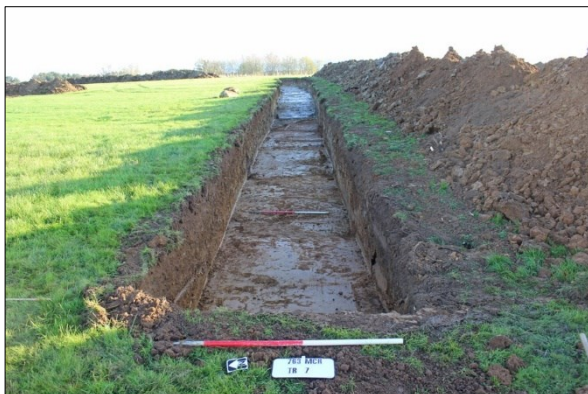
Plate 7: Trench 7 facing east-northeast

Trench no	7	Length (m)	40	Width (m)	2	Depth (m)	0.70-1.10
Co-ordinates	506239, 237844					Area (sq m)	80.00
Description	Contained a boundary representing the interface between natural grey clay and yellowish-brown sand. No archaeological features.						
Context No.	Type	Depth (m)	Description				
700	Topsoil	0.16	Mid greyish brown silty clay				
701	Subsoil	0.28	Light greyish brown slightly sandy clay				
702	Natural	>0.66	Grey clay with chalk inclusions				
703	Natural	-	Mid yellowish brown clayey sand

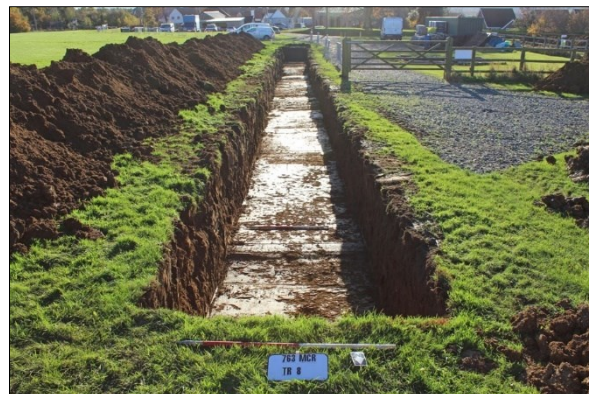
Plate 8: Trench 8 facing south-southwest

No features of archaeological interest were identified in any of the evaluation trenches. Trench 8 contained evidence of two recent geological test pits and there were two ceramic land drains in Trench 10.

Trench no	8	Length (m)	40	Width (m)	1.90	Depth (m)	0.90
Co-ordinates	506208, 237832					Area (sq m)	76.00
Description	Trench 8 was relocated to preserve site access. A modern posthole was present in line with the gate. Further to the south of this were two square features that were modern geological test pits, as attested by the contractors on site. No other archaeological features present.						
Context No.	Type	Depth (m)	Description				
800	Topsoil	0.17	Mid greyish brown silty clay				
801	Subsoil	0.26	Light greyish brown slightly sandy clay				
802	Natural	>0.47	Mid yellowish brown clayey sand

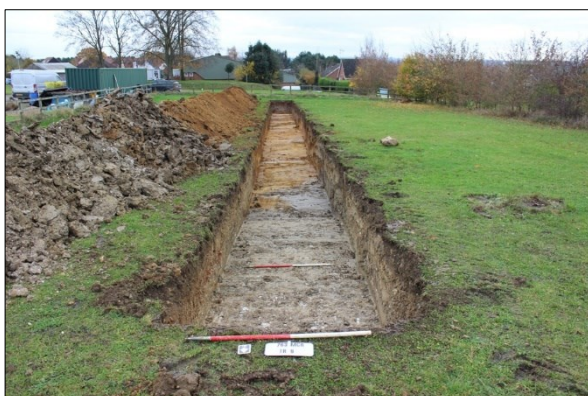
Plate 9: Trench 9 facing south-southwest

The site stratigraphy was relatively consistent throughout the trenches, except for the natural soil, which changed between the north and south of the site. The topsoil was mid greyish brown silty clay and was between 0.1 and 0.18m deep, below this was light greyish brown silty clay varying between 0.19 and 0.6m. The natural soil in the northern half of the site was grey clay with chalk inclusions, this was excavated to approximately 0.6m depth in sondages. This clay gave way to an underlying geological layer of mid yellowish brown clayey sand in the southern half of the site, and a clear boundary could be seen where the grey clay overlay the sand in Trenches 7, 9 and 10 (Plates 15-18, Fig. 7).

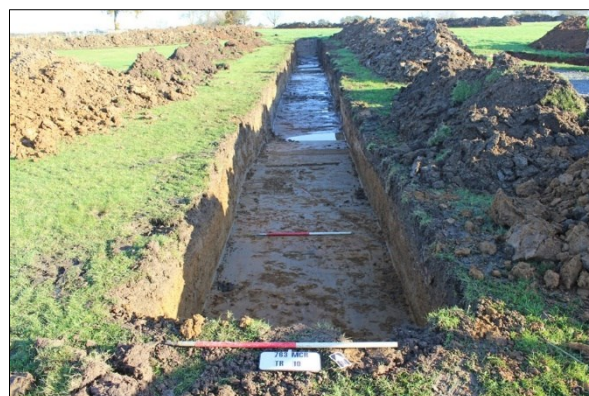
Plate 10: Trench 10 facing northeast

Trench no	10	Length (m)	40	Width (m)	2	Depth (m)	0.83-1.30
Co-ordinates	506211, 237858					Area (sq m)	80.00
Description	Trench 10 was relocated to preserve site access. it has a similar stratigraphy to trench 9. Two ceramic land drains were present towards the southwest end of the trench. Upper natural (1003) to the northeast end, lower natural (1004) to the southwest.						
Context No.	Type	Depth (m)	Description				
1001	Topsoil	0.16	Mid greyish brown silty clay				
1002	Subsoil	0.20	Light greyish brown slightly sandy clay				
1003	Natural	>0.36	Grey clay with chalk inclusions				
1004	Natural	-	Mid yellowish brown clayey sand

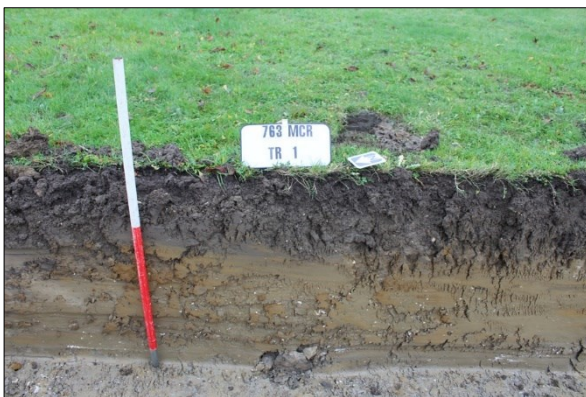
Plate 15: Trench 1 stratigraphy facing east-southeast

Trench no	1	Length (m)	40	Width (m)	1.78	Depth (m)	0.60-1.30
Co-ordinates	506212, 237931					Area (sq m)	71.20
Description	First trench excavated, a 1.3m deep sondage was dug at the north-northeast end. The natural clay in the north end of the sondage was very dark, suggesting the presence of roots and possibly a pond in the past. No archaeological features.						
Context No.	Type	Depth (m)	Description				
100	Topsoil	0.17	Mid greyish brown silty clay				
101	Subsoil	0.24	Light greyish brown slightly sandy clay				
102	Natural	>0.89	Mid yellowish brown sandy stoney clay, inclusions of rounded and sub rounded chalk				
103	Natural	-	Grey clay with chalk inclusions

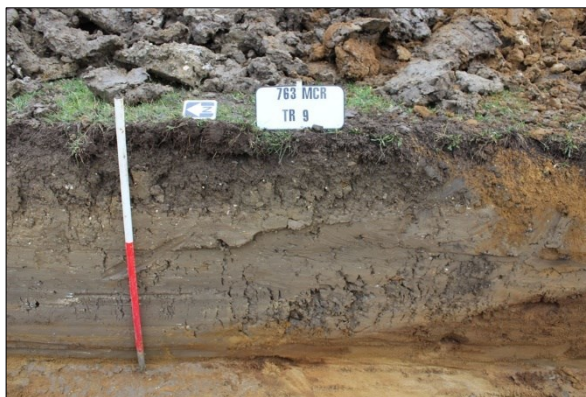
Plate 17: Trench 9 stratigraphy facing east-southeast

Trench no	9	Length (m)	40	Width (m)	1.81	Depth (m)	0.88
Co-ordinates	506176, 237831					Area (sq m)	72.40
Description	The upper natural soil (902) gives way to the lower counterpart (903) at an interface located 10m from the north-northeast end of the trench. No archaeological features present.						
Context No.	Type	Depth (m)	Description				
900	Topsoil	0.18	Mid greyish brown silty clay				
901	Subsoil	0.26	Light greyish brown slightly sandy clay				
902	Natural	>0.44	Grey clay with chalk inclusions				
903	Natural	-	Mid yellowish brown clayey sand

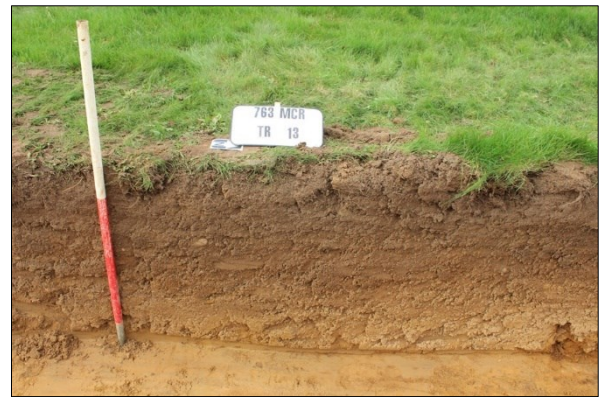
Plate 18: Trench 13 stratigraphy facing west-northwest

Trench no	13	Length (m)	32.60	Width (m)	1.80	Depth (m)	0.55-0.93
Co-ordinates	506228, 237734					Area (sq m)	58.68
Description	Trench 13 was divided into two in order to avoid overhead power cables, with the new Trench 13 relocated further to the north-northeast and Trench 14 located further to the south-southwest. Their combined length was 40m, to match the original intended length of Trench 13. No archaeological features present.						
Context No.	Type	Depth (m)	Description				
1300	Topsoil	0.16	Mid greyish brown silty clay				
1301	Subsoil	0.23	Light greyish brown slightly sandy clay				
1302	Natural	>0.16	Mid yellowish brown clayey sand
