**Historic Building Recording at  
Holywell Spring Farm  
Ashby de la Zouch  
Leicestershire  
August 2015**

Report No. 15/203

# Historic Building Recording at Holywell Spring Farm, Ashby de la Zouch Leicestershire August 2015

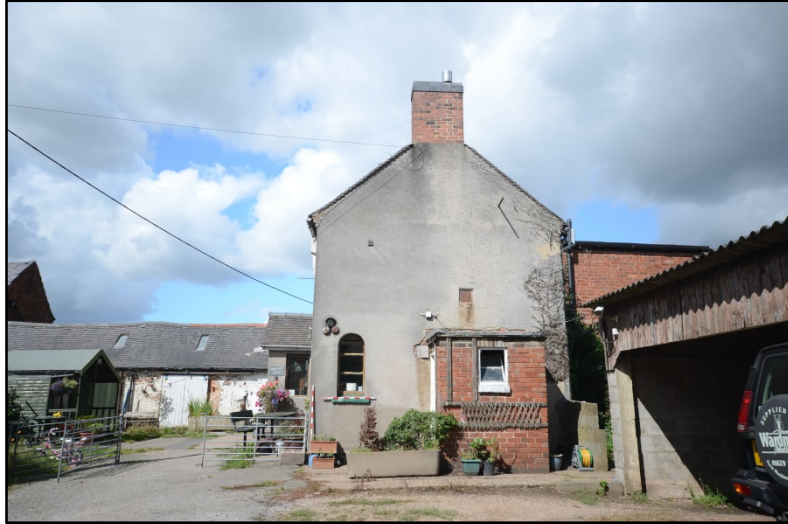
The east gable elevation is fairly plain with a narrow window opening into the kitchen. A later small brick outbuilding has been constructed against the north corner of the wall. The main south facing elevation is interrupted by a short covered passage between the farmhouse and the adjacent barn. The main part of the elevation is of

The Farmhouse, east elevation, looking north-west Fig 7

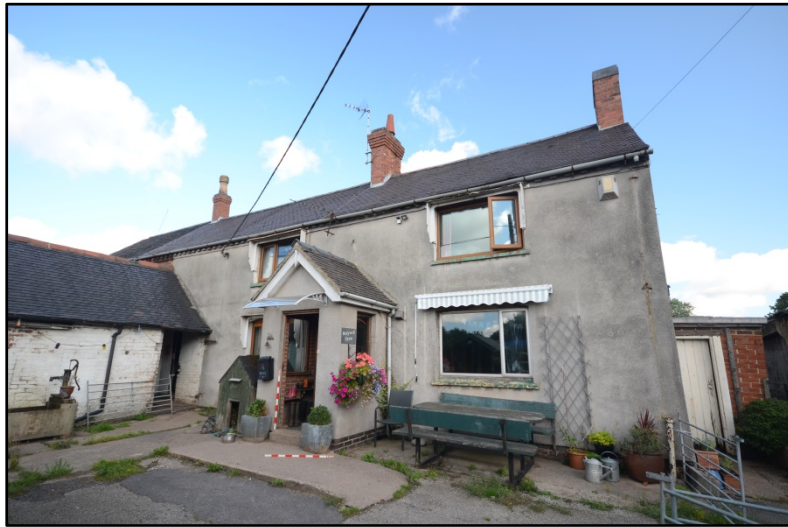
three bays with ground and first floor windows flanking a gabled brick porch. The windows are modern replacements within the original openings and have decorative wooden surrounds. The windows at ground floor level have green painted coping brick sills. Within the covered passage are opposing door openings. To the north is a single width door with bullnose brick sill which opens into a small utility room. The wall within the passage is white washed brick and has not been rendered. The opposing doorway has a sliding door on rails and opens into another small utilities room with washing facilities. The western portion of the farmhouse, beyond the western chimney, is an extension to the earlier building and dates to between the 1880s and 1920s. The farmhouse has a scheme of brick dentils at the eaves which is not continued onto the extension. The ground floor of the extension is a single room with access from the north through a simple single width door. This door was locked and the room was not accessed during the survey. The west elevation has two identical rectangular windows with purple coping brick sills. The windows have wooden frames and comprise side hung three light casements flanking a fixed central element with top hung ventilation pane. The ground floor window has a concrete lintel whilst a timber lintel is utilised at first floor. A small cross of protruding purple bricks is located above the first floor window. The north elevation of the extension is plain and a ground floor outbuilding or shed abuts the wall here.

The Farmhouse, main façade, looking north-east Fig 8

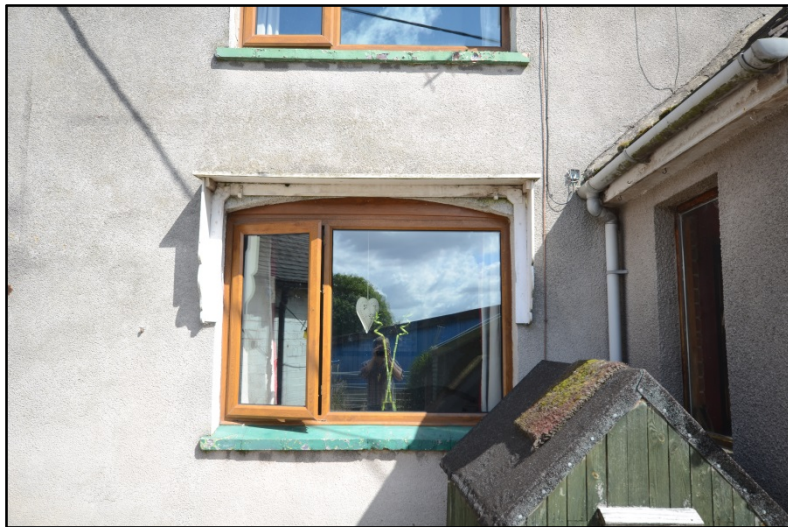
Detail of ground floor window Fig 9

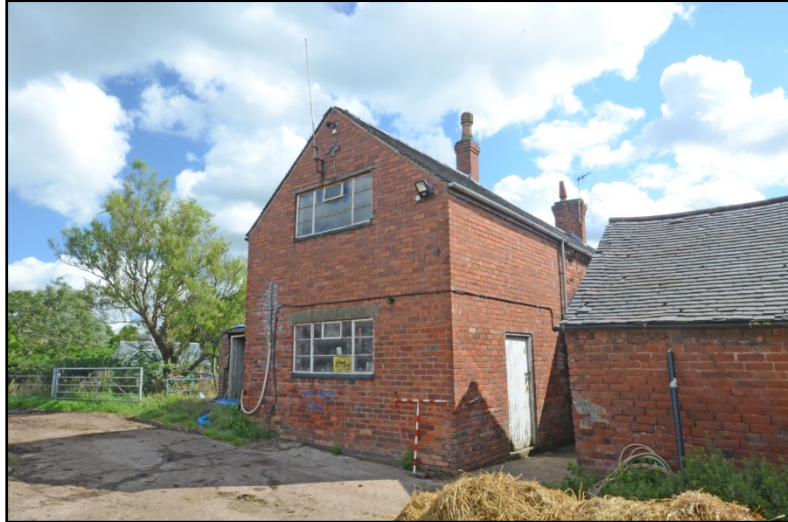
The western extension, looking east Fig 10

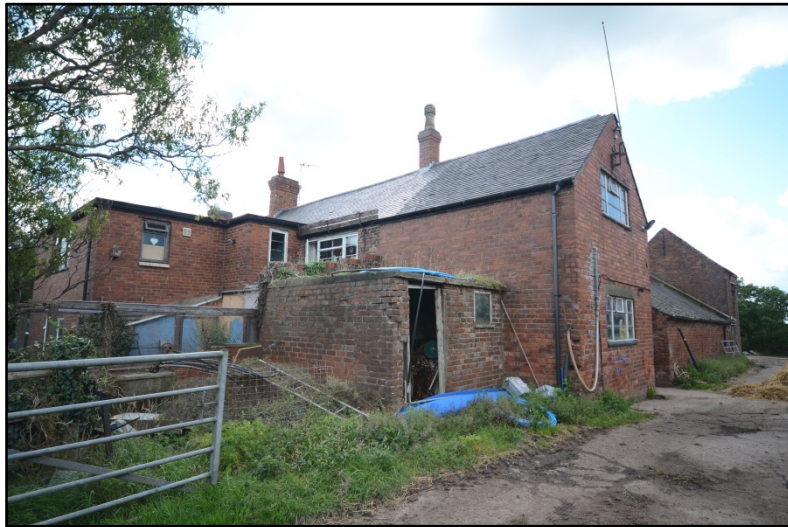
The west elevation and extensions, looking south-east Fig 11

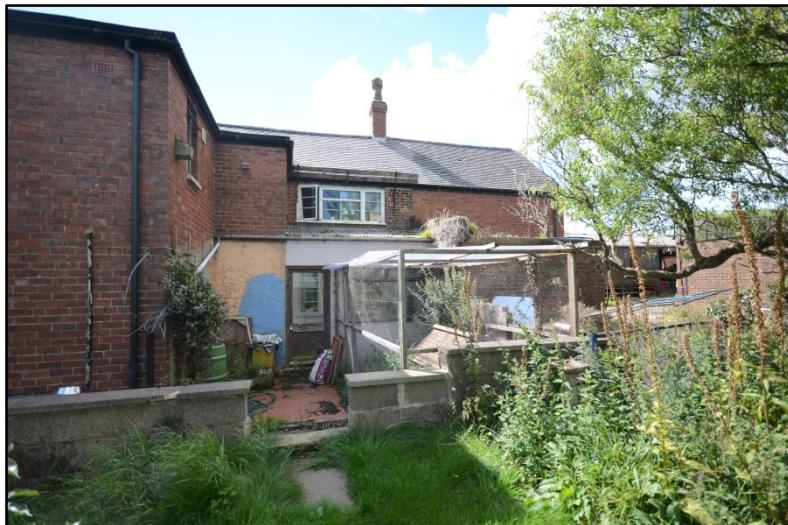
The large extension to the rear of the building was constructed between 1923 and 1961 and replaces a much smaller extension which was built between 1883 and 1923. At ground and first floor, facing north, are wide rectangular window openings, the lower of which is a modern double glazed replacement. At ground floor the extension comprises a pantry / laundry room. This room has a floor of square quarry tiles and a brick and tile work surface, similar to those utilised in dairy rooms, is located against the south wall of the room. The upper floor of the extension is occupied by a bedroom. A single storey brick porch with a catslide roof of corrugated sheets is located between the rear extension and the main farmhouse.

The rear extensions, looking south-west Fig 12

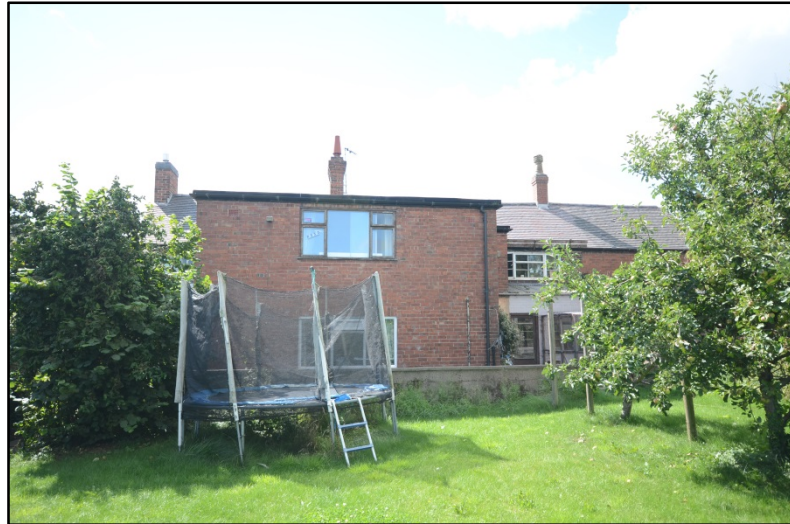
The rear extensions, looking south-west Fig 13

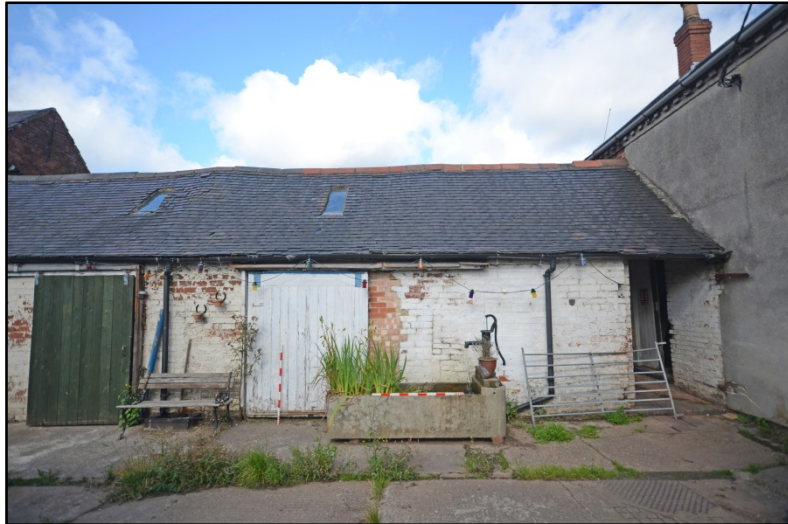
The west elevation has largely been lost or is obscured by the eastern range of barns. To the east the building faces onto an open, paved garden area with a small shed and seating. A concrete water trough adjacent to the building now serves as a water feature. The east elevation is constructed of whitewashed brick in an irregular Sussex

Bond, containing a mix of stretchers and headers. Sliding doors on iron rails allow access to the main rooms. A recessed six-light window with bottom hung upper element is located at the south of the elevation. An adjacent single-width door opening has been blocked in modern brick. A former window located at the western end of the building has been blocked in brick. The western door opening has undergone repair work on one side. The repair is fairly modern and utilises modern brick and CMU (Concrete Masonry Units).

The east barn, east elevation, looking north-west Fig 19

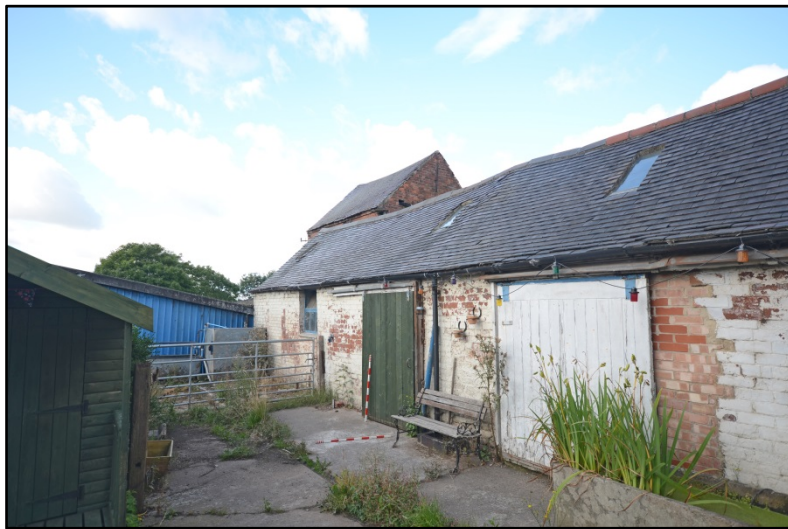
The east barn, east elevation, looking south-west Fig 20

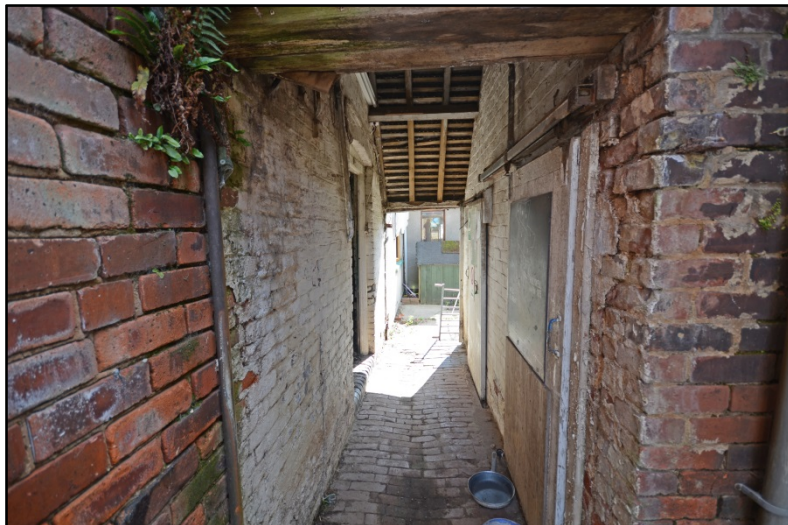
The covered passage, looking south-east Fig 21

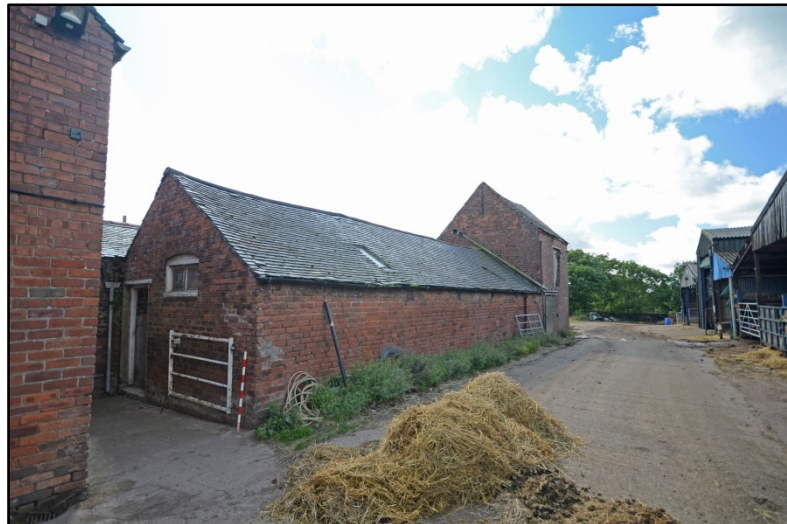
The western barn dates to between 1883 and 1923 and comprises a north-south aligned linear range measuring c20x x 4.5m. This range fully abuts the earlier range to its east and shares a common wall. The range is constructed of red brick, primarily in stretcher bond with occasional rows of stretchers and headers. The gabled roof is constructed of slate tiles with rounded ridge tiles and forms a valley with the adjacent roof. Pairs of roof lights have been added to either side of the roof. The internal roof structure comprises white painted timber king posts trusses with diagonal bracing and iron ties through the king post and lower member. The trusses support timber purlins, rafter and the battens which carry the roof tiles.

The west barn, looking south Fig 22

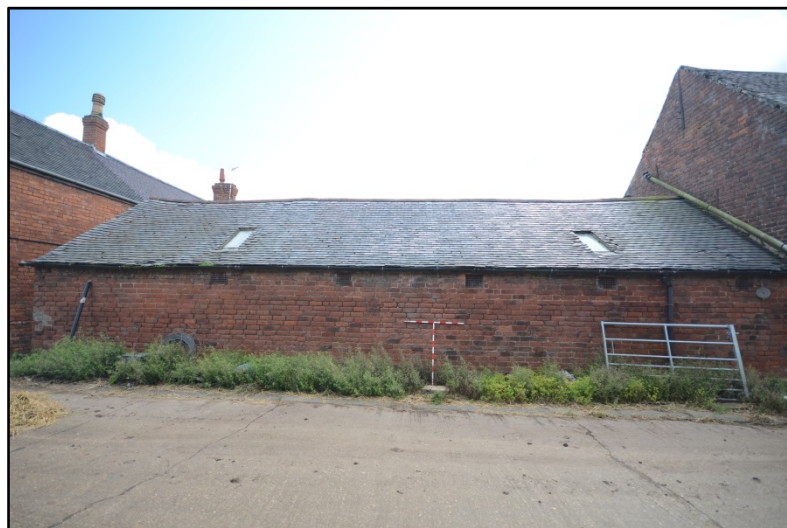
The building stops short of the farmhouse, in line with the covered passage, but its roof is not continued over the space between. The north elevation has an off-centre single-width ledged and braced door with simple wooden lintel, which opens into the northern room, and a small two-light window with arched brick lintel which is located beside the door. A simple iron gate is hinged to the north elevation and can be swung outward to close off the passageway when cattle are moved around the farm. The west-facing elevation is plain with no window or door openings. A number of equally spaced square vents with iron grilles are located below the eaves.

The west elevation of the western barn Fig 23

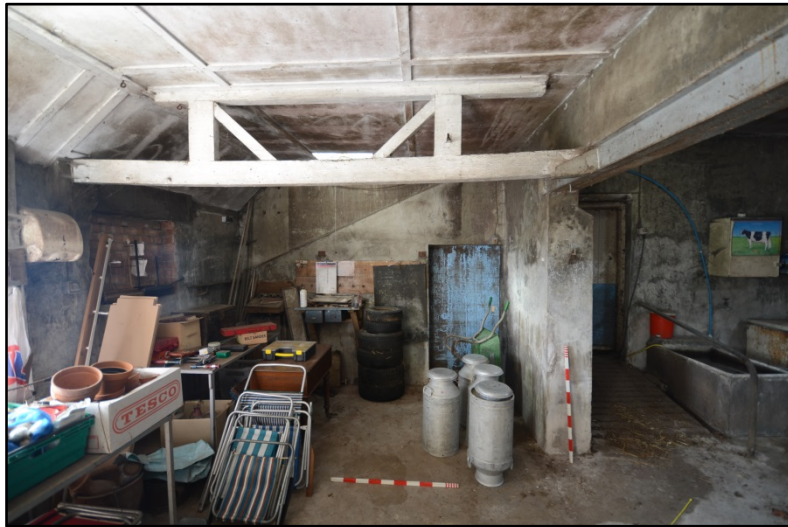
The south room was the largest of the three and the west wall had been partly removed to create a shared space with the later adjacent range. An RSJ (Rolled Steel Joist) spans the width of the opening between the two. The room has a concrete floor and the walls are plastered and painted. Two queen post trusses with diagonal bracing are exposed below the underside of the roof and are supported over the RSJ. At their eastern ends the trusses are supported over protruding brackets. A single-width, blue painted wooden door located in the south-western corner of the room allows access to the modern cowshed.

The east barn, southern room, looking south-west Fig 26

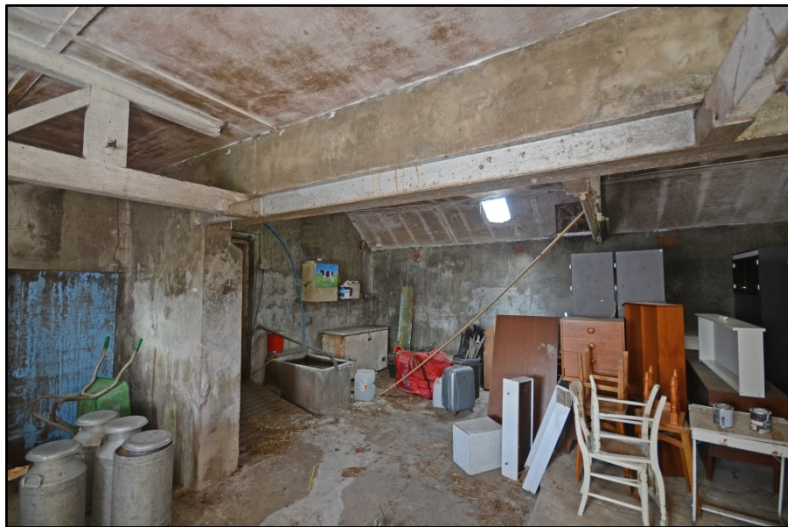
The remainder of the building is a single room, made larger by the removal of the west wall of the earlier barn. At the time of this survey, this space was used for the storage of large furniture which prevented a thorough inspection of the room. The floor of the room is on two levels with a timber plank platform at the northern half with a concrete surface adjacent. The ceiling of the room has been lowered so that only the lower portion of the trusses is exposed.

The south room of the east and west barns, looking west Fig 27

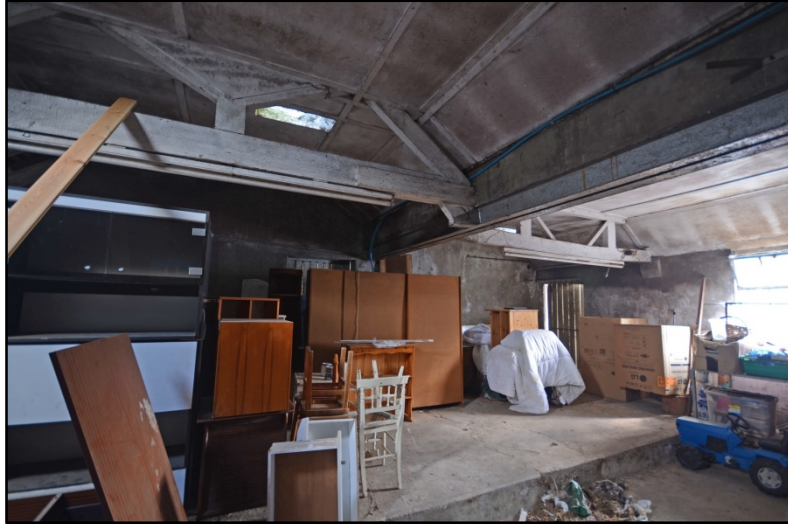
The south room of the east and west barns, looking north-east Fig 28

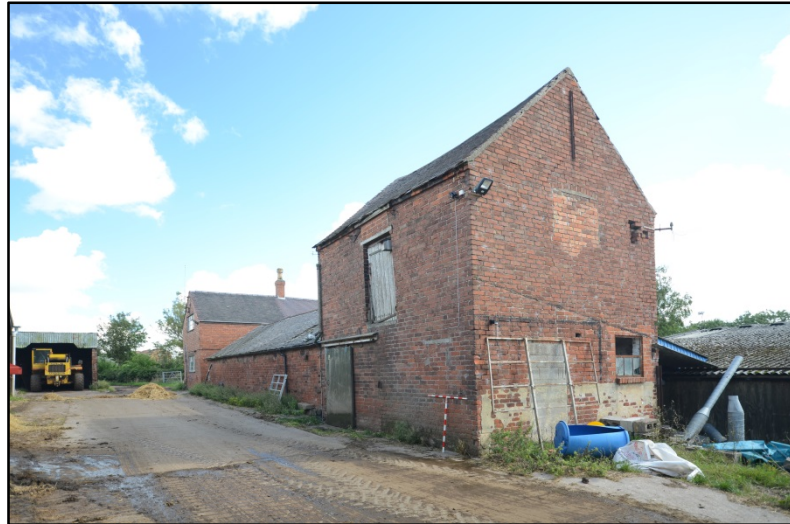
The Granary is contemporary with the western barn and is part of the same structure. It is a two-storey building on a square plan measuring c5 x 5m. It is constructed of red brick, primarily in stretcher bond with occasional rows of headers and stretchers, and has a gabled roof of slate tiles. A smaller structure with sloping roof formerly abutted with southern wall of the granary.

The Granary, looking north-east Fig 31

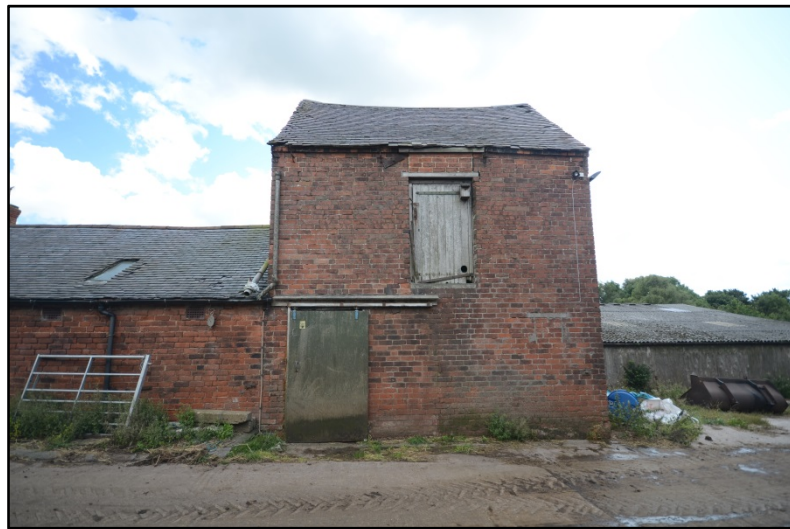
The west elevation is a continuation of the west wall of the barn and there is no join between the two. A single-width door opening with green-painted sliding timber door provides external access to the ground floor room. A small square vent with timber lintel is located adjacent to this door and has been blocked in brick. A loading door is located centrally at first floor level. A transom light above this door has been blocked with brick. The south gable elevation presents a former door opening, blocked with CMU, which formerly opened into a single-storey building, demolished prior to survey. Adjacent to this door is a square window opening with modern brick surround which is a later addition to the building.. An original window opening with arched brick and timber lintel is located centrally to the elevation and has been blocked in brick.

The Granary, west elevation Fig 32

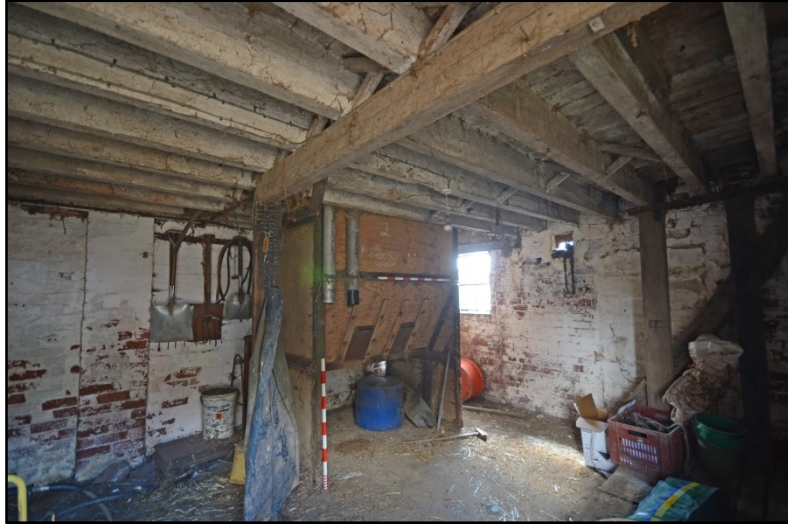
The ground floor space is a single square room with concrete floor and an exposed timber ceiling of joists supported by a central beam with cross-bracing. A ledged and braced door in the north-east corner of the room allows access to the south room of the barn. A wooden feed chute is located off-centre to the room and allows easy dispensing of feed from the upper floor which is accessed by a narrow stair in the south-west corner of the room. The upper floor is effectively a platform which occupies the western half of the room with the feed chute rising from the ground floor. A small crawl space has been created above the ceiling of the south room of the adjacent barn which can be accessed by ladders.

The Granary, ground floor room with feed chute Fig 34
