**Historic building recording  
at Draper's Hall  
Coventry  
April 2019 - October 2020**

Report No. 21/081

MOLA (Museum of London Archaeology) was commissioned by the Prince's Foundation, on behalf of the Historic Coventry Trust, to undertake a programme of Level 3 historic building recording at the Grade II\* listed Draper's Hall, Bayley Lane, Coventry, Warwickshire (SP 3363 7895, Fig 1). This was required prior to works being undertaken on the building (Planning Ref. LB/2014/0862) for alterations in line with conversion to a centre for Music and Performance. This project ran concurrently with a programme of excavation between April to Jun 2019, the results of which are to be published in a separate report (Thompson 2021).

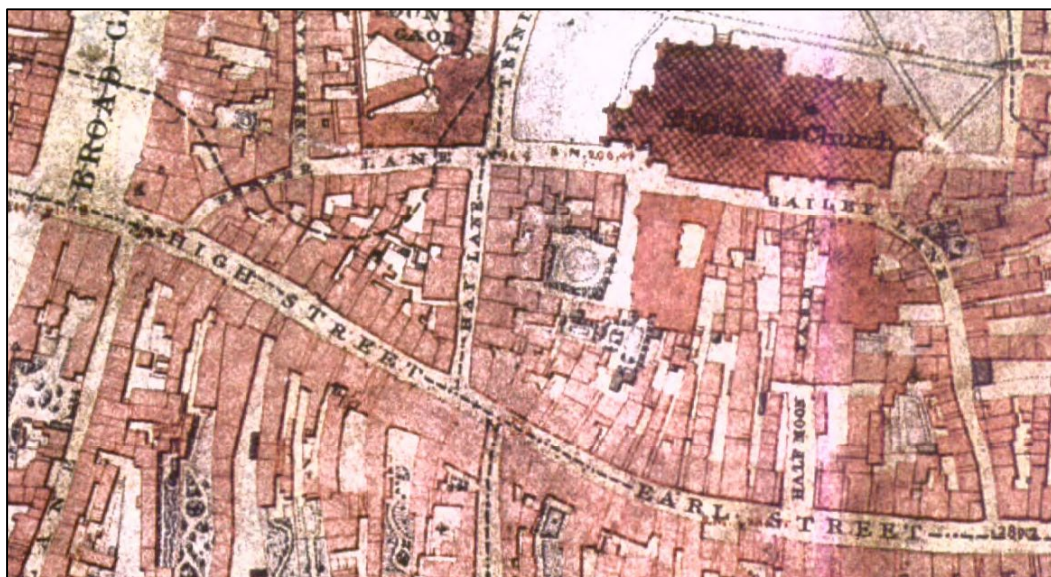
The local board of health plan of Warwick 1851 (Ref. OS 1/500) reproduced by kind permission of Culture Coventry/Coventry Archives Fig 8

The Board of Health map of 1851 (Fig 8) shows the sudden expansion of property and buildings across the city. It shows the Draper's Hall with housing on its immediate east side, giving a reduced road width. This was surveyed prior to the 1864 extension on the east side. The location of buildings can be seen to the east of Draper's Hall. Rickman and Hutchinson proposed extension to the south of the Ballroom is still a garden. The Half Moon Inn lies to the west of the hall.

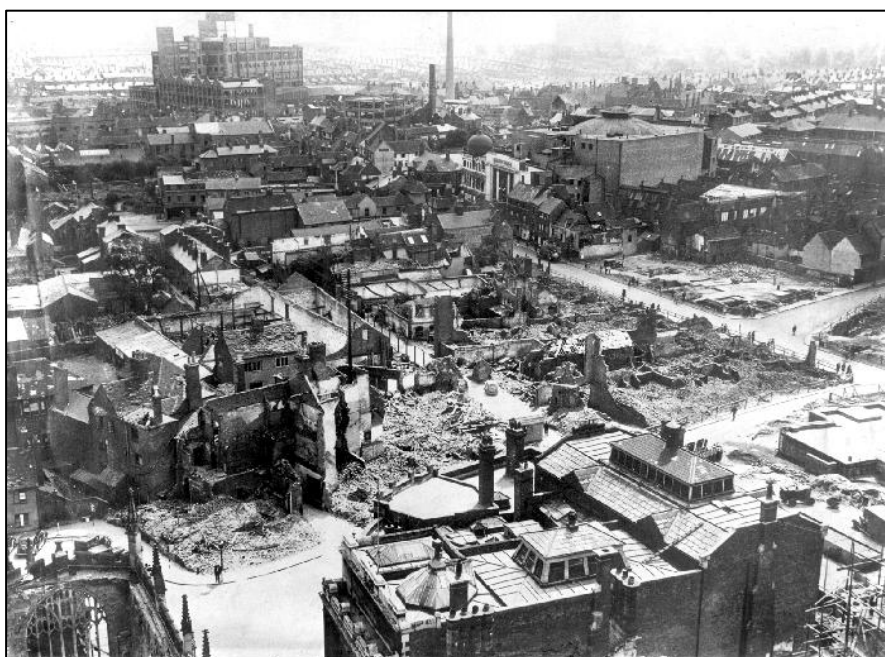
Photograph of Drapers Hall (foreground) following November 1940 blitz, source unknown Fig 13

The destruction caused by the bombing of Coventry in the Blitz is recorded in a photograph dated November 1940 (Fig 13). A series of historic domestic properties located on the east side of Bayley Lane were affected and later cleared remaining undeveloped until the 1960s. The damage to the cathedral can just be seen in the bottom left corner. Surprisingly Draper's Hall stands almost untouched. The building to the south of the hall was also destroyed, later rebuilt as it appears on the 1956 OS map (Fig 14).

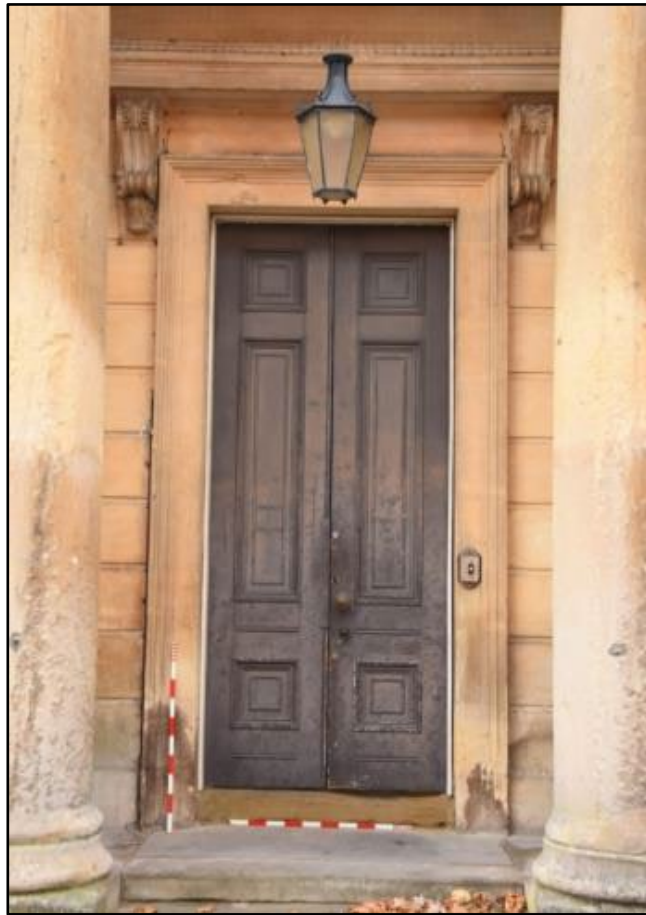
The main entrance door is set within the portico and contains a double-leaf panelled timber door within a stone surround (Fig 17). The surround is dressed with a prominent moulded stone architrave and surmounted with a projecting hood that is supported on two scroll-moulded brackets at either side of the doorway (Fig 18). A wrought iron lantern is fitted in the centre of the frieze above the doorway with a wrought iron bracket bolted through the lintel. The double doors each comprise three moulded panels and a horizontal flush bead to the lock rail. The original doorknob has been replaced more than once.

Entrance door on the north elevation, taken from the north

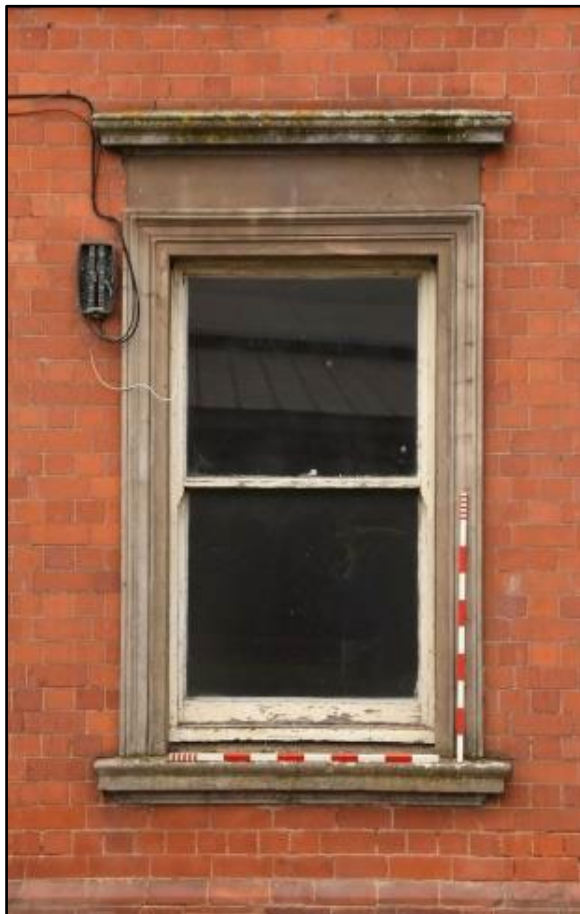
Example of sash window on the 1890s range, taken from the east Fig 26

The fine red brickwork continues across from the two previous sections of the 1890s range. A small plinth is present, interrupted by several inserted square air bricks, and a doorway to the north. The doorway retains a moulded doorcase topped by small entablature and drip hood but retains a modern door, identified by the Conservation plan as dating to 1961 (ACA 2005). To the south are two identical apertures with stone sills and moulded surrounds with entablature with drip hoods similar to the doorcase. The windows are one-over-one timber sashes with horns (Fig 26).

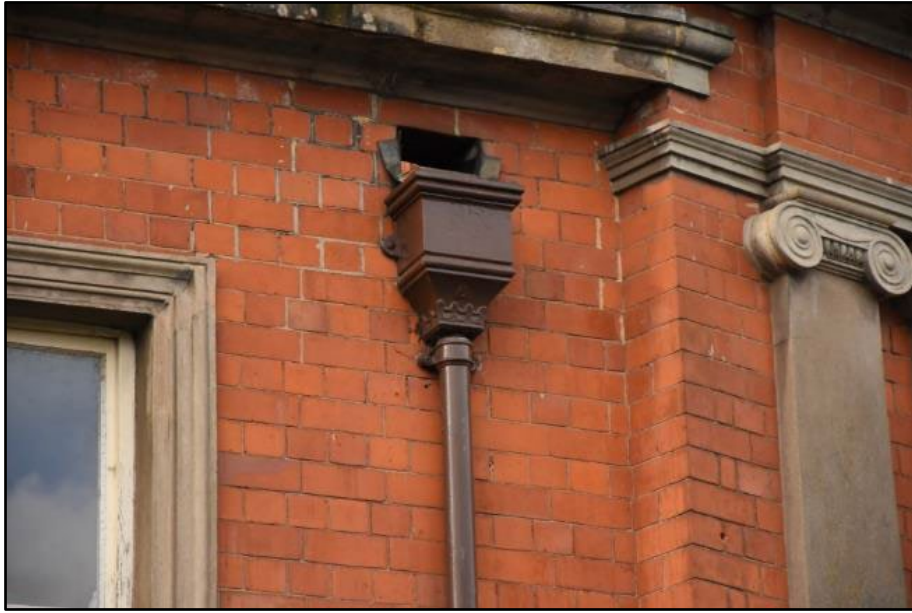
Rainwater hoppers on the elevation of the Summoner's House, taken from the east  
Fig 27

The lower and upper levels are divided by a stone string course seen elsewhere. This forms the sill of the three upper windows which mirror the position of the lower apertures. They also retain stone moulded surrounds with one-over-one sashes, with horns. The elevation is flanked by two rainwater pipes, interrupting the string course. They retain their rainwater hoppers (Fig 27). Above, the elevation has a projecting moulded stone cornice with upper parapet wall. The parapet wall has two top courses of Staffordshire blue bricks and completed with thin capstones. Behind the parapet is a flat asphalt roof (see Section 6.2.4 for component parts), with various glazed timber lanterns.

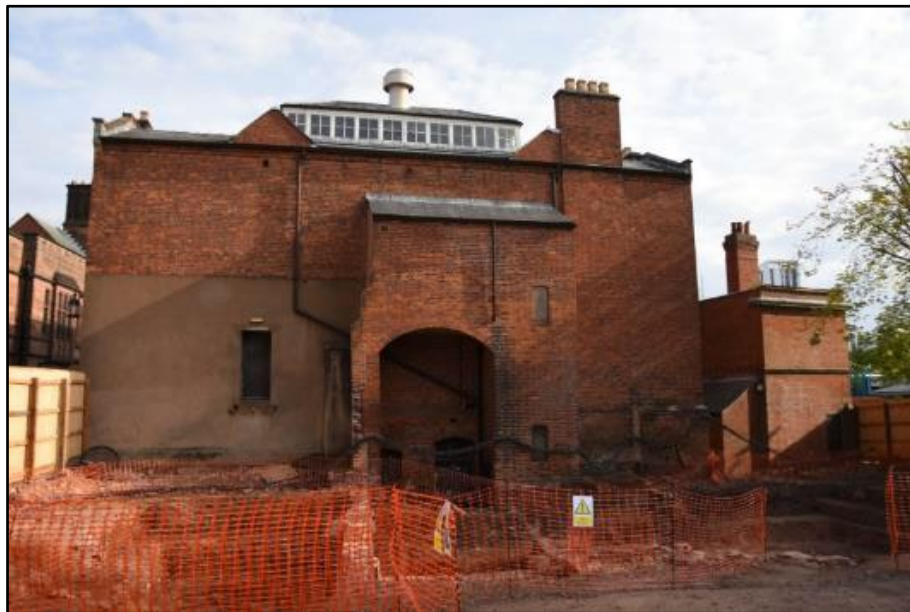
South elevation of the 1830s range, taken from the south Fig 29

To the west the elevation is rendered to mid-height in cementitious material. Its only feature is an inserted fire exit door and stairs, probably mid-20th-century in date (ACA 2005). The render is most likely explained by looking at cartographic evidence (see Section 5) with the presence of abutting buildings directly to the south until the 1930-40s.

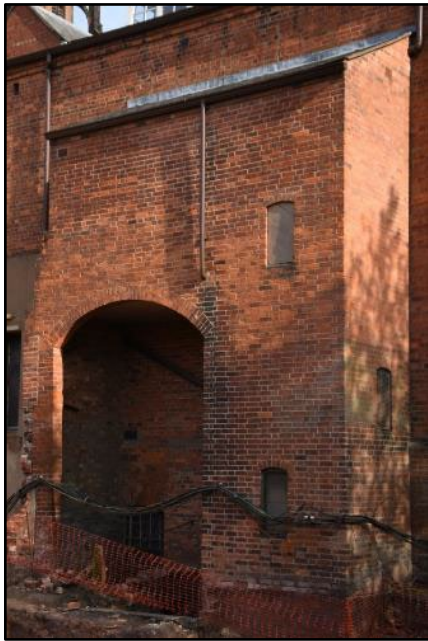
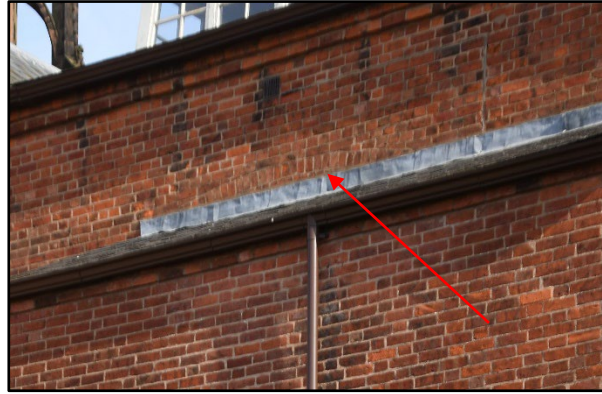
Brick porch giving access to the 1841 orchestra pit within the ballroom, with arch indicated, taken from the south-east Fig 30

To the east a shallow projecting chimney stack rises to the roof line and is topped by stone coping and four terracotta pots, each with a cannon pattern. Sitting centrally on the elevation a brick porch, added in 1841 (ACA 2005). This rises to almost full-height with a lean-to slate roof and is buttressed to the west (Fig 30). The outer walls of this porch do not correspond with the brick walls of this elevation (Fig 31). This retains a large arched opening on its south face giving access to a void. Wide stone stairs within the void lead to a door to the lower ground floor, and window adjoining, both below cambered arched heads. To the east a door gives access to a spiral stair to the Ballroom orchestra pit. The spiral stair is marked by several single-light apertures below cambered heads to the south and east elevation of the porch. Within the porch the brick walls retain some evidence of tuck-pointing (Fig 32). Above this, and high on the elevation, there is evidence of an arched opening hidden by the construction of the porch.

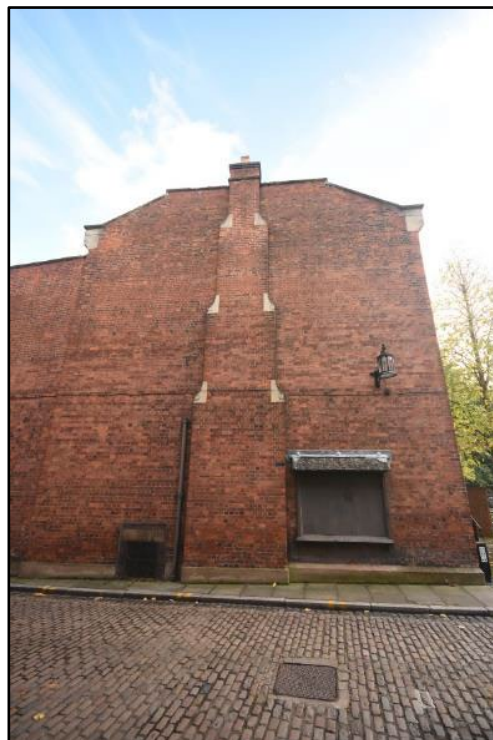
Fig 33

The gable end of the Ballroom rises to stone copings supported by stone kneelers to the gable (Fig 33). Its main feature is a central projecting chimney stack tapering with shoulders to the apex. There are three shoulders in total and each retains a stone block (Fig 34). The lower two are inscribed with scrolls, the upper one is plain. This may represent the refronting of this elevation with the insertion of St Mary Street. The stack is finished by Staffordshire blue copings and a single terracotta pot. At lower level to the east of the stack is a large timber noticeboard and heavy lead flashing to a tiled canopy. This perhaps was a service hatch and corresponds to the Wine Cellar (44) on the lower ground floor and described in more detail below in Section 6.3.2.4. Above this is an iron lantern. To the west of the stack a single aperture lights the lower ground floor.

Gable end of the 1830s range, taken from the west

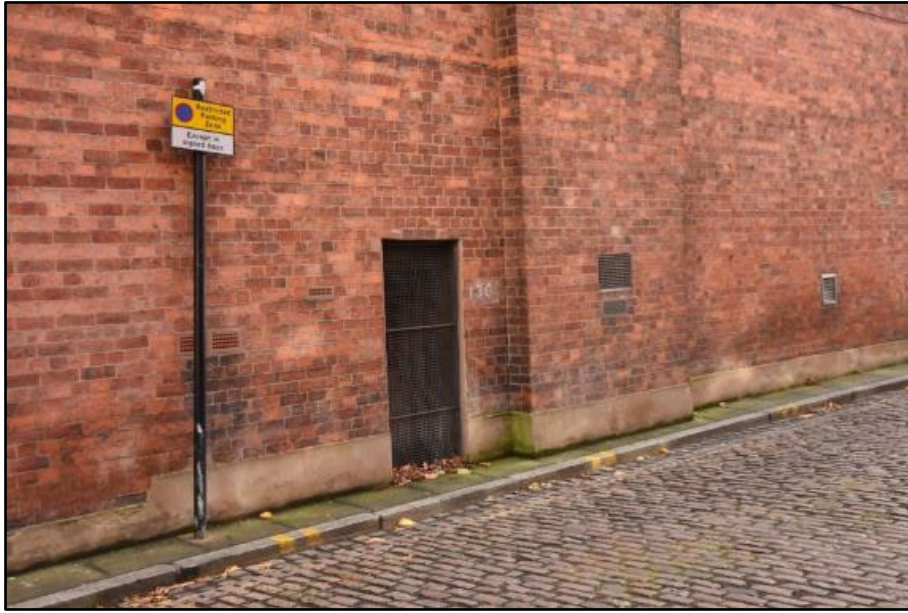
Door giving access to lower ground floor along the western elevation, taken from the north-west Fig 36

The long west elevation (Fig 35) is fairly plain with various air bricks present and rises to a lead roof. A single door at lower level gives access to rooms in the basement and sits below an iron lantern (Fig 36). This was later the access to the air-raid shelter used during the Coventry Blitz (Drappershall 2015). Two chimney stacks of the same style seen on the gable end and described above are present. At the northern end of the long elevation the scar of a previously adjoining pitched roof building is visible in the brickwork (Fig 37). Also, at this end the west elevation of the street front façade can be seen. It is formed of ashlar blocks as before with rustications. The corner of the portico is marked by a parapet post with Anthemion tympanum and the Bathstone quoins of the portico are keyed into the brickwork.

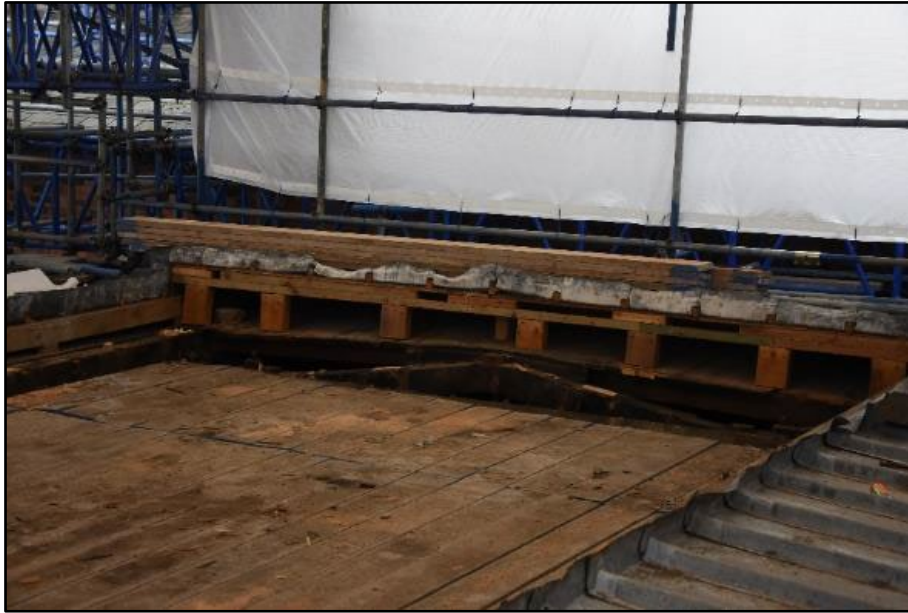
Area of exposed timber frame to the roof lantern above the Tea Room, looking south-east Fig 40

The Tea Room lantern was completely removed, and this allowed the roof of this area to be partially inspected. This revealed the existing lead coping was held with timber struts, likely modern. Beneath this the original roof structure was partially visible and comprised two shallow trusses flanking the aperture for the lantern (Fig 40). Each had a central bolt to its apex, and one at either end. Two empty mortises flank the apex; it is not clear what their original purpose would have been. On the lantern-side of the truss are a series of pegs at regular intervals. To each long side of the former lantern aperture the timber displayed bolts and several notches for removed members. Beneath the lead coping, and the modern timbers that had been inserted to support its weight, a series of timber boards provided a flat surface. It is possible this was the base for the original lead coping, but after some time a shallowly pitched frame was inserted to help the run of rainwater.

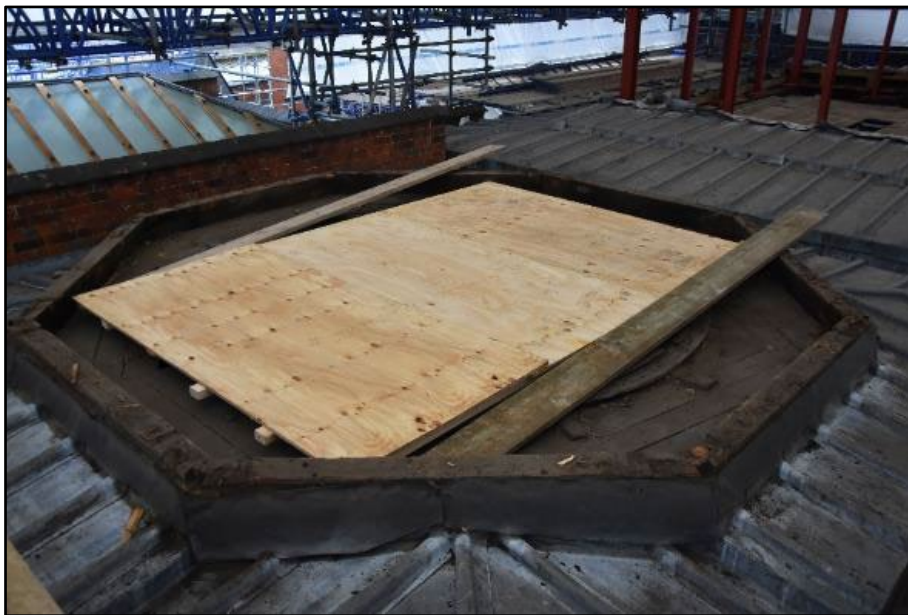
Exposed timber frame to the Reading Room lantern, looking south-east Fig 41

The lantern to the Reading Room was also removed and its timber-frame exposed (Fig 41). The octagonal frames timbers all retained notches at either end, a pair to each angle of the octagon, presumably for support of the removed lantern. Within the frame a series of floorboards provide a small walking area around the circular roof light.

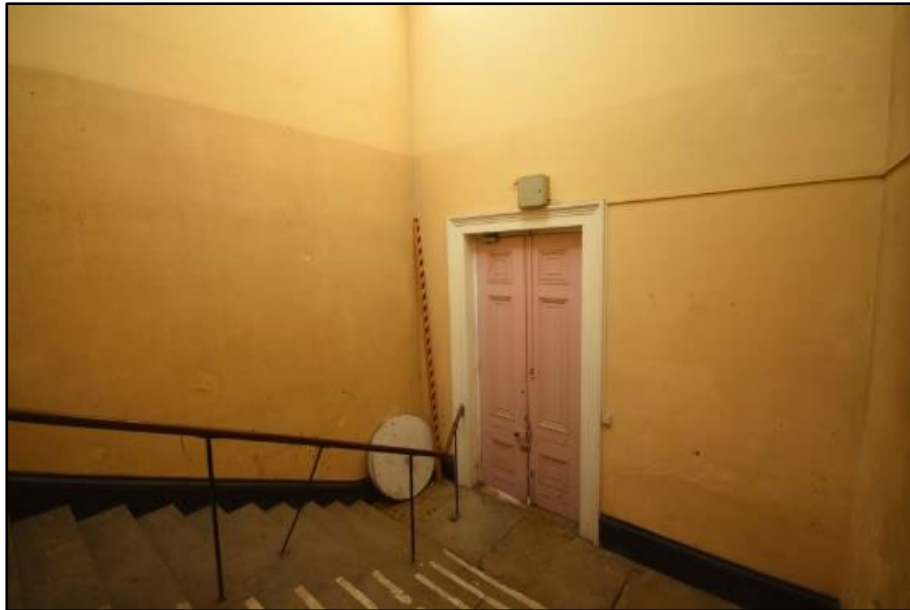
Fig 42

Interior of the Vestibule, taken from the south-east

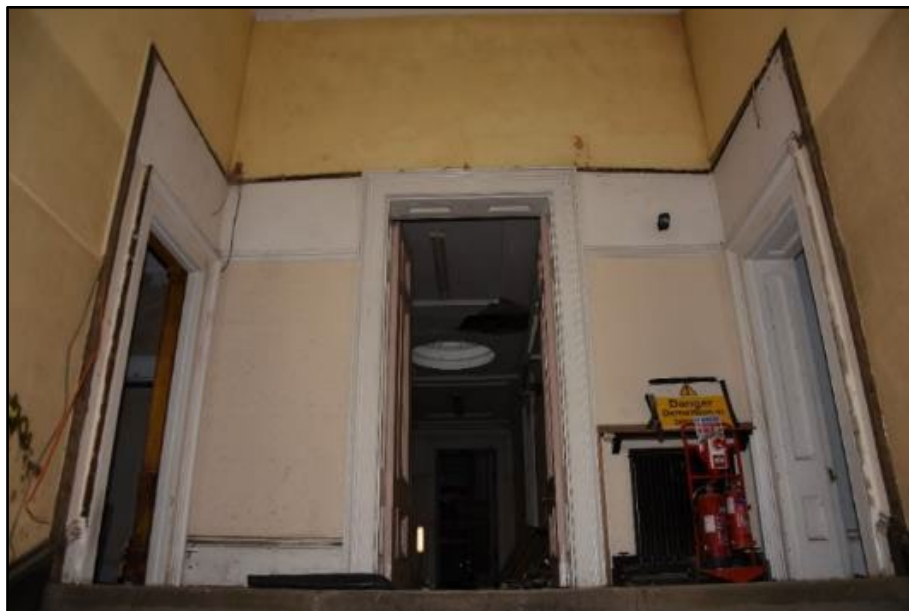
The Lobby after the soft-strip during the planned works, taken from the north Fig 47

During the planned works the lobby partitions were removed (Fig 47). This revealed the skirting between Lobby and Vestibule is continuous and so predates its insertion. A change in colour of the Vestibule walls also coincided with the high picture rail in the

Lobby suggesting it was once also continuous. The carpet in the Lobby was also removed revealing stone flags preserved beneath.

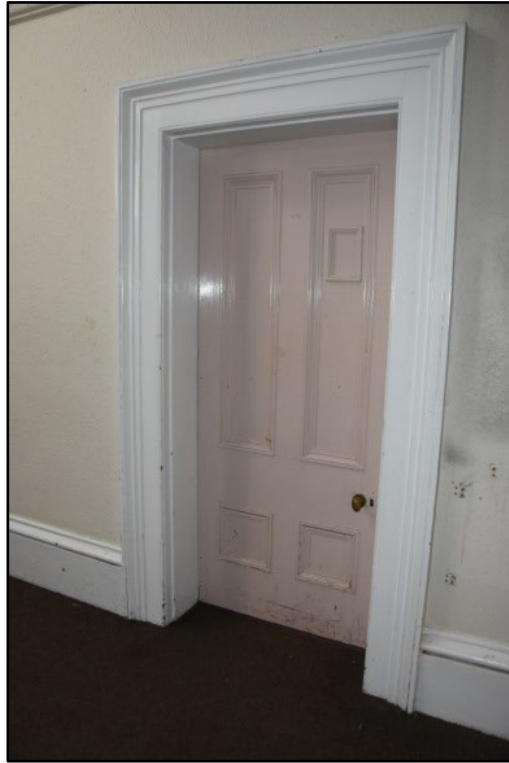
Fig 50

Door to the Kitchen, taken from the south-west

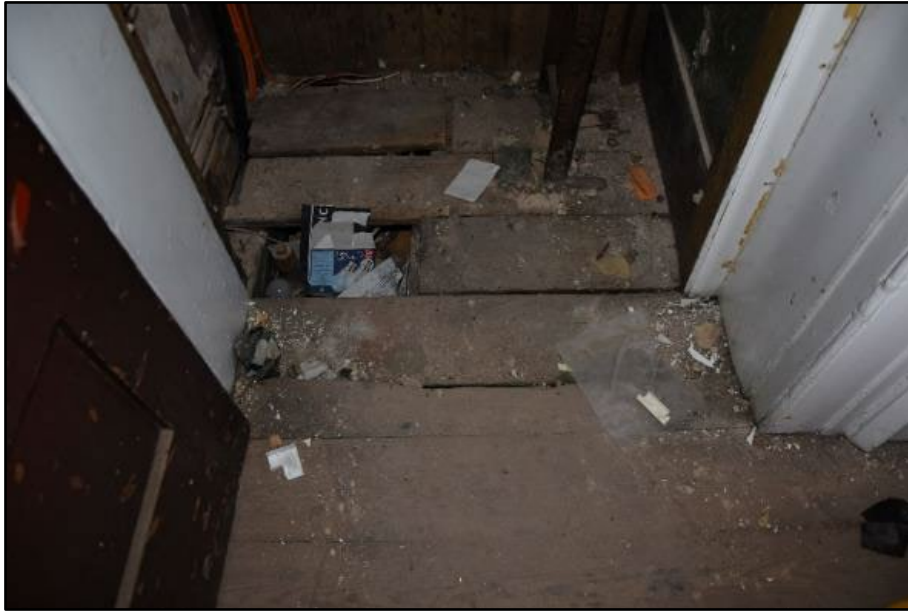
Floorboards in the Central Corridor and service cupboard, taken from the west Fig 52

Monitoring works revealed the carpet was lain over wooden floorboards running north to south, measuring 6" wide (15.5-16cm). However, these boards did not continue into the service cupboard described above which corresponds with it being the original entrance to the basement (Fig 52). When the boards were lifted the underlying common joists were exposed measuring 2½" wide by 7⅓" high (6cm by 18.5cm) and spaced with gaps of 9¾" (25cm). They were aligned east to west and there didn't appear to be any alterations of repairs to the arrangement.

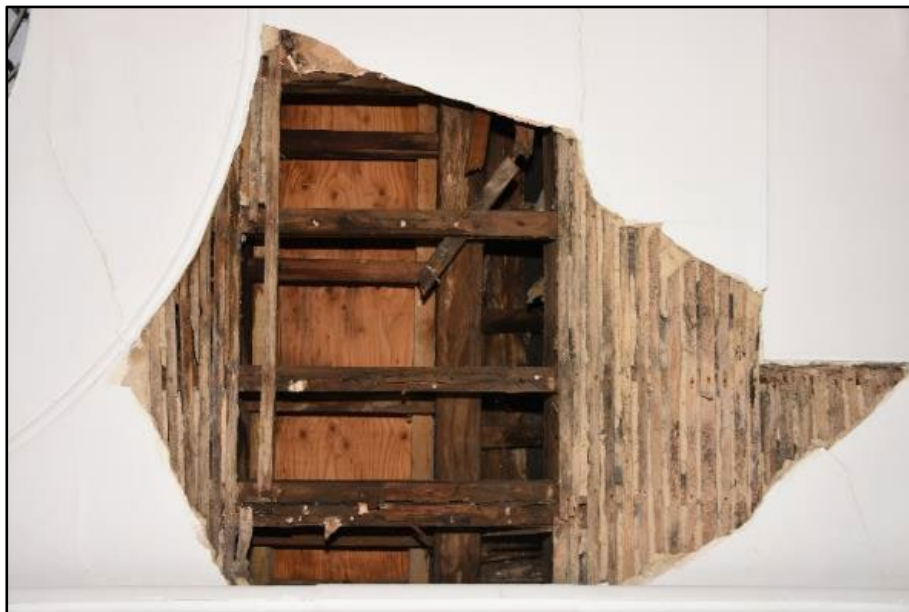
Lath and plaster ceiling revealed in the Central Corridor during monitoring works Fig 53

Part of the ceiling plaster was removed revealing lath and plaster (Fig 53). The laths were machine-made and nailed onto the battens, the plaster could not be inspected in close detail. Where the laths were removed the structure of the roof above was exposed. The battens ran north to south and were nailed to joists orientated east to west. Above this the roof structure appeared to have been replaced with later softwood.

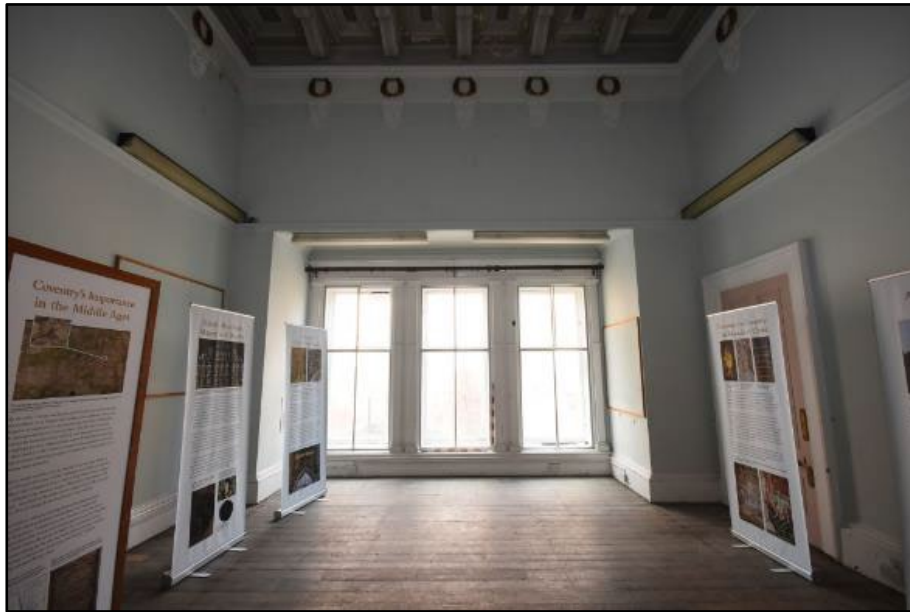
Fig 54

Interior of the Reading Room, taken from the south

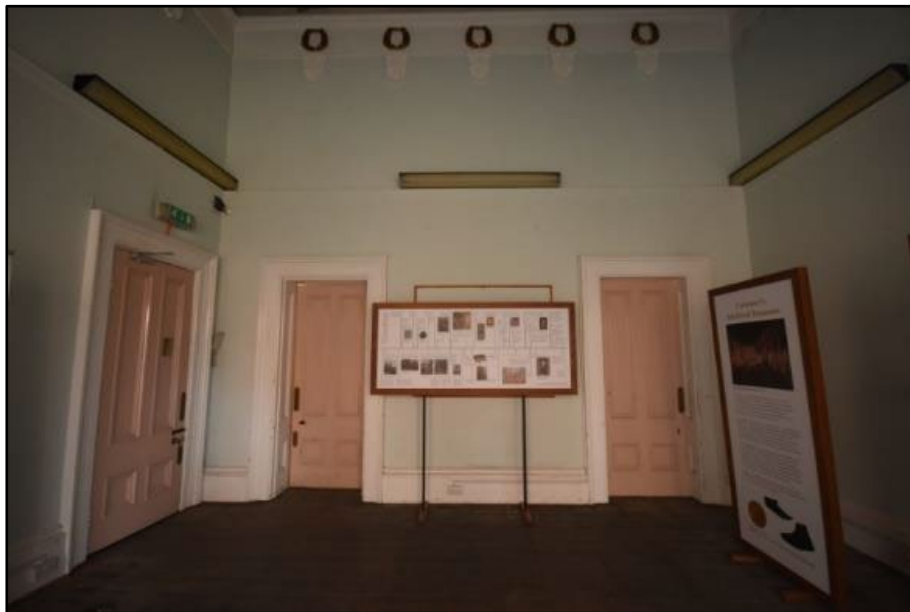
Fig 55

Doors within the Reading Room giving access to the Lobby (left) and Tea Room (right), taken from the north-west

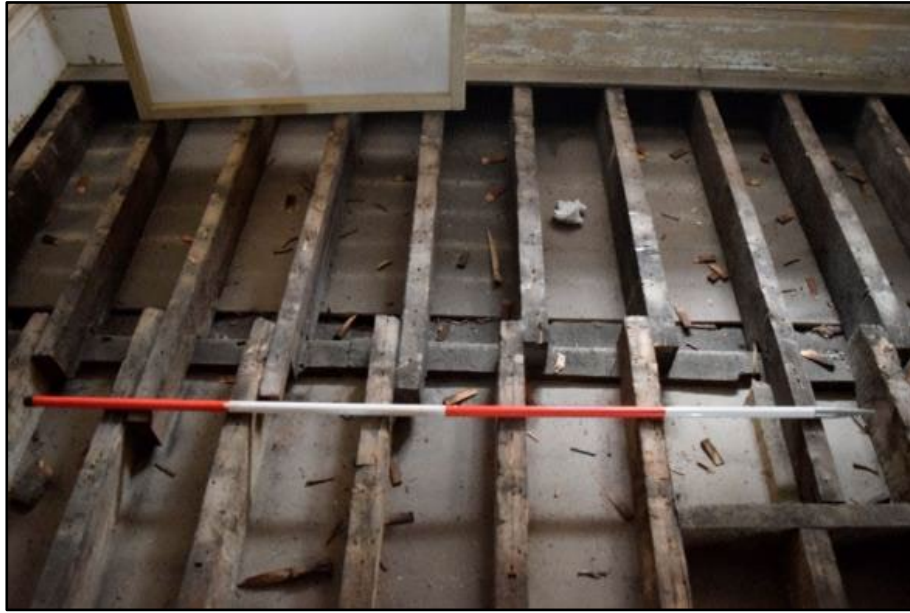
Floor joists in the Reading Room showing the distinction between the main room (bottom) and the extended north bay (top) taken from the south Fig 56

The extension of the room to the north in 1894 formed a small bay which was probably used for the billiard player's bench. The three inserted windows to the north extend from floor to ceiling and bring ample natural light into the room. Each is flanked by slender pilasters with moulded bases and capitals with upper reeded shafts (Fig 61). Secondary glazing has been inserted, as it has for most of the internal windows in the building. Behind this the sashes retain catches and handles.

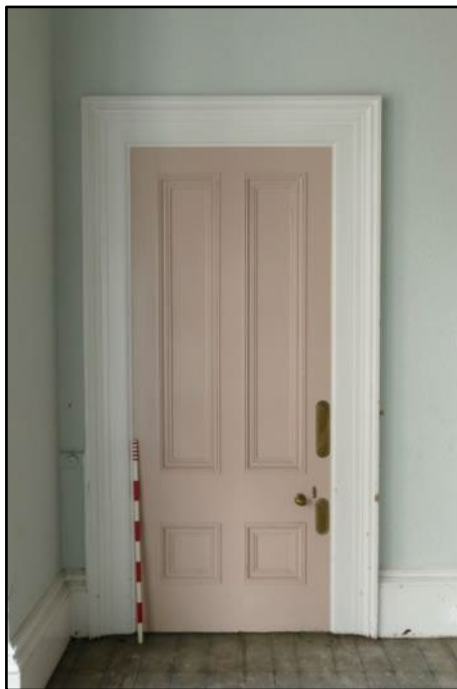
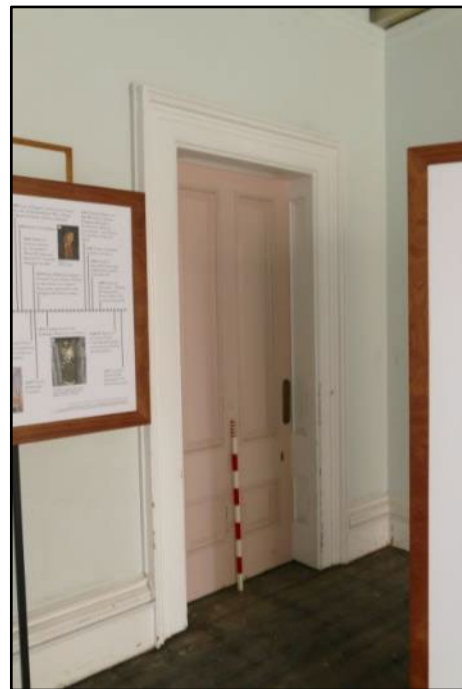
Fictive door examples from within the Reading Room, taken from the west and north-east Fig 57

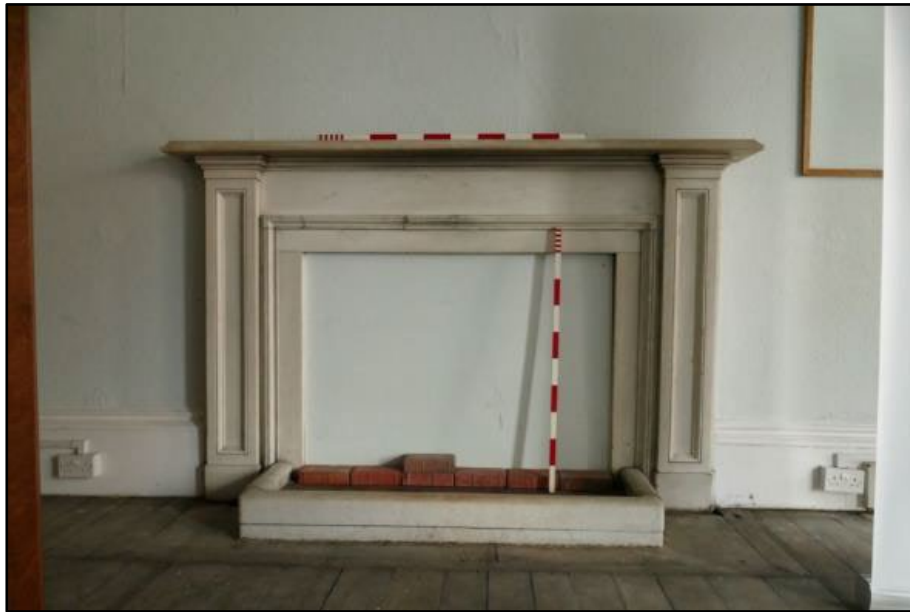
Fireplace within the Reading Room, taken from the east Fig 58

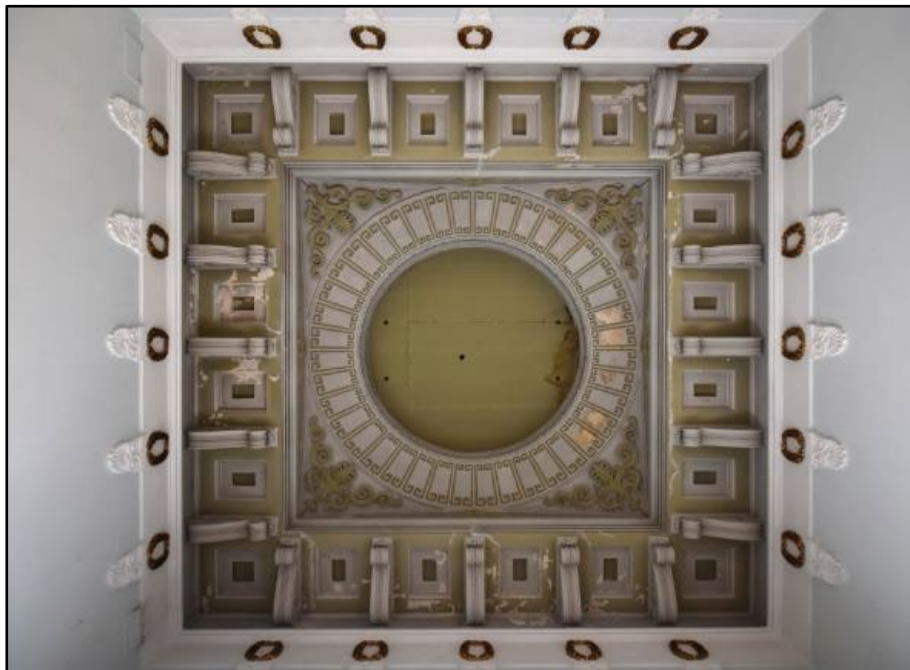
Ceiling in the Reading Room, looking up Fig 59

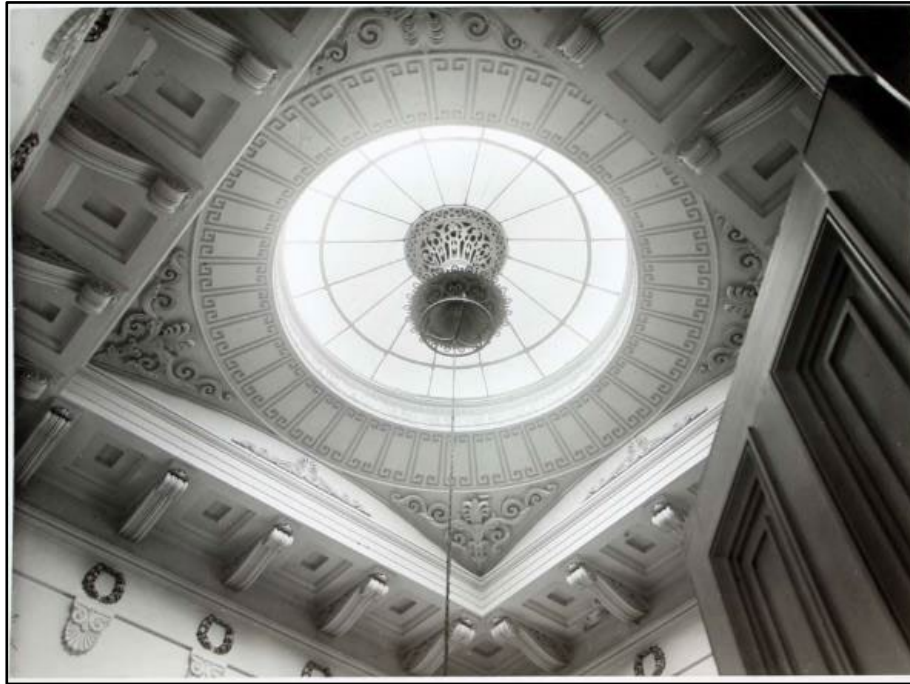
Ceiling in the Reading Room photographed in 1957, reproduced with permission of the Coventry Evening Standard, previously Trinity Mirror (Ref. PA468/5/11/5/2/4), and Historic England (Ref. AA58/388) Fig 60

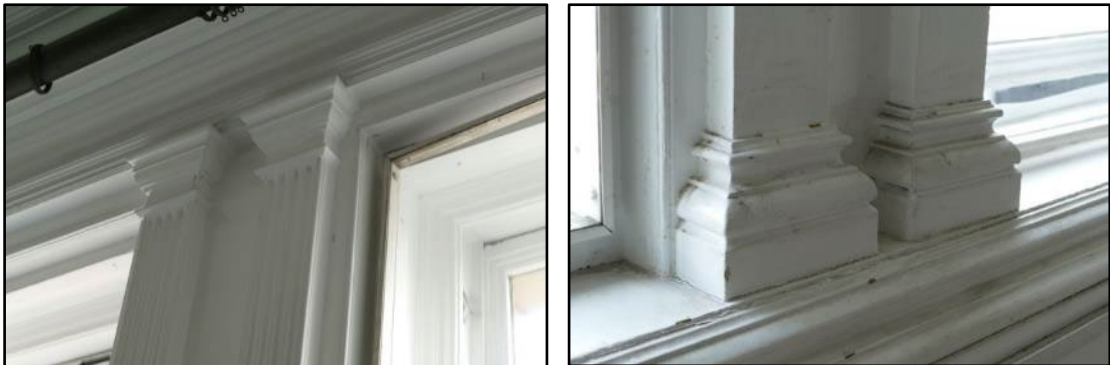
Detail of the sash windows inserted in the 1860s, taken from the south Fig 61

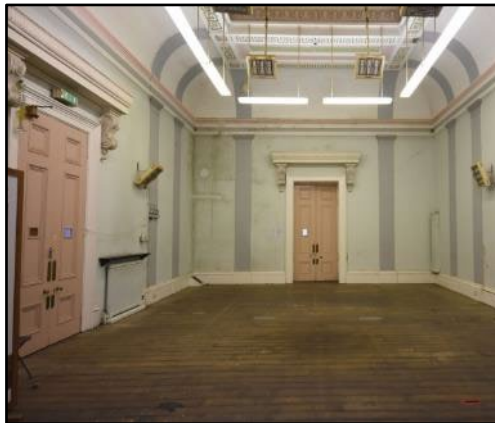
Interior of the Tea Room, taken from the north, versus the same view in the original 1828 scheme reproduced with permission of Culture Coventry/Coventry Archives (Ref. PA468/5/5/9) Fig 63

The interior of the Tea Room has a wooden floor, high moulded skirtings and painted plaster walls with slightly projected impression of pilasters (Fig 63). The ceiling has a rounded coving springing from the internal cornice to a roof lantern. The floorboards are of softwood, run east to west, and measure 6" wide (15.5-16cm). In the south-east corner of the room was observed a hot air vent in the floor. This vent is connected to a former hot airflow system fed from the Boiler Room on the lower ground floor (Fig 64). There is also an air vent within a short internal shaft in the south-west corner fed from an external vent in the west wall.

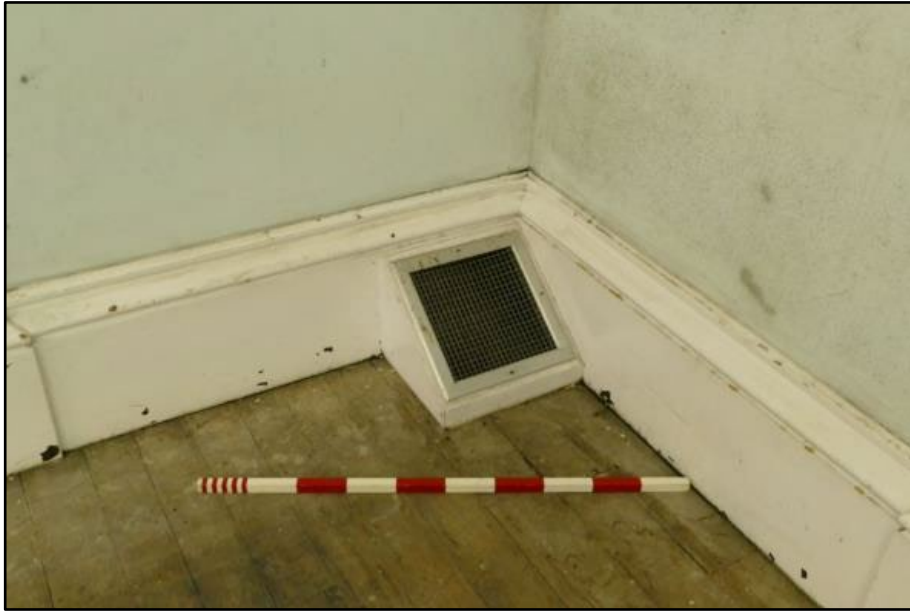
Air vent in the south-east corner of the Tea Room, taken from the north-west Fig 64

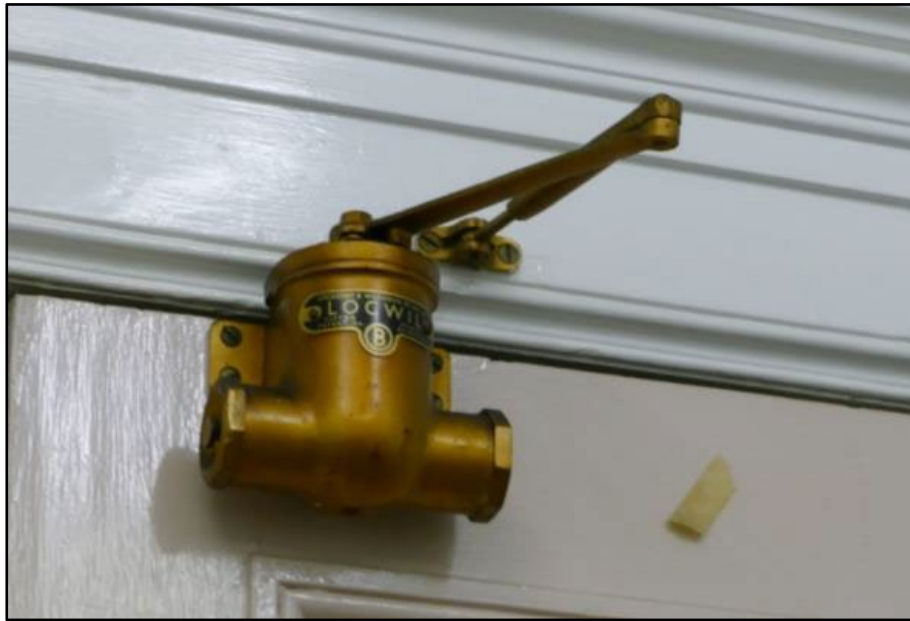
Fig 66

Brass door closer in the Tea Room, taken from the south

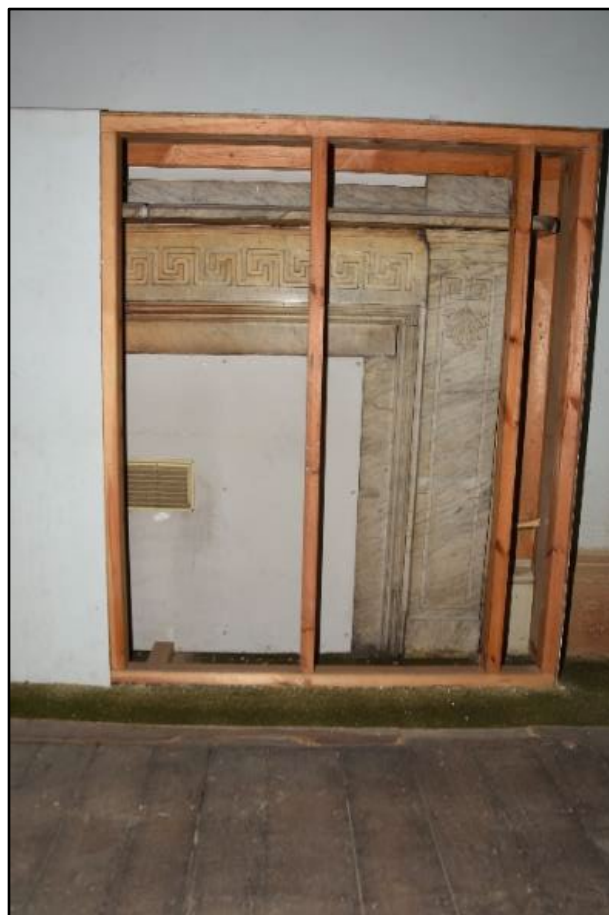
Exposed fireplace in the Billiard Room, taken from the east Fig 67

To the north the two doors to the Reading Room are similar to those seen elsewhere, that to the west being fictive as noted above. The true example retains its finger plates, doorknob, and a locking bolt. A Lockerbie & Wilkinson brass door closer also survives from the mid-20th-century (Fig 66). There is a large fireplace on the west wall which was boarded and not visible during the survey but was visible in 1957 when it had carved anthemion detail to the jambs. This was partially exposed during the monitoring works as of marble with a Greek meander below the shelf (Fig 67).

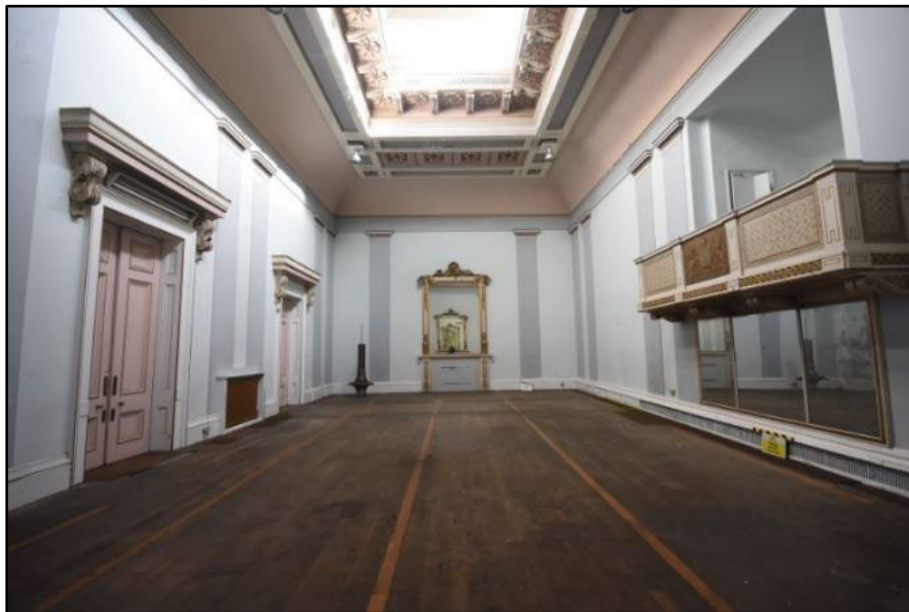
Fig 70

View of the Ballroom, taken from the west

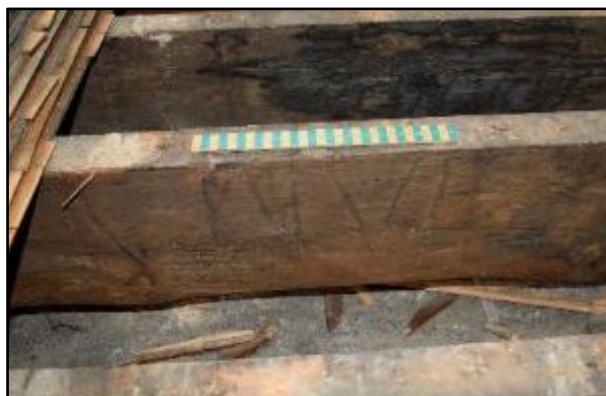
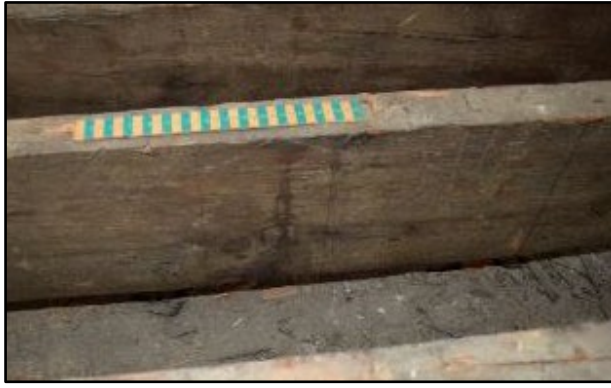
Fig 71

Examples of scribed/scratched timber marks in the Ballroom

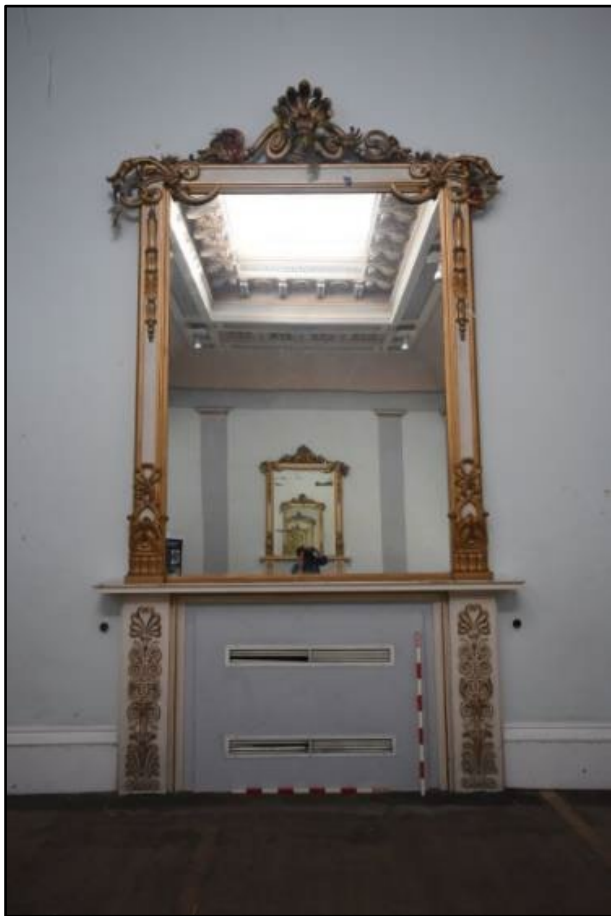
Fig 72

Fireplace in the Ballroom, taken from the west

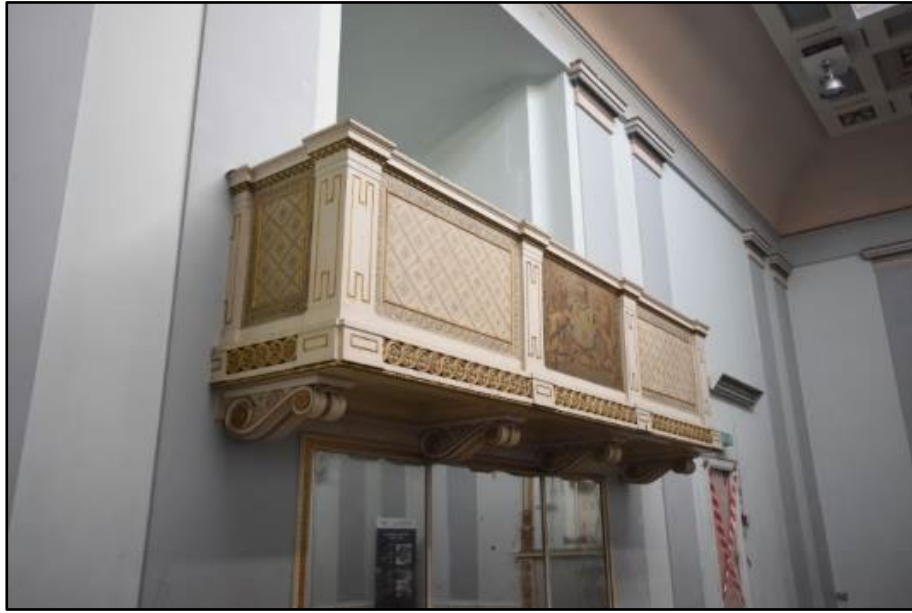
Fig 75

Orchestra gallery in the Ballroom, taken from the north-east

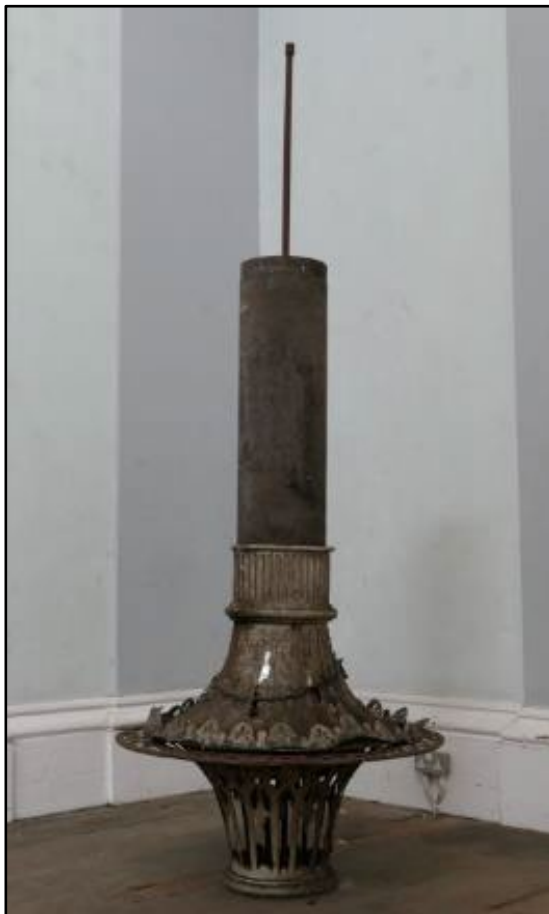
Fig 76

Lantern ex situ in Ballroom, taken from the south-west

The walls rise to a coved ceiling and rectangular border to the lantern of simple recessed panels and large floral motif. At least four chandeliers once hung from the panels, one remained *ex situ* during the survey (Fig 76), the others have been replaced by modern lighting. The other chandeliers were sold to a London antique dealer in 1960 who still had them in his possession in 2019 (M Webb 2022, 3 February). The roof lantern is further recessed and bordered by scrolled brackets and floral motif (Fig 77). Around this, and below the timber lantern a border of Greek meander is present. The lantern retains top-hung casement windows with glazing bars to all sides (Fig 78). The ceiling of the lantern itself is decorated with moulded plasterwork in simple

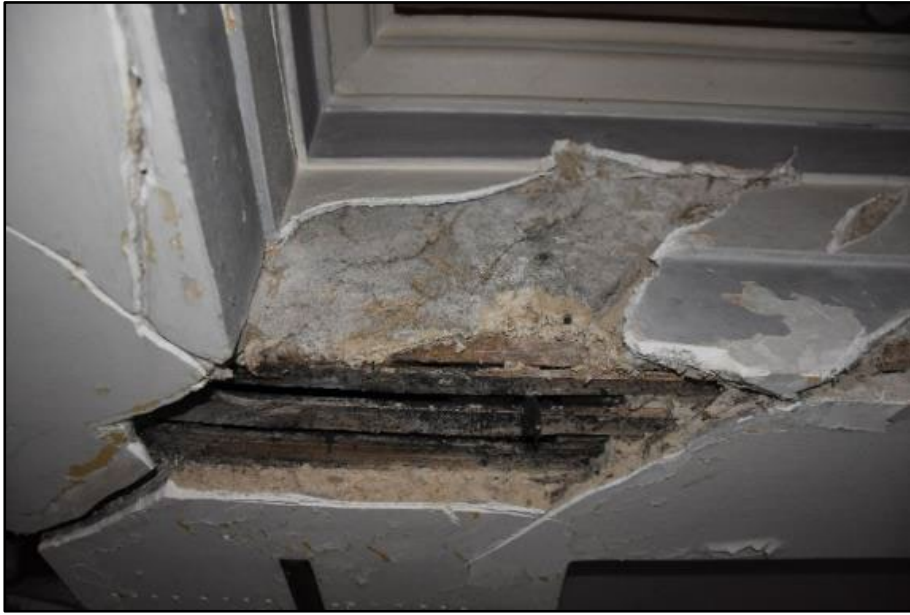
Cracks in the plasterwork to the lanterns frame reveal laths beneath, looking west  
Fig 80

When the lantern was inspected during the works an internal scaffold was erected within the room in order to allow conservators to work on the plasterwork. On closer inspection the two long sides of the lantern are bowed inward, creating an optical illusion for whomever stands on the floor below (Fig 79). Several large cracks in the plasterwork revealed the lantern sits within a lathwork frame (Fig 80). Some of the mouldings are carved timberwork (Fig 81).
