**Historic building recording  
at Draper's Hall  
Coventry  
April 2019 - October 2020**

Report No. 21/081

MOLA (Museum of London Archaeology) was commissioned by the Prince's Foundation, on behalf of the Historic Coventry Trust, to undertake a programme of Level 3 historic building recording at the Grade II\* listed Draper's Hall, Bayley Lane, Coventry, Warwickshire (SP 3363 7895, Fig 1). This was required prior to works being undertaken on the building (Planning Ref. LB/2014/0862) for alterations in line with conversion to a centre for Music and Performance. This project ran concurrently with a programme of excavation between April to Jun 2019, the results of which are to be published in a separate report (Thompson 2021).

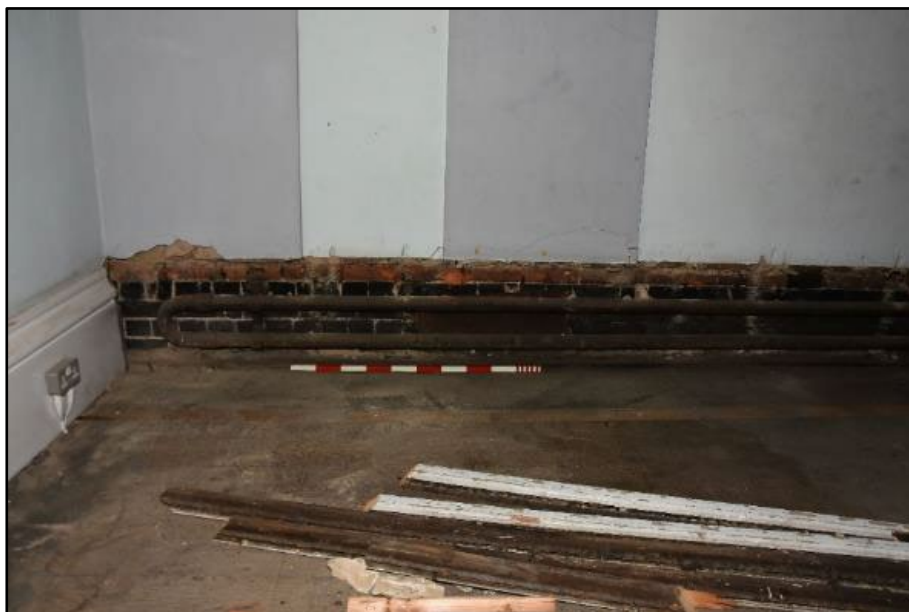
During planned works the section of boxed pipework along the south wall was exposed revealing the underlying brick fabric of this outer wall (Fig 82). Only exposed by four courses the lower three courses were of very dark fabric, almost black, topped by a red/orange fabric. It appeared to be laid in English bond.

Section of exposed brickwork to the south wall, taken from the north Fig 82

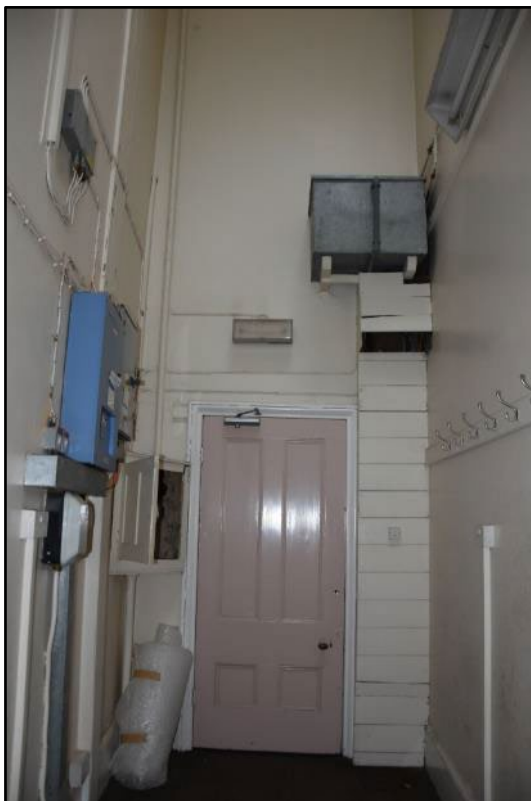
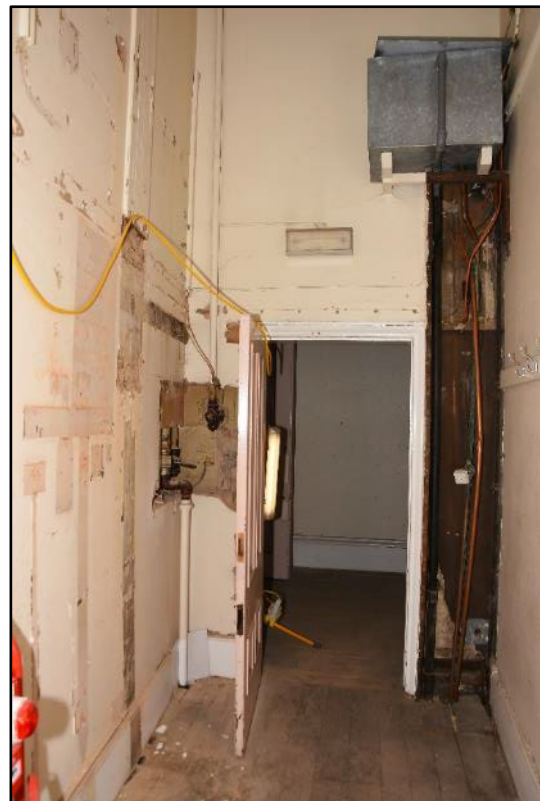
Fig 83

A soft-strip during the planned works revealed very little (Fig 83).

Service Corridor before and after soft-strip, taken from the east

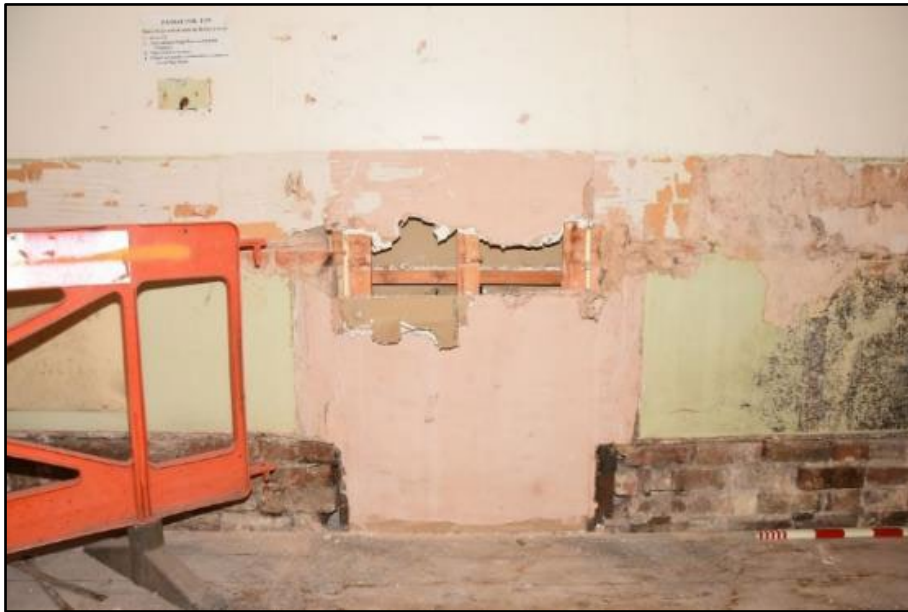
Section of wall fabric exposed during monitoring, taken from the south Fig 86

Removal of the kitchen finishes during the planned works revealed some previously unrecorded fabric. Several sections of skirting boards were removed revealing the underlying fabric of the wall construction. To the north this exposed English bond brickwork with the occasional wooden peg, of red/orange fabric with a few darker examples. To the north this changes to an undeterminable bond of differing quality fabric. Towards the centre of this wall there is a gap in the brickwork of under c1 metre (Fig 86). Above this section of wall is constructed with softwood framework, visible where plaster has been removed. This corresponds with an earlier opening into the WCs (12) visible on the 1957 NMR plan (see Section 5).

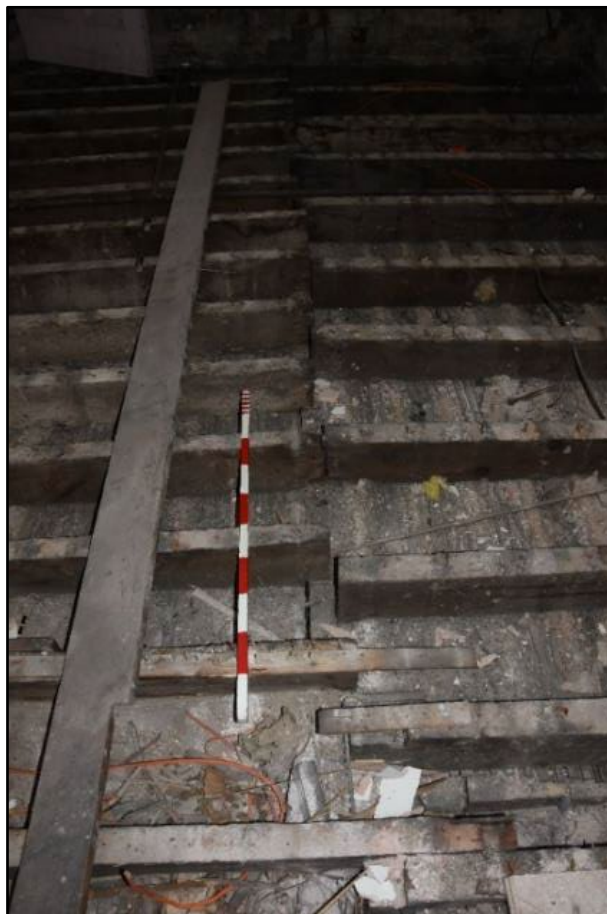
Removal of the flooring during the soft strip revealed wooden floorboards running east to west measuring 6½" (16.6cm) wide. Further removal of the floorboards revealed the underlying floor joists extending north to south. There is a distinct split running off-centre down the room with two sets of joists (Fig 87), with no correlation between them where they meet in the centre of the room.

Arrangement of joists in the kitchen on lifting of floorboards Fig 87

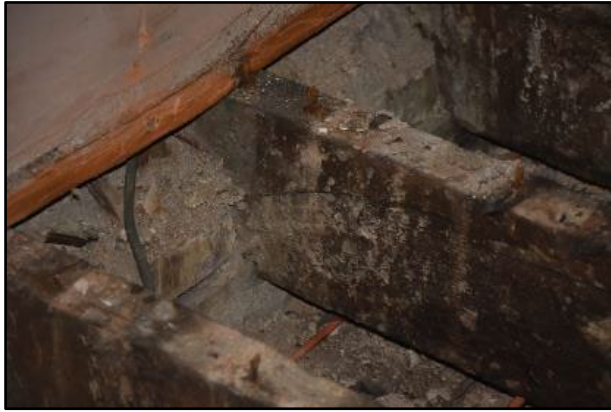
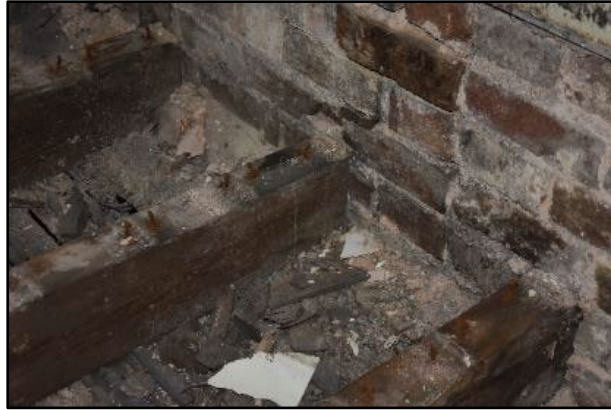
Fig 88

To the north of the aforementioned split the joists measure 3" wide and 6¾" high (7.5cm by 17.5cm) and are spaced 14¼"-14½" apart (36-37cm). Where they correspond with the north wall, they rest abutting the bricks, with at least one exception being set into the brickwork (Fig 88). To the south the joists measure 2½" wide and 7½" high (6.5cm by 19cm) and are spaced 10½" (26.5-27cm) apart. Both sides extend towards a central supporting joist over which the south joists are notched, those to the north rest atop. The southern joists are weathered at this end also. The southern joists are notched over a wall-plate, set into the room, and they are set into the brick wall above (Fig 88). This arrangement indicates the southern joists are the primary phase, and the weathering to the north ends suggests they were formerly set into a brick wall where moisture build-up occurred.

Arrangement of joists meeting the south (left) and north (right) wall

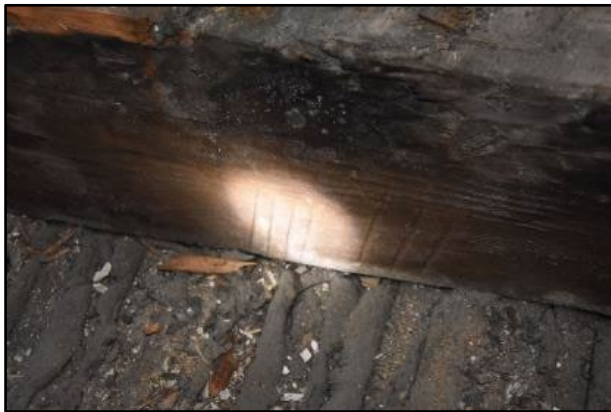
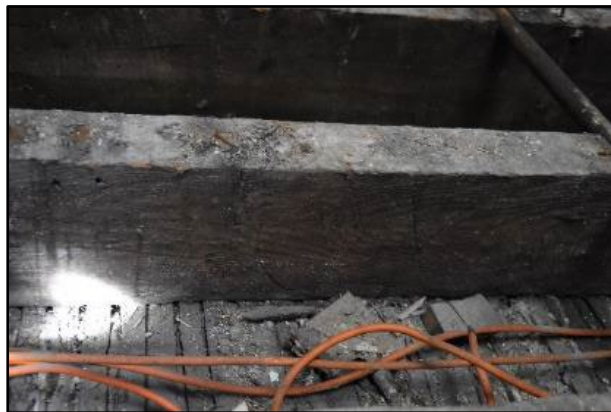
The southern joists have good examples of circular saw markings, and two examples of scribed/scratched timber markings (Fig 89), like in other areas of the building. The split correlates to the original line of the building according to the 1828 and 1850s surveys (Figs 7 & 9).

Scribed or scratched markings to the joists Fig 89

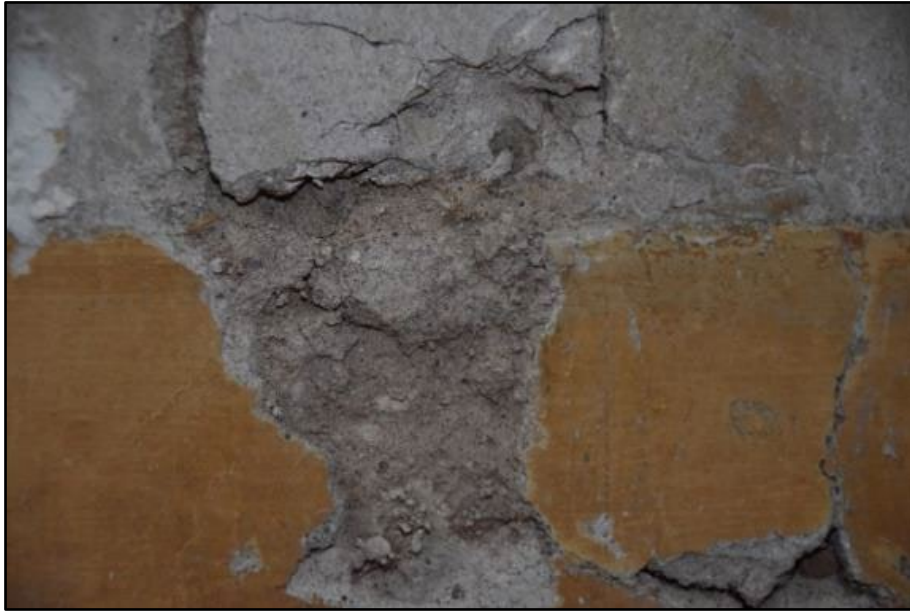
The pattern of the wallpaper still survives on the plasterwork where the paper has been removed and on the north wall to the west. On close inspection the plaster has come away in small patches revealing a moderate animal hair content (Fig 94). Also, along this northern wall there is an area of darker plaster with horizontal bands, one suggestion has been this was a cupboard (Fig 95). The door to the New Card Room (16) intersects this outline and as this room and the corridor are part of the same phase this makes that conclusion unlikely.

Detail of the plaster to the north wall of the East/West Corridor, taken from the south  
Fig 94

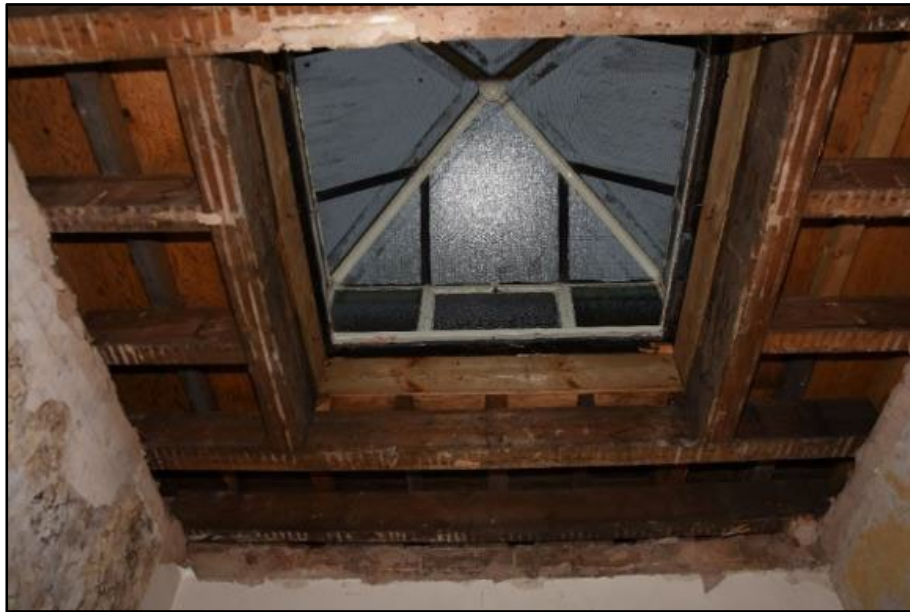
Also, as part of the planned works the plaster to the ceiling was removed from the eastern section of this corridor (Fig 96). This revealed a series of north-south orientated softwood joists mortised into the framework for the roof lantern. Above these joists the frame has been replaced with modern material in a previous refurbishment. The scars of laths still mark the soffit of the joists, indicating the former ceiling construction was lath and plaster.

Exposed construction of the ceiling over the eastern section of the East/West Corridor, taken from the west Fig 96

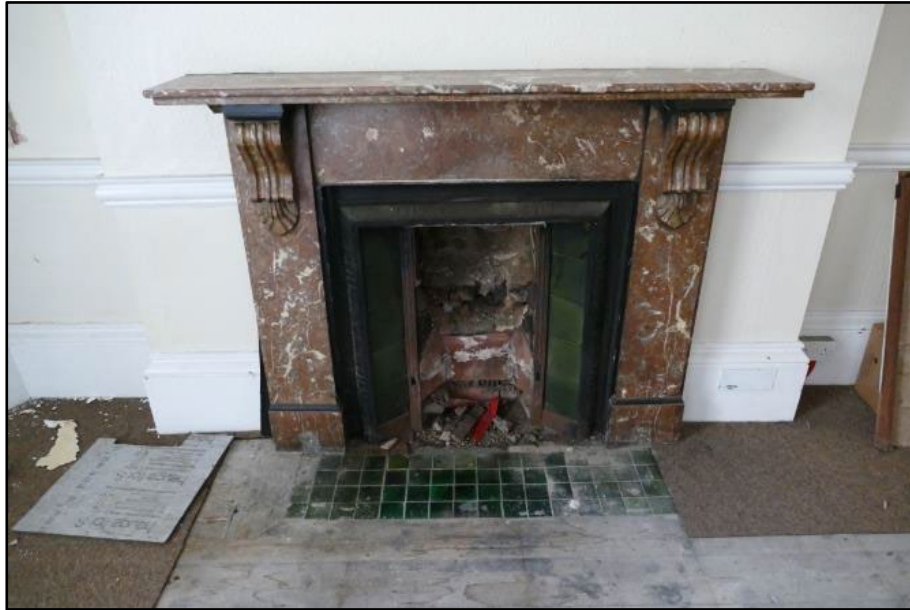
A fireplace on the eastern wall is marble and of simple but robust form (Fig 98). Scrolled brackets with Anthemion pendants support a shelf. There is a tiled hearth and tile slips, but no grate is present.

Fireplace in the New Card Room, taken from the west Fig 98

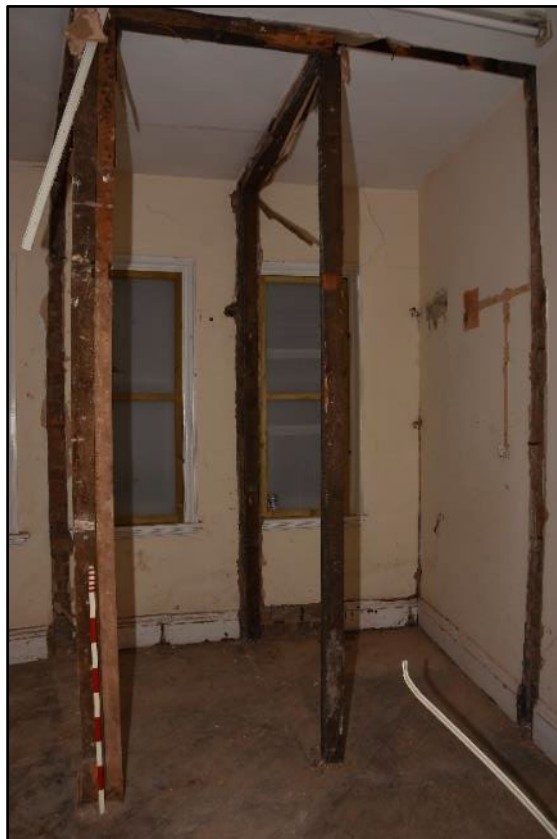
The soft strip during planned works revealed much more information regarding the construction of this area. The exposed floorboards were laid east to west across the combined spaces. Much of the internal partitions had been removed by the first monitoring visit but the softwood studwork for the partitions to the WCs (30 & 32) survived and were recorded (Fig 104). These partitions appeared to have comprised lath and plaster infill, the laths survived in places and were machine-made, and nailed to battens which were fixed to the main studwork. No plaster survived.

Internal partitions to the WCs during monitoring of works, taken from the south-west Fig 104

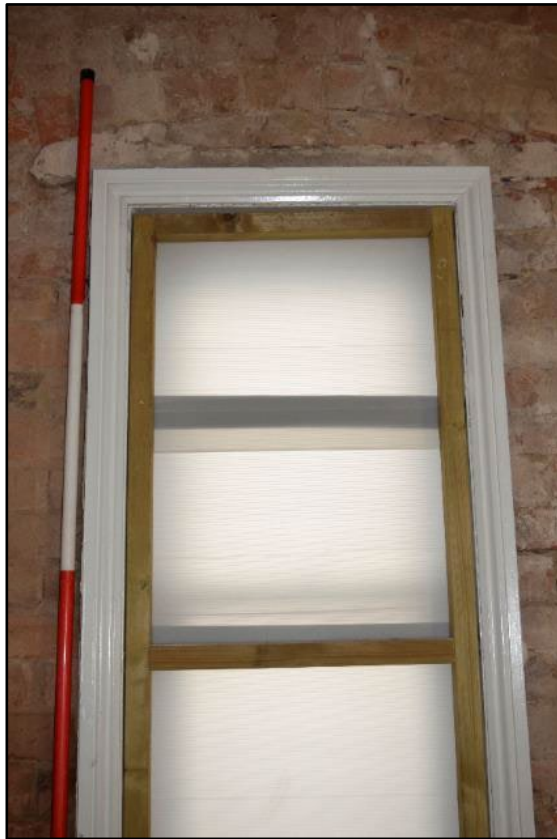
Fig 105

Brickwork exposed during the monitoring phase, looking north-east

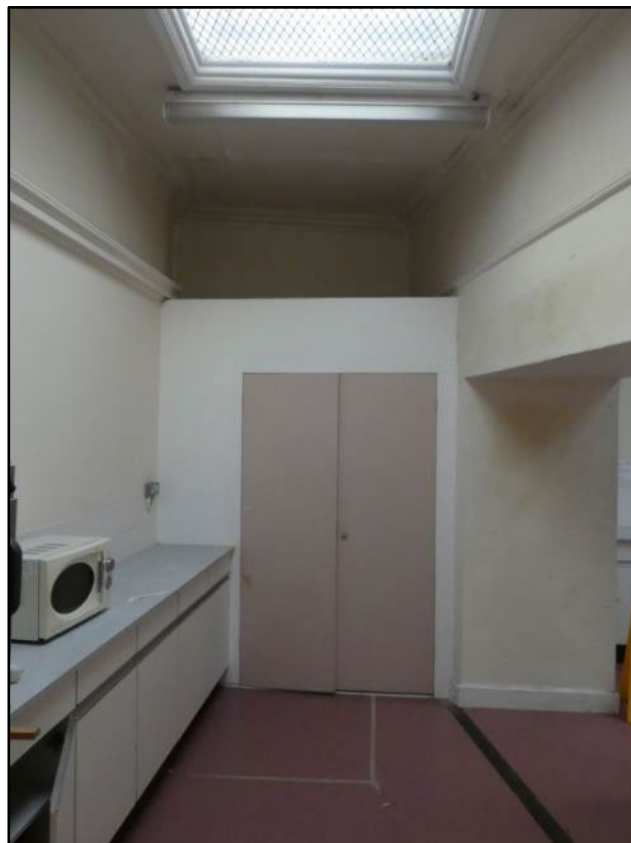
Located within the 1890s phase this area was a former storeroom for the bar to the west and then a second kitchen. It is accessed from the main Kitchen (11) to the west and the east end of the East/West Lobby (19) to the north. The room retains a high skirting, and high picture rail but otherwise plain plastered walls to a moulded cornice (Fig 106).

Interior of Former Bar Store, taken from the north Fig 106

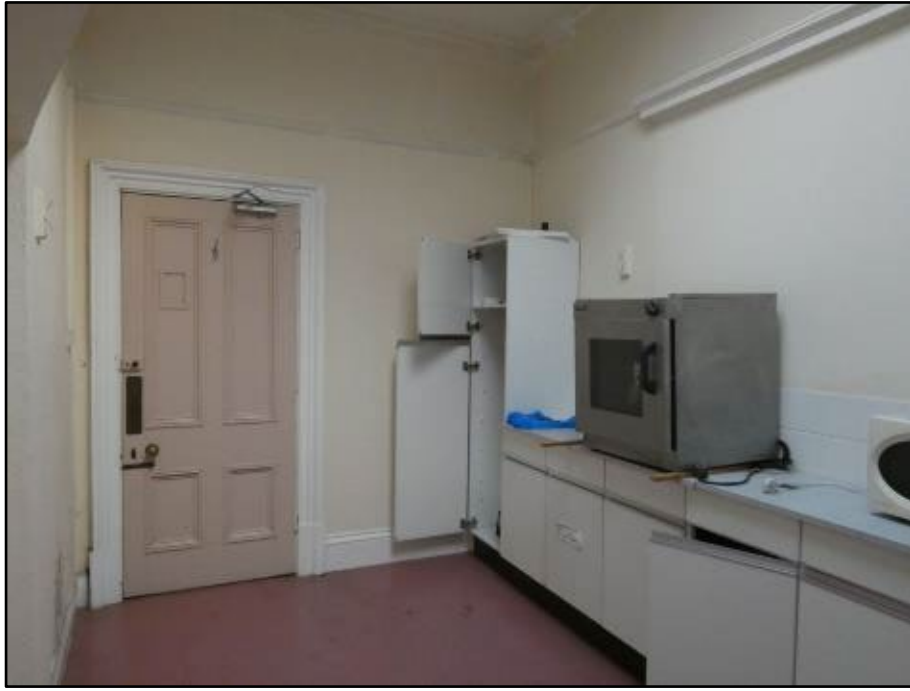
The west wall has been cut to provide access into the adjoining Kitchen presumably when this phase was constructed. To the south a cupboard has been created in modern materials. To the north the door from the East/West Lobby is of four-panels within a moulded surround, as elsewhere (Fig 107). The room is lit by a rectangular roof lantern with moulded timber surround.

Interior of Former Bar Store, taken from the south Fig 107

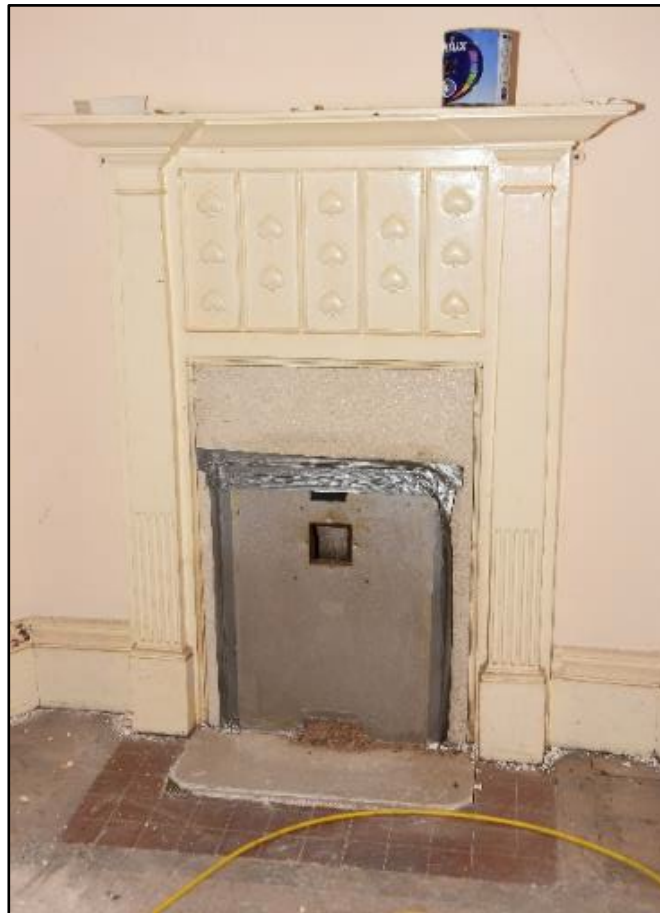
During the planned works a fireplace was revealed on the east wall (Fig 108). This was timber and had been converted to take a gas stove at some point in its history. It was tall with a narrow moulded shelf and framed by tapering pilasters with short reeded sections to their shafts. Below the shelf was five raised panels with spade motifs. The floorboards cut around the tiled hearth seemingly contemporary with the room. The floorboards in the main section of the room were aligned north to south. To the west the floorboards from the kitchen run through and over these boards, creating a small step (Fig 109).

Fireplace revealed during the planned works, taken from the west Fig 108

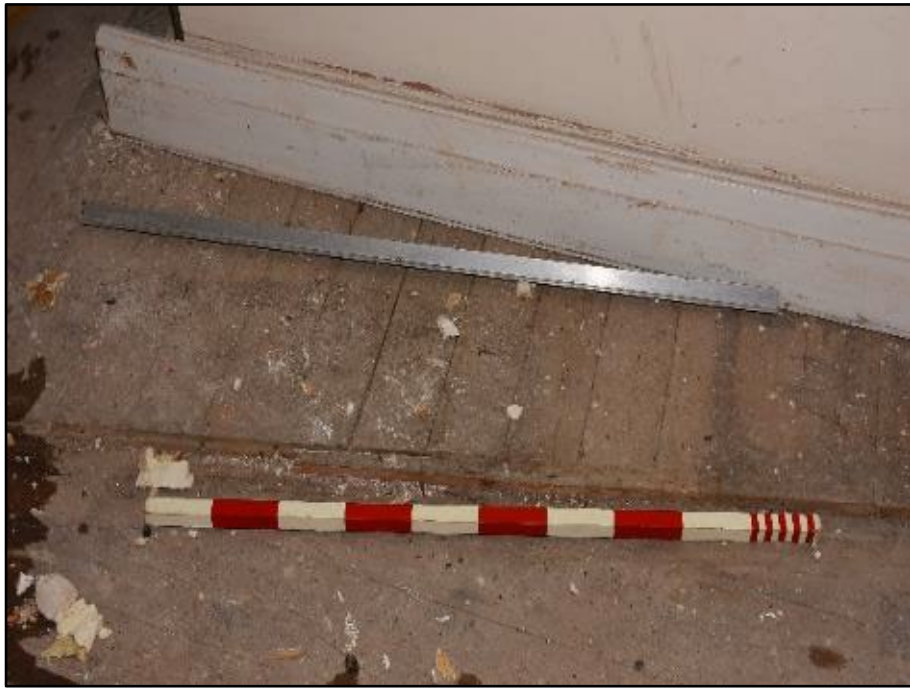
Fig 109

Section of floorboards in the Former Bar Store, taken from the east

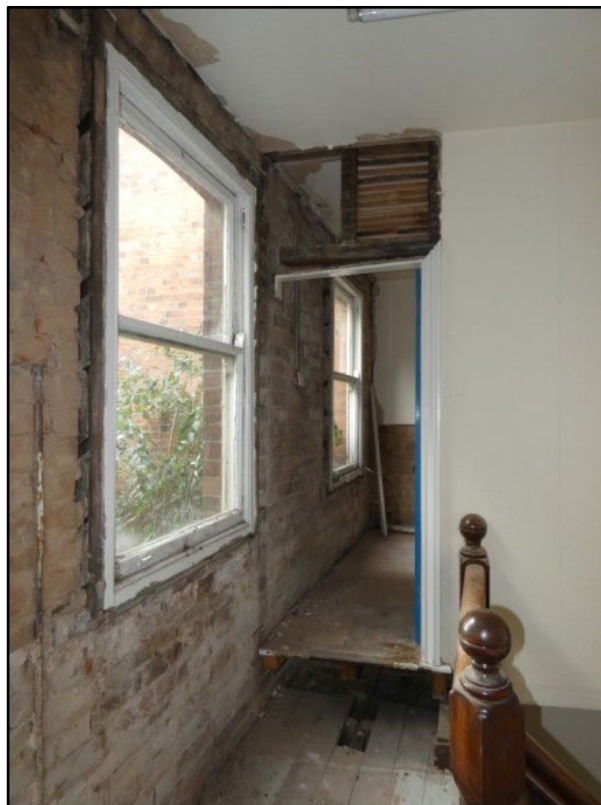
Landing area in the Summoner's House, taken from the east Fig 110

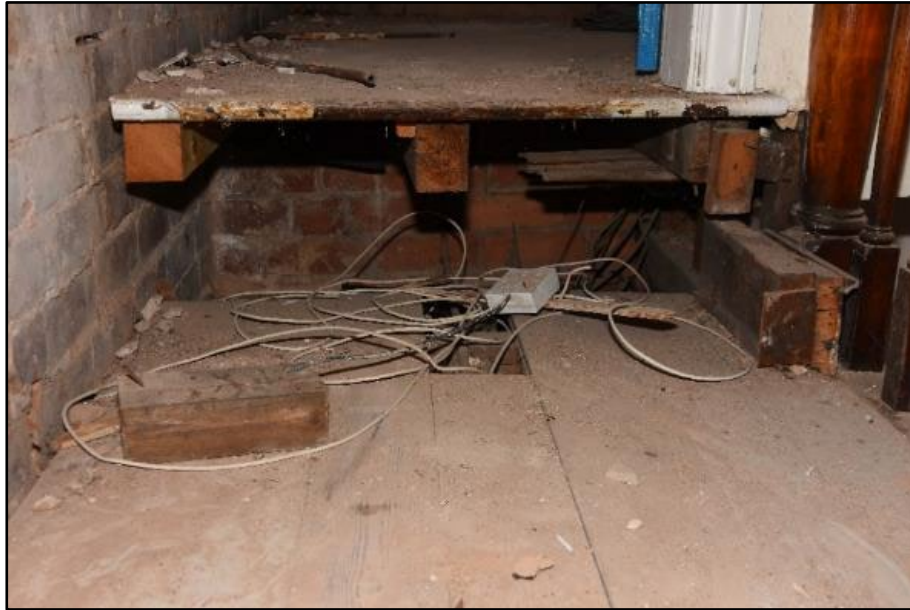
Underside of the floor arrangement of Bedroom 3 (23) in the Summoner's House, taken from the east Fig 111

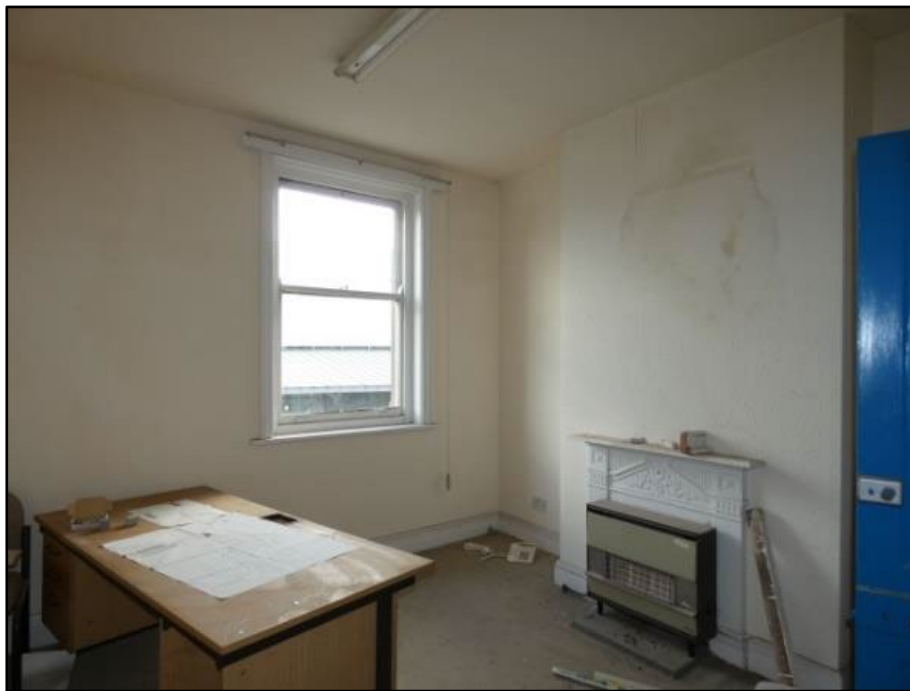
To the east two plain recessed four-panelled doors with lock cases to the rear provide access into the principal bedrooms (Fig 112). Where the frames were removed during the planned works the supporting brickwork was of red/orange fabric with a timber board acting as a lintel. Both rooms retain skirtings, wallpapered walls, a plain ceiling and their own fireplace. The fireplaces retain their timber surrounds with plain pilasters to a run of tassel-like moulding and corner roses. The central section is decorated with sunflowers and a reeded linen-fold type pattern. Both now have been obscured by electric heaters and retain a simple shelf. Their windows to the street are the same as seen elsewhere in the Summoner's Accommodation. Those to Bedroom 3 (23) retains moulded horns and a sash catch. Where the plaster has been removed the construction of the sash box has been revealed. Slanting timber boards slope down towards the interior from the exterior.

One of the bedrooms in the Summoner's House, taken from the north-west Fig 112

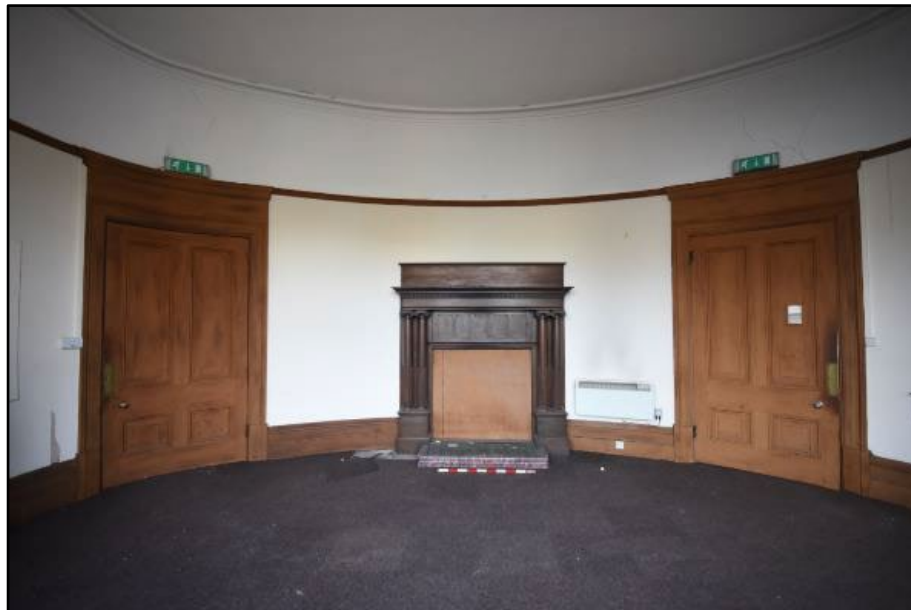
Two doors on the west match that seen in the East/West Lobby of four-panels below modest entablatures (Fig 113). However here they differ as they are curved to match the wall line (Fig 114). The west wall also retains a fireplace with timber surround and tiled hearth, now blocked. The surround comprises two sets of Ionic columns on tall plinths to a moulded shelf with modillions. The woodwork in this room, excluding the fire surround, appears to have been painted to lighten its appearance.

Interior of the Dining Room, taken from the north-east Fig 113

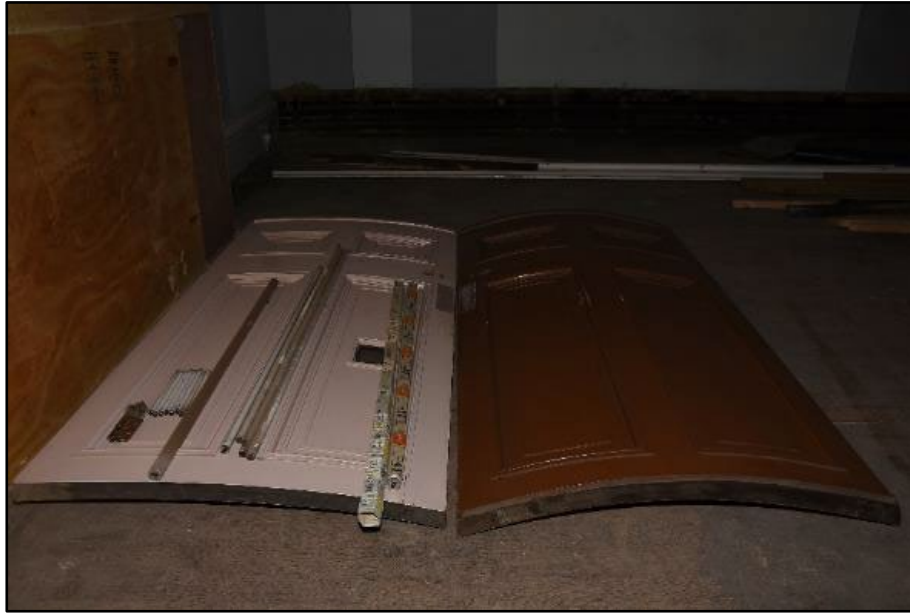
Curved doors from the Dining Room lying ex situ during the monitoring phase, looking south Fig 114

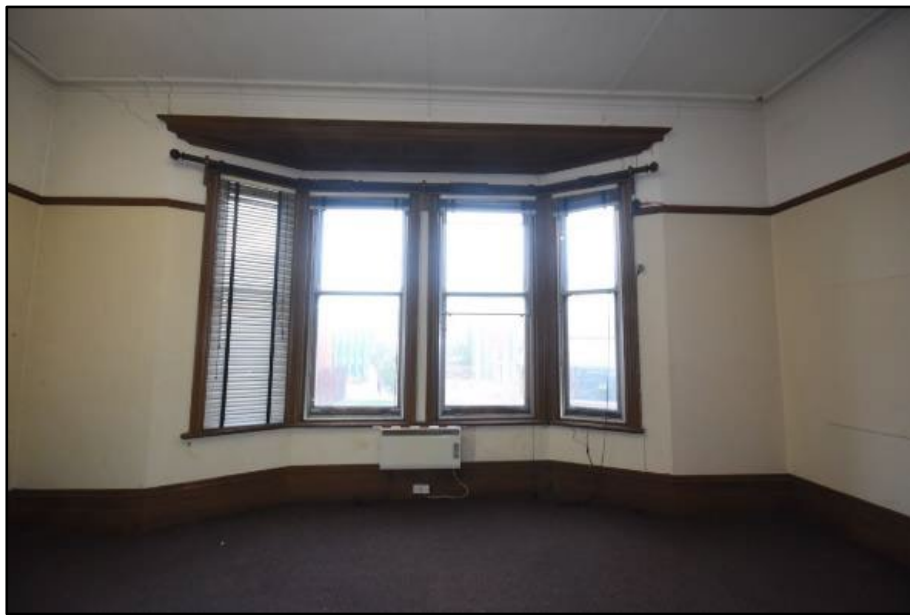
The bay window to the east comprises four one-over-one sashes within timber surrounds (Fig 115). The sashes all retain their horns and have been obscured by the addition of secondary glazing.

Bay window in the Dining Room, taken from the south-west Fig 115

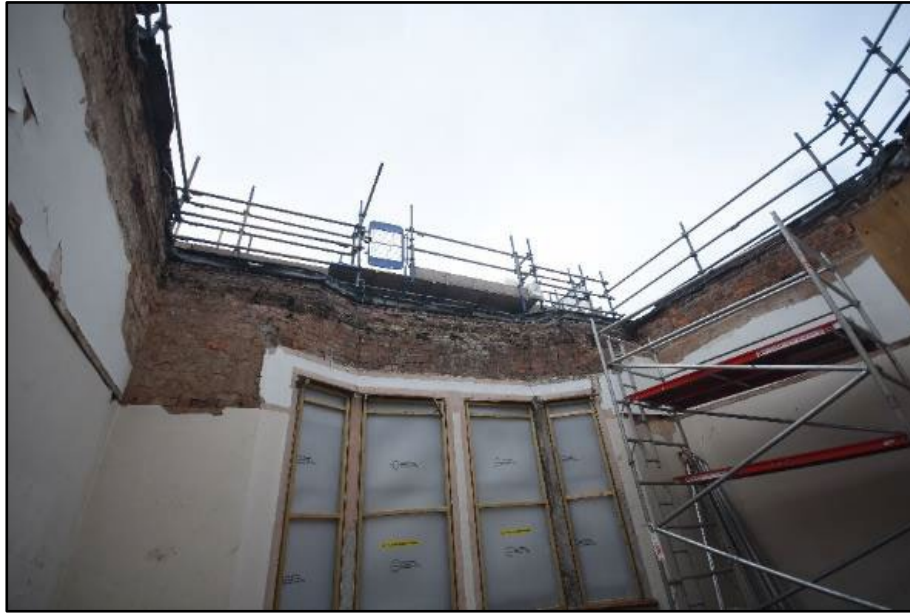
During the monitoring phase the roof of this room was removed. This exposed the top couple of courses of brickwork (Fig 116). The windows each retain arched heads within the brickwork. It is mostly laid in red brick and the top five courses are a much darker fabric.

Exposed brickwork to the wall during the monitoring works, looking east Fig 116

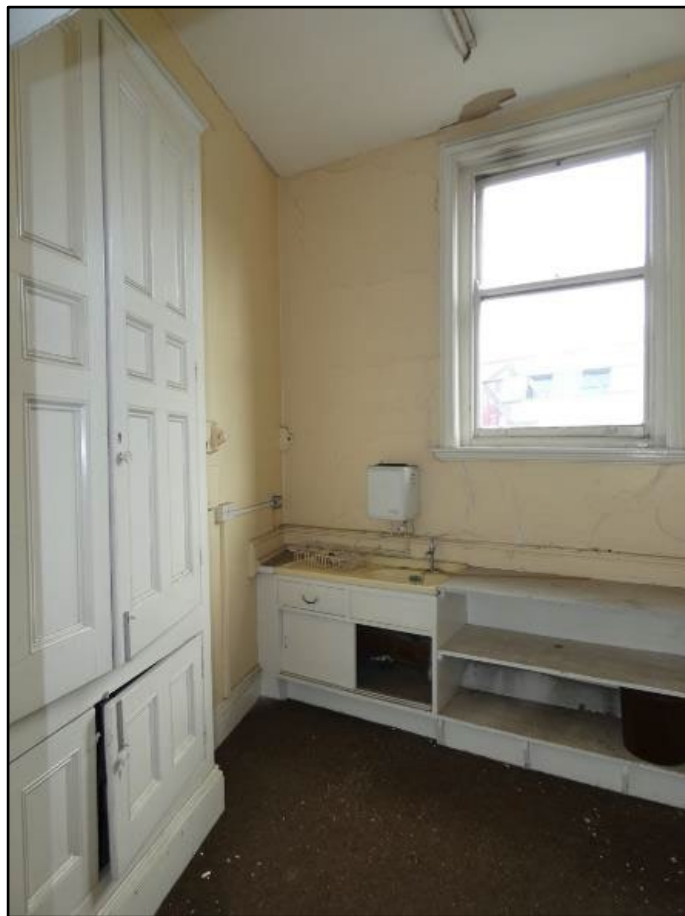
From the Dining Room a door gives access to a Service Room (27) and Stair Lobby (28) leading up from the lower ground floor from the Summoner's House and its rear entrance. The Service Room retains a skirting in places but is dominated by a set of fitted cupboards to the north wall and a set of kitchen units to the east (Fig 117). The cupboards are most likely original and comprise moulded and recessed panelled doors on barrel hinges (Fig 118). The kitchen units are modern but retain a moulded 'skirting' to the walls around the countertop suggesting they replaced an earlier piece. The window to the east is set high on the wall and sits within a moulded timber surround.

Interior of the Service Room, taken from the west Fig 117

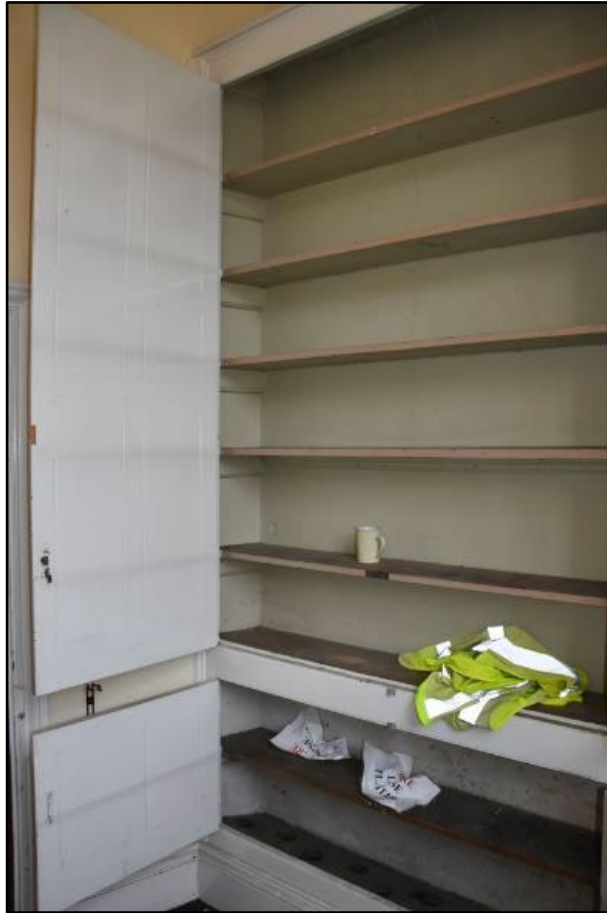
Interior of the cupboards in the Service Room, taken from the east Fig 118

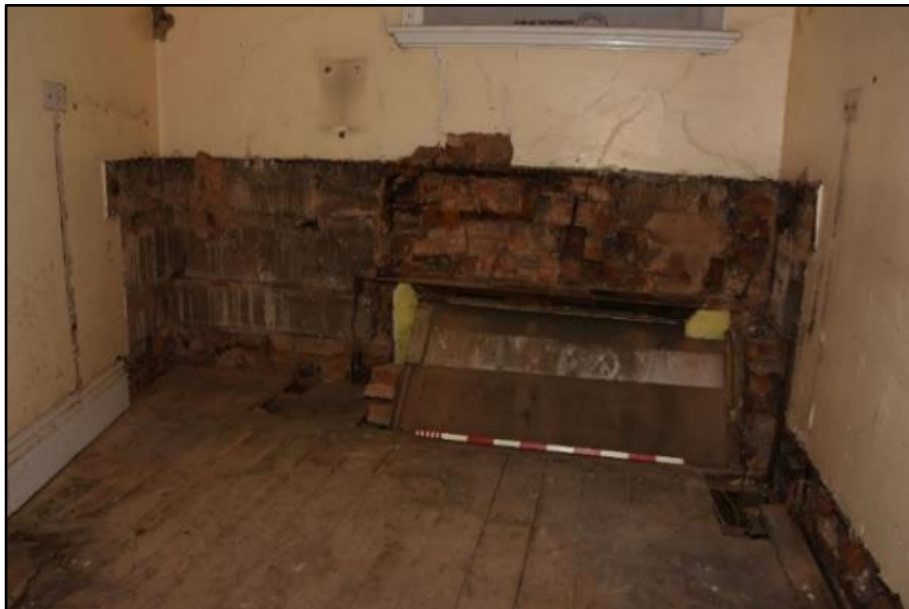
Exposed area of brickwork in the Service area (27), taken from the west Fig 119

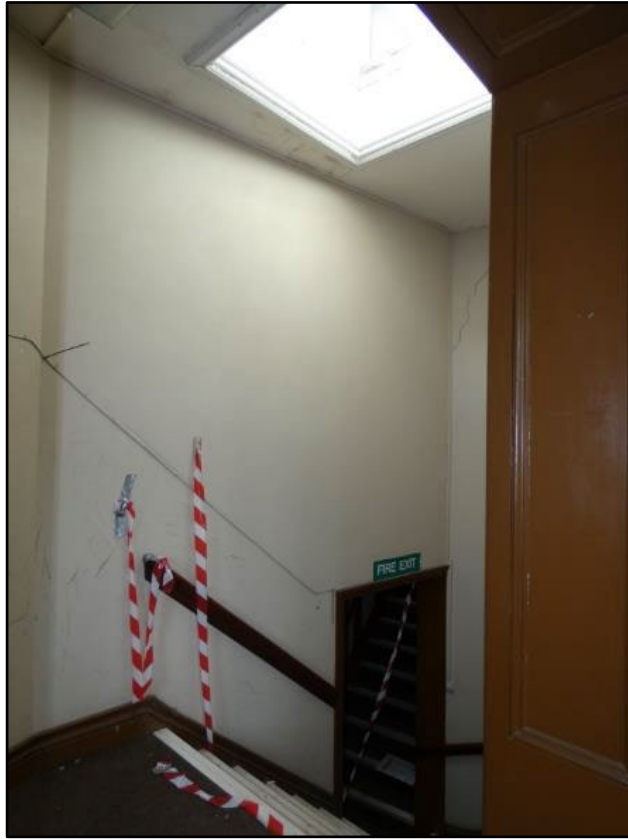
The stair is lit by a square roof lantern with moulded surround in timber and glass (Fig 120). The floorboards revealed during planned works were aligned east to west.

Stair to the lower ground floor, taken from the north-east Fig 120

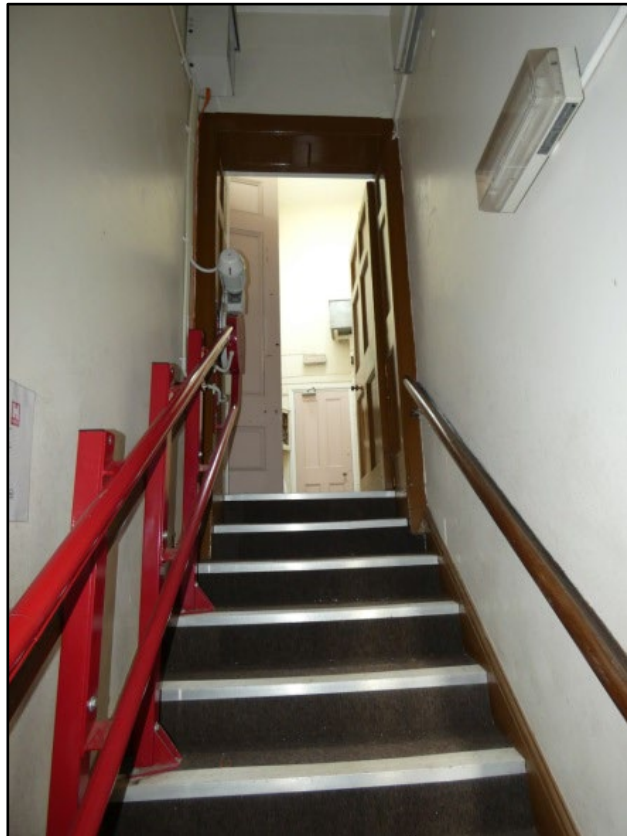
Fig 122

The stairs from the Dining Room and Service Corridor are clad in modern material (Fig 122) however their arrangement is historic and so the underlying fabric could be of some age. They rise from a stone flag floor, the flags being much worn, a simple skirting and plain plastered walls (Fig 123). The door through to the Summoner's accommodation has moulded and recessed panels of four-panel form. An archway containing stone steps to the west leads down to the Principal Basement Corridor. The door here is of five-panels with latch. The door to the exterior on the south is of six-panels, simply recessed with modern handle. Above the over-light seen externally has security bars.

Stairs from ground floor to lower ground floor, taken from the south

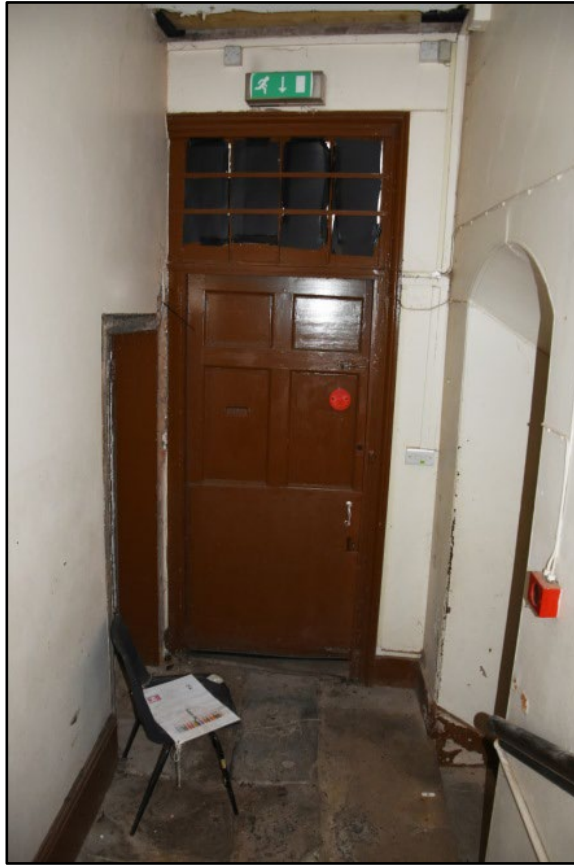
Entrance lobby from the rear of the building, taken from the north Fig 123

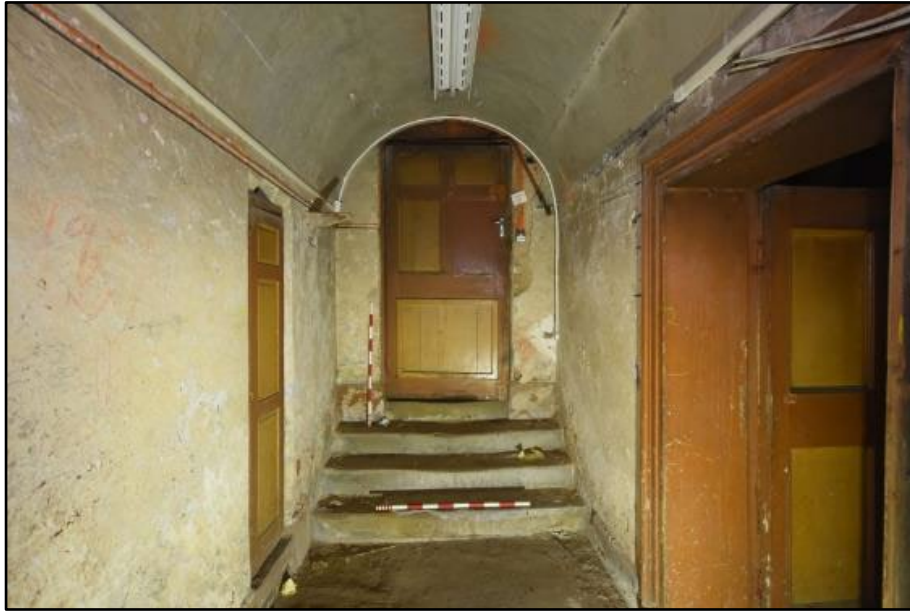
The space is divided by a wooden partition or screen part way along the corridor, the shorter section is to the east. From the Summoner's House a short flight of stone steps provide access but this was most likely externally accessed during the original 1830 construction (Fig 124). At the top a door of five-panels has been repaired but otherwise comprises recessed panels. The floor is laid with flagstones. Painted masonry walls rise to a simple moulded picture rail and a barrel vault ceiling. The picture rail has been removed to the south but its outline remains.

Access from the lower ground floor Entrance Lobby to the corridor, taken from the west Fig 124

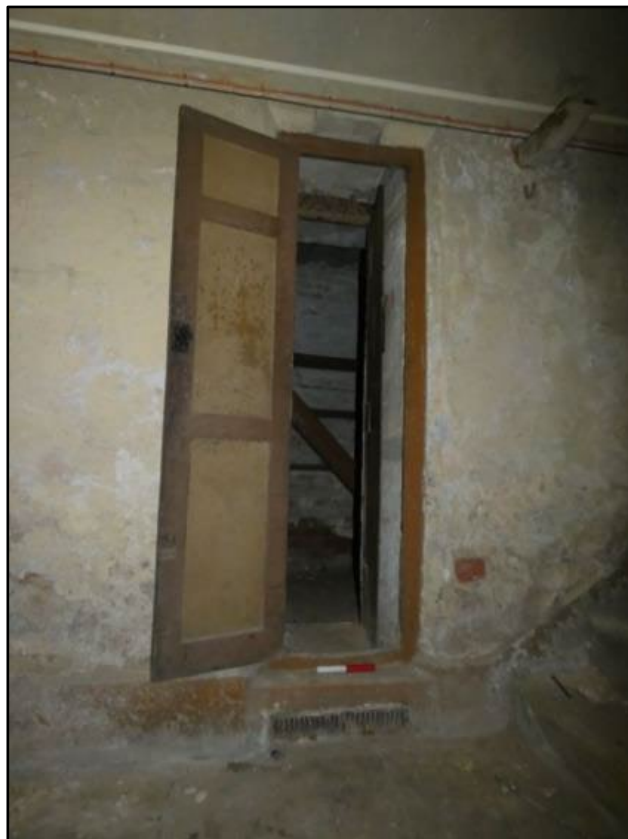
On the north wall a slender door set above a grille comprises three fielded panels with a small lock case to the rear (Fig 125). This gives access to a further cast-iron slender door suggesting the need for security, the barrel hinges are more robust than other examples in the building and a single key hole is present. The interior of the cupboard has painted brick walls, and a barrel vaulted ceiling. Two sides are lined by wooden shelving. Most likely this was utilised to store high-value items like silverware.

Door into Store from the Corridor, taken from the south-west Fig 125

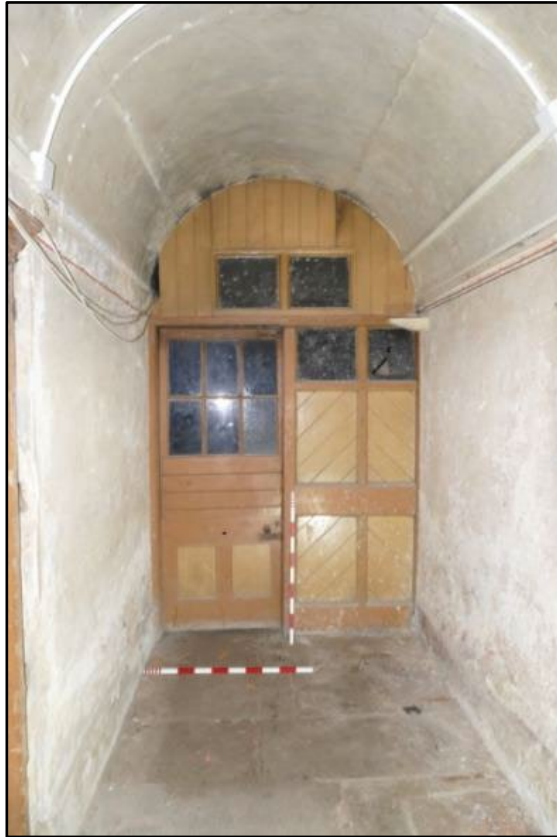
To the west the partition is formed of timber and glass (Fig 126). A door of six-lights over horizontal boarding and two lower panels gives access to the second section of the service corridor. One of the glass lights is of frosted glass. Adjacent to the door the partition continues of six-panels, the upper two of glass, the lower four of diagonal boarding. Above the arch of the barrel vaulting is infilled with vertical boarding and a two-light window.

Screen dividing the Corridor into east and west, taken from the east Fig 126

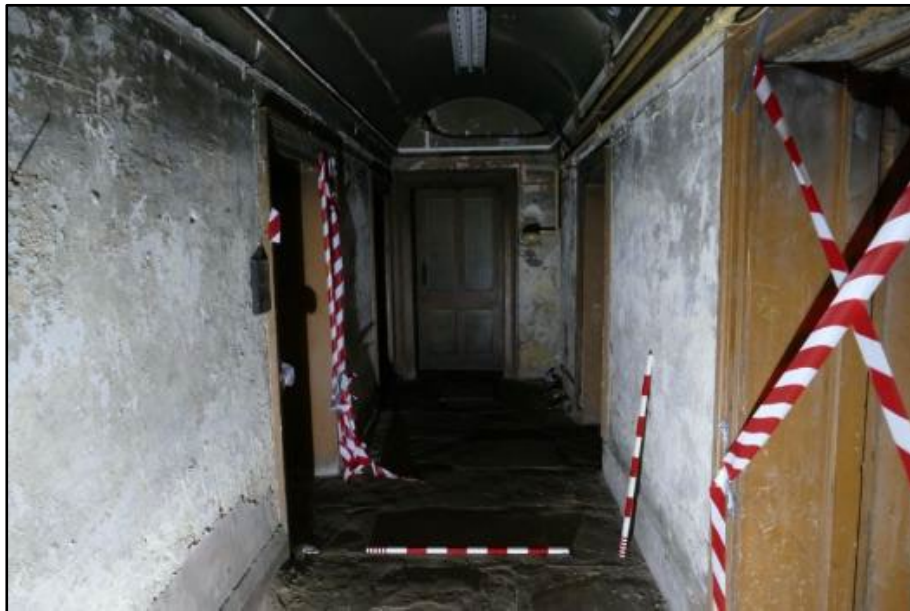
The longer section of the corridor continues past the partition and gives access into various other service areas (Fig 127). The space continues much the same from its eastern section. The majority of the doors are as that to the Kitchen of four-panels with recessed ovolo-moulded panels. Three examples to the Second Basement Corridor (62), Store (45) and Store Rooms to the north (69-75) have round-ended slits in their upper panels and retain locking bolts or door knobs (Fig 128). At the western end the door to the Former Coal Store (43) is simply recessed with latch. That to the Wine Cellar (44) is boarded with several rows of ventilation holes and latch (Fig 129).

West portion of the Corridor, taken from the east Fig 127

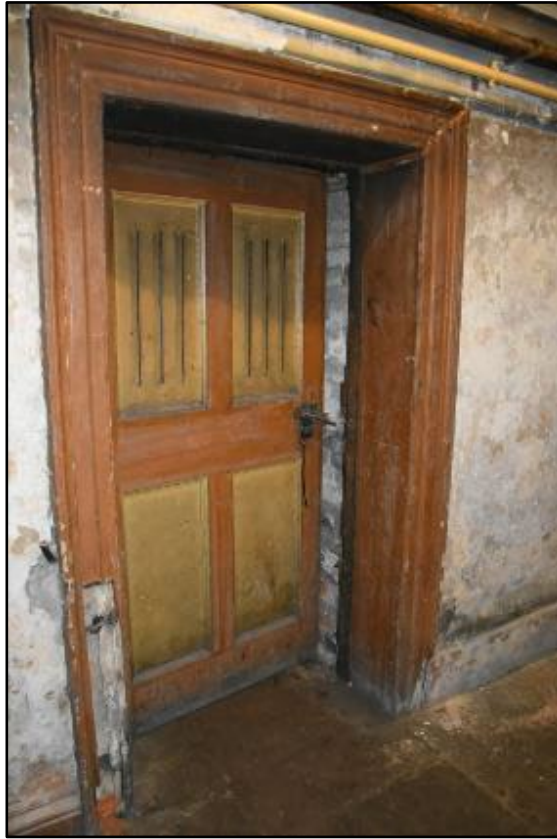
Example of the common door type in the Corridor, taken from the south-west Fig 128

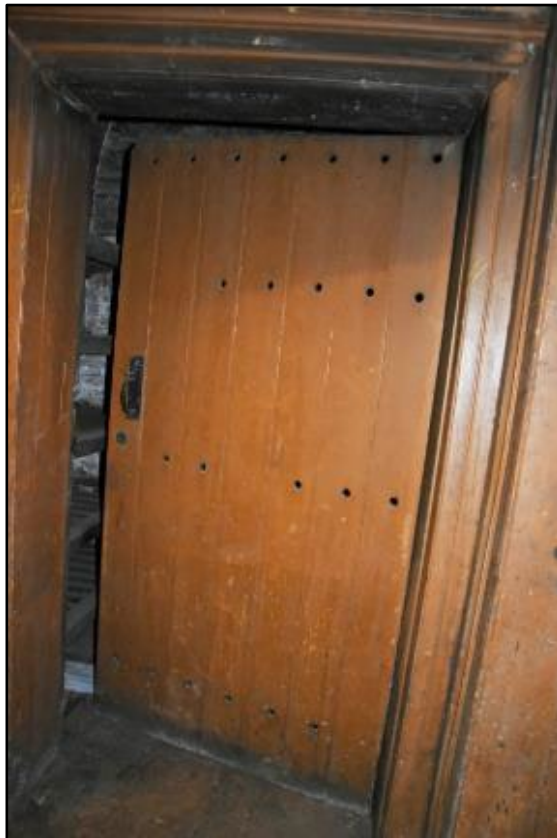
Door to the Wine Cellar from the Corridor, taken from the north Fig 129
