**Historic building recording  
at Draper's Hall  
Coventry  
April 2019 - October 2020**

Report No. 21/081

MOLA (Museum of London Archaeology) was commissioned by the Prince's Foundation, on behalf of the Historic Coventry Trust, to undertake a programme of Level 3 historic building recording at the Grade II\* listed Draper's Hall, Bayley Lane, Coventry, Warwickshire (SP 3363 7895, Fig 1). This was required prior to works being undertaken on the building (Planning Ref. LB/2014/0862) for alterations in line with conversion to a centre for Music and Performance. This project ran concurrently with a programme of excavation between April to Jun 2019, the results of which are to be published in a separate report (Thompson 2021).

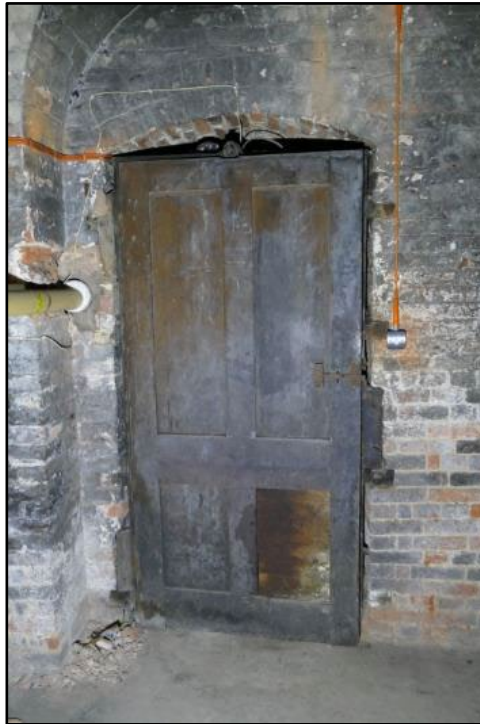
This is located at the end of the Principal basement corridor (41-42) and is accessed by a four-panelled door with simply recessed panels and a latch handle (Fig 130).

Door providing access into the Former Coal Store, taken from the west Fig 130

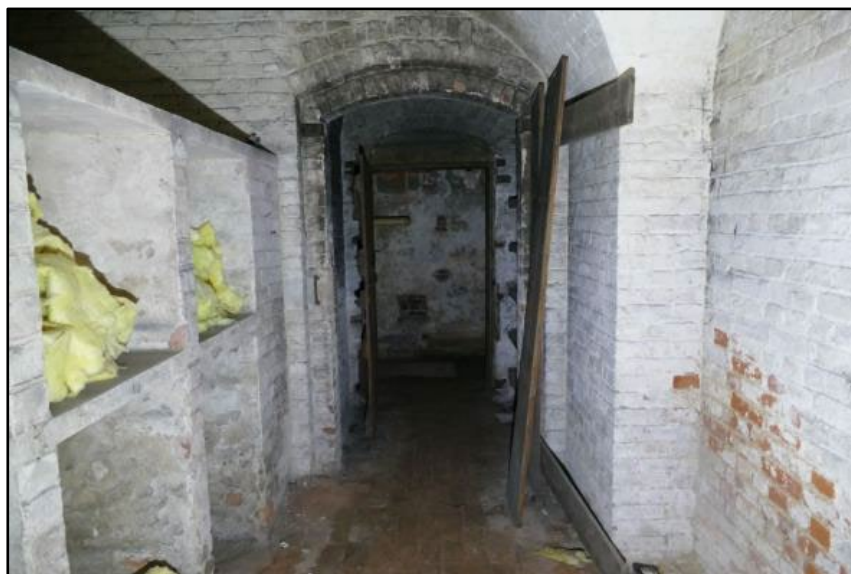
This room is located within the 1830s phase and is given access from the Principal Basement Corridor via a small lobby. The door from the corridor is described above. It sits beneath a cambered arch of brick headers. Internally the lobby has its own barrel vault ceiling but retains nothing of interest. The door from lobby to cellar also sits below a cambered arch of brick headers and comprises a door similar to that from the corridor but on heavy iron pintles (Fig 132). This door has been damaged and no longer functions.

Entrance into the Wine Cellar with redundant door to a small lobby, taken from the south Fig 132

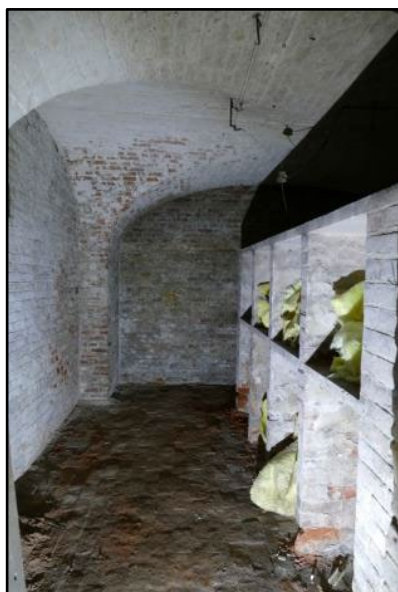
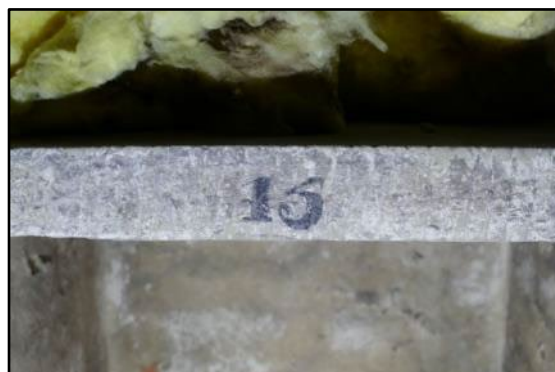
Internally the cellar is similar to its neighbour the Former Coal Store (43) with brick floor, walls and groin-vaulted ceiling. It has been fitted out with brick wine bins, four and a half upper and lower with brick walls and concrete shelves (Fig 133). The shelves were numbered and a few examples of this remains. There was no evidence internally of the potential service hatch seen on the west elevation (Section 6.2.4).

Wine bins in the Wine cellar, taken from the north, and example of numbered shelving Fig 133

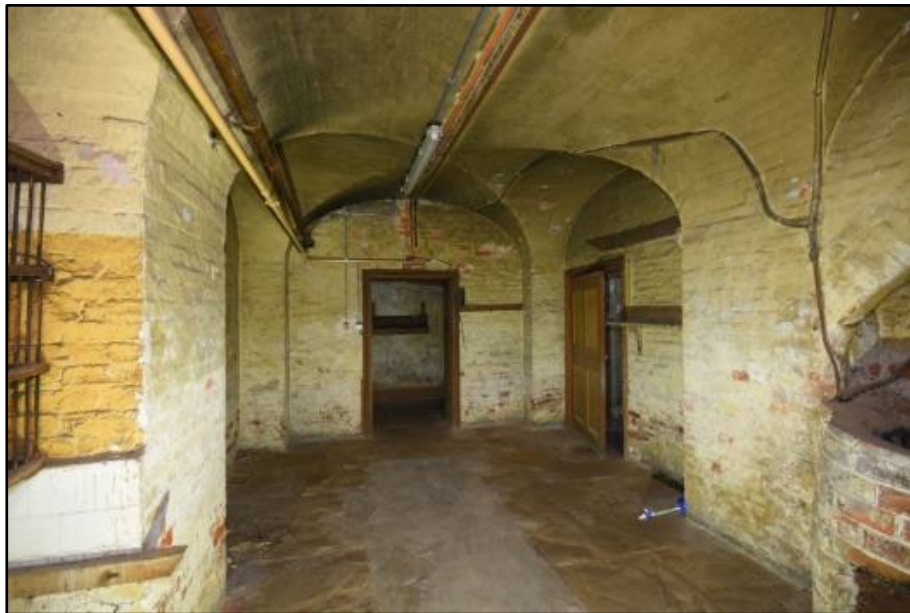
Fig 134

This room is located within the 1830s phase and given access from the Principal Basement Corridor. There is a door surround but no door and no obvious evidence of there having been one. This sits below a cambered brick arch. The room has a stone flag floor and brick walls to a groin-vault, as elsewhere (Fig 134). Its use as a scullery is clear from various features in the niches created by the brick columns from which the vault springs.

Interior of the Scullery, taken from the south

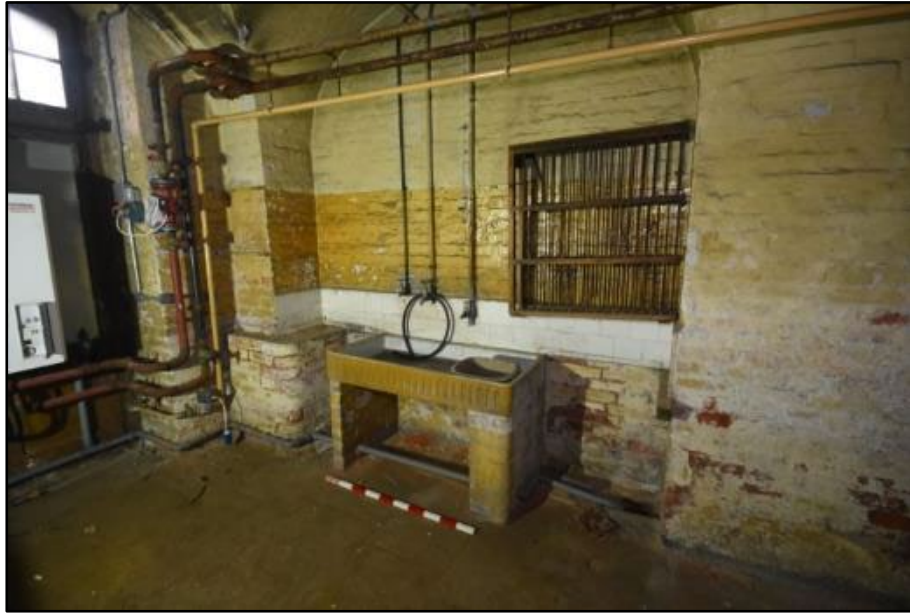
Fig 135

On the north wall a ceramic sink on brick piers is fed by three taps with pipes dropping down from the ceiling (Fig 135). A line of tiles run along the back wall. There is a timber drying rack fixed within the niche.

Sink on the north wall of the Scullery, taken from the north-east

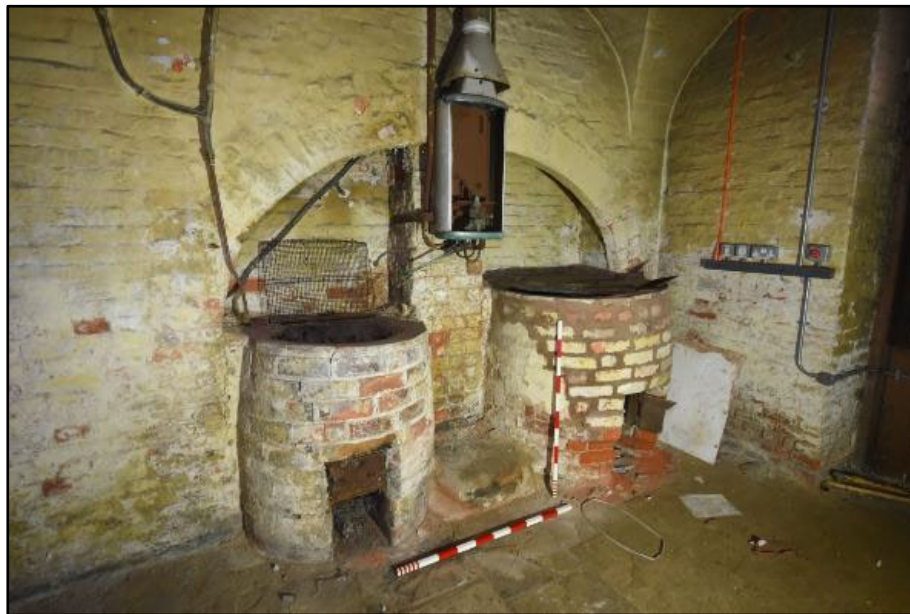
Opposite this on the south wall the niche has been filled to create a lower brick arch over two brick coppers (Fig 136). They both retain little heating stoves beneath and lower doors for the clearing out of ash. One retains its wooden top. Between them lies a worn stone block. Further to the east a four-panelled door gives access into the Kitchen (47). The door has moulded panels within a moulded surround, and sits below a cambered brick arch. Directly adjacent are two timber shelves.

Brick coppers on the south wall of the Scullery, taken from the north-west  
136

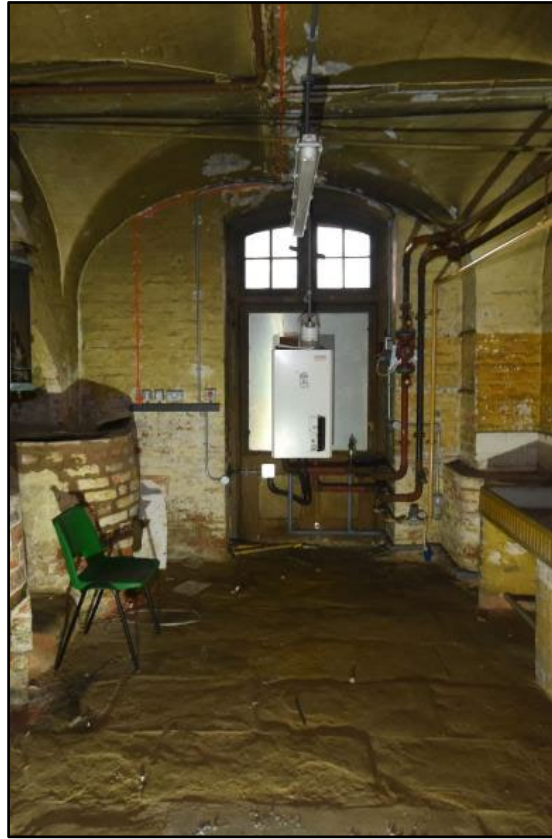
The south wall retains a door to the exterior (Fig 137), now fixed with various service pipes and a boiler attached. As such little is visible beyond two lower simply recessed panels and two upper four-light windows creating an over-light.

Door to the exterior from the Scullery, opening into the push-out on the south rear elevation, taken from the north Fig 137

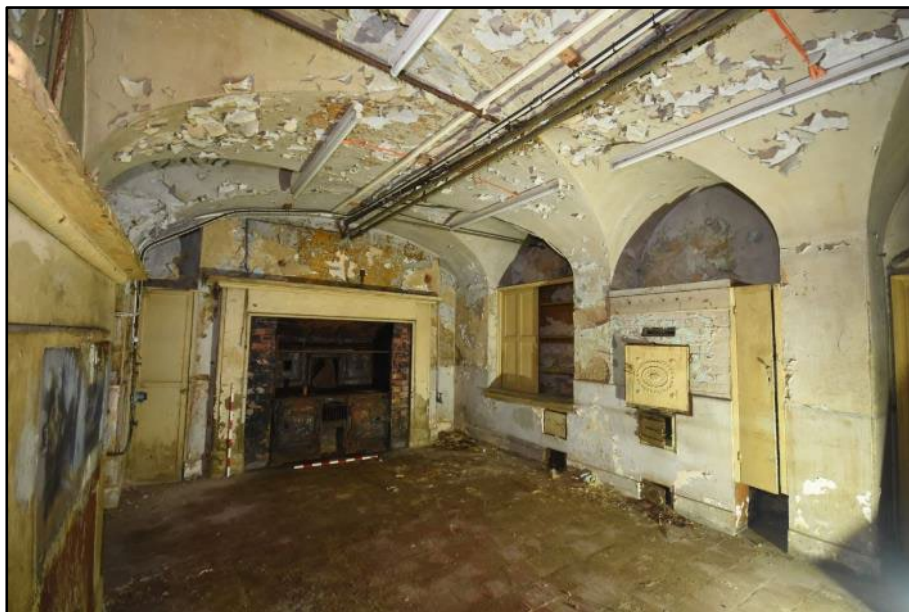
This room is located within the 1830s phase and given access from the Principal Basement Corridor. The room has a tiled floor, a plain skirting, plastered walls and a groin-vaulted ceiling as in the other basement rooms, but plastered and painted (Fig 138). As the kitchen this room has the highest level of status of all the lower ground floor rooms. The whole room up to c1m in height has been rendered for hygiene, although it is not clear when this was done.

Interior of the Kitchen, taken from the north-east Fig 138

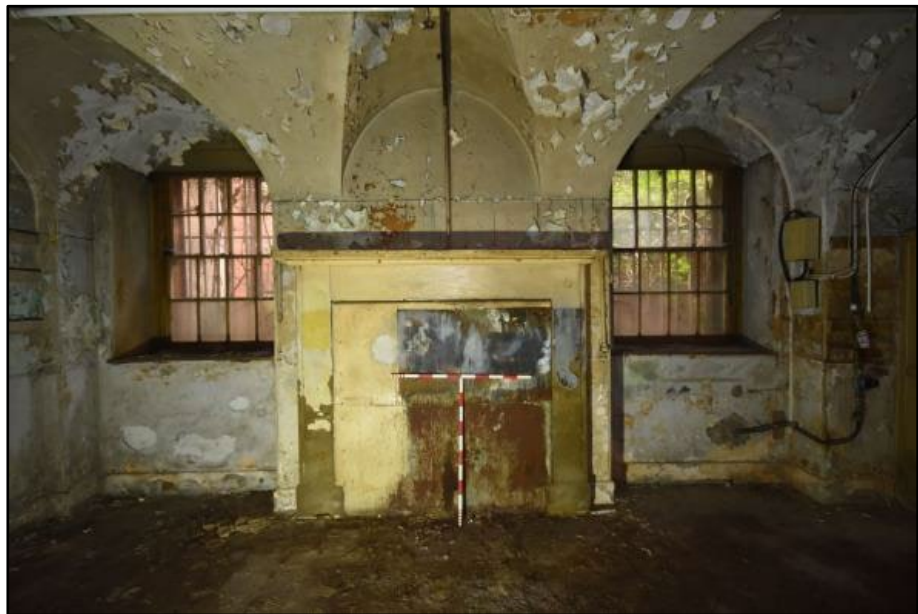
The east wall is dominated by a secondary fireplace, smaller than the one to the south but still tall (Fig 140). It also has a plain timber surround with shelf and has been blocked. This is flanked by two windows set within deep reveals. They are both eight-over-eight sashes with no horns and iron bars to the exterior.

East wall of the Kitchen, taken from the west Fig 140

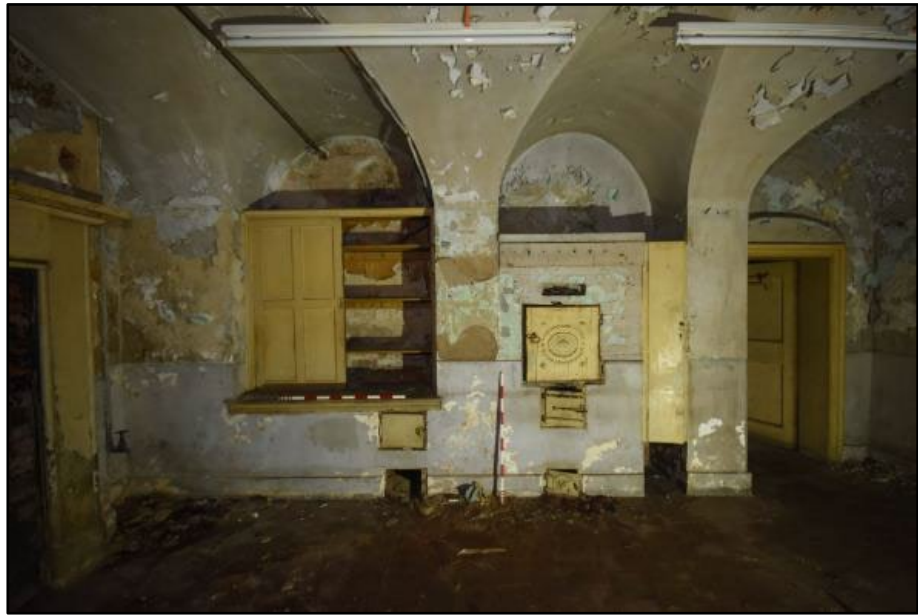
The western wall has three niches (Fig 141), the northern example is more deeply recessed and provides access into the scullery as seen above. From this side the door is of two-panels, rather than the four seen from the scullery and retains a towel rail. The other niches contain features related to kitchen activities. The central example retains a very slender cupboard, and a brick structure with iron door. Below this two more smaller doors also survive, most likely relating to this brick structure which may be an early oven (Fig 142). The southern niche retains a cupboard with surround and shelf. Internally several shelves are enclosed by two four-panelled doors, one has been lost. Below this are two small metal doors as seen elsewhere for a stove, and clearing out of ash. Their relation to the cupboard above is unknown.

West wall of the Kitchen, taken from the east      Fig 141

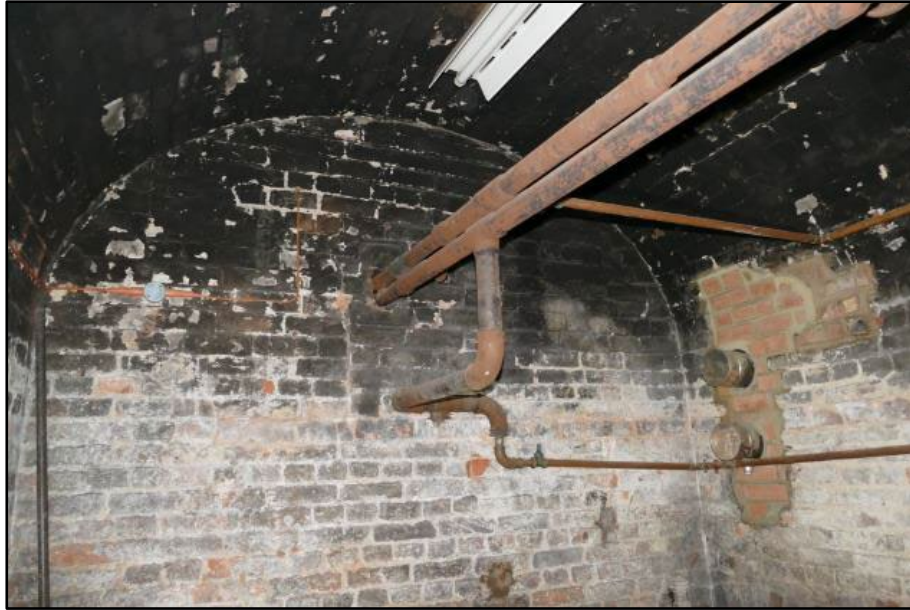
This room is located within the 1830s phase and is accessed from the Principal Basement Corridor via a double door. Each leaf is of three panels of which the central one comprises slats. The panels are moulded to the corridor and plain to the rear. The room is much the same as elsewhere with a brick floor, walls and barrel-vault ceiling (Fig 143). A boiler survives, with various pipework also present (Fig 144). The boiler sits on a concrete slab and is marked as modern in the CMP (ACA 2005) but likely had a modern casing at the time of that survey. The existing equipment is cast-iron and likely 19th century in date. There is some repair to the north-east with new insertions. There appears to be a small blocked arched aperture to the east wall near the door.

Interior of the Boiler room, taken from the south Fig 143

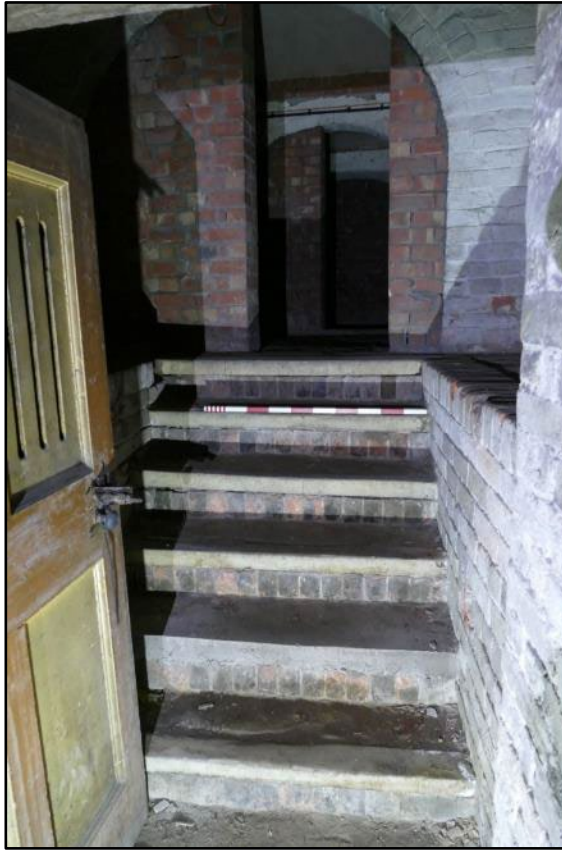
Beyond this a set of short steps (Fig 145) comprising brick risers with timber treads give access into the subsequent sequence of storage spaces (69-73). There is a brick floor throughout, roughly laid, and painted brick walls with few distinguishing features. The ceiling is plastered and otherwise plain. The space is divided by a series of brick walls containing large arched brick apertures (Fig 146). These have then been partly infilled with modern Flettons, distinguishable by their kiss marks, with cement mortar and part of the conversion to air raid shelter in the 1940s (ACA 2005). These leave only simple openings to allow pedestrian access.

Steps up to Stores 69-75, taken from the south Fig 145

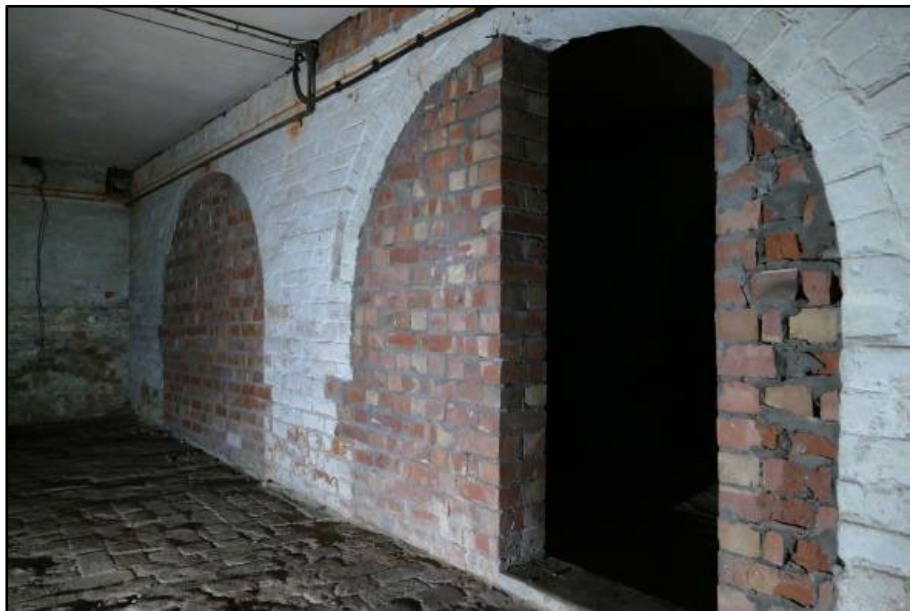
Brick arched partitions in the Stores, later infilled, taken from the south-east Fig 146

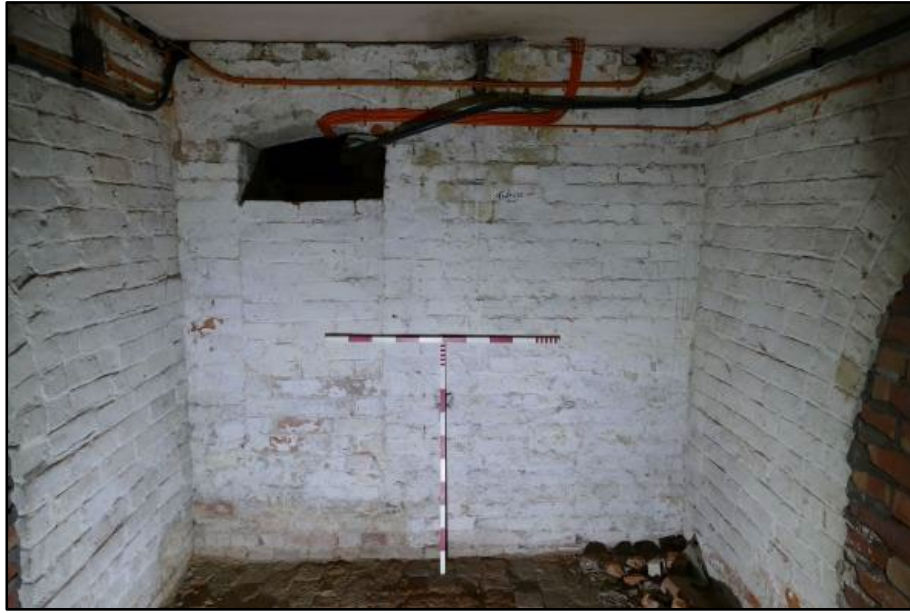
Fig 147

Store 70 has a narrow, blocked arch with cambered head to the east (Fig 147). It is painted which suggests it is not contemporary with the blocking of the arched openings elsewhere.

Blocked aperture in Store 70, taken from the west

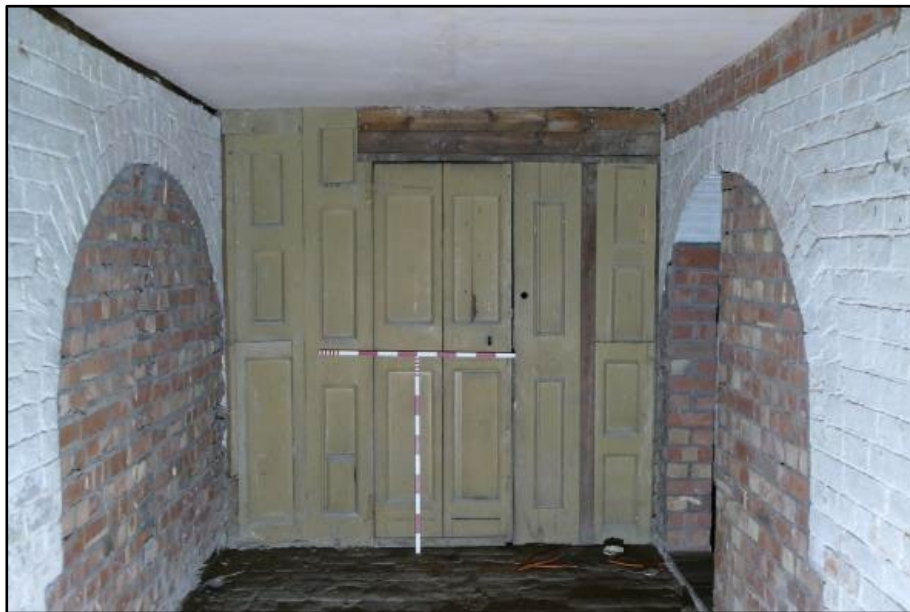
Fig 148

Cupboards in Store 71, taken from the west

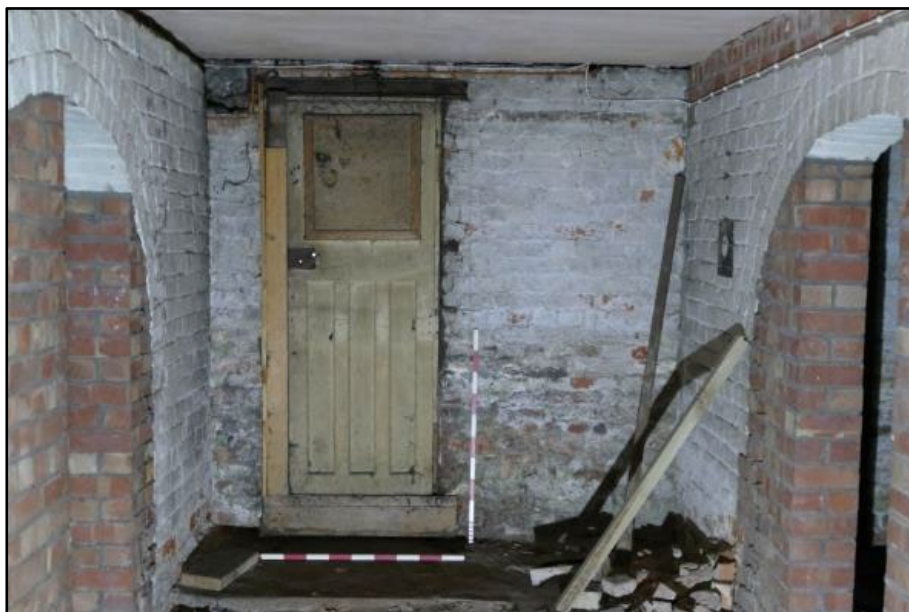
Door to exterior in Store 72, taken from the east Fig 149

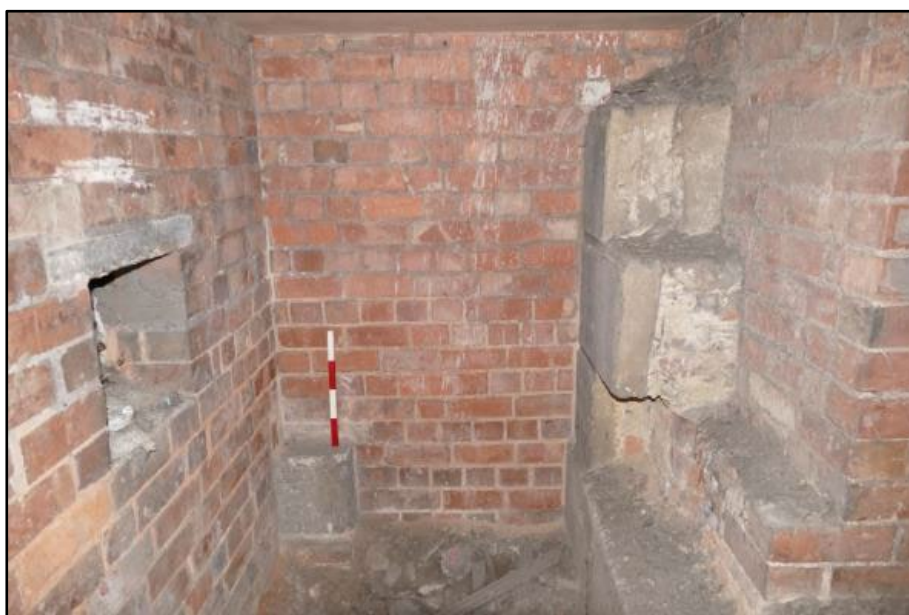
East wall of the void beneath the Portico, taken from the west Fig 150

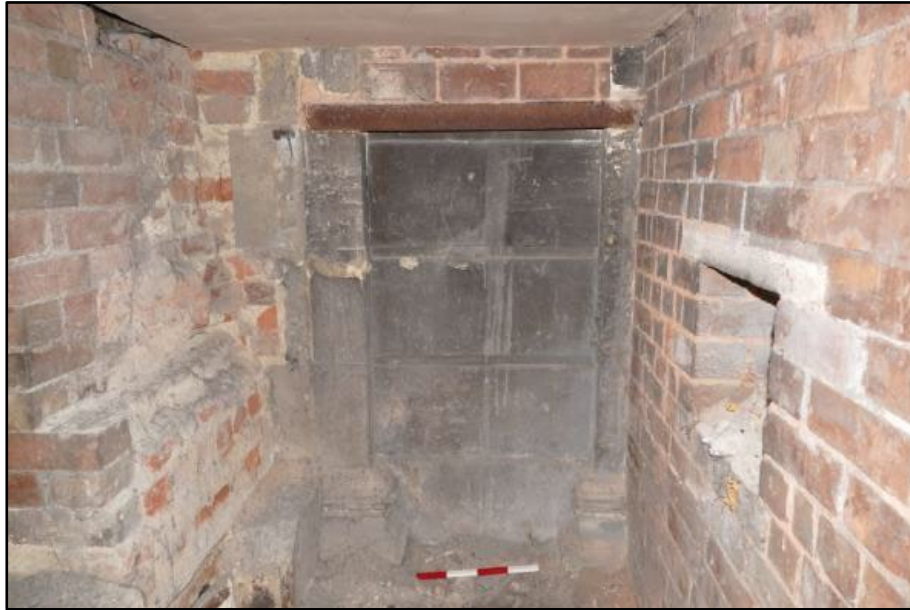
West wall of the void beneath the Portico, taken from the east Fig 151

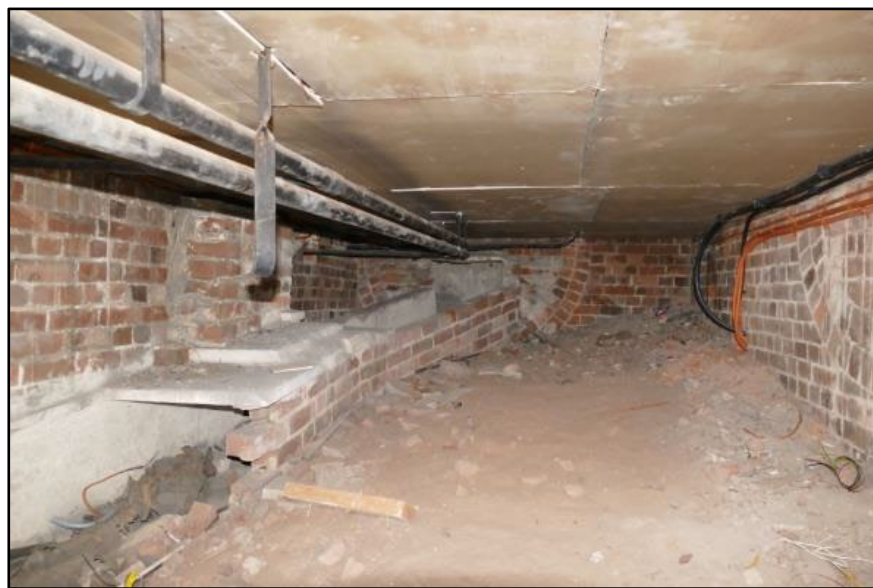
The Duct Room was accessed via an aperture in Store 70 before this was blocked (see above). It is also accessible through a door on the north wall of the Basement Corridor set at a high level making it difficult to access. The space has a rubble floor, brick walls and a plasterboard ceiling and slopes from north to south (Fig 152). The brickwork is laid in English bond with three inverted arches to the north, east and west. The brickwork changes in fabric to the south and the change is marked by a buttress on the east. The ceiling boards have been removed to the south and reveal softwood joists and boards to the room above (Fig 153).

Of note in this room is the presence of a duct, curving from the north and a small aperture in the wall. It is of brick, the same fabric as the walls, with the inner sides rendered and a stone or concrete top. The CMP notes its most likely use to have been to carry fluid, or hot air, or for ventilation (ACA 2005, 117).

Interior of the Duct Room, taken from the south Fig 152

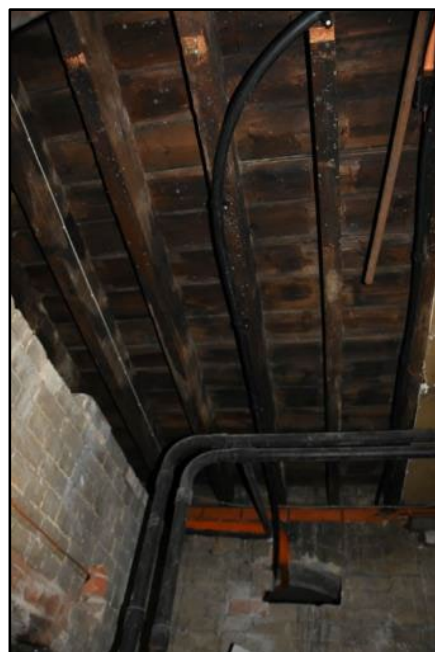
Exposed ceiling in the Duct Room, taken from the east Fig 153

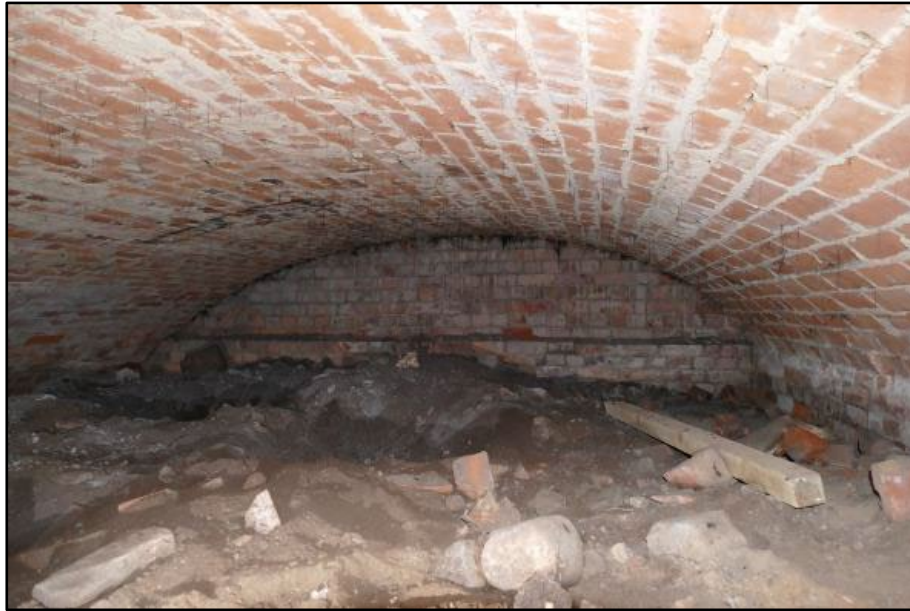
This space is accessed from Store 74 through a small aperture. It is filled with building rubble and has brick walls with a low barrel-vaulted ceiling (Fig 154). The top point of the vault barely reaches over c1m as these rooms accommodate the change in ground level seen externally.

Interior of the Vault, taken from the west      Fig 154

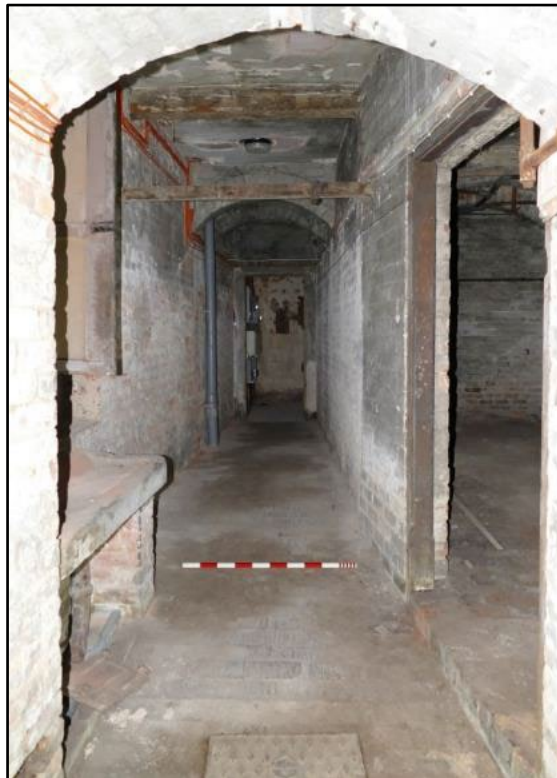
The brick floor slopes up to the north to accommodate the changing ground level. The room (Fig 155) has bare brick walls and a plastered ceiling with two brick arches towards the south, and two to the north end, and at least one timber joist running east-west. The door from the Principal Basement Corridor is four-panelled.

Basement Corridor, taken from the south Fig 155

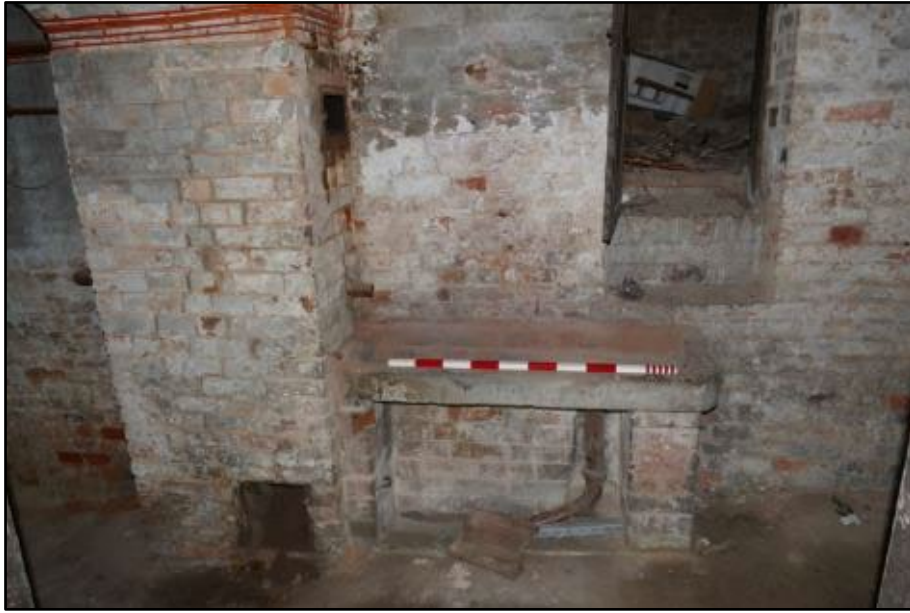
At the south end of the north wall a column supports one of the brick arches overhead. Directly adjacent to one is a rectangular shallow stone basin supported on brick rounded piers (Fig 156). Below a single pipe would have provided drainage. The adjoining brick column retains two small apertures with cast-iron fittings and a cast-iron pipe for the provision of water. Both have lost their doors, the lower example, almost floor-level, survives *ex situ* and reads *Open this door and clean out soot once a year*. Directly adjacent lies an aperture high on the wall with two-panelled door, giving access to the Duct Room (67). At the south end of the south wall a four-panelled door provides access to a Store Room (64) and a second aperture steps up to further stores within this phase, and then subsequently into the area below the later phase. This aperture has a simple door frame but no door.

Stone basin to the south of the Basement Corridor, taken from the east Fig 156

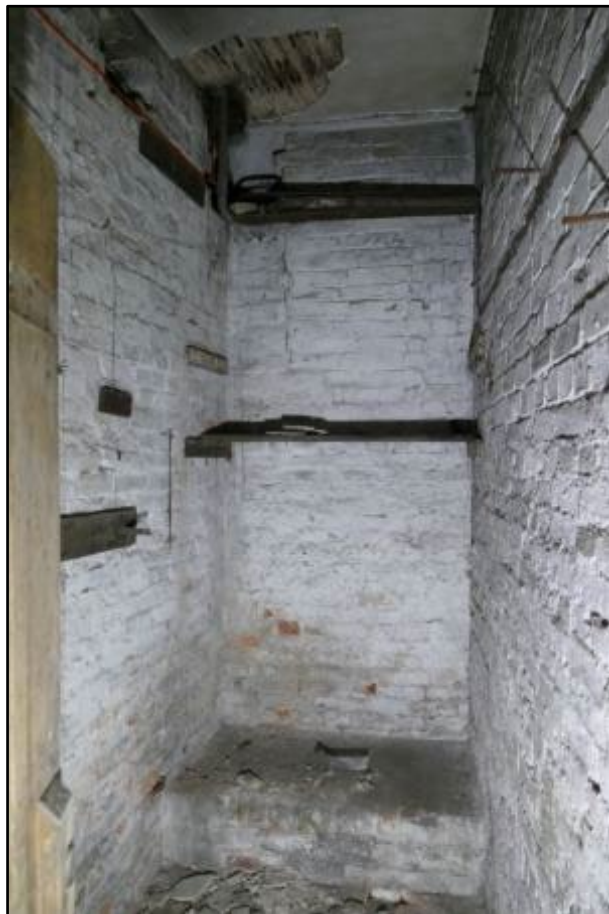
The Store (64) forms a single space with painted brick walls, brick floor and a large, raised brick step to the east (Fig 157). The ceiling is plastered but where this has come away lath and plaster is revealed. Various timber shelves and hooks are present.

Interior of the Store, directly off the Basement Corridor, looking east Fig 157

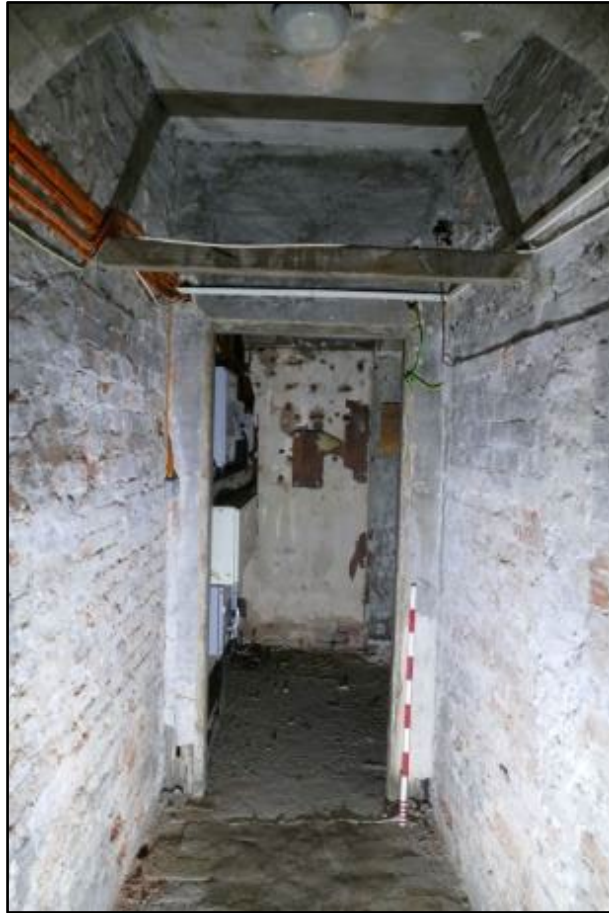
Fig 158

At the north end a partition with timber door frame creates a lobby (Fig 158). The partition is plastered and where this has failed lath and plaster is revealed. Within the lobby there is a concrete floor and plastered walls with various service fittings to the west.

North end of the Basement Corridor, taken from the south

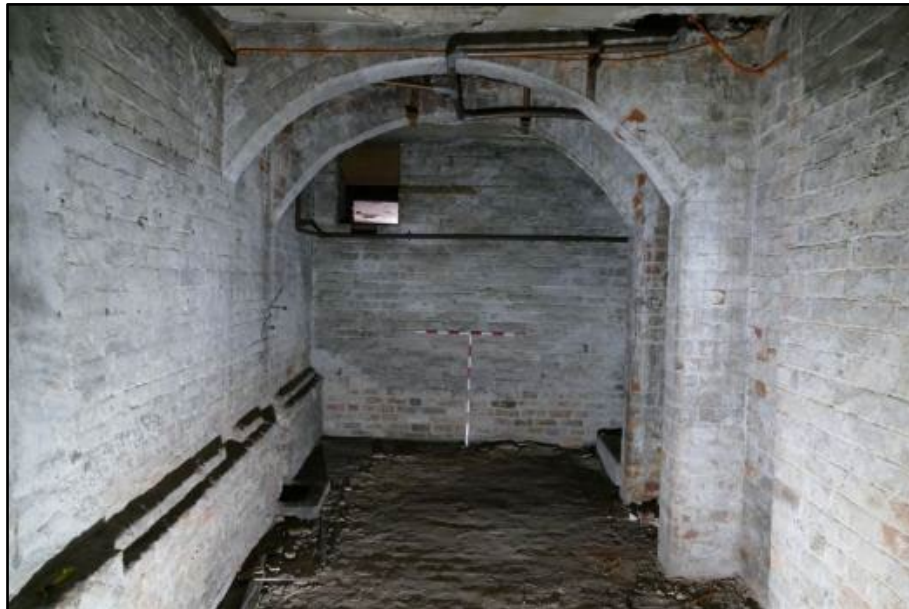
The doorway into Store 63 does not retain a door but there is evidence for one previously. The space comprises a storeroom with brick floor and walls. Various niches and recesses mark the walls and overhead to the north are two large arches supporting the ceiling (Fig 159). One niche to the south wall retains evidence of an inverted arch in the brickwork. To the west a projecting plinth runs partly the length of the wall. To the east at the north end a step provides access through an arch to further rooms within the 1890s phase, but with the construction phase this room belongs to, this would originally have been closed. There is an area of exposed lath and plaster to the north.

Interior of Store 63, taken from the south Fig 159

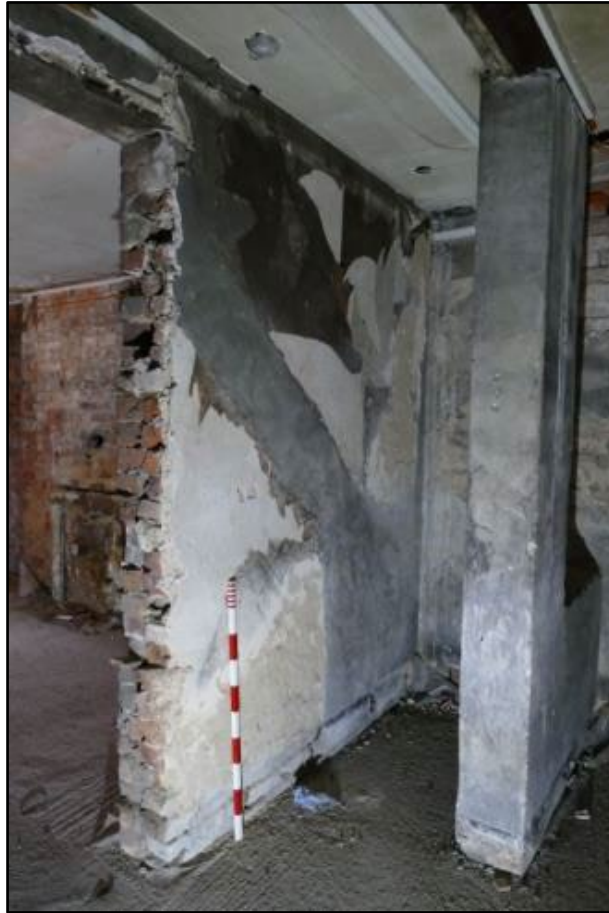
Store 60 is a smaller space accessed from the lobby at the end of the basement corridor and subsequently gives access into the original Coachmens Waiting Room (58). There is a concrete floor, with plastered walls and a plaster ceiling. Where the plaster is failing the brickwork of the walls is exposed (Fig 160).

Interior of Store 60, taken from the south-west Fig 160

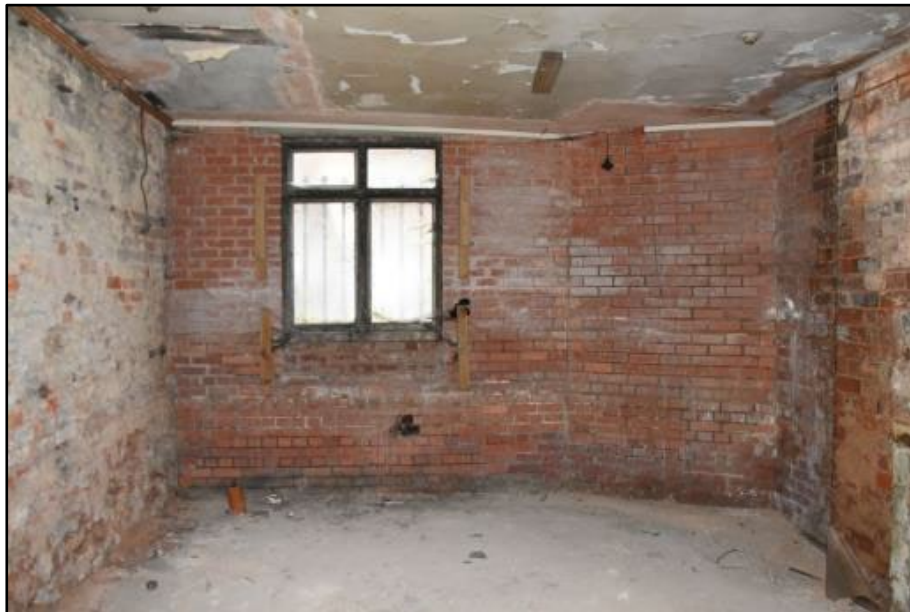
Fig 161

The floor is concrete screed, and the walls represent a mixture of construction phases. To the north fine red brick has been laid in stretcher bond and suggests this elevation has been rebuilt (Fig 161). A single four-light fixed window comprises a timber frame with modern glass. To the east this partially continues but the majority of the elevation comprises older brickwork with a central projecting chimney stack (Fig 162). The stack retains a cambered arch to a fireplace which has lost its surround and represents several phases of infill. To the south this brickwork continues with a tall, inserted aperture reaching almost to the ceiling (Fig 163). The original lies to the west below a cambered arch and infilled with brick.

North wall of the Coachmen's Waiting Room, taken from the south

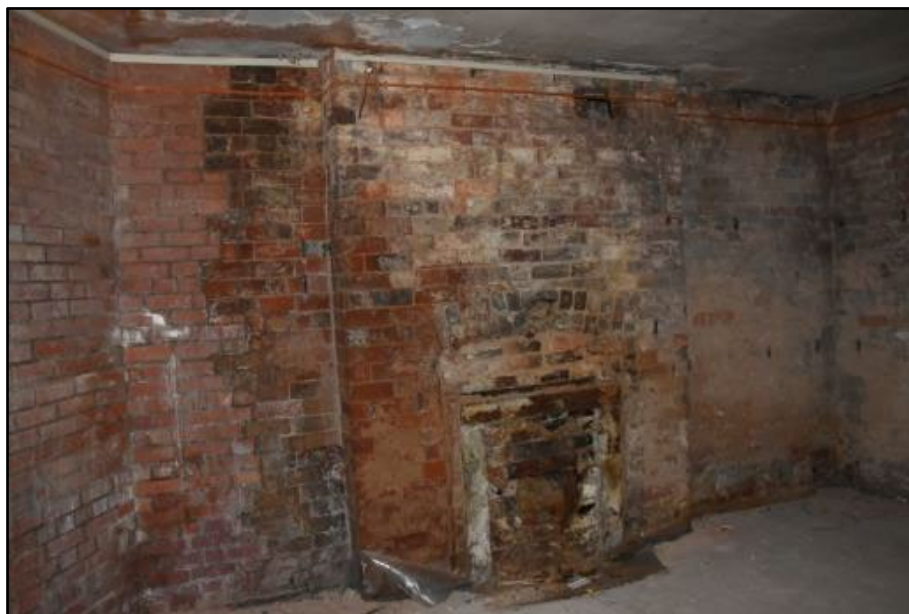
East wall of the Coachmen's Waiting Room, taken from the north-west Fig 162

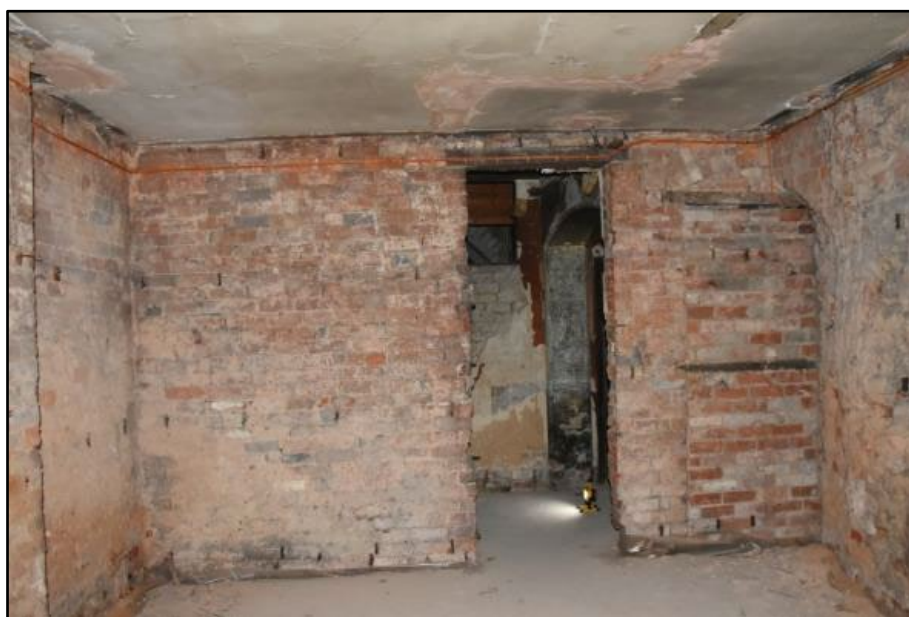
South wall of the Coachmen's Waiting Room, taken from the north Fig 163

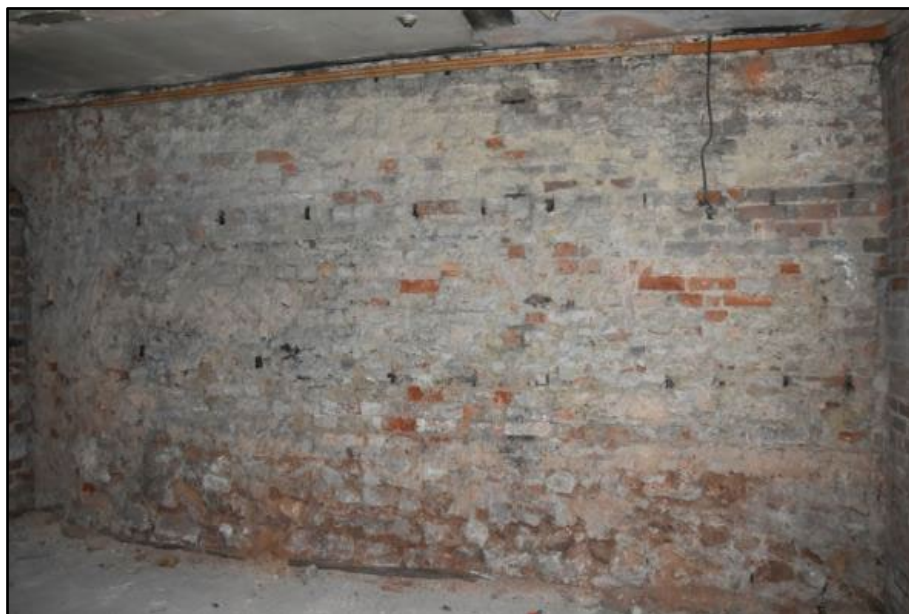
The west wall retains much interest (Fig 164). Its construction is part stone or rubble with brick in places. The plaster here is rough and little can be determined other than this predates the 1832 construction. It therefore possibly represents the only standing remains of the previous Hall.

West wall of the Coachmen's Waiting Room, taken from the north-east Fig 164

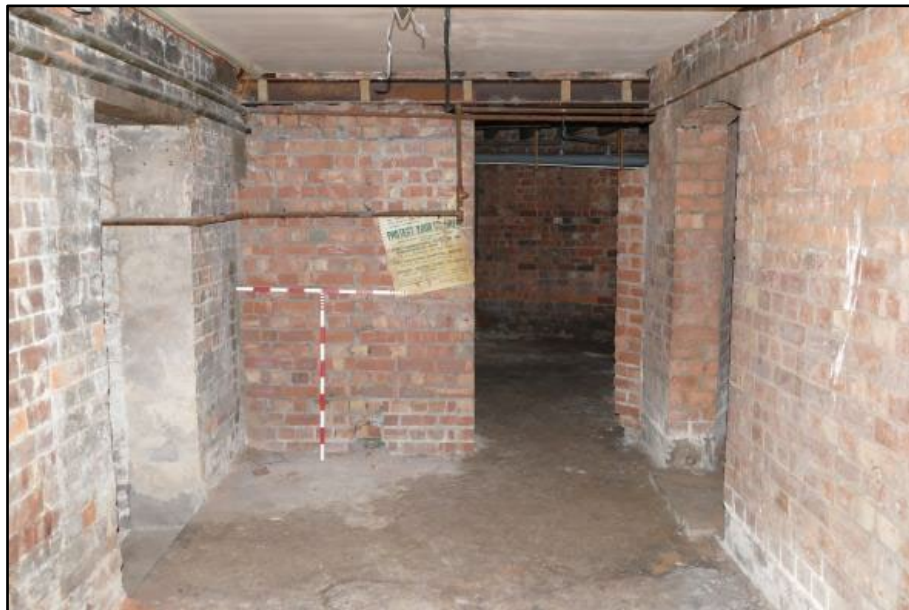
Fig 166

To the north the dividing wall between Store 57 and the 1890s Coachmen's Waiting Room (58) is constructed of Flettons and stands structurally distinct (Fig 166). An un-affixed poster (Fig 167) dates from 1934 when the City Isolation Hospital was located at Stoney Stanton Road before moving to Whitley where the name was changed to the Whitley Infectious Diseases Hospital.

North end of the Store, taken from the south

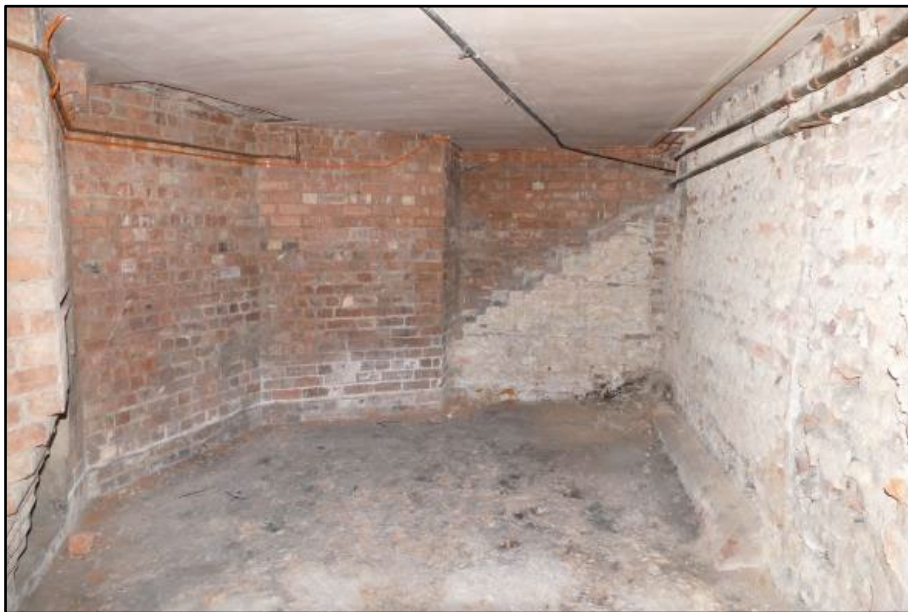
To the south a canted section of wall, its return and the south wall are constructed in red brick in an indeterminate bond, resembling in places English bond but otherwise inconsistent (Fig 168). To the south-west a stepped section of brickwork and heavy mortar sits in front of the red brick wall. This is perhaps a remnant from the original construction, superseded during the construction of later ranges.

South end of the Store, taken from the north Fig 168

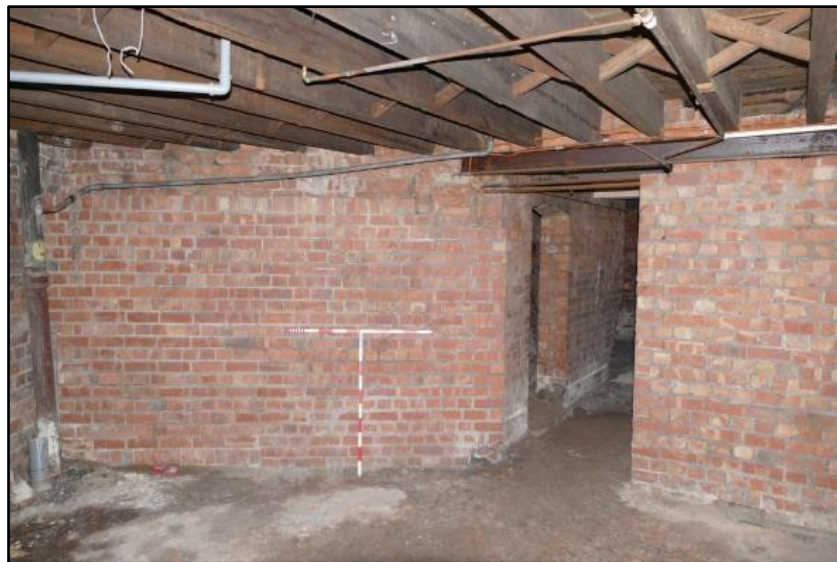
The south wall (Fig 169) comprises Flettons in English bond, the south-east canted section displays the occasional Fletton (Fig 170) but is otherwise of red brick and structural continuous with the other walls to Store 56.

South wall of the Coachmen's Waiting Room, taken from the north Fig 169

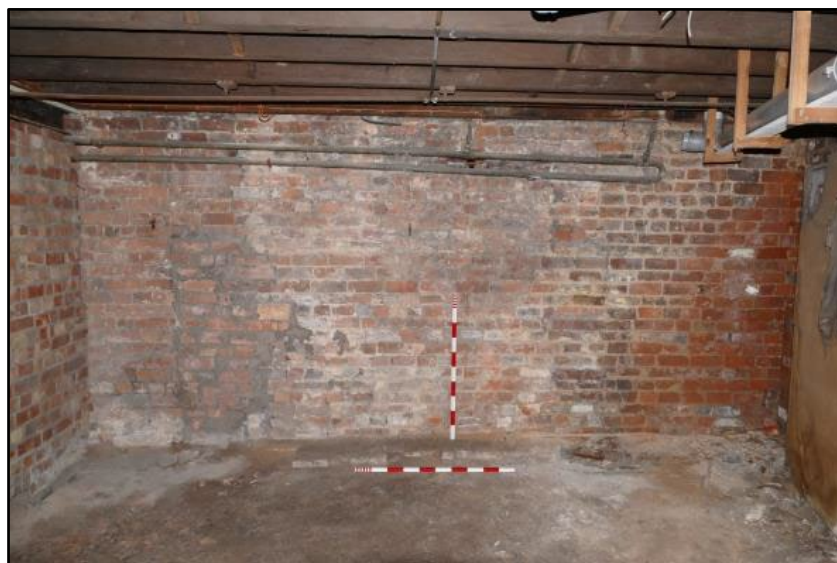
South-east wall of the Coachmen's Waiting Room, taken from the west Fig 170
