**Historic building recording  
at Draper's Hall  
Coventry  
April 2019 - October 2020**

Report No. 21/081

MOLA (Museum of London Archaeology) was commissioned by the Prince's Foundation, on behalf of the Historic Coventry Trust, to undertake a programme of Level 3 historic building recording at the Grade II\* listed Draper's Hall, Bayley Lane, Coventry, Warwickshire (SP 3363 7895, Fig 1). This was required prior to works being undertaken on the building (Planning Ref. LB/2014/0862) for alterations in line with conversion to a centre for Music and Performance. This project ran concurrently with a programme of excavation between April to Jun 2019, the results of which are to be published in a separate report (Thompson 2021).

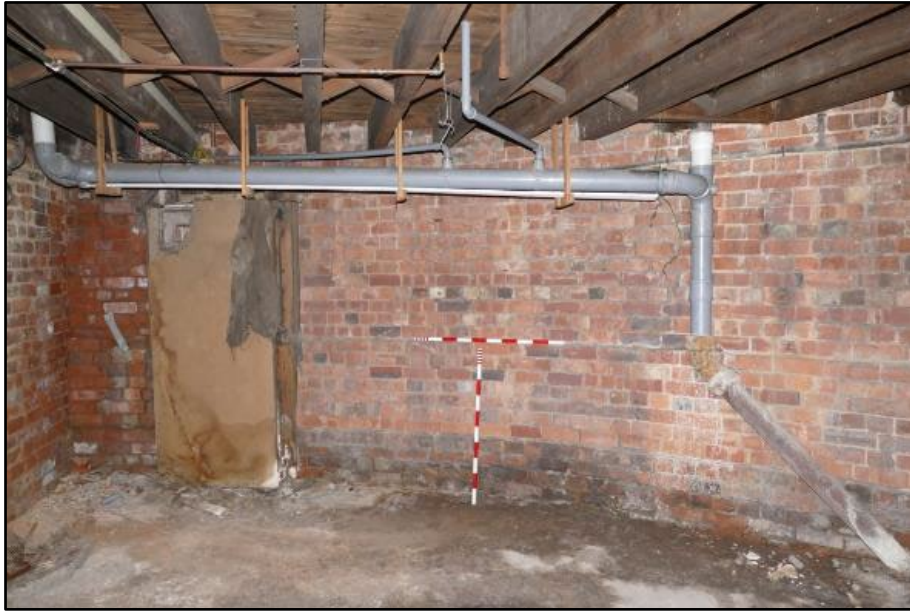
Fig

To the west older brickwork is present but several areas have been re-pointed making the construction sequence unclear. The north-east curved wall (Fig 171) is lain in English bond with the door to the exterior to the west. This has been built into the room within its own projecting timber frame.

North curved wall of the Coachmen's Waiting Room, taken from the south  
171

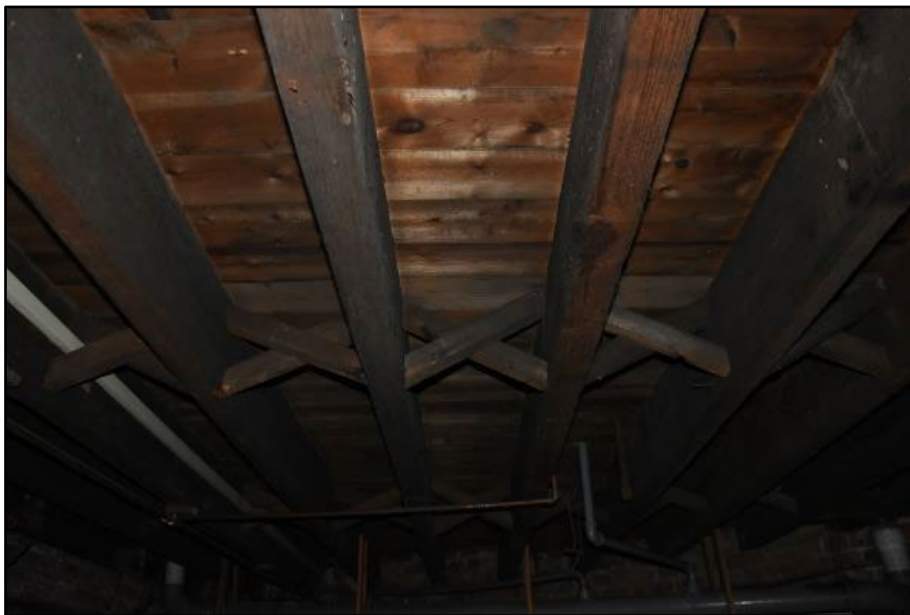
The ceiling comprises softwood timbers on end supporting boards above (Fig 172). Between the timber which run north to south, small overlapping timbers imitate scissor bracing.

Ceiling in the Coachmen's Waiting Room, taken from the south Fig 172

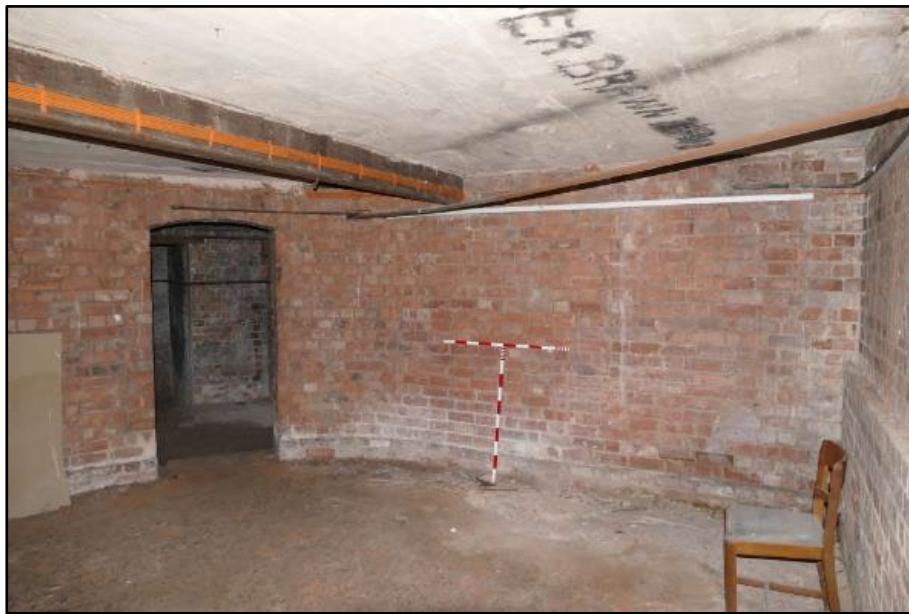
Fig 173

Accessed through the low aperture or full height arched doorway from Store 57 this room has a concrete floor, bare brick walls and a plastered ceiling (Fig 173). The brickwork is of Flettons in English bond. A central brick pier supports a long steel support running north-east to south-west.

Interior of the Store, taken from the south-east

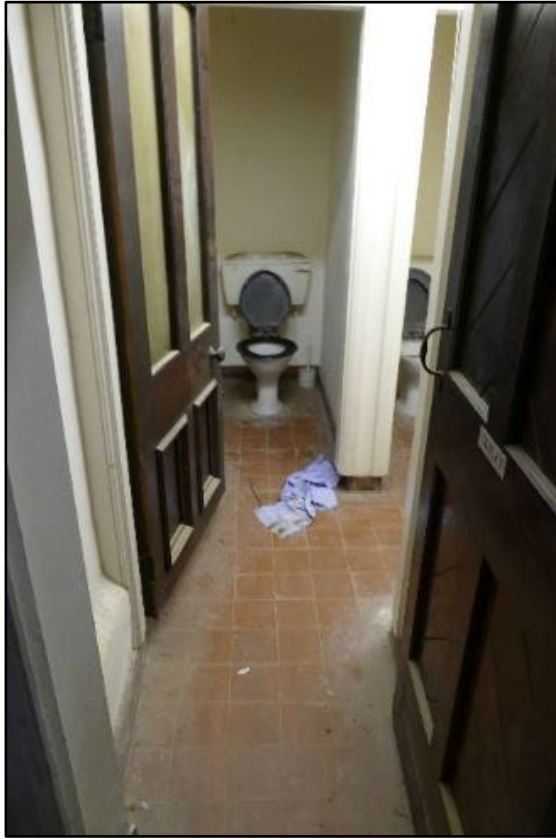
The pre-1930s WC block, seen on the exterior as a lean-to range, lies to the south. This is accessed via a four-panelled door, each panel being moulded with diagonal boarding. A second inner door is also of four-panels, the upper two were formerly glazed but are now boarded, and the lower two imitate bolection moulded panelling. Beyond this there is a modern tiled floor, plain walls and the space is occupied by two WCs enclosed by their own doors (Fig 177).

Interior of the WC block within the Summoner's House, looking south Fig 177

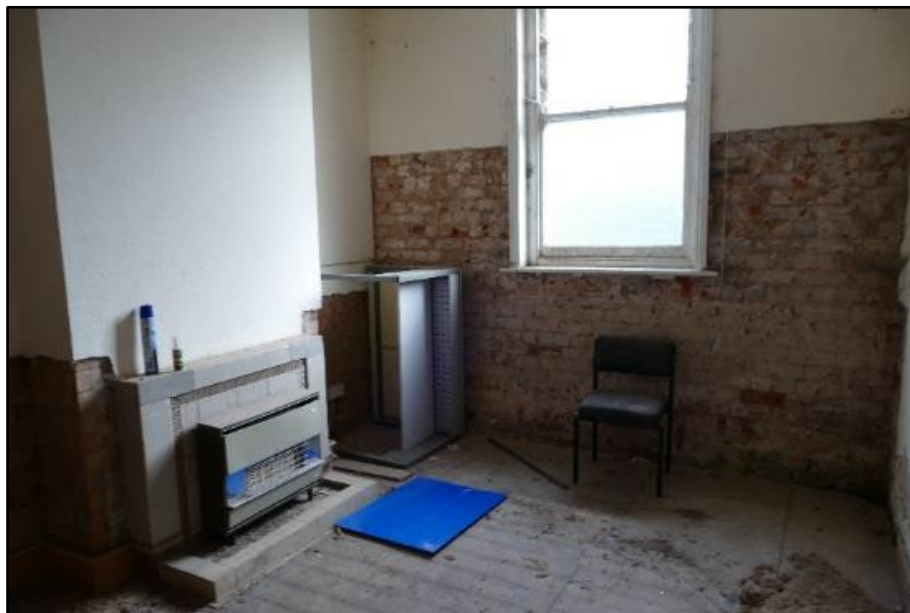
To the south-east a modern door within a moulded surround provides access to a Reception Room (52). The room has floorboards running north-south and the walls have been partially stripped to reveal bare brick but otherwise retain plaster. There is a chimney stack with electric fire to the north (Fig 178). The surround is also modern of glazed tiles. A single window to the east comprises a one-over-one sash with horns.

Reception room within the Summoner's House, looking east Fig 178

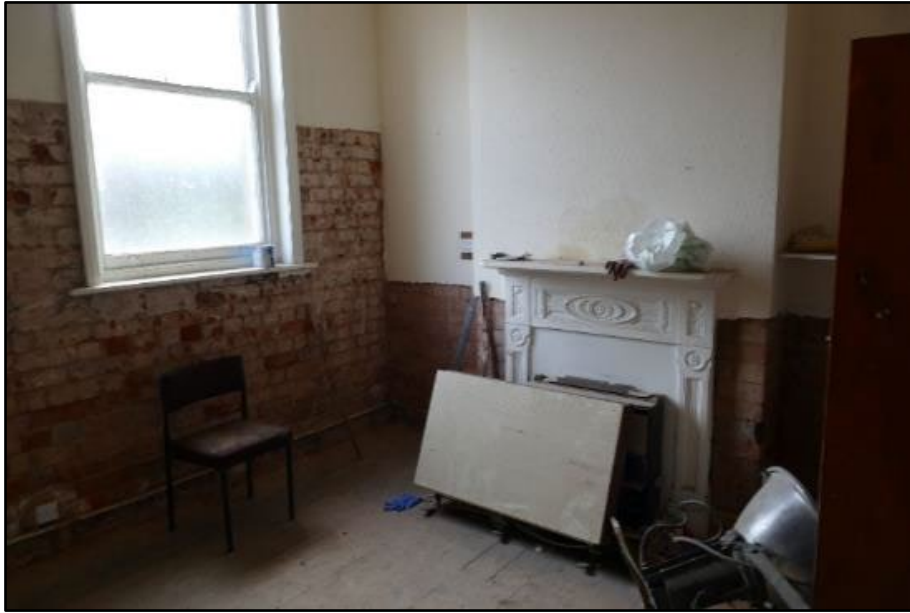
A second Reception Room then lies to the north (53) with similar features to its counterpart including being accessed via a modern door within moulded surround. Its floorboards are of the same orientation and width, a similar window lies to the east and a chimney stack lies to the south (Fig 179). The chimney stack here retains its surround however with sunflower and thistle decoration within an ordered arrangement typical of the late 19th-century. It has now been blocked. To the north a four-panelled split-leaf door of simply recessed panels and shelf gives access to a Lobby (54) and Kitchen (55).

Reception room within the Summoner's House, looking east Fig 179

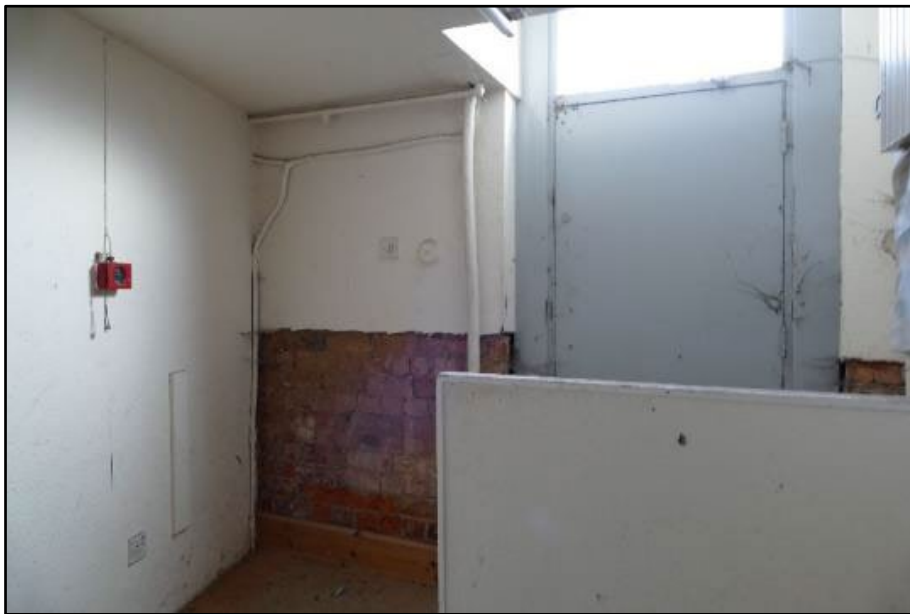
In the lobby there is a skirting to plastered walls and a plain ceiling (Fig 180). To the west, as well as the split-leaf door seen in the reception room, a second door giving access to the Kitchen (55) is present. This is of four-panels, the longer upper two panels are of frosted glass, and the lower two are simply recessed. Both sit within moulded surrounds, that to the Kitchen has a small simple entablature (Fig 181). To the east the floor steps up to reach exterior ground level and the brick walls are exposed. There has been some reconstruction here, the ceiling has been cut through to allow for the change in height. The door to the exterior, as seen externally, is modern.

Lobby within the Summoner's House, looking east Fig 180

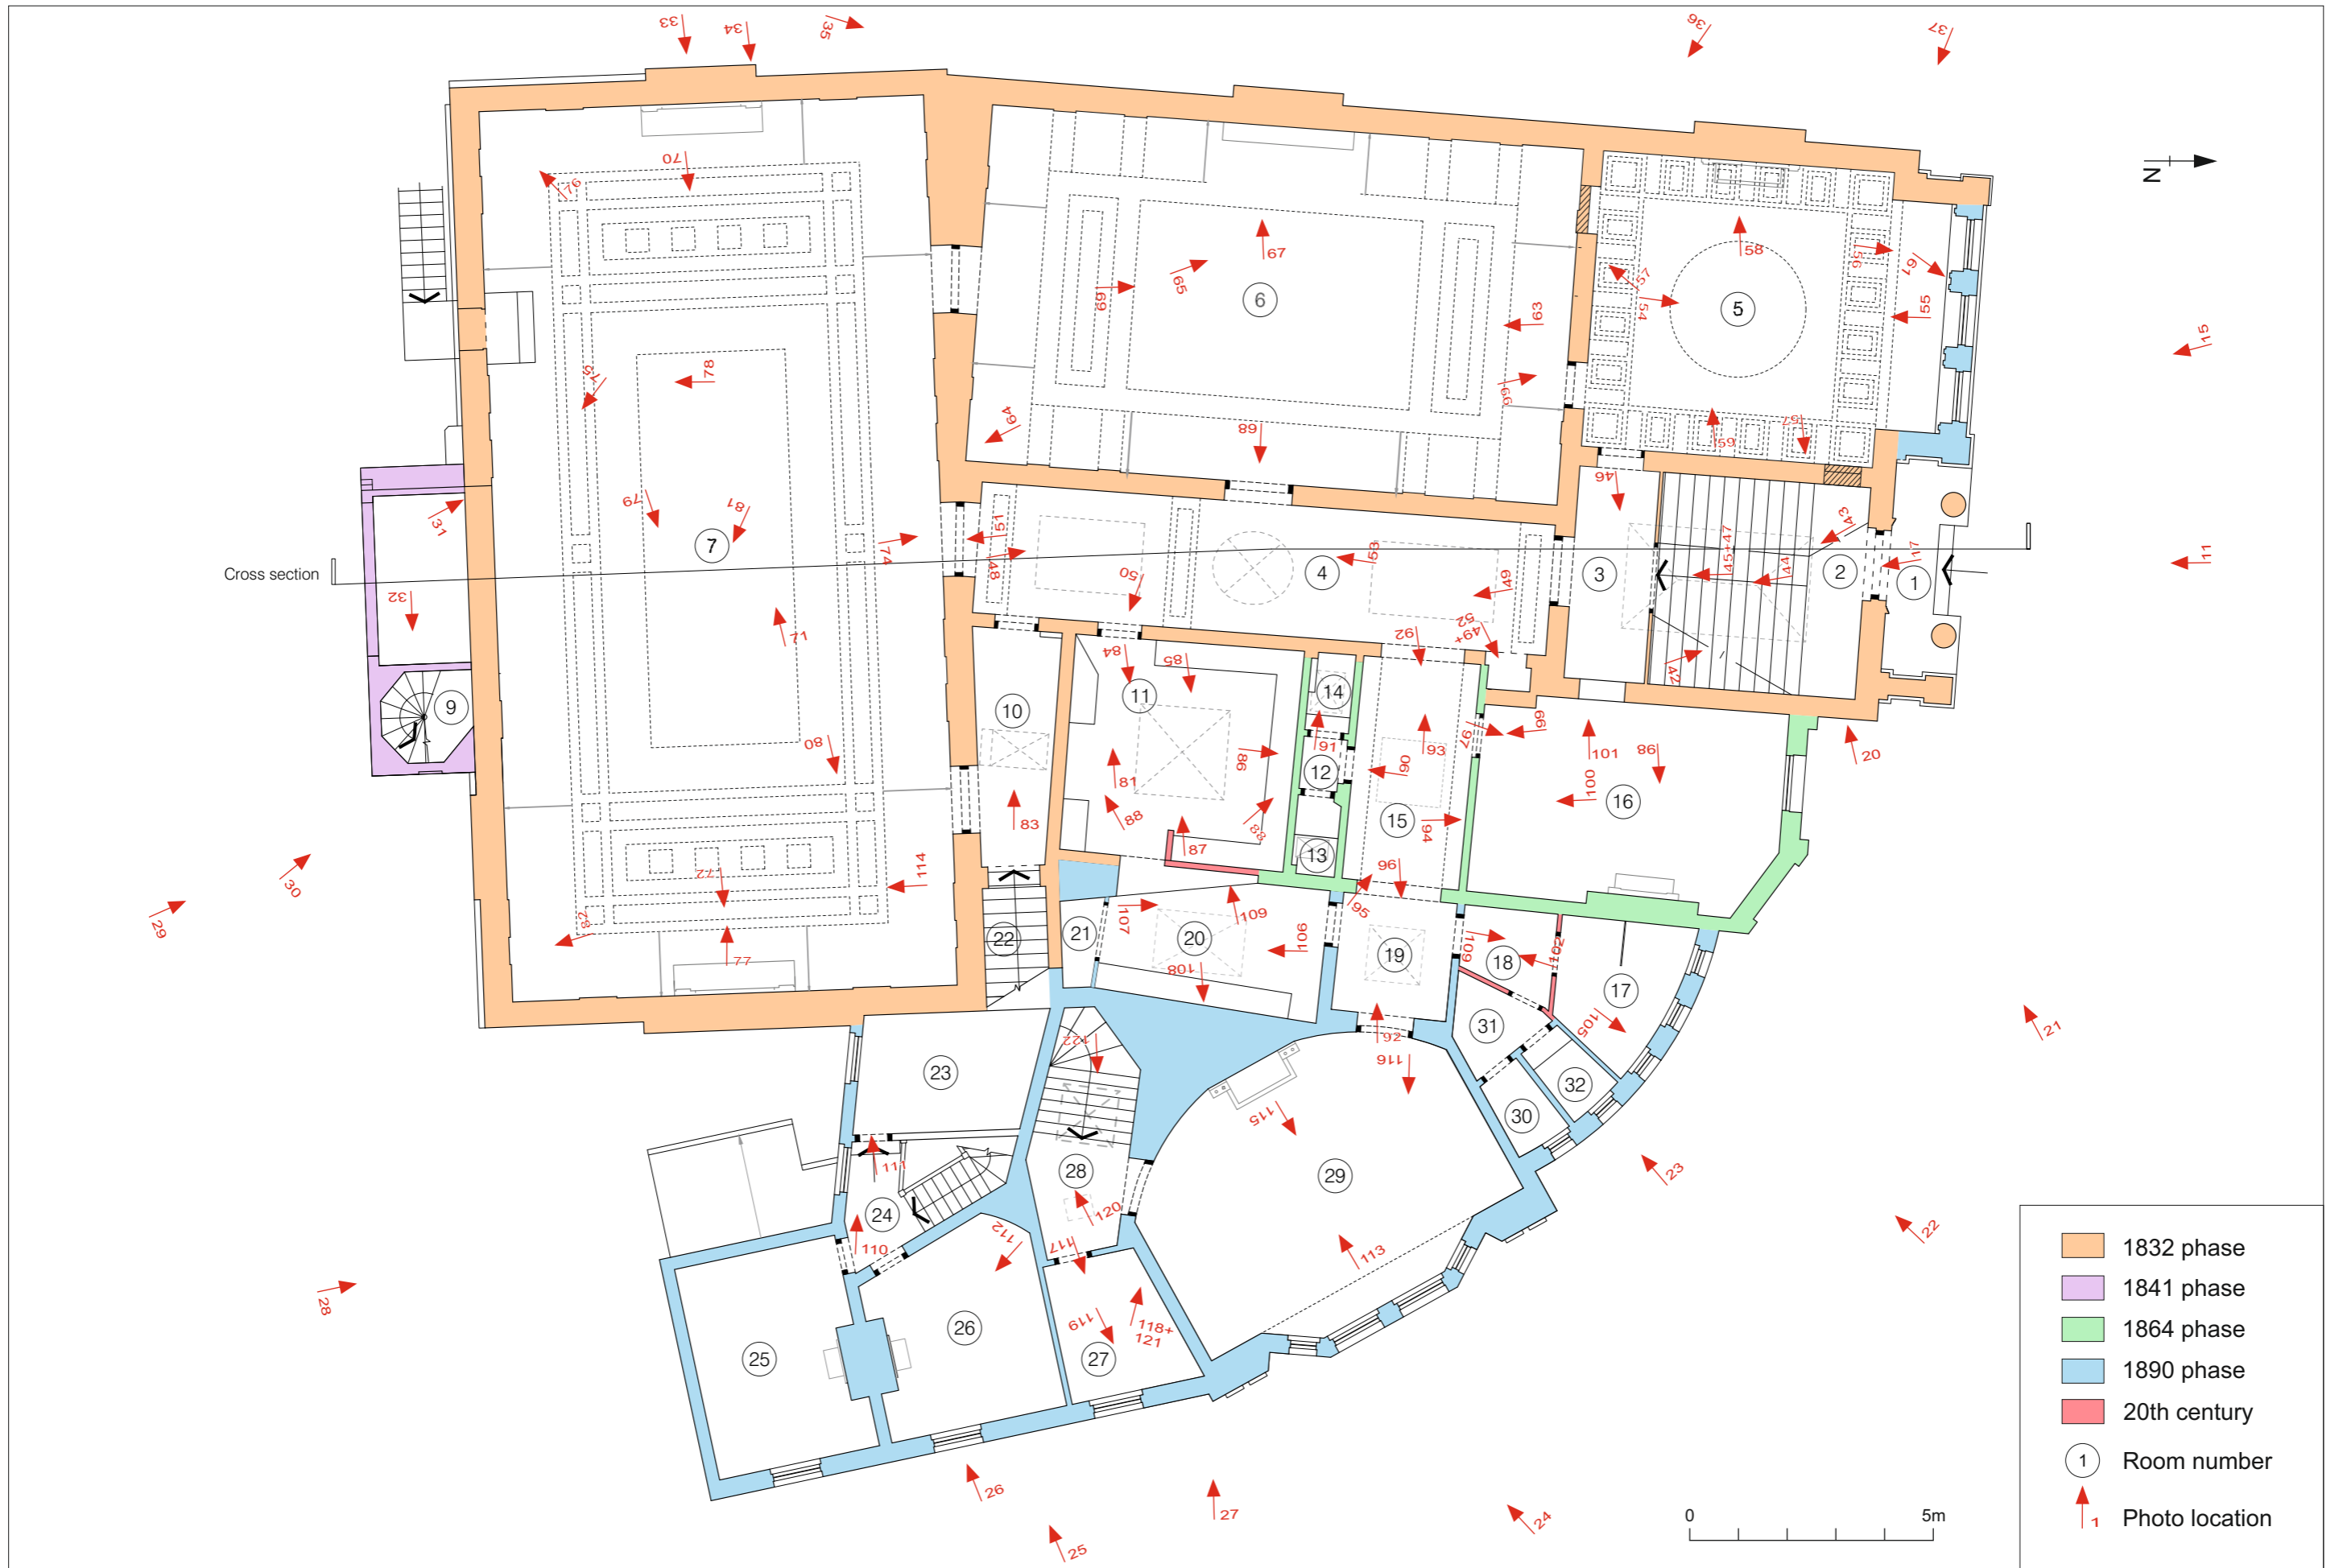
Scale 1:125

Ground Floor plan with general phases and photo locations Fig 184

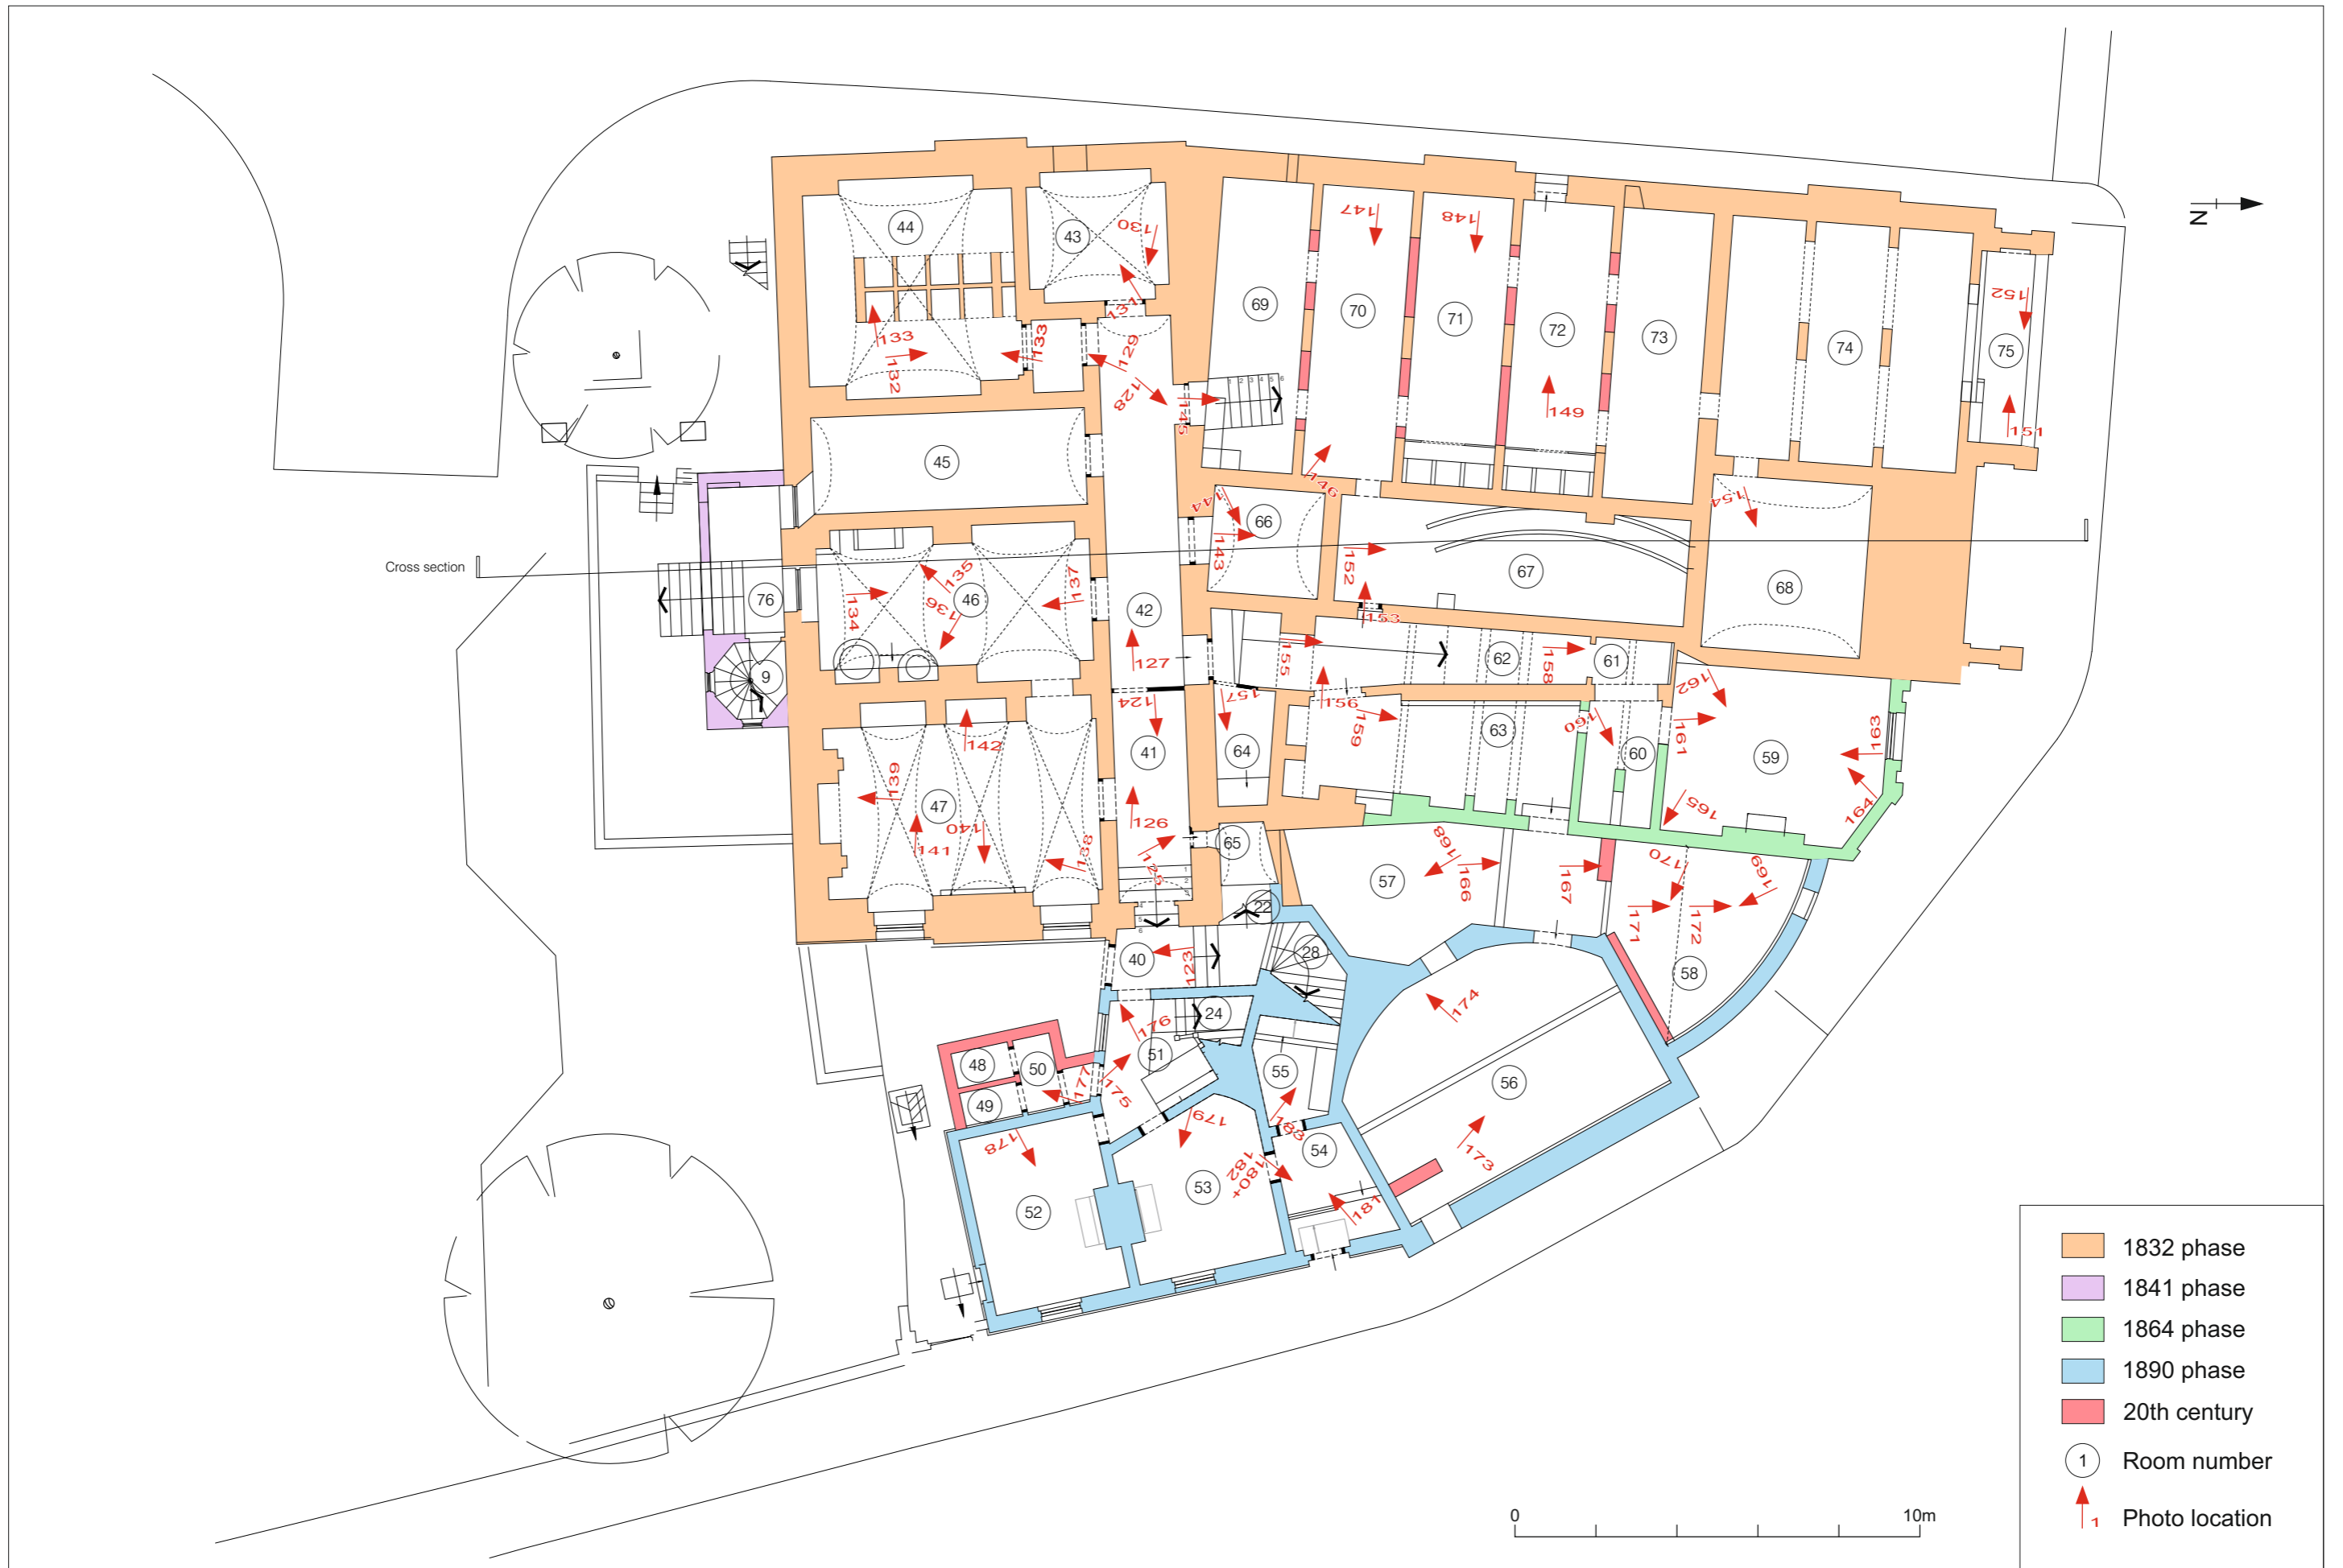
Scale 1:150

Lower Ground Floor plan with general phases and photo locations Fig 185

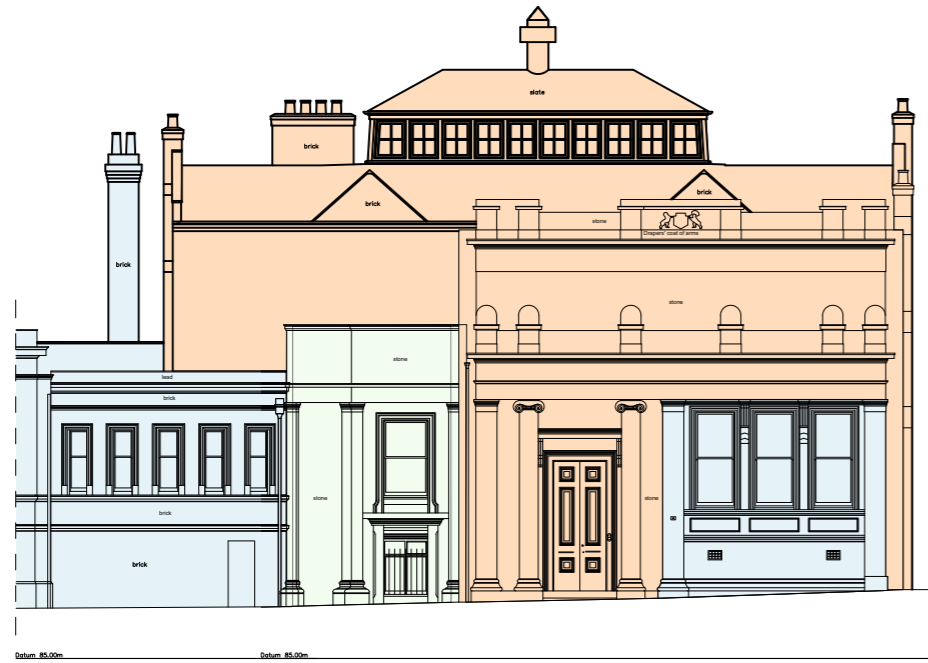
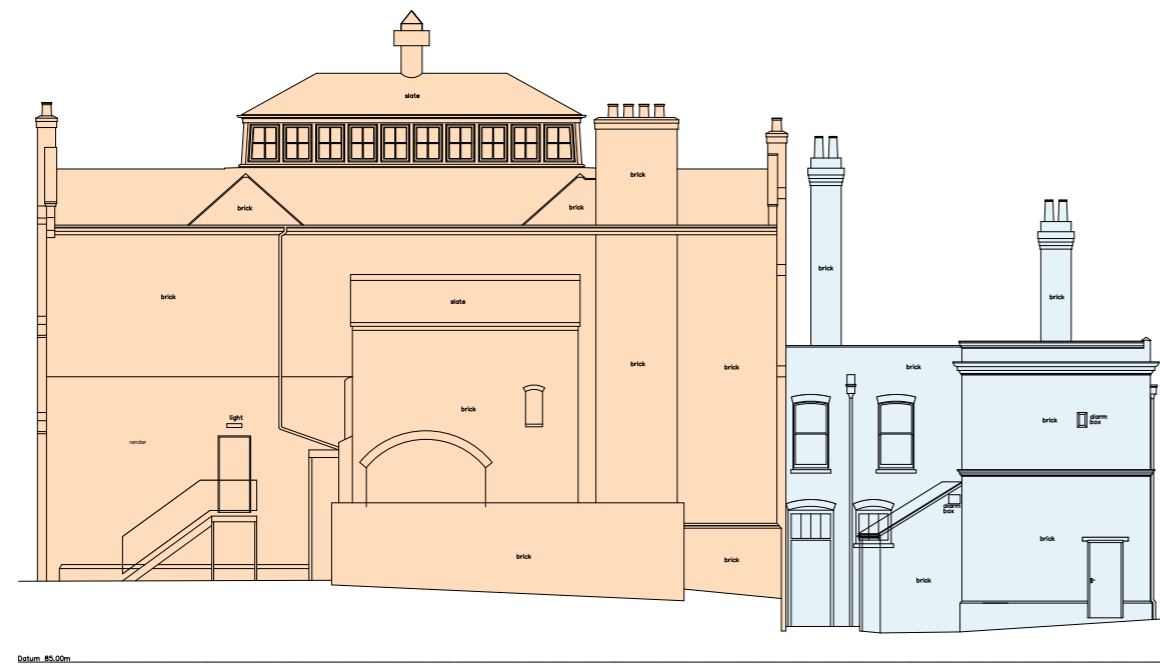
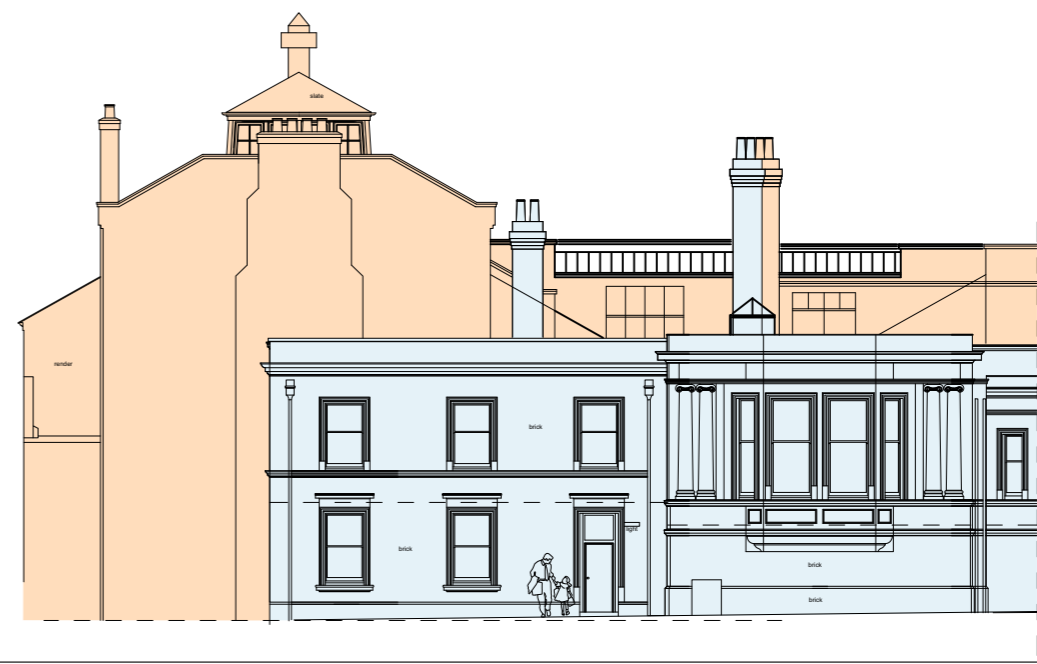
MOLA was supplied with measured survey drawings of floor plans, elevations and sectional elevations of the building produced by The Prince's Foundation in April 2018. These drawings were annotated on site with information relating to the historical significance of features and then converted to conform to the Historic England's guidance for the illustration of historic buildings (Historic England 2016b) and RCHME standards (1996). These are reproduced as part of this report (Figs 184-188).
