**Historic building recording  
at Manor House Museum  
Kettering GLaM Project  
Northamptonshire  
June 2021**

Report No. 21/073

Accession number: ENN110105

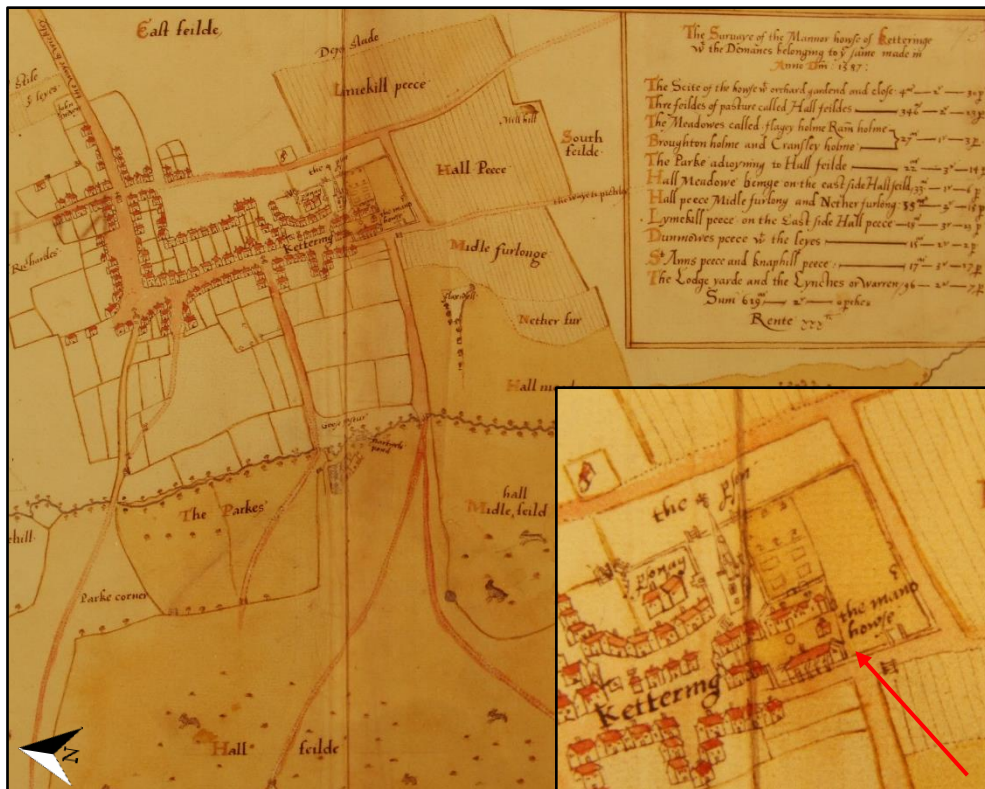
Extract from the Treswell Map of Kettering in 1587 (Archives ref. F.H.272/2) Fig 2

The earliest available cartographic source dates to 1587 (Fig 2) and depicts Kettering and its surroundings in order to illustrate the property belonging to the manor. Due to the nature of the maps' purpose the rest of Kettering is fairly standardised in the illustration. The Manor House lies to the south of the town, essentially surrounded by its lands and fields to the south and west. Some of these fields are named: *Hall meadowe*, *hall Middle feild*, *Hall feilde*, and so on.

The Church of St Peter and St Paul is depicted with spire and tower to the north of the area delineated in a darker yellow as belonging to the manor. It appears to be surrounded by a wall with one long range fronting the street, with a small lone building between the outbuilding and the house. The house itself appears to have two end wings, and a carriage arch, or arched opening along its western front. There are gardens set out to the east with perhaps an orchard to the rear. However, some care must be taken in relying upon the depiction of buildings on maps of this kind, as the manor house is the focus of this illustration, we can be fairly confident in its arrangement being correctly depicted.

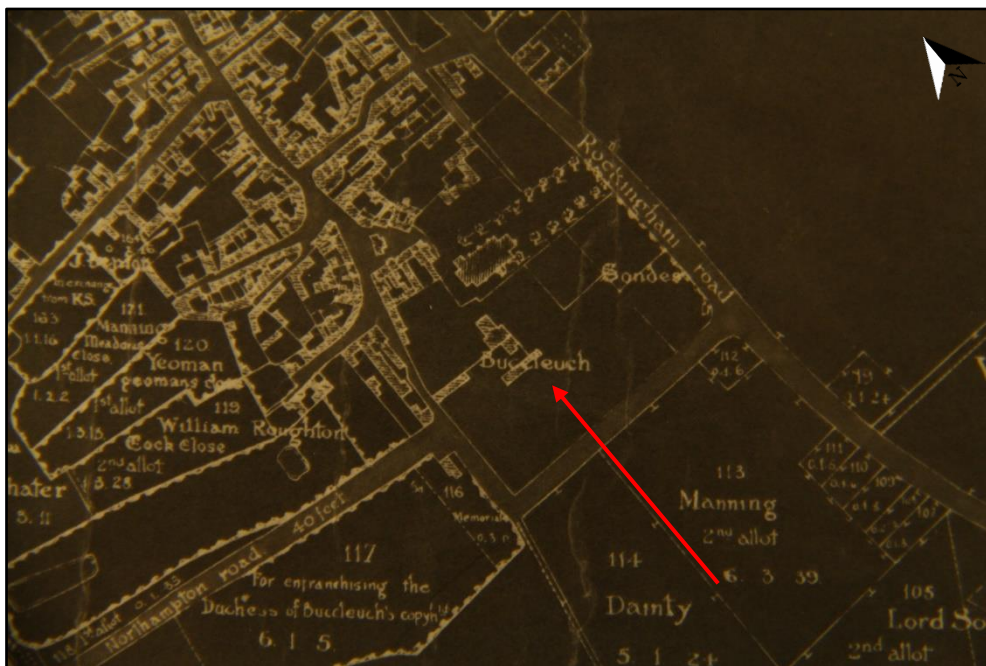
Enclosure map of Kettering, surveyed by J Eagle, 1804 (Archives ref. Map/2648) Fig 4

A town plan of Kettering in 1804 (Fig 4) also depicts the Manor House in more detail than previous sources. The town of Kettering lies to the north and has expanded further east and west than previous cartographic depictions. However, it still appears fairly small-scale. The Manor House lies within a large plot as before, and there are indications of a few outbuildings within the proximity of the house. The plots to the east appear empty but have been noted as belonging to Sondes, the Lord of the manor at the time. The Manor House is labelled as (Dukes of) Buccleuch who was one of the lords of the manor at the time, the Earl of Rockingham being the other. Elsewhere the names Henry Duke of Buccleuch and Elizabeth Duchess of Buccleuch appear on other plots around the town.

On the town plan the house itself is depicted as a rectangular central range, the north range appears present and there is also a small L-shaped range to the south-east. This does not entirely correlate to previous sources, nor the current arrangement.

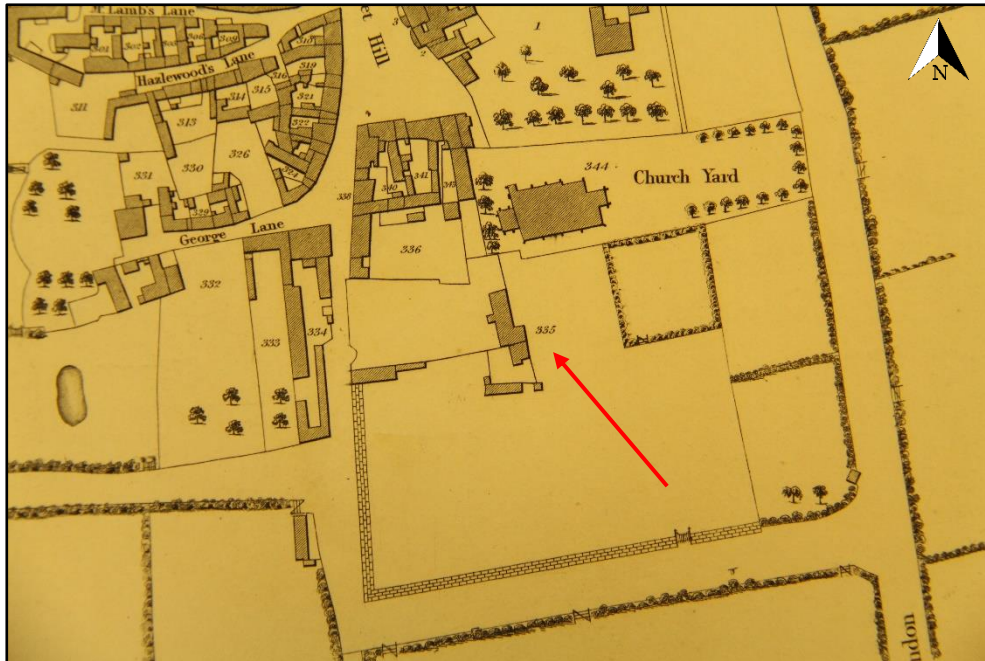
A plan of the Town of Kettering in the County of Northampton. First delineated by Mr Eagle 1804, corrected to the present time and published by Robert Smith 1826 (Archives ref. Map/5596) Fig 5

Another 19th century source includes a town plan dated 1826 (although drawn in 1804, perhaps using the Enclosure map as a base). The surround plot of the house is depicted with walled border, and a gate to the south-east (Fig 5). The buildings depicted are very similar to the previous source with several outbuildings present and the main range sitting far back from Sheep Street. The house is depicted as an L-shaped range with small western projection. An additional range abuts its southern face and seems enclosed within its own plot here with outbuildings to the south as previously mentioned.

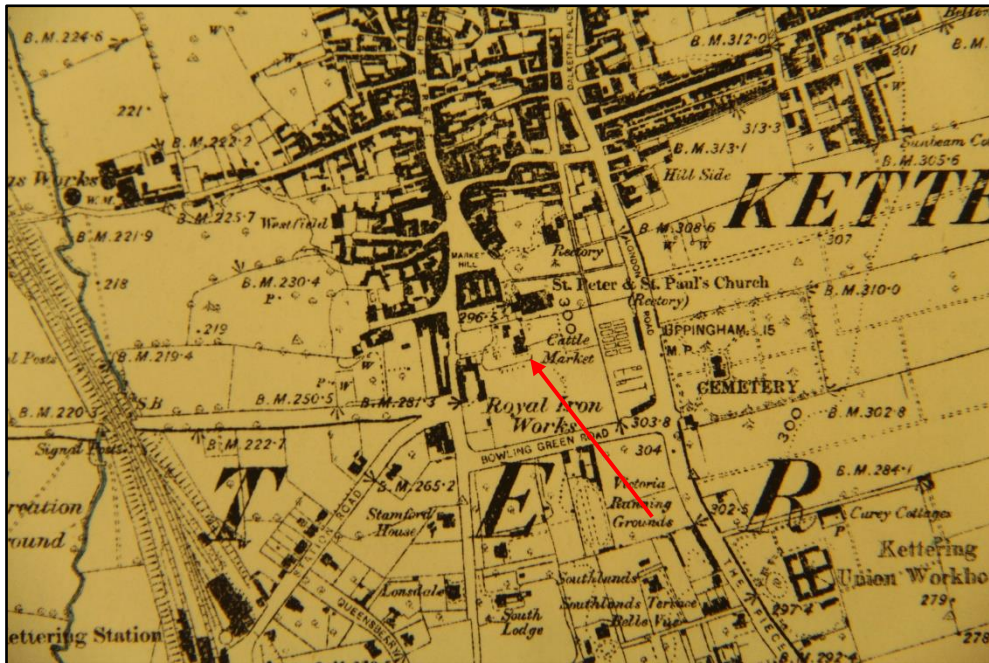
Ordnance Survey map 6-inch, 1886, sheet XXV.SW Fig 6

The late 19th-century OS map shows the Manor House to the south of the town centre, in close proximity to the Church of St Peter and St Paul (Fig 6). It sits well back from the street with a considerable rear garden, and several outbuildings. The wider arrangement of the settlement is similar to previous sources, but there has been extensive development to the south. In closer proximity of the site, the Royal Iron Works lies to the south-west but this is cleared in the early 20th century to make way for the Public Library on later sources.

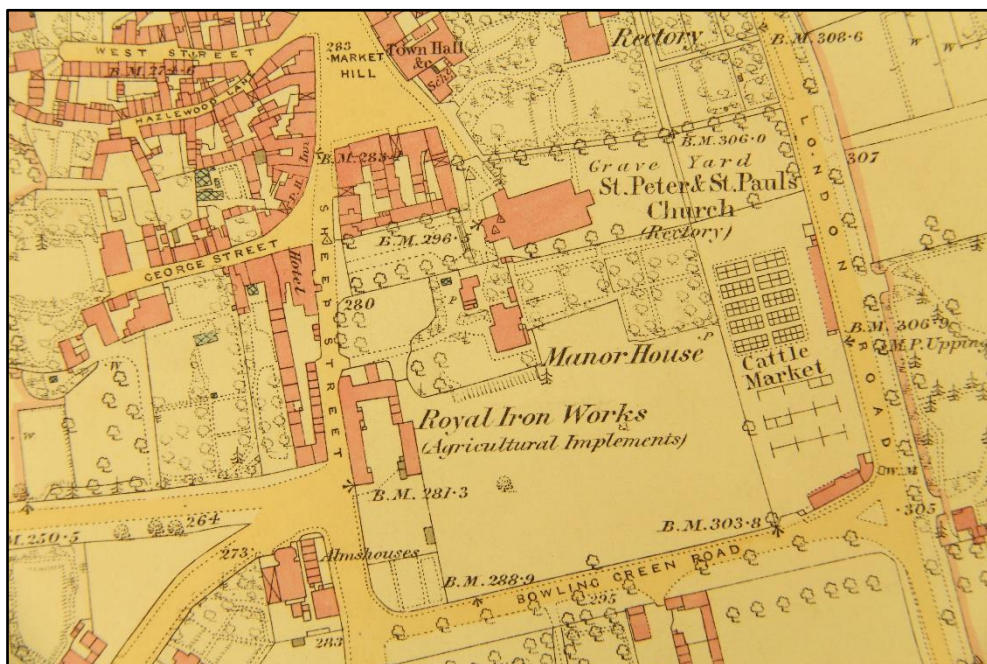
Ordnance Survey map 25-inch, 1887, sheet XXV.14 Fig 7

Dated to 1887 the 25-inch Ordnance Survey shows more detail to the site itself (Fig 7). The main house sits within formal gardens which are depicted with a boundary wall or similar to the west and a driveway leads to the front of the house. To the rear a formal arrangement comprises a series of paths and borders with a series of trees depicted. The main building appears as an irregular form although the northern range appears to extend with additional projection to the east. To the north-west a roughly L-shaped outbuilding is noted to have a pump. Around this time a Thomas Blackwell is listed as occupying the Manor House (1890, 407).

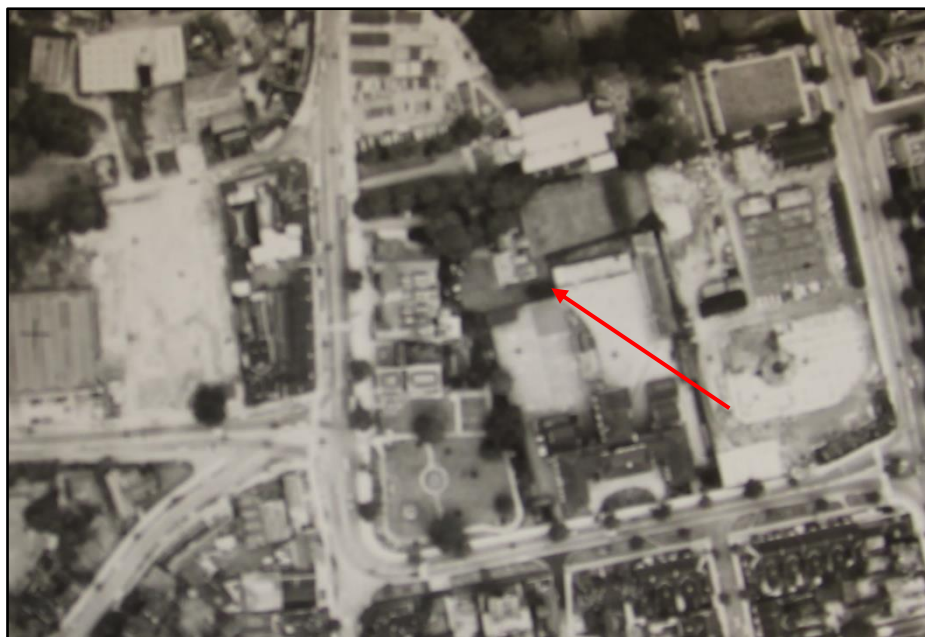
Aerial photograph 1960s from the Historic Environment Record, reproduced with permission Fig 10

An aerial photograph from the 1960s shows a little more detail of the changes that were happening to the site's surroundings during this time (Fig 10), although the quality of the detail is limited. The gardens of the house appear to comprise lawned areas, there is a large collection of trees or a wooded area to the north and north-west, and the concrete of the cattle market and school certainly isolate the manor house within its setting. The main roof was orientated north to south with a northern extension, and three smaller roofs projecting to the east.

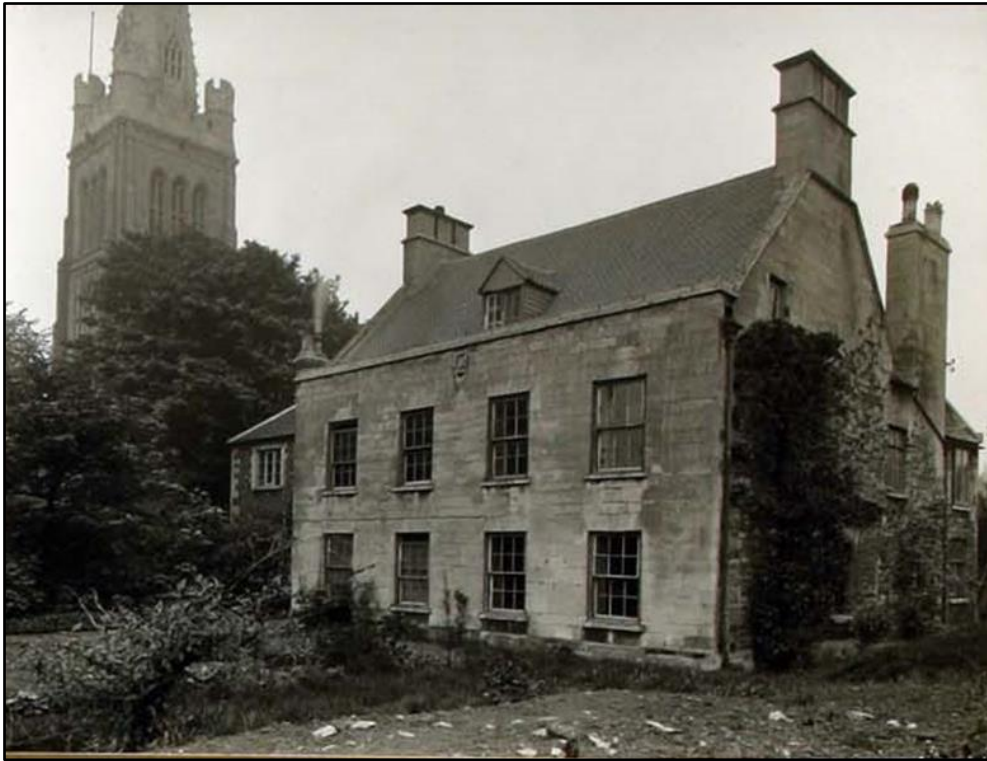
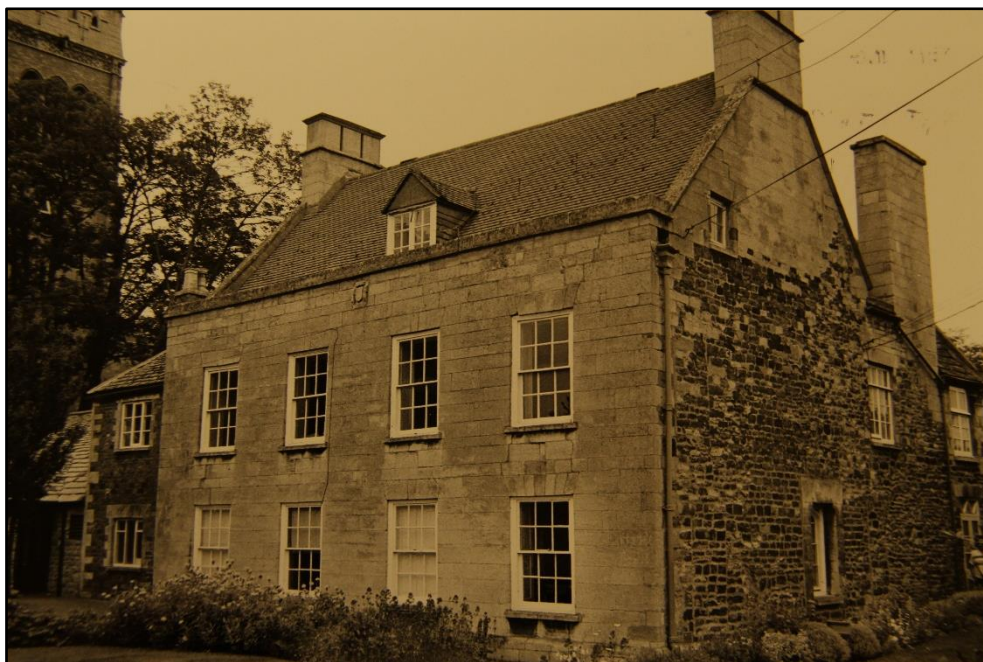
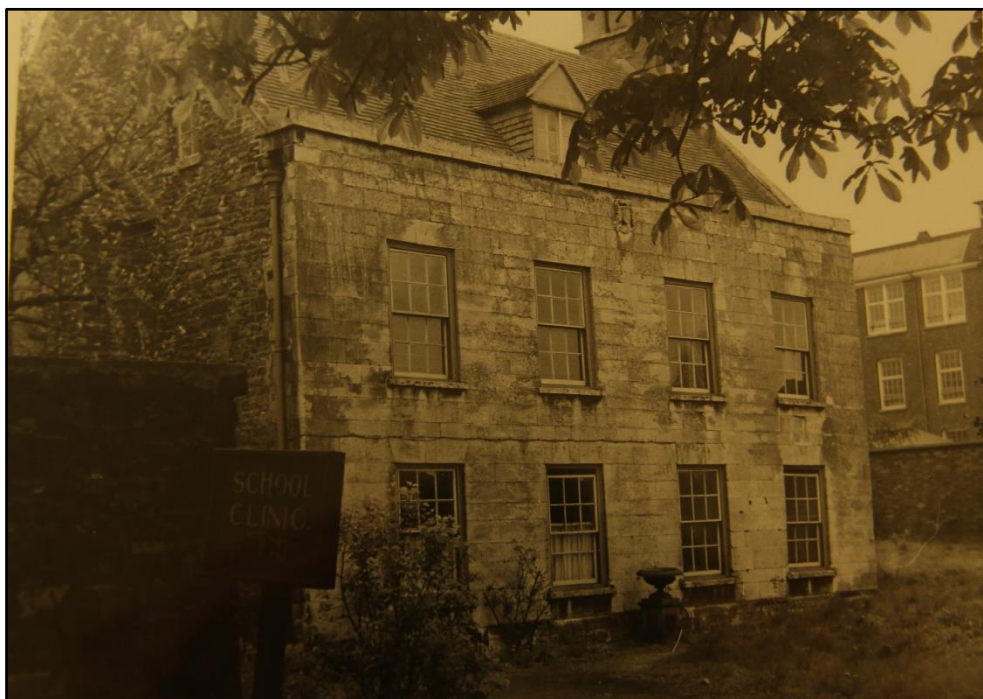
Two photographs (Figs 11 and 12), dated 1940s and 1990s respectively, show the house in much the same arrangement as was seen during the survey (Figs 14-16). The ground floor window to the north range remains unblocked and appears to retain a three-light window. Another photograph (Fig 13) from the Historic Environment Record collection is undated but it shows the house from a differing angle. In the background the school building is evident, dating this image to post-1926 and the lawned area to the front of the house suggest it is earlier than the previous sources' 1990 date.

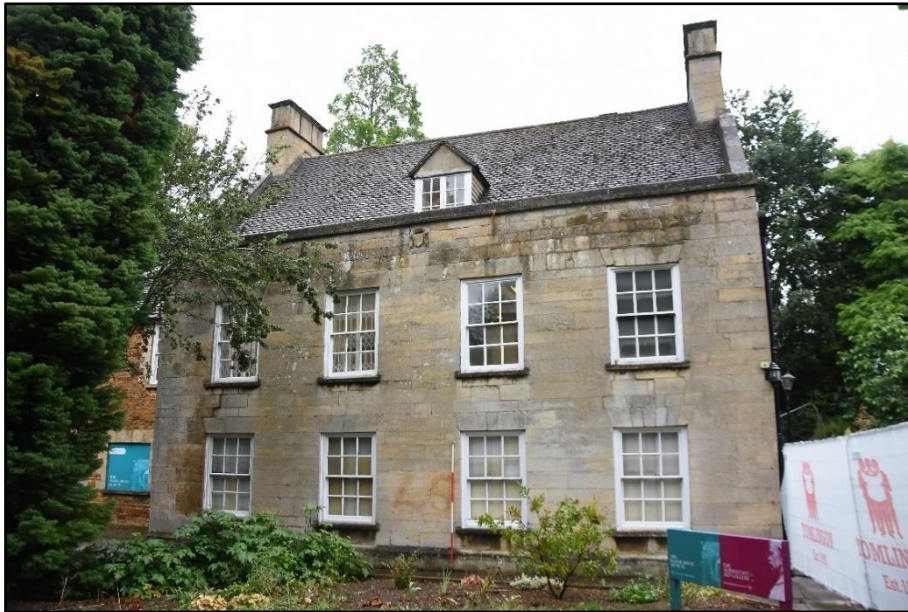
View of the west elevation of the main range, looking north-east Fig 17

The main house presents its formal frontage along this elevation rising in ashlar blocks from a small plinth, to a parapet (Fig 17). The mortar joints are fine, although various repair attempts are visible and as a result some structural issues are evident. Along the façade several put-log holes are evident in rows and equally spaced. A single basement light to the north is reminiscent of a more historical arrangement and it is one of the only reminders on this face. The symmetry is present in four windows to the ground floor, mirrored above to the first floor. They all comprise six-over-six timber sashes with stone sills and splayed voussoirs; only a few examples have horns. Though very worn the remnants of a crest can be seen sitting centrally below the parapet.

Above the parapet the Collyweston roof rises with two chimney stacks in the same ashlar stone as to the frontage to each gable. A single gabled dormer sits centrally within the roof pitch. The gable is rendered and it is clad with tiles. It houses a timber casement with six panes to each light.

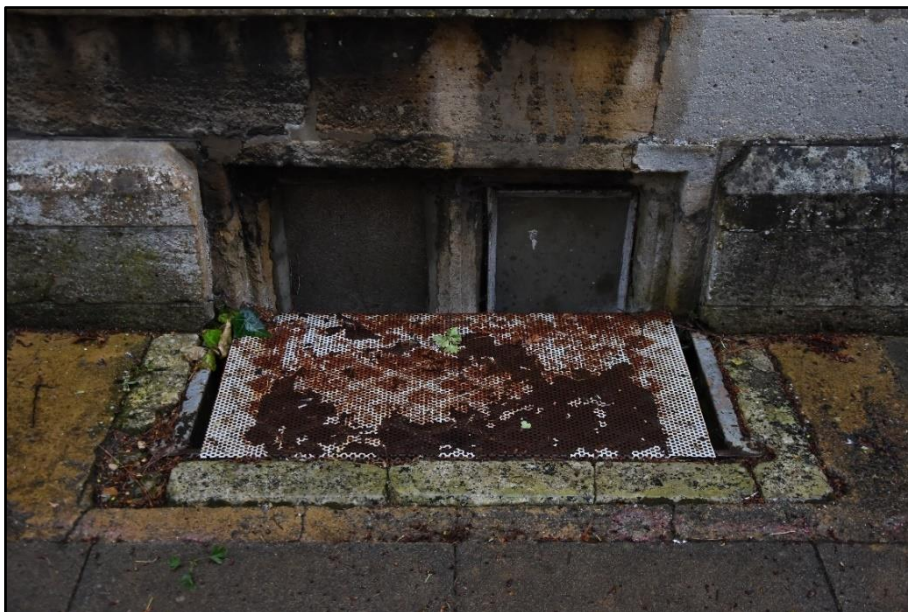
Basement light to the west elevation, looking east Fig 18

The basement light mentioned above sits in a light well with modern grille but it is set within a stone surrounds of some age (Fig 18). The window cuts through the plinth and appears to be quite worn.

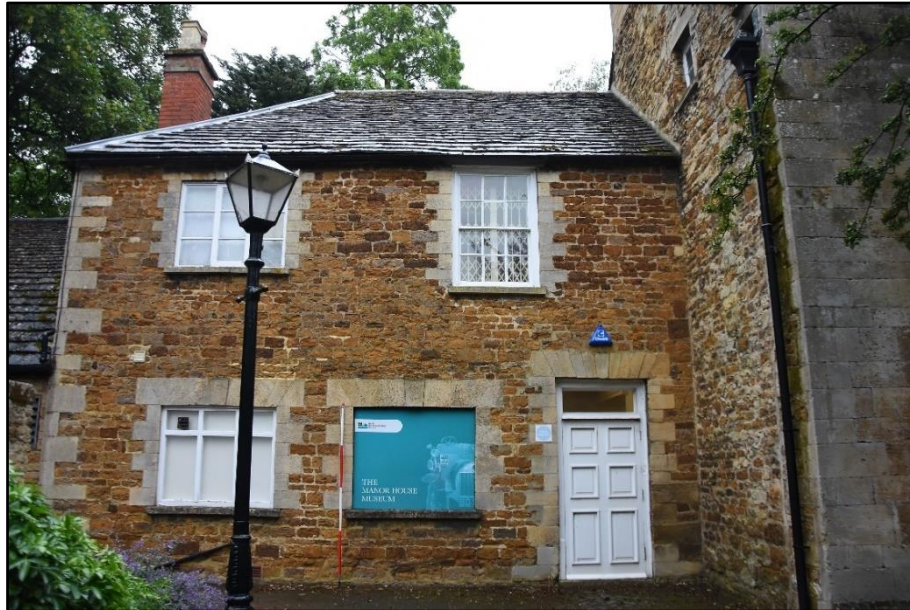
View of the west elevation of the north range, looking east Fig 19

To the north, and set back from the main elevation, the north range abuts the gable end of the main house (described in more detail below). It is constructed of sandstone rubble stone with a mixture of mortar types suggesting some past repair (Fig 19). The apertures are all dressed with ashlar stone, and so are the quoins to the north-west corner of the range. There are two windows and a door to the ground floor, and two windows lighting the first floor. The entrance door, now the main door into the house, has a squared lintel comprising splayed blocks; a feature repeated to

the other apertures with the exception of one of the first-floor examples. The door has a rectangular over-light with modern glass. The door itself has six-panels but is entirely modern. Of the ground floor windows, one is blocked, the other is six-lights but is modern, with a vent to the upper left light. They both have squared lintel with splayed blocks, and stone sills. The two windows to the first floor differ from each other. That to the north has the same dressings as to the ground floor with three-lights. The central light is a casement and each has three panes. The other window has stone jambs and sill but has a slender timber lintel sitting beneath the eaves. The window is a six-over-six timber sash with no horns. The roof has a tall red brick chimney to the north end with stone pots.

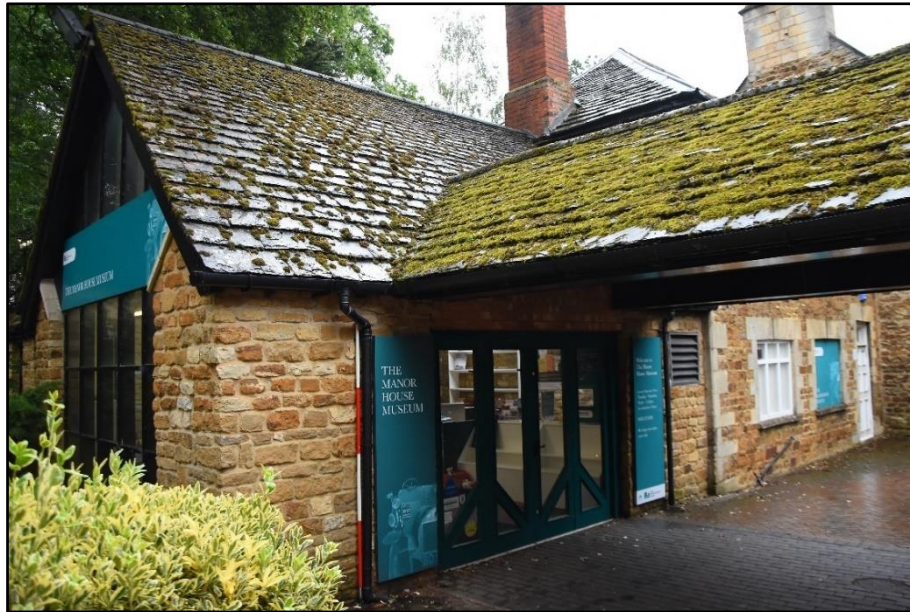
View of the museum range's west elevation, looking south-east Fig 20

The museum range extends to the north abutting the stone quoins of the north range to the south. Here the range is constructed of coursed rubblestone. The museum entrance sits below a veranda which protrudes from the range to the nearby Blitz Tearooms to the west (Fig 20). The veranda has a pitch Collyweston roof and frames the timber and glass doors to the museum. Above the doors is a section of Fletton brickwork. Beneath the veranda roof the timber frame comprises a variant of a scissor-brace form with timber boarding to the roof pitch.

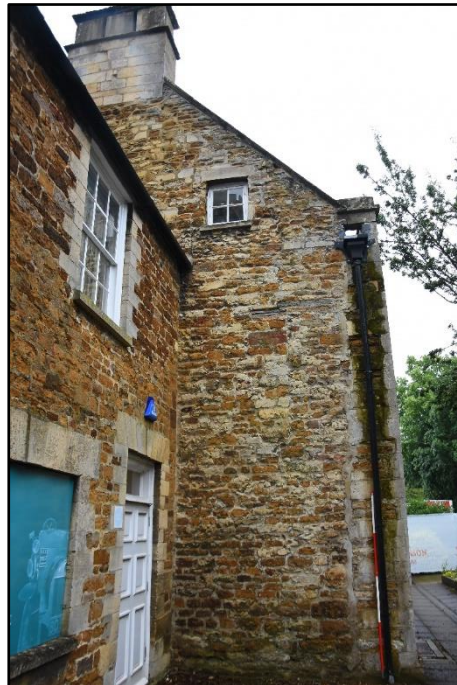
View of the main range's north elevation, looking south Fig 22

The formal frontage to the west elevation, which is described above, can be seen to be a later addition from this angle. The ashlar blocks making-up the façade retain a straight joint which has seen later render re-pointing, perhaps another indication of structural problems. A rainwater hopper and pipe carry water from behind the parapet to the ground. Stone coping tops the gable end and rises to the large chimney stack. The stack is constructed of ashlar with three large square pots, with simple shelf.

There is an interesting area to the first floor where two timber bearers top a second straight joint. This lies parallel to the straight joint for the ashlar frontage and several larger rubblestone blocks have been used to the east.

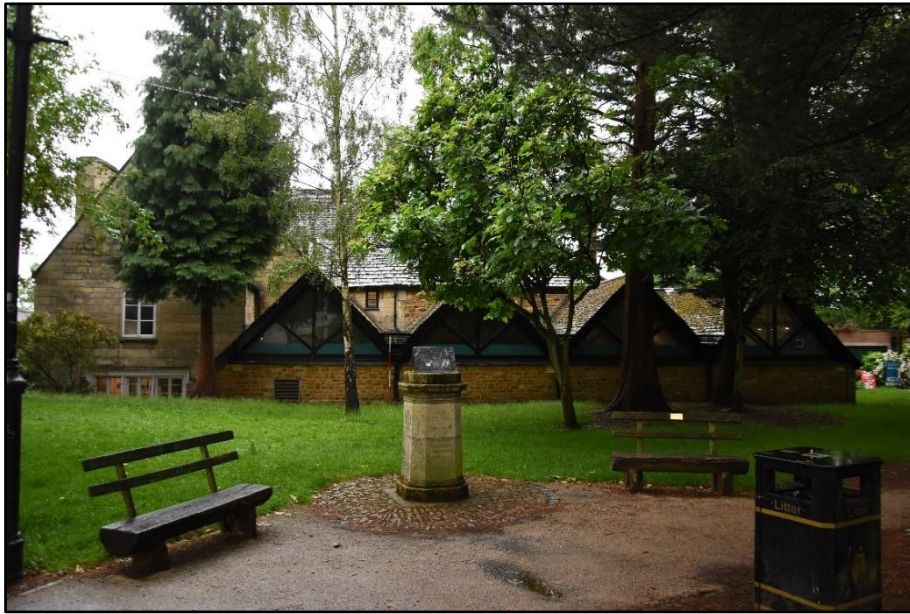
View of the east elevation of the rear range and museum range, looking west Fig 23

The east elevation comprises the gable end of the rear range and the museum range which extends across the elevation in a series of gabled ends (Fig 23). These obscure the ground floor of the main range and north range, although they are partly visible above to the first floor.

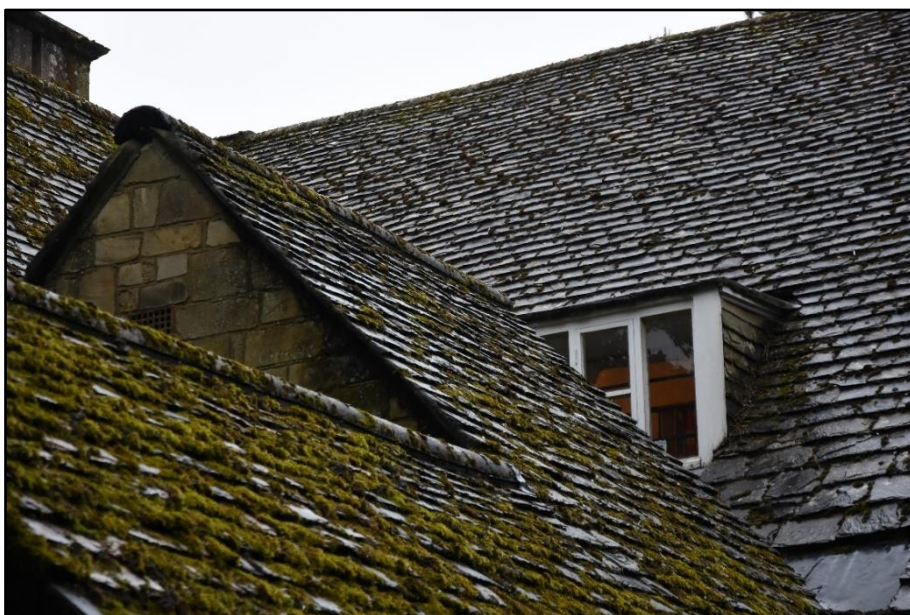
Stone extension to the east elevation, looking south-west Fig 24

The museum range comprises four gabled ends above a coursed rubblestone wall topped by blue brick coping. Each gable end comprises timber and glass in a glazing pattern similar to a king-post truss form. Timber bargeboards are met at the intersection between two gables with a grille and rainwater hopper and pipe. The far southern gable also houses a stone projection (Fig 24), its roof line forming a catslide roof to the northern pitch. This sits awkwardly in front of a dormer to the rear pitch of the main range. The dormer has a flat-roof and tile cladding. The window is of three-lights and the central light is a casement.

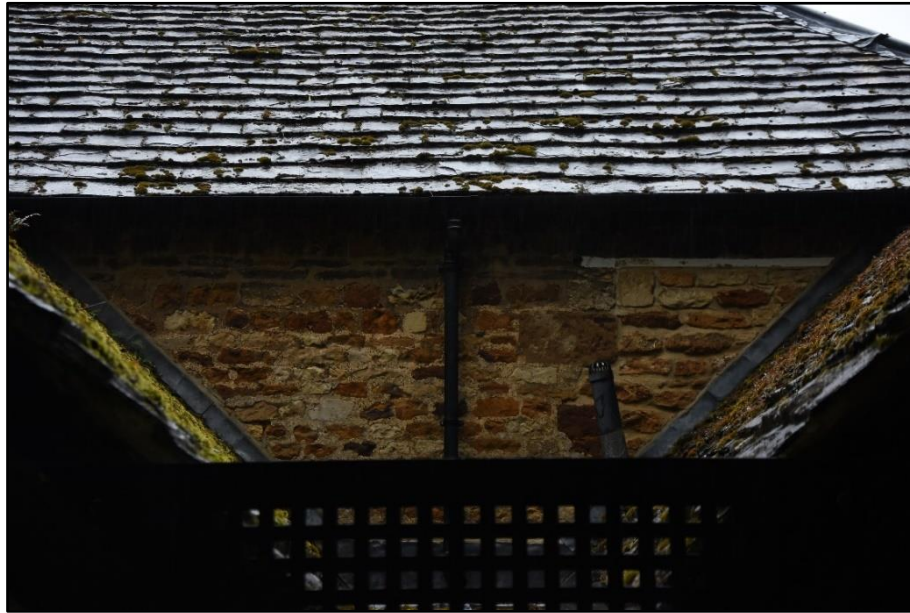
East elevation of the north range, looking west Fig 25

Behind the museum range, the first floor of the main and north ranges is exposed. Between the far southern gable and south-central gable the rear of the main range is also exposed (Fig 25). This is constructed in stone and a single two-light timber window with timber sill lights the staircase internally. Between the south-central and north-central gable a blocked aperture is visible. The construction to the main range is roughly coursed rubblestone, there are a few courses of much more slender stone below the eaves. To the jambs of the infilled aperture several larger stones have been utilised. The infill is coursed rubblestone. There is a slender timber lintel below the eaves.

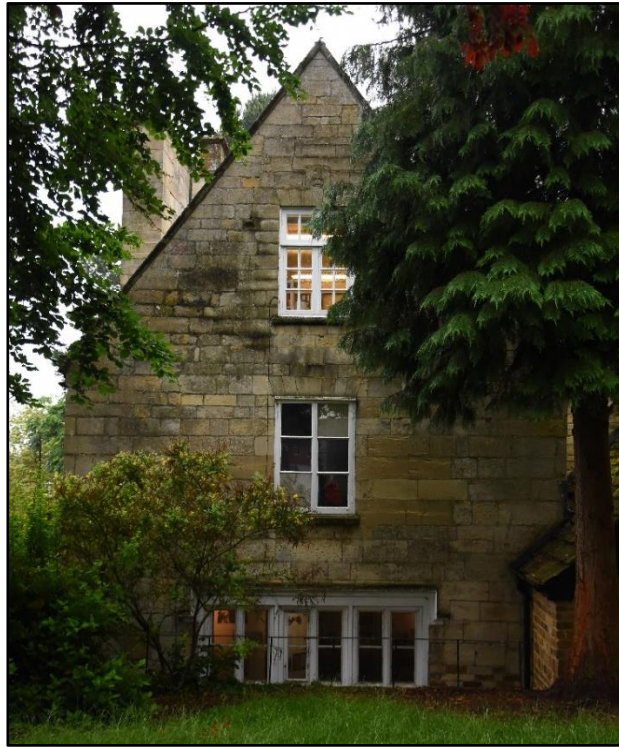
East elevation of the rear range, looking west Fig 26

The east elevation of the rear range projects from the main range and is partially absorbed within the museum range to the north-east corner (Fig 26). The elevation rises in ashlar blocks, but in a less formal arrangement than that to the west elevation. Three apertures light the ground floor, first floor and attic space and all are of interest. To the ground floor a six-light stone mullion window retains a stone drip hood with label stop. It has large ovolo-mouldings and each light has two panes which are possibly fixed.

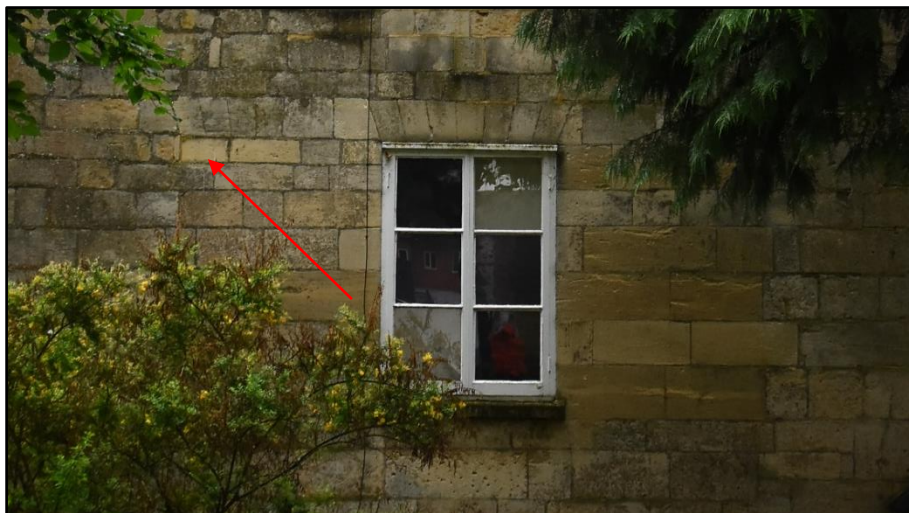
First floor window to the east elevation of the rear range, area of interest indicated, looking west Fig 27

Above, on the first floor a single two-light casement, each light with three panes, sits in an area of interest (Fig 27). It retains a stone sill and splayed stone voussoir. The voussoir continues to the south where an apparent straight joint suggests the aperture was once much wider. To the north an area of brick repair indicates the same.

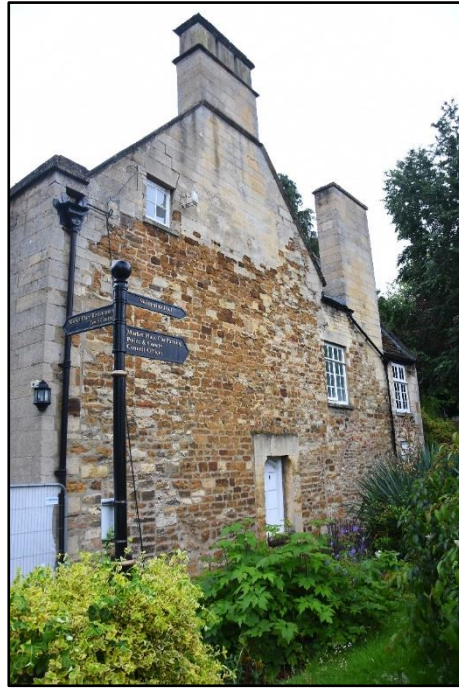
View of the south elevation of the main and rear ranges, looking north-east Fig 29

To the south the side elevation of the main and rear range is exposed (Fig 29). This faces a small area of garden and a large car park. The elevation is mainly rubblestone, rising from a small plinth, but areas of renewal are evident in the same ashlar blocks as noted in the west front; the gable end of the main range, chimney stacks and some areas to the rear range at upper level. The join between the main range and rear range appears evident in a straight joint at ground floor level.

To the main range the ashlar blocks of the formal front are visible to the west and a straight joint to indicate their insertion to this elevation is clear. They rise to the parapet with stone coping, a rainwater hopper and pipe carry water to the ground, mirroring the north elevation.

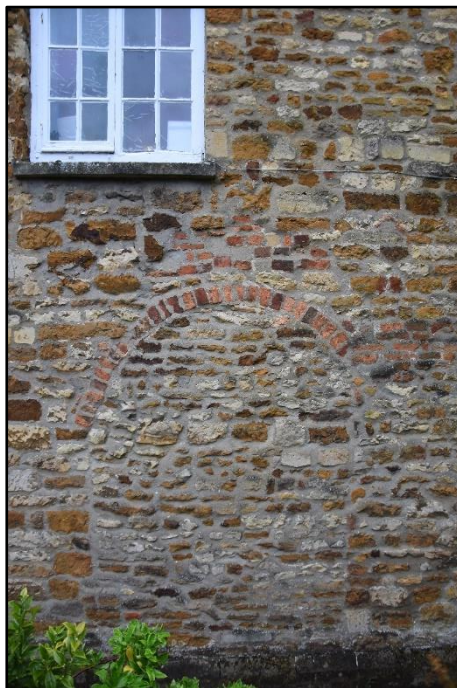
Arched blocked opening to the south elevation of the rear range, looking north Fig 32

To the ground floor of the rear range a large arched opening has been blocked (Fig 32). The head is marked by brick headers, forming a semi-circular arch. The former purpose of this opening is unknown, but it does correspond with a large chimney stack seen internally and described below. Further east a doorway creates a fire escape for the museum. This has a stone lintel with splayed stonework, in the style of a voussoir, and is similar to the apertures seen previously (Fig 33). The door itself is modern with applied mouldings and a blocked over-light.

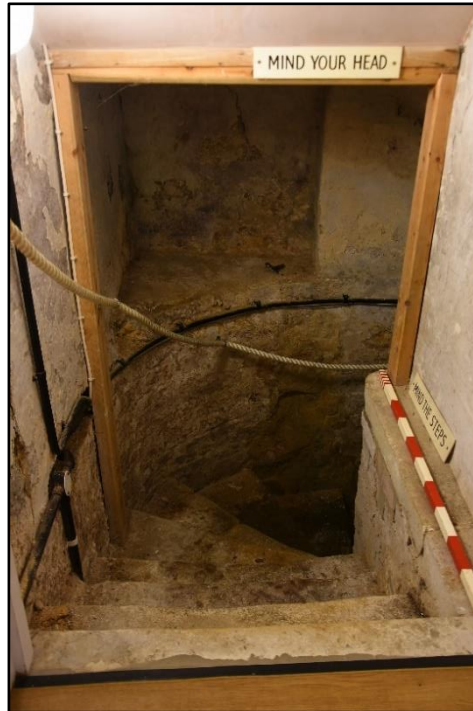
Stairs descending into the basement, looking west Fig 35

The basement extends beneath the main range (Fig 34) and is accessed beneath the staircase in the Stair Hall. The staircase (Fig 35) is a winder with stone steps which turns southwards and descends to a single chamber with barrel vault ceiling with a single window at the far western end (Fig 36).

As the staircase descends the curved north wall appears to be constructed in stone. At upper level this is obscured by render but where this has failed some bricks are visible. However, the overall construction sequence is not clear. The southern wall of

the stairs is laid in brick with some repair with cement mortar. The carcass of the staircase above is not visible and has been recently boarded and plastered.

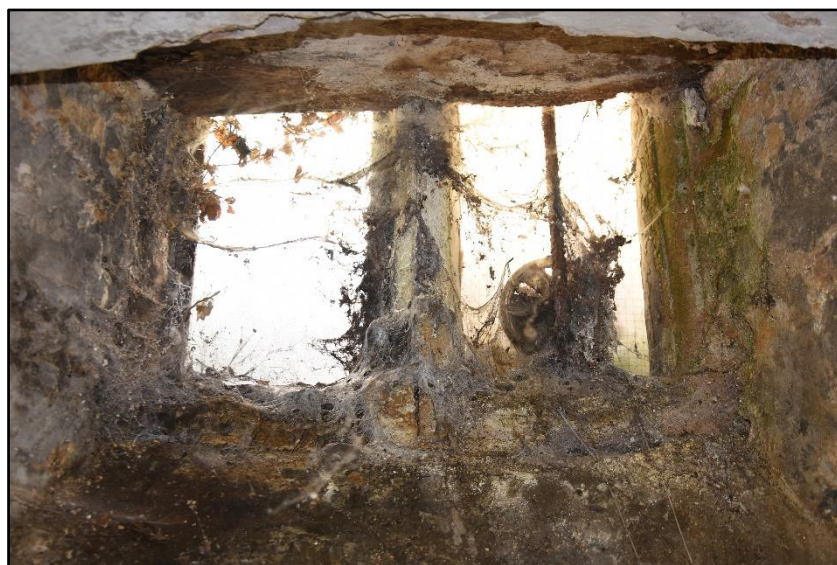
Basement window, looking east Fig 38

At the far western end of the room a single two-light stone window lights the space. The aperture has a deeply sloped sill as it cuts through the external wall or foundations and sits in a light well seen above (Fig 38). The mouldings are ovolo and are of some age but the glass is modern. One light has a wrought-iron safety bar and a fan vent.

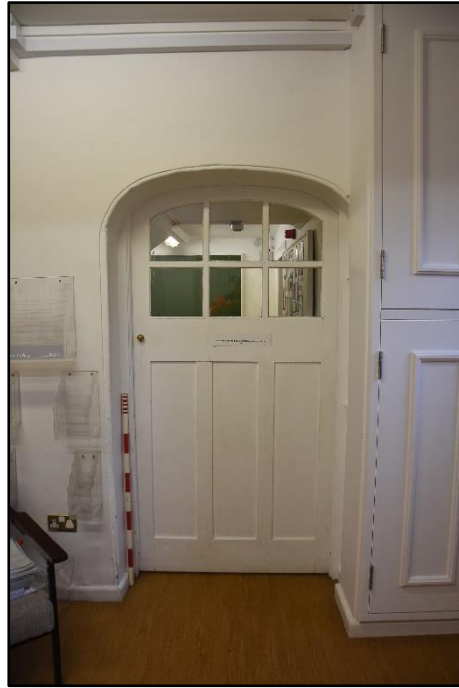
Door giving access to the stair hall from the lobby (GF03), looking south Fig 41

To the south the door to the stair hall (GF01) is of some age with a beaded surround and made of timber but on modern hinges (Fig 41). The door has three lower panels and six upper glazed panes with a cambered arch head.

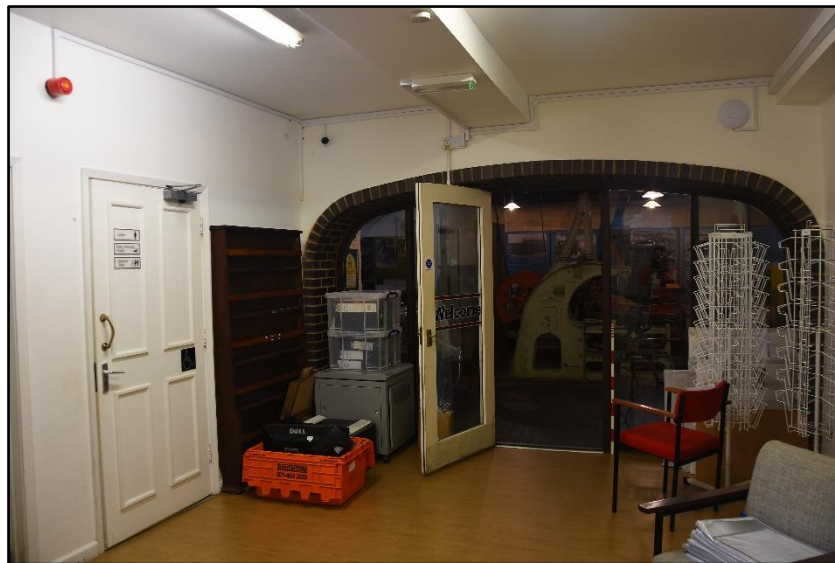
View of the lobby (GF03), looking east Fig 42

The east wall has been almost entirely removed to provide a timber and glass partition through to the museum range (Fig 42). It is framed with a large cambered brick arch, but the thickness of this formerly external wall is notable.

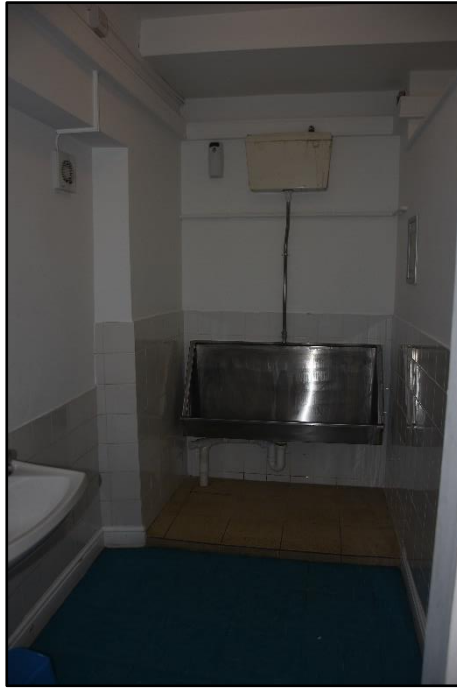
View of the men's WCs (GF05), showing blocked window and chimney stack, looking north Fig 43

These lie to the north of the lobby (GF04) and retain nothing of historic interest although they lie within the north range. A blocked window seen externally within the men's WCs to the west is presented as a simple recess internally (Fig 43). A plain protrusion within both WC's to the north wall is presumably a former chimney stack but nothing is now visible, with the exception of the tall brick chimney seen earlier.

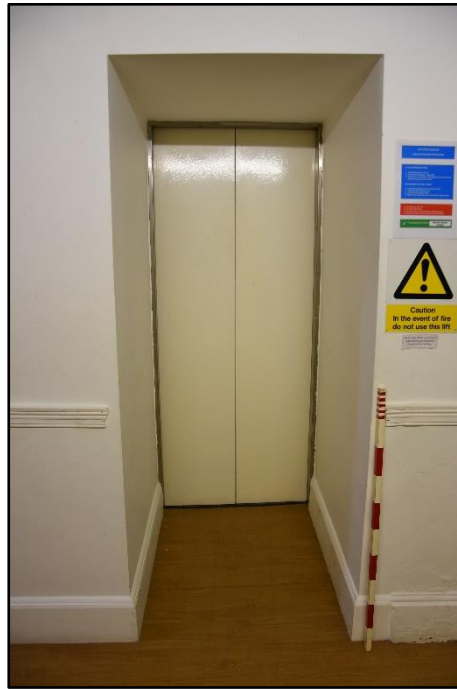
Access to the lift from the stair hall (GF01), looking east Fig 45

To the east a lift has been inserted through the formerly external wall (Fig 45) and the southern wall is plain and largely obscured by a notice board (Fig 46); to the west is a

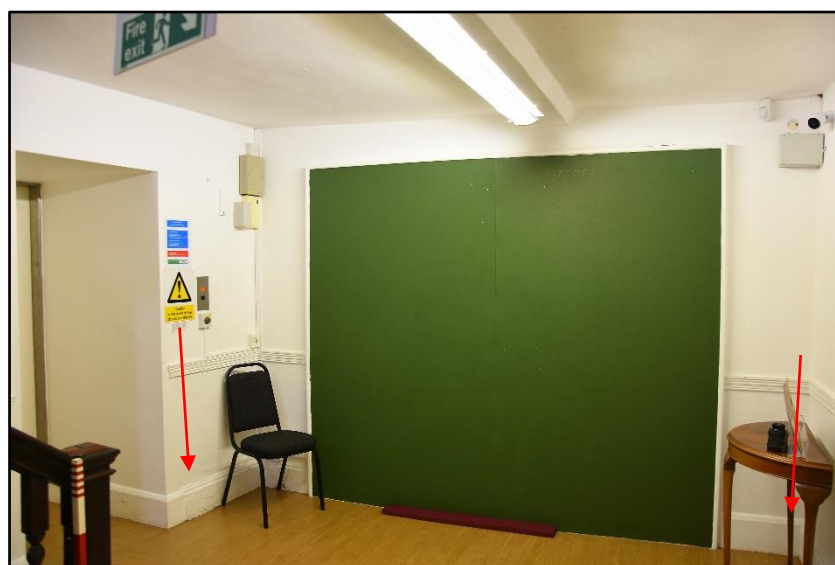
View of the stair hall (GF01) and the breaks in skirting indicated, looking south-east Fig 46

The floor is modern with a tall skirting which has been cut to insert the lift along the east wall. The skirting retains an ovolo moulding (Fig 47) but does not return in the south-west corner along the south wall (see Fig 46). A dado rail marks the plaster walls with little other embellishment; this stops either side of the lift aperture.

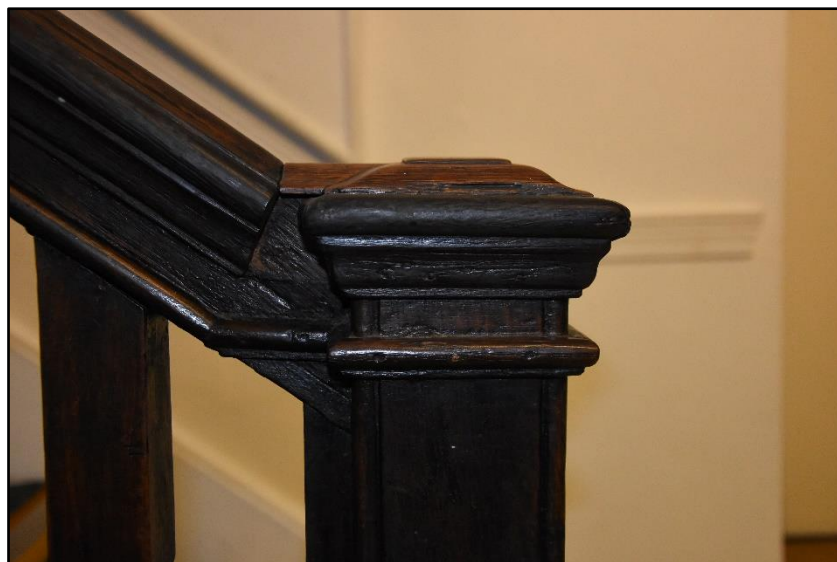
Detail of the newel post to the staircase in GF01, looking east Fig 48

The open-well stair rises on a closed string in hardwood, likely oak, with carpet to the steps. The newel post is square in plan but plain and rising to a moulded top with flat square moulding (Fig 48). It may have never had a finial or these may have been carefully removed. The string is robustly moulded above the first flight, which is plain, and the handrail is a toads-back type in profile. The balusters are finely turned and there is evidence of nails to their bases, either suggesting replacement or repair. The robust pegging (2cm or  $\frac{3}{4}$ " wide) is visible in several places indicating its carpentry and age (Fig 49).

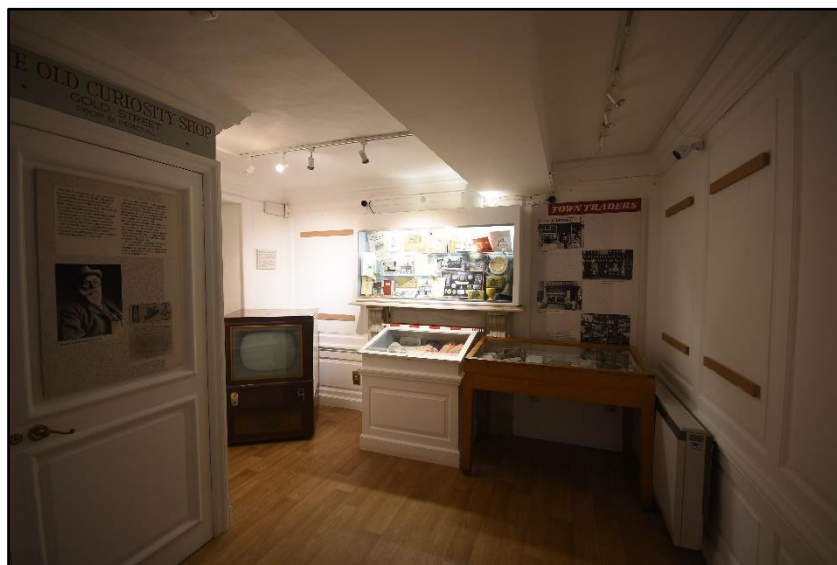
View of the white exhibition room (GF02), looking north-west Fig 50

The floor is modern but historic skirting with a moulding profile can be seen to the east and north, and partly to the west, where not obscured by display cases. There is panelling all around, which has been replicated across a large display case in the south-west corner of the room (Fig 50). The panelling consists of one small and a large, fielded panel separated by a low dado rail and a simple cornice. A boxed-in joist extends north to south and the panelling has been moulded around it to the south.

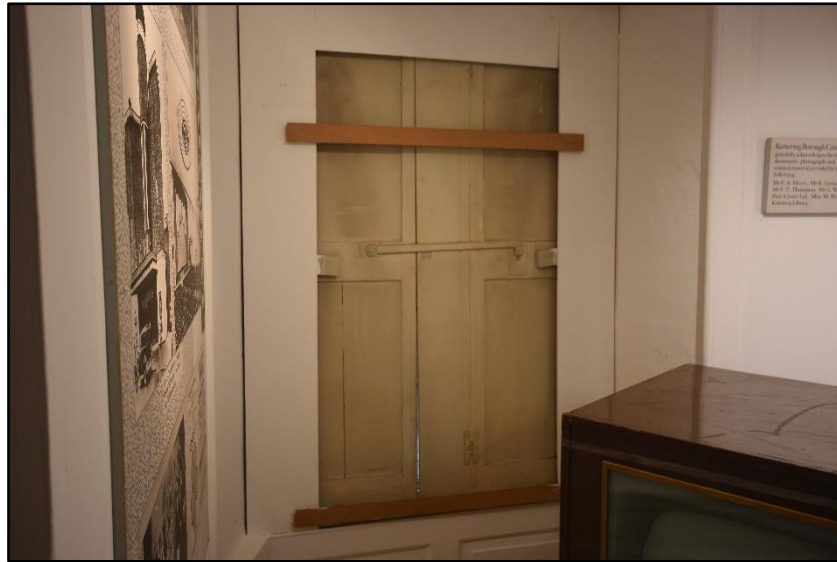
Shutters visible within GF02, looking west Fig 53

To the west two windows form part of the formal front that is visible externally. One lies outside of the display case and has been partially blocked (Fig 53). The shutters behind have long stay bars and H-hinges. The shutters are more visible to the south within the display case and retain an earlier muted paint scheme.

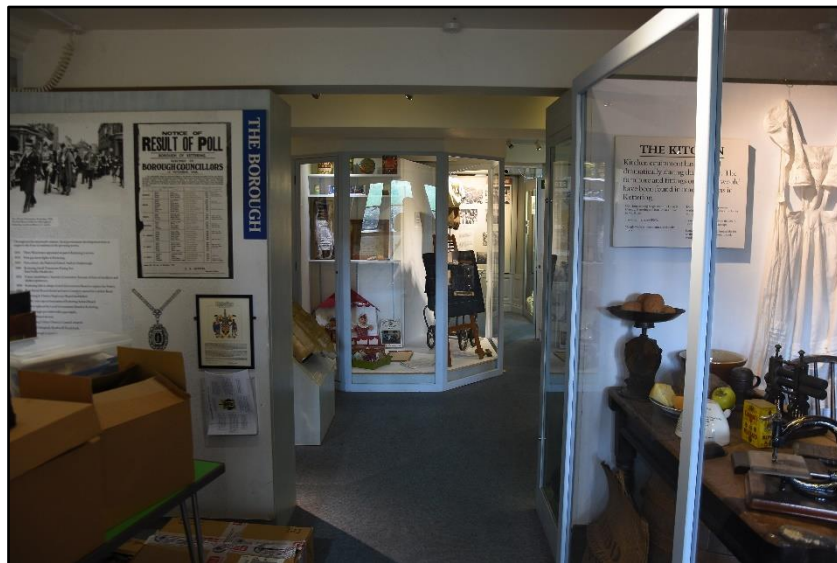
View of the green museum exhibition space (GF03), looking west Fig 54

Housed within the main range and rear range this room extends from the formal front on the west elevation to the rear of the building. The room is largely occupied by museum exhibits including large glass display cases which obscure much of the original fabric (Fig 54).

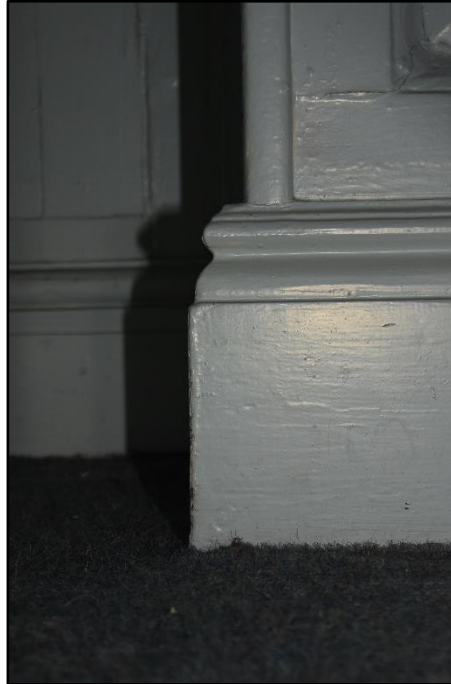
Skirting profile in the green museum space (GF03), looking west Fig 55

The floor is carpeted but a historic skirting with moulding profile is still visible (Fig 55). The panelling is consistent across the room and in the adjoining white museum exhibition space (GF02) described above. A moulded cornice extends around and into the various display cases. There are several boxed-in joists which extend across the room on a north to south alignment. One correlates with a step in the north wall and could represent a former dividing wall, which must pre-date the panelling (Fig 56). Where the current paint has flaked there is evidence of former colour schemes including pale blue and sage green.
