**Historic building recording  
at Manor House Museum  
Kettering GLaM Project  
Northamptonshire  
June 2021**

Report No. 21/073

Accession number: ENN110105

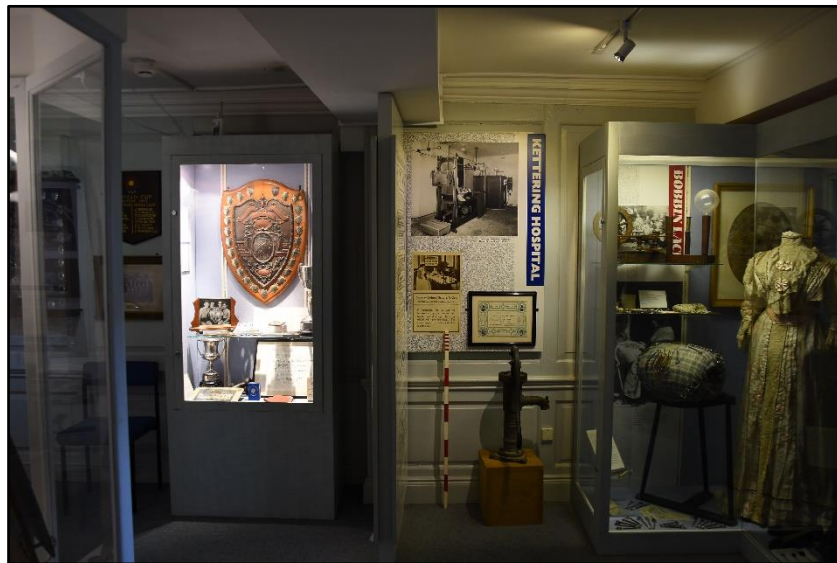
The floor is carpeted but a historic skirting with moulding profile is still visible (Fig 55). The panelling is consistent across the room and in the adjoining white museum exhibition space (GF02) described above. A moulded cornice extends around and into the various display cases. There are several boxed-in joists which extend across the room on a north to south alignment. One correlates with a step in the north wall and could represent a former dividing wall, which must pre-date the panelling (Fig 56). Where the current paint has flaked there is evidence of former colour schemes including pale blue and sage green.

Panelling and former dividing wall position in GF03, looking north Fig 56

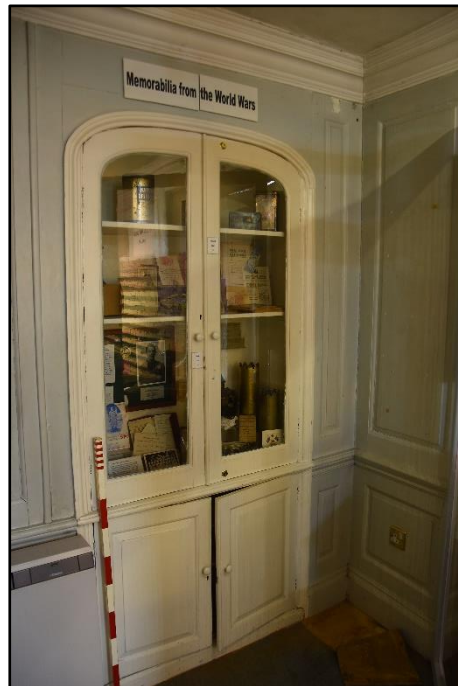
Fig 57

To the south-west corner a single cupboard is set into the panelling. It has a cambered arched head with upper and lower cupboard doors; the upper examples are glazed (Fig 57).

Cupboard in the green exhibition room (GF03), looking south-west

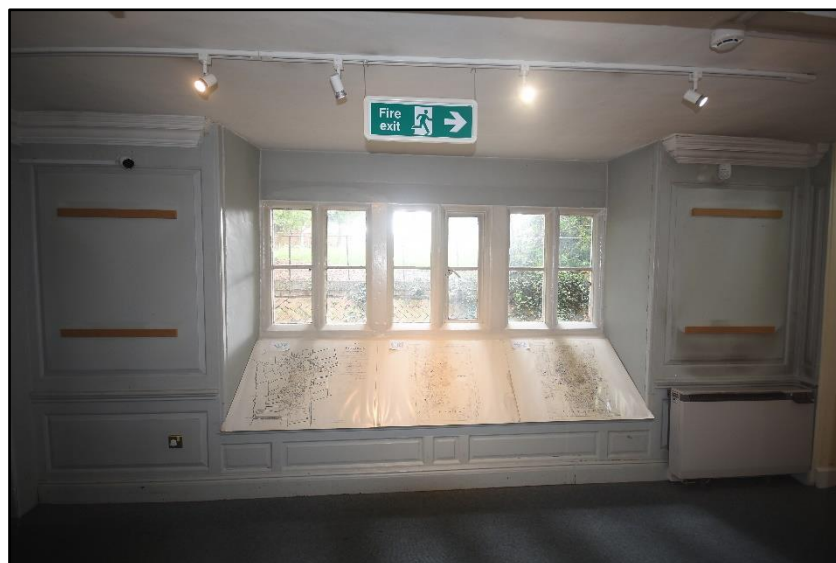
To the east wall the large six-light window with stone mullions seen externally is present (Fig 58). It has a large sloping sill currently used as a museum display, so

could be a modern insertion. The panelling and cornice to the north and south respect this aperture. The off-centre casement window has a simple catch.

Stone mullion window in the green exhibition room (GF03), looking east Fig 58

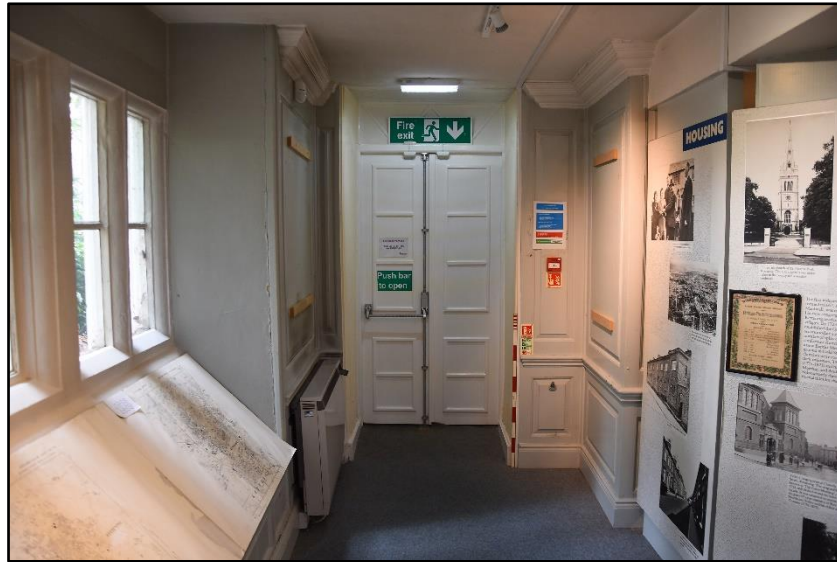
To the south-east the fire door located on the south elevation is visible (Fig 59). The floor level rises here and the aperture itself is fairly plain but the cornice returns into the wall either side. The door appears modern.

Fire door visible within GF03, looking south Fig 59

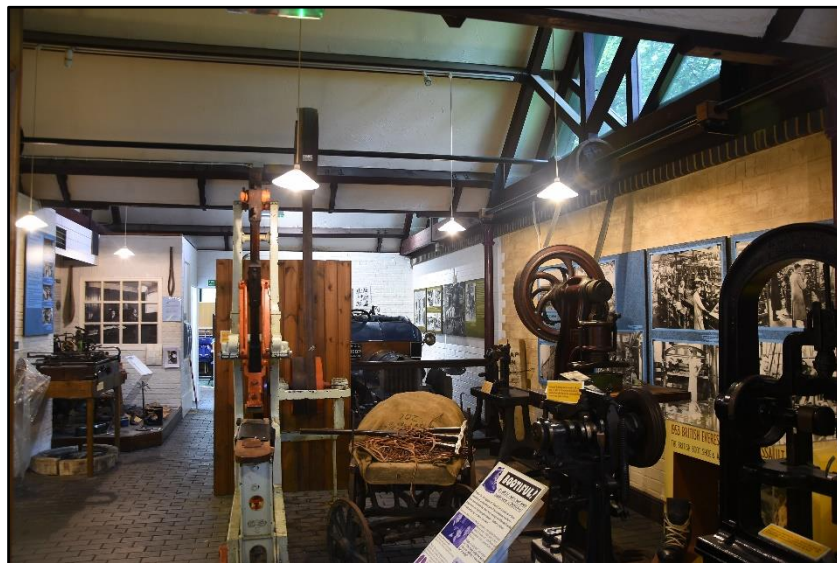
View of the museum range (GF06), looking north Fig 60

The museum range extends along the north and east elevations of the historic ranges and comprises a L-shaped space housing the museum's larger exhibits. As noted externally it is created using a series of individual gabled roof pitches extending east to west (Fig 60). The floor is blue bricks throughout and various museum exhibits, including a car, some machinery and several display cases obscure the view of the structure.

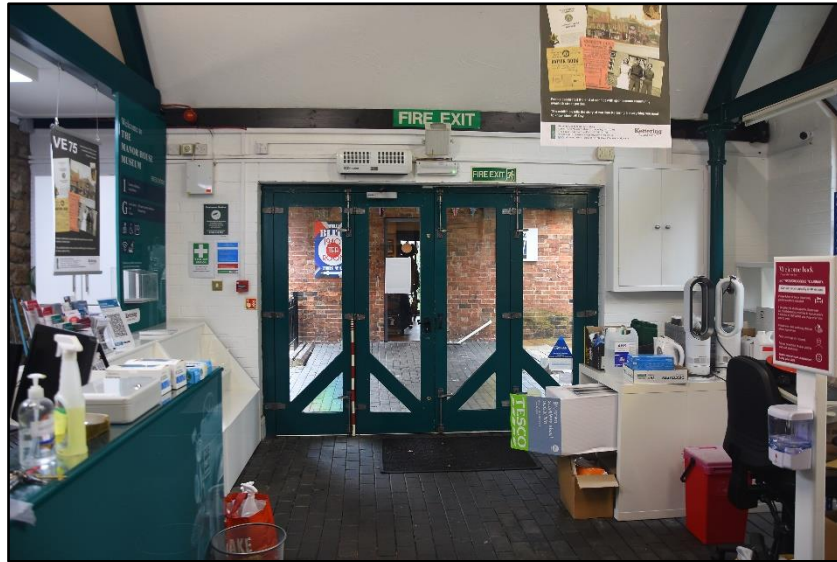
The long east wall is laid in stretcher bond with a top course of blue brick below the glazed gable ends above. The wall to the north is laid in Flemish bond, with no obvious reason for this distinction. The windows are a mixture of timber and glass and are all full height and multi-paned. The main entrance to the museum lies to the west through a set of double doors with side panels (Fig 63).

Main entrance into the museum within GF06, looking west Fig 63

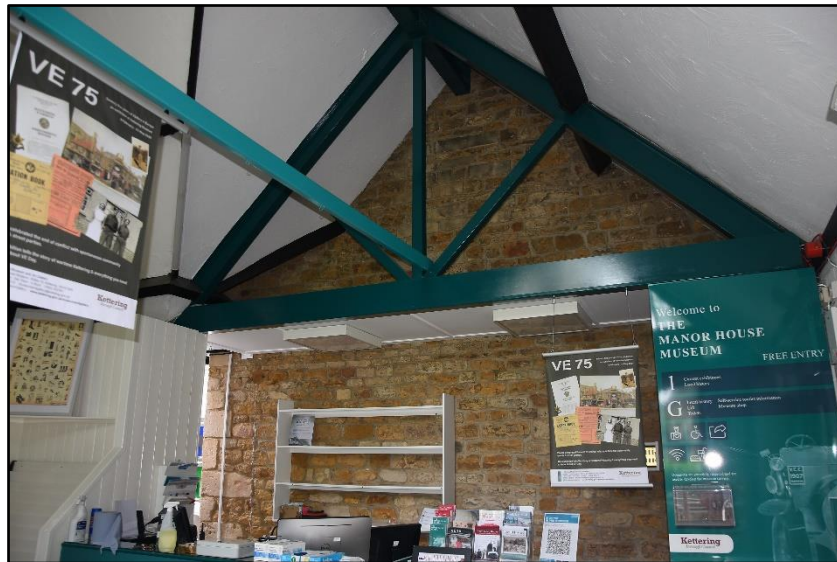
To the south-west the north wall of the northern range is visible (Fig 64). It is construction of coursed rubblestone as seen before, and there are ashlar quoins to the range's north-east corner. The east wall of the north range is also encompassed within this space but is rendered and painted.

Exposed north formerly external wall of the north range within the museum range (GF06), looking south-east Fig 64

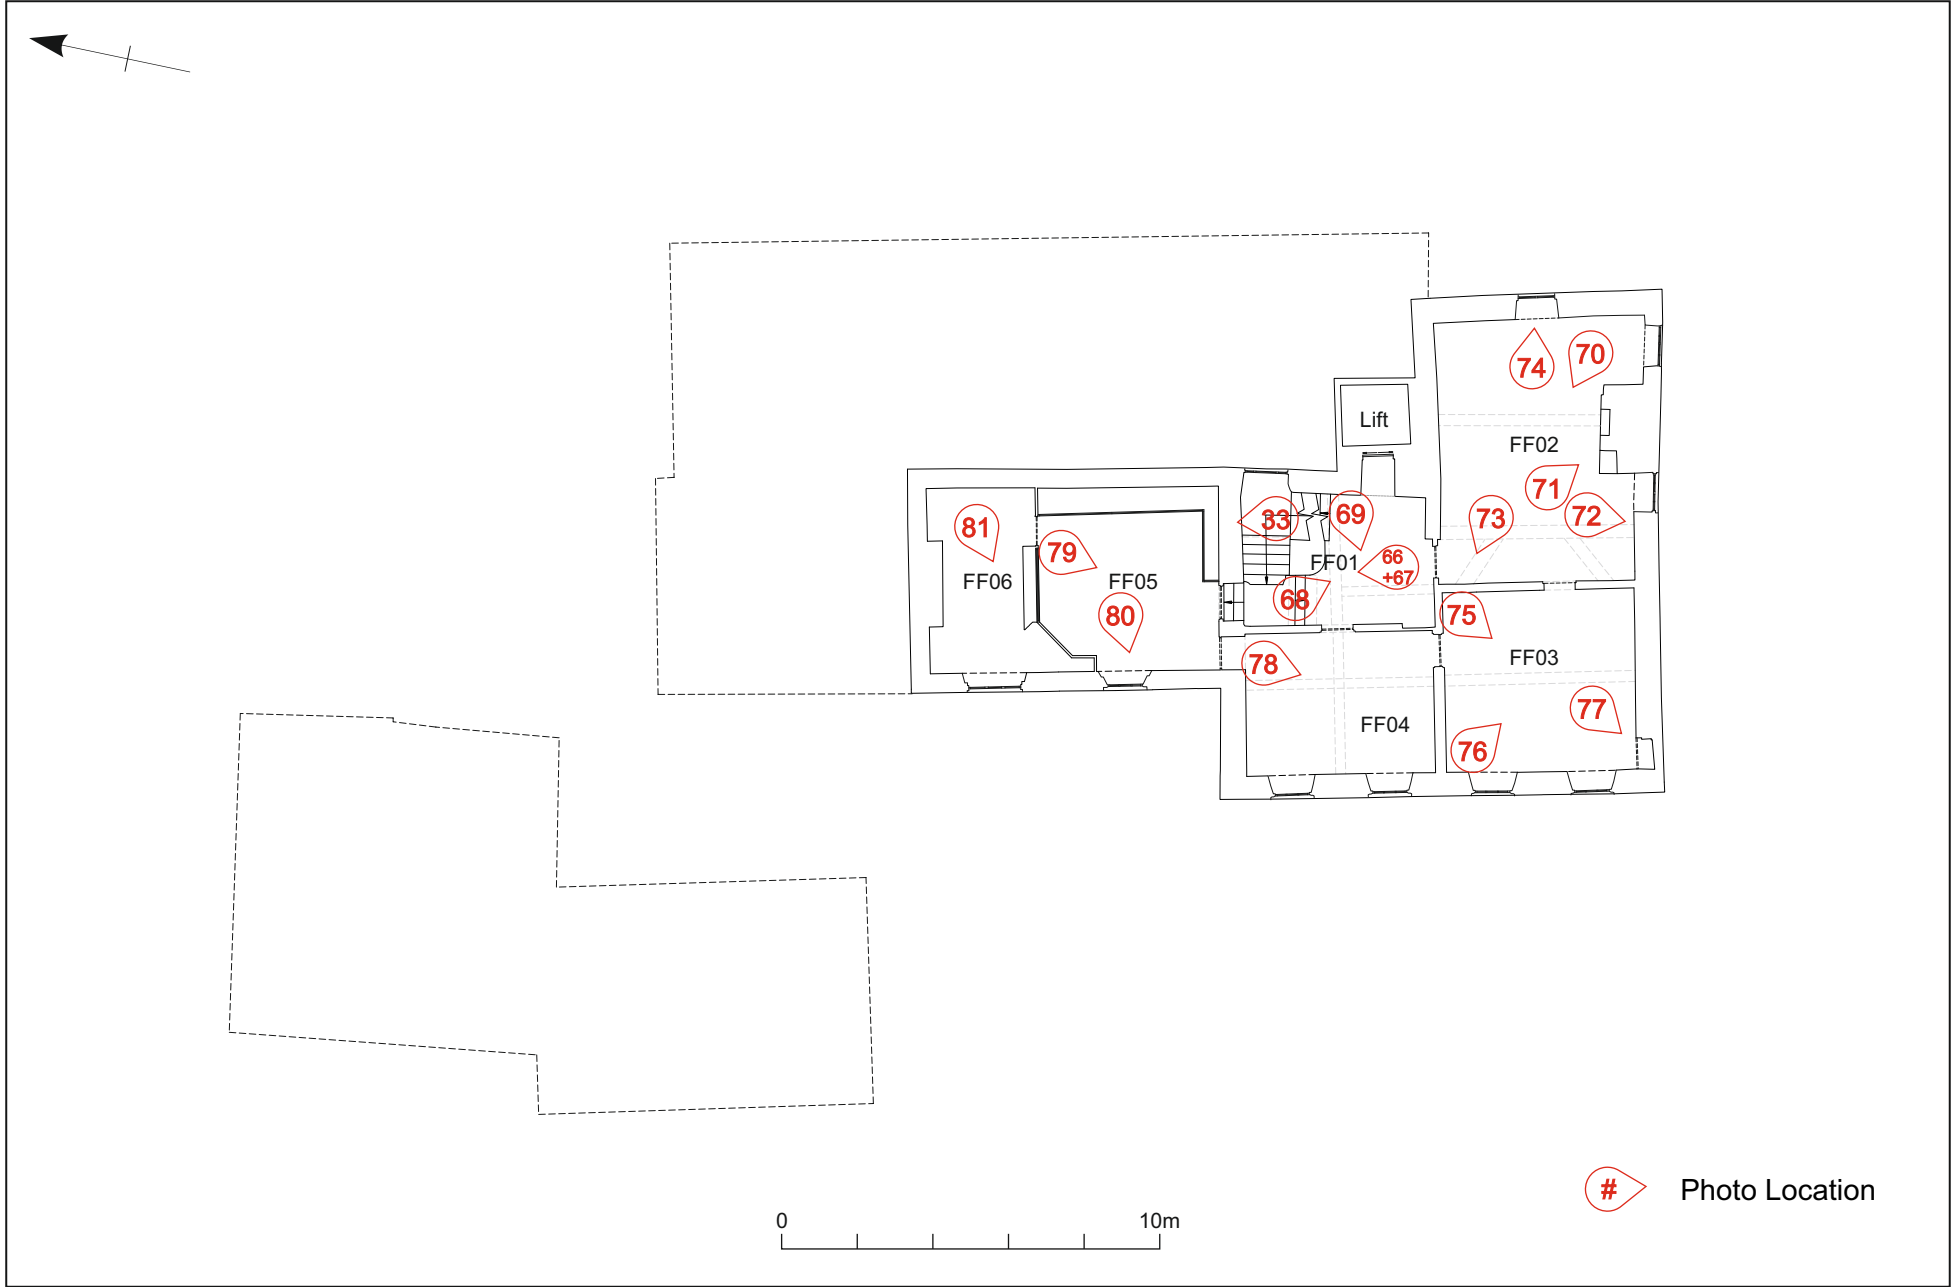
Fig 65

First floor plan with photographic locations

The access to the first floor is via the staircase mentioned in GF01 above. This rises to the landing (FF01) from which gives access to the other spaces on this floor. The first floor comprises rooms within all the major ranges except for the museum range (Fig 65).

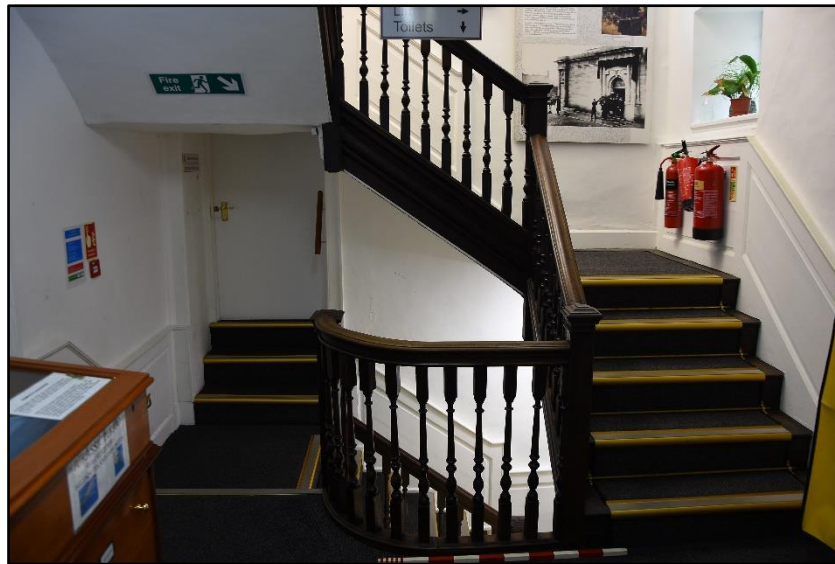
The stair rises as described above with a curve to the balustrade on the landing (Fig 66). A join in the timber is visible along this curved section. The panelling continues on the opposing wall but is interrupted on the half-landing with a door providing access to room in the north range; this door retains a historic surround and two steps. The stairs continue with a short straight flight to the main landing area. To the ceiling a single north to south joist with chamfers extends between a wall-plate with chamfer set into the south wall, and an east-west joist above the stairs which also has chamfers (Fig 67).

View of the landing to the first floor (FF01), looking north Fig 66

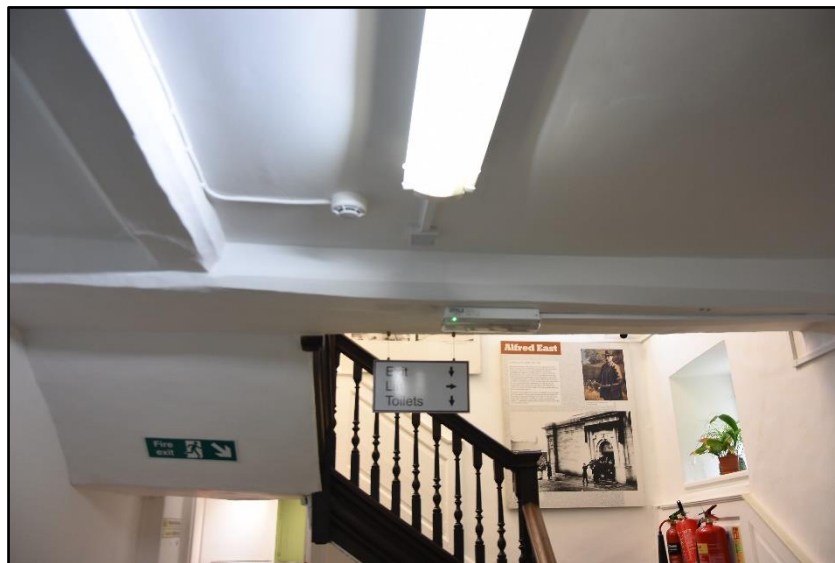
Ceiling joists to the landing in the main range (FF01), looking north Fig 67

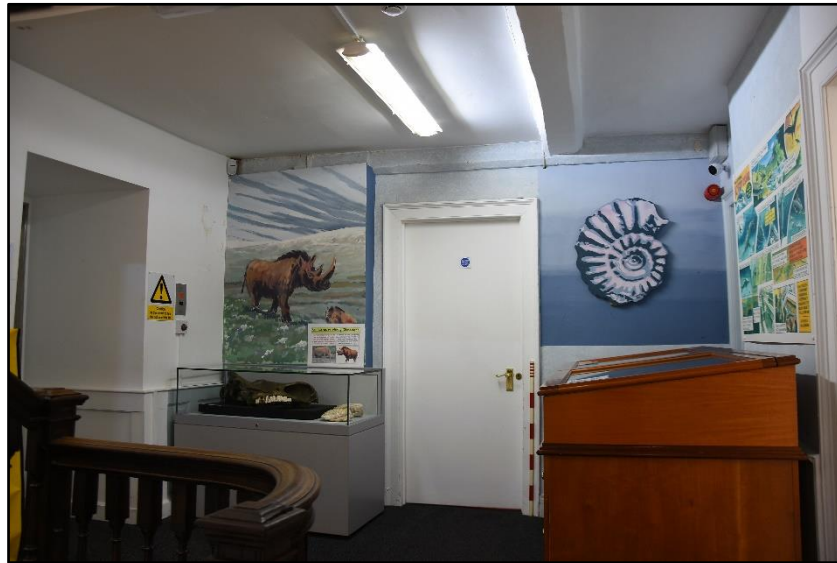
Fig 68

To the east the lift access cuts through a deep section of wall and the dado rail continues into the deep reveal (Fig 68).

View of the landing (FF01) in the main range, looking south

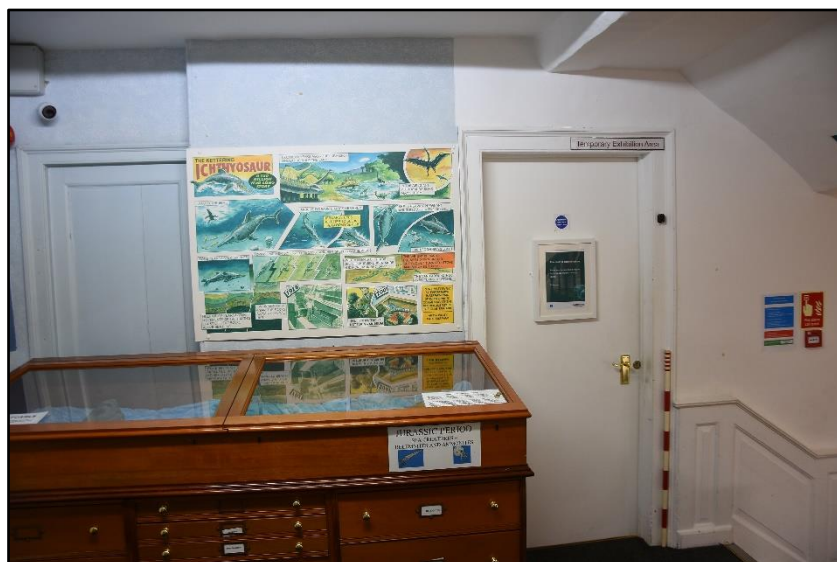
On the west wall a slight adjustment to the wall line is evident to the south end (Fig 69). Here a blocked door retains the same surround as elsewhere with a panelled door.

Door leading to FF04 (right) and a blocked door (left) on the landing (FF01), looking west Fig 69

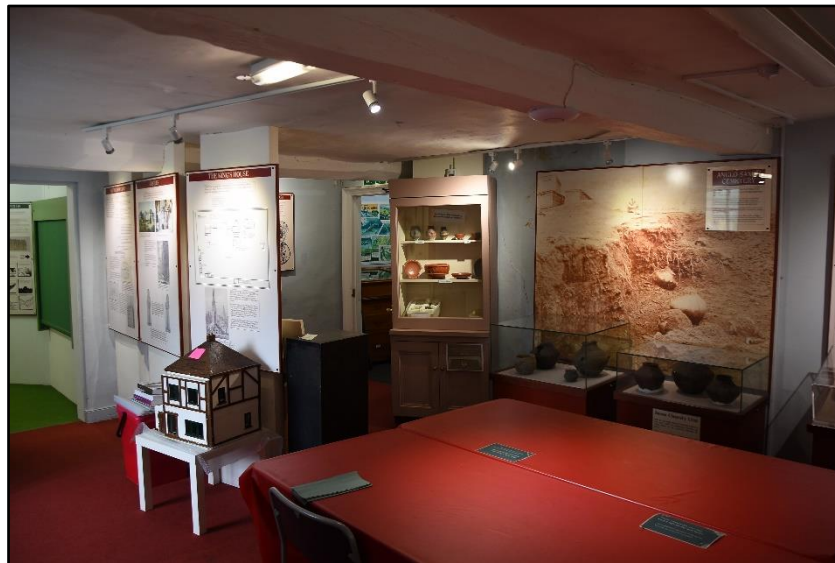
It has a carpeted floor, a simple skirting and plaster walls which show some irregularity (Fig 70). There is no cornice and the ceiling is also plastered with noticeable areas of bowing. Several north-south extending joists of considerable robustness extend across the room. They measure 30cm deep and 20cm wide (11¾" by 7¾").

View of the blue exhibition room (FF02), looking north-west Fig 70

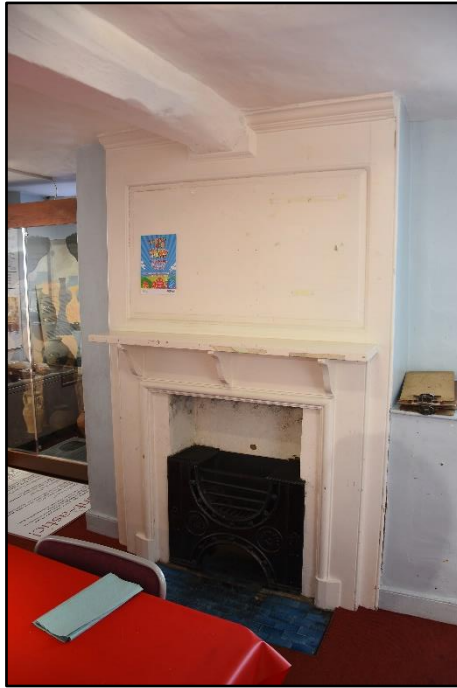
The eastern example extends from the large chimney stack (Fig 71) on the south wall, it is chamfered and stopped to both sides but these stops to the south are partly obscured by the stack. The western example is only chamfered and stopped to the east face (Fig 72), this corresponds to a misalignment in the north wall, perhaps suggesting a former room division here. No empty mortises on the soffit of this joist were noted. To the west of this joist two diagonal joists of slender profile extend in a south-easterly and south-westerly direction before meeting the western wall of the room (Fig 73). In addition, the ceiling to the west of the joist here steps up by an extra c10cm.

As mentioned, the south wall retains a large chimney stack with chimney piece of simple bolection moulded surround with simple shelf, below a moulded fielded panel and cornice. The grate is cast-iron and glazed blue hearth.

Chimney stack in the blue exhibition room (FF02), looking south-east Fig 71

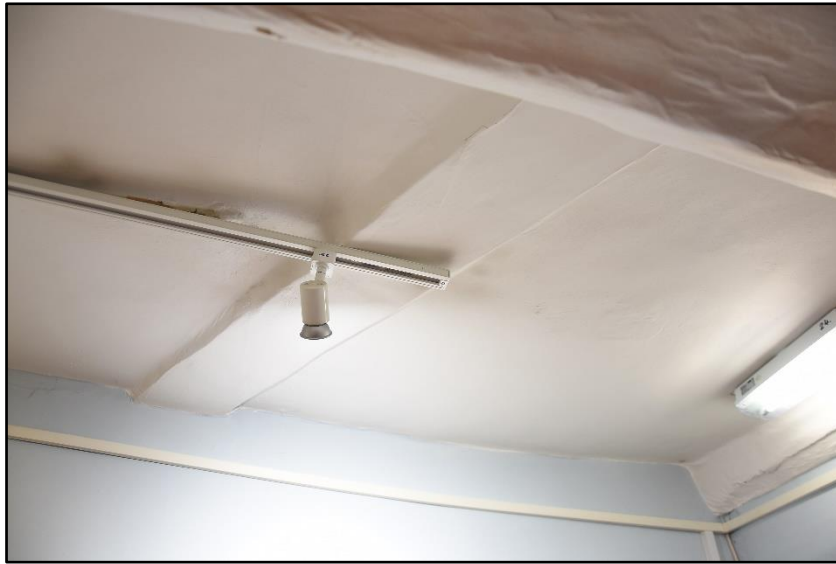
Diagonal beam in FF02, looking west Fig 73

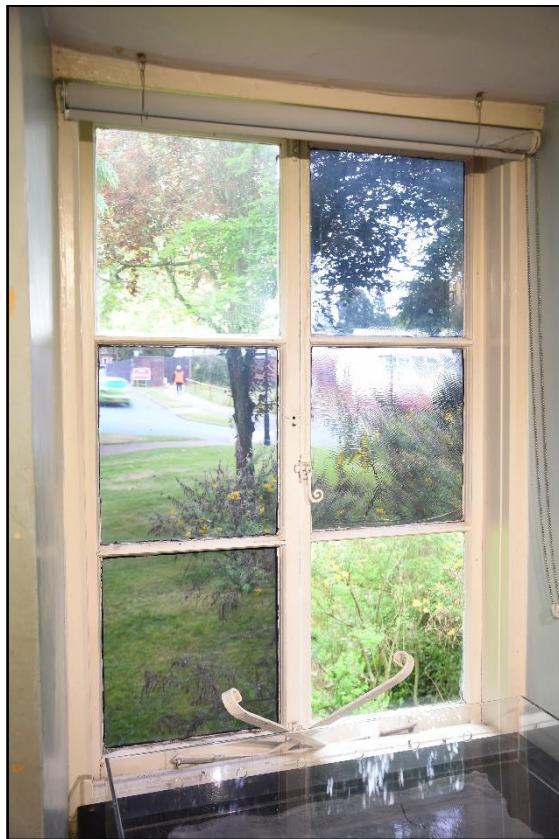
One of the windows is visible to the east and retains a scrolled catch to the casement (Fig 74). The obscured glass and two long stay bars suggesting both lights open.

Window in the blue exhibition room (FF02), looking east Fig 74

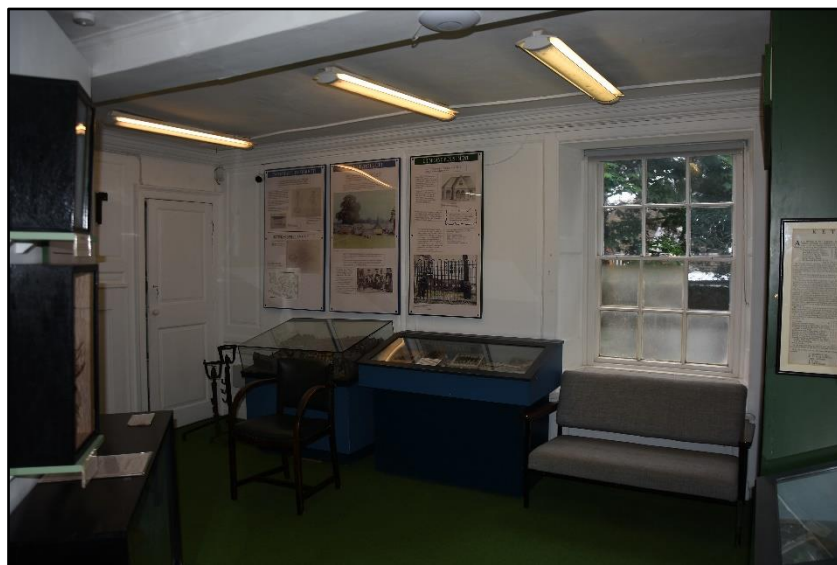
Fig 75

The room is carpeted with similar panelling as is seen elsewhere, apparently extending around the room (Fig 75). There is no surviving skirting on the east wall or across the fireplace. A ceiling beam, square in profile with simple moulding, extends north to south and carries a simple moulded cornice; this measures 30cm wide and 17cm deep (11¾" by 6¾").

View of the green exhibit room (FF03), looking west

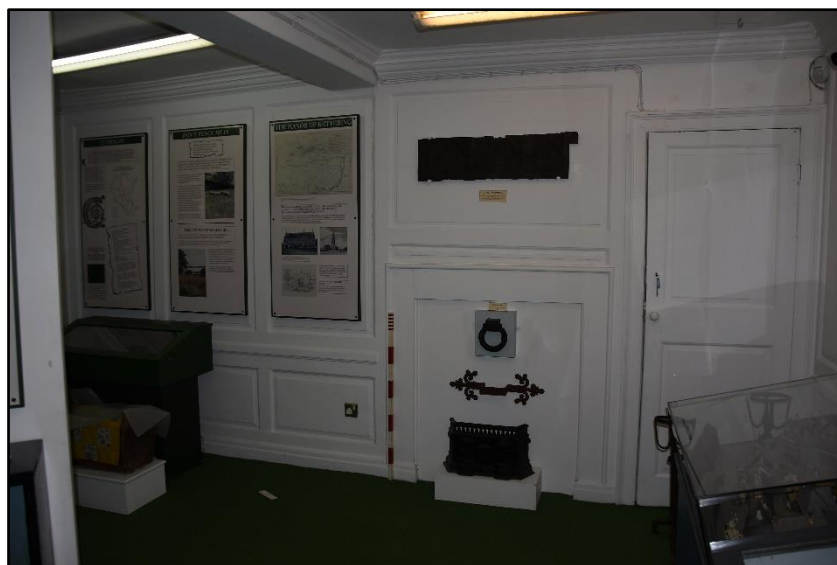
Fig 76

A blocked fireplace sits on the south wall which the panelling seems to respect. It has a simple timber surround and is fairly plain (Fig 76). A cupboard to the west of this has a moulded surround with two-panel door. The door sits on I-hinges with a simple doorknob. Internally it is fitted with shelves and the door has a lock case to the rear (Fig 77).

Fireplace in the green exhibit room (FF03), looking south-east

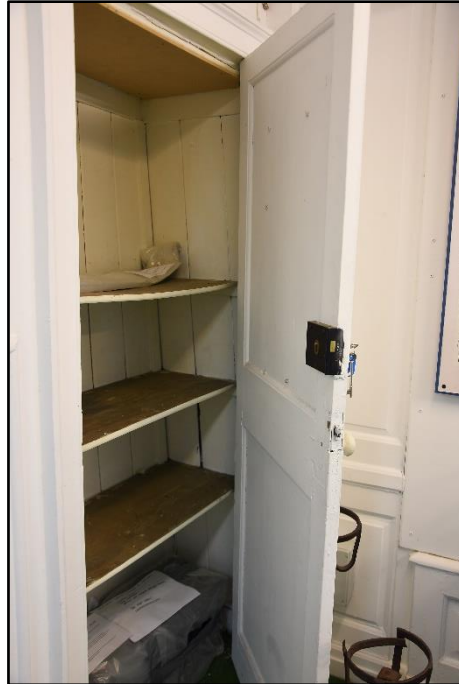
Fig 77

Interior to the cupboard in FF03, looking south-west

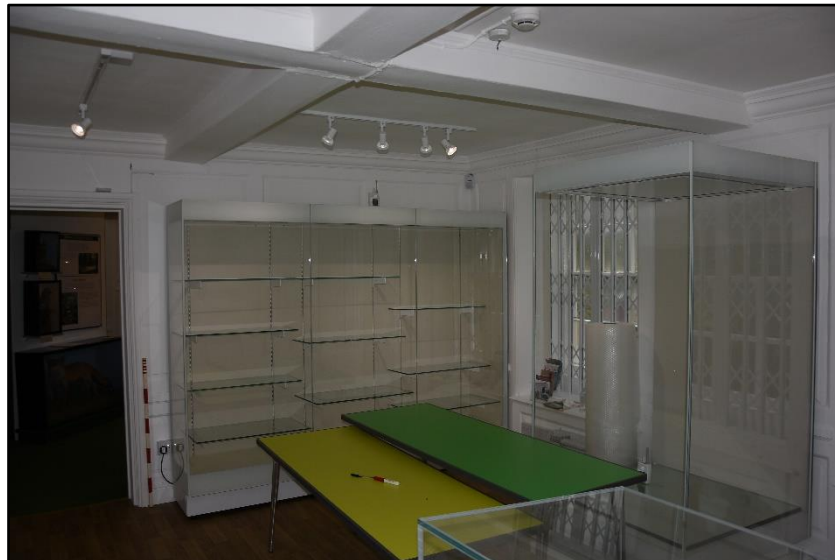
Fig 78

This room is housed within the main range along the formal west front. The room is used to house temporary travelling exhibitions and as a result several display cases are present within the room which partly obscures the fabric (Fig 78).

View of the white exhibition room (FF04), looking south-west

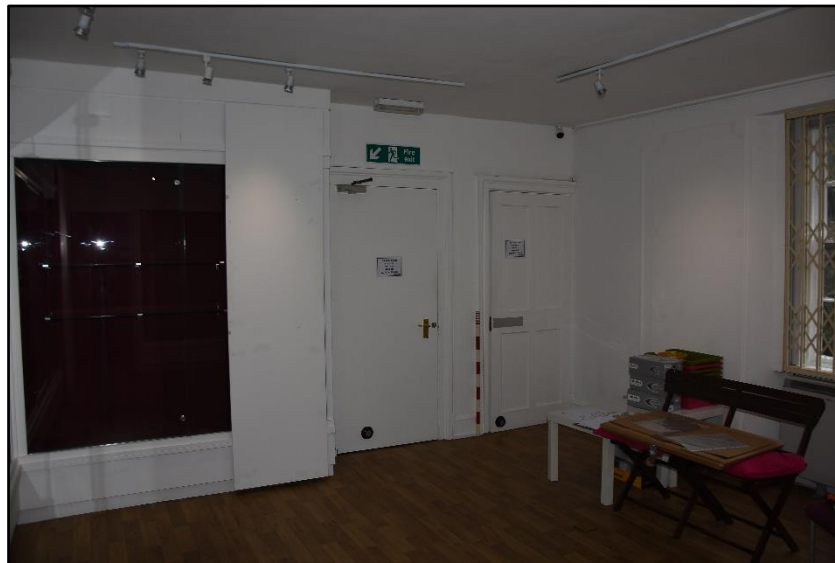
To the south wall another door provides access from the landing (Fig 79). It retains a historic frame and four-panelled door and enables access to the main range from FF04.

View of the temporary exhibit space (FF05), looking south-west Fig 79

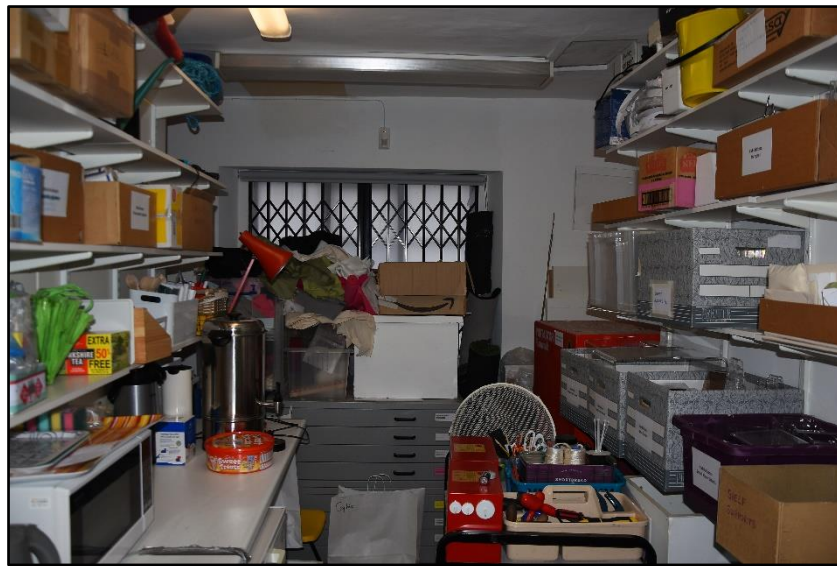
The north wall holds a single door giving access into staff kitchen (Fig 81). This room retains nothing of interest except the loft hatch to the roof above (described below). The window to the west wall is obscured by modern security bars.

View of the staff kitchen (FF06), looking west Fig 81

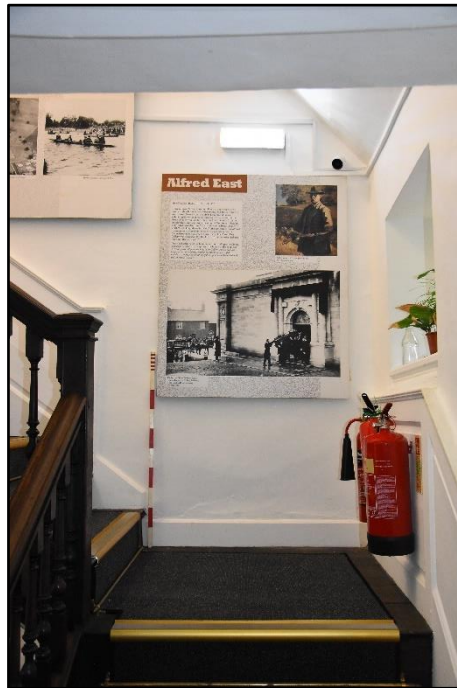
The stairs are carpeted but floorboards are exposed in places and measure 24.5cm-27cm (9½"-10½") wide. As the stair rises the panelling on the opposing wall mirrors this, but stops to the north in an area of half-landing before continuing to the west (Fig 83). There could have been a former opening here, but this is not reflected in the existing north range, whose floor levels do not correspond to this arrangement.

Half-landing between first floor and second floor, looking north Fig 83

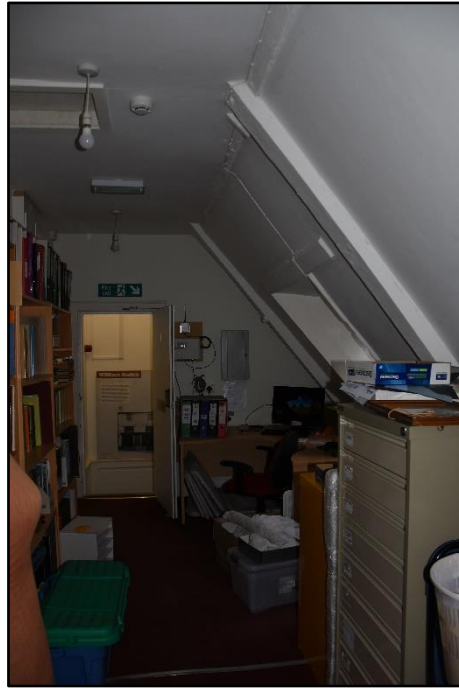
This area is housed within the roof space over the main range and gives access to other storage areas to the west and south (SF02 and SF03), as well as another office space housed within the roof space over the rear range (SF04) (Fig 85). The doors to these rooms are all modern but have historic frames with the same moulding, except for the example leading to the rear range (SF04). This door also cuts through the roof pitch in this area and appears slightly awkwardly arranged.

Office space within the second floor (SF01), looking north Fig 85

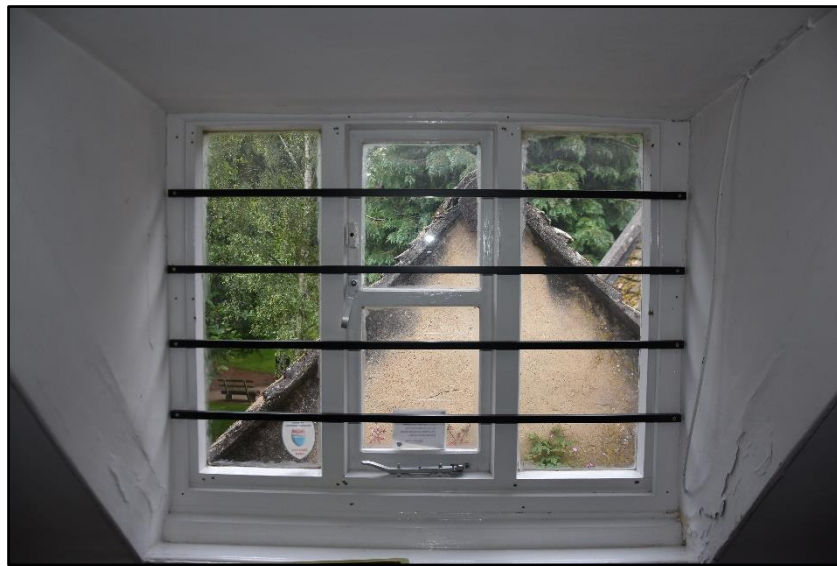
The room is carpeted with no skirting to plaster walls. There is a dormer window to the east, and though the window is modern, the sill appears historic (Fig 86).

Dormer window in the office space to the second floor (SF01), looking east Fig 86

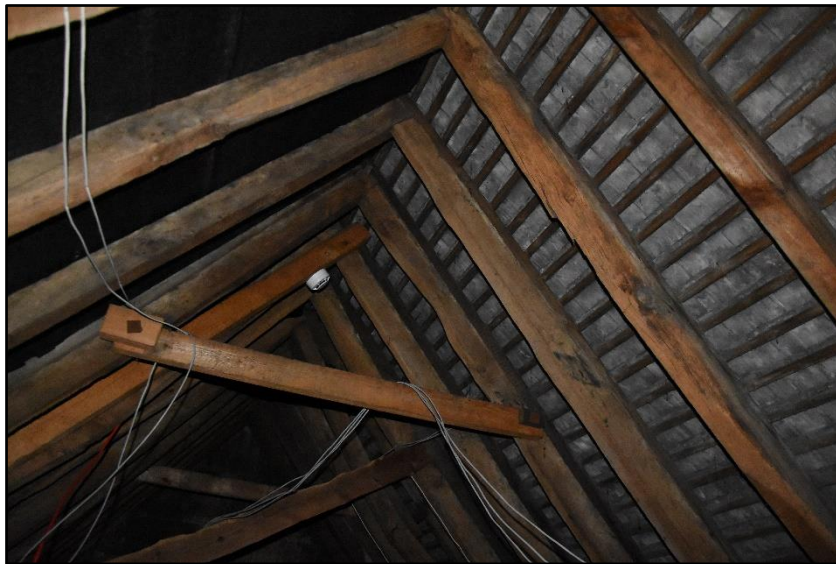
Several roof timbers are exposed in this area and comprise simple rafters with a purlin which appears to ride over the backs of the rafters. The roof is further visible through a roof hatch. From here the tops of the rafters are visible and these comprise simple coupled rafters pegged at the apex. There are some inconsistencies between the north and south ends of the roof space (Figs 87 and 88) and there appears to be more replacement timbers at the north end of the roof. However, no thorough investigation could be conducted due to access issues and thus no firm conclusions could be reached.

South end of the roof over the main range, looking south Fig 88

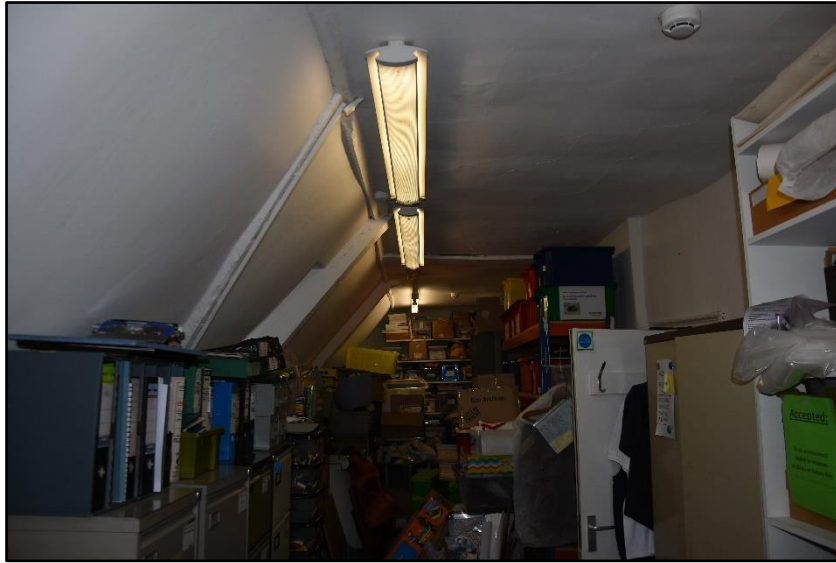
This room is housed in the main range to the west and is only accessed through the adjoining room (SF01). It is currently being used as a storage area for the museum and as a result very little fabric was visible (Fig 89).

View of the storeroom on the second floor (SF02), looking north Fig 89

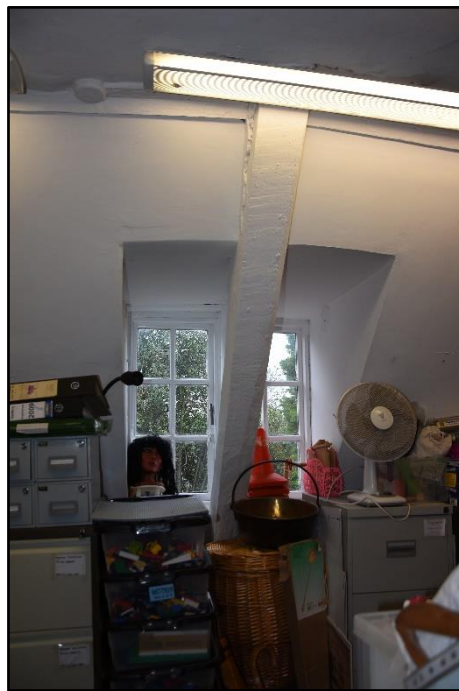
At the north end two rafters rise from the wall-plate, one cuts through a dormer window which then forms part of the central mullion with boarding (Fig 90). The window is 20th century in date. Several of the timbers show evidence of carpentry markings in the form of saw marks.

Rafter to the roof over the main range in SF02 cutting a dormer window, looking west  
Fig 90

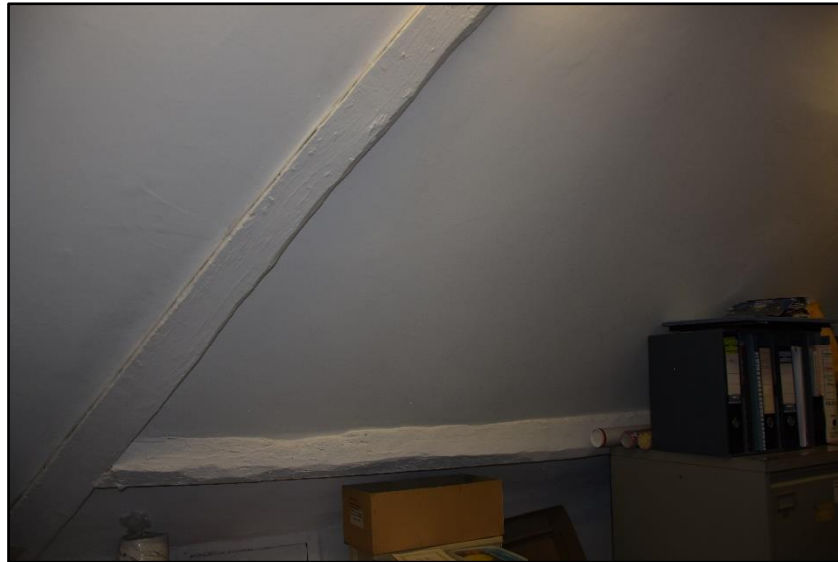
To the south the rafters frame a hip with collar, but the visible wall-plate continues across (Fig 91).

Hip rafters in the roof over the main range, looking west Fig 91

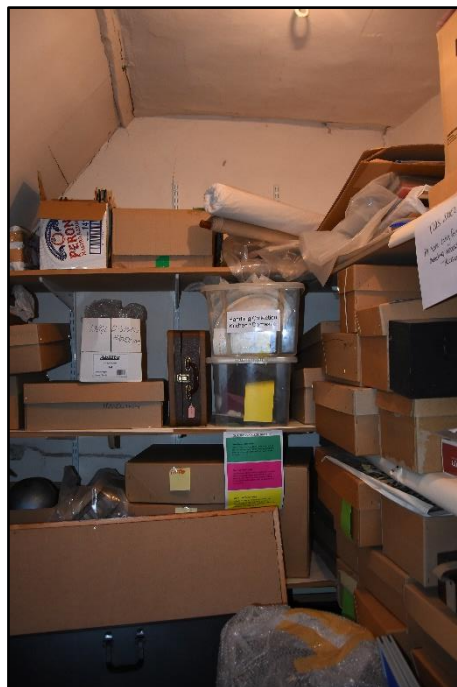
This space is housed with the eastern pitch of the roof over the main range. It is used as an additional storage area (Fig 92) and as a result very little fabric was visible. The upper purlin and wall-plate are partially visible to the east and carry through from the main space (SF01).

Cupboard (SF03) to the south of the main office space, looking south Fig 92

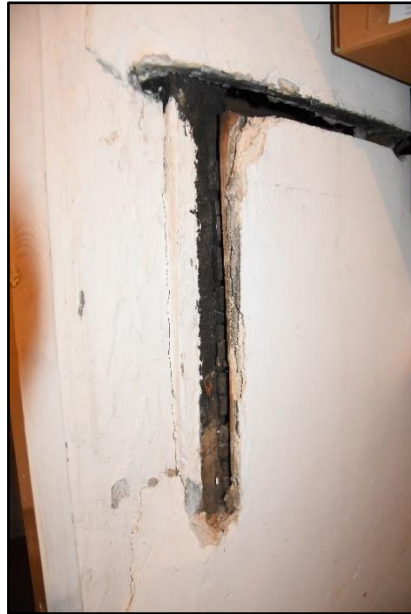
A stud and rail are visible to the west of the door on the north wall (Fig 93). Some laths appear exposed suggesting this partition is of some age.

Stud and rail exposed within the cupboard (SF03), looking north-east Fig 93

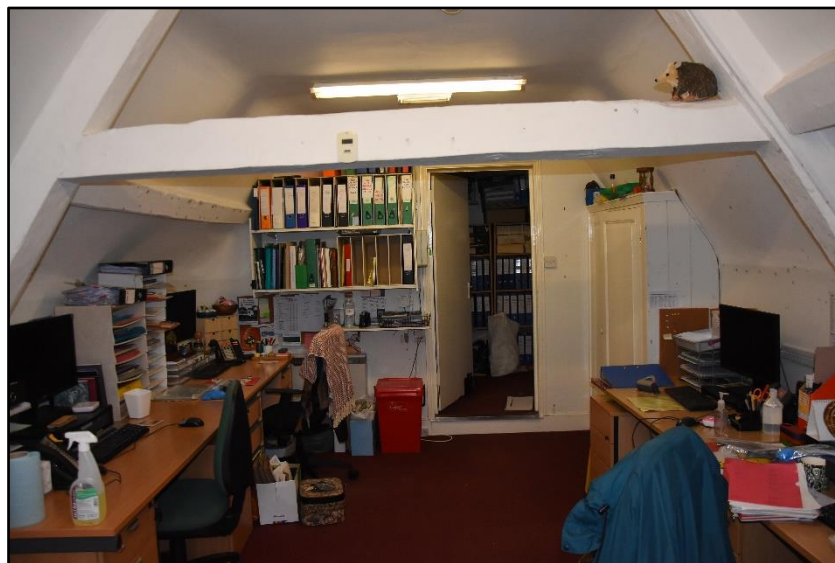
The exposed roof structure comprises a single truss (Fig 94). This is formed of principal rafters rising through the space and triangulated by a double-pegged collar. To the south pitch a single purlin extends westwards, but there is an empty mortice for the corresponding lost elements to the east face (Fig 95). To the north side of the roof one purlin extends eastwards, but there is no evidence of an empty mortice for the corresponding member to the west.

Office space (SF04) over the rear range with truss exposed, looking west Fig 94

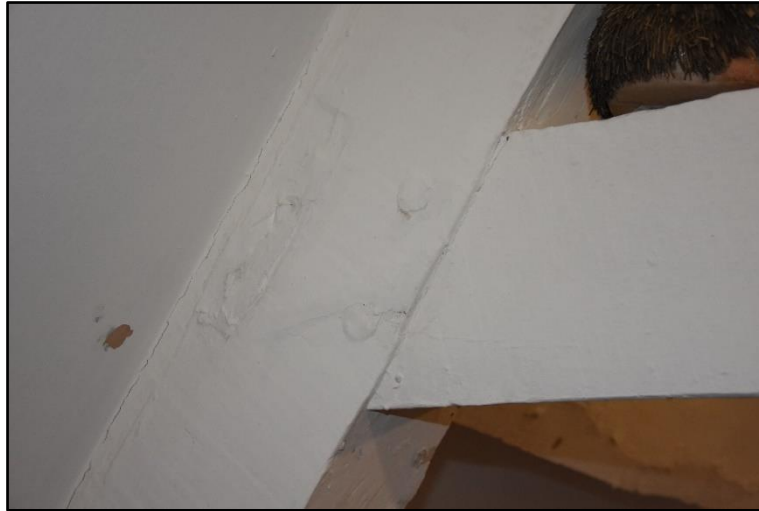
Empty mortise to the east face of the truss in the roof over the rear range, looking west Fig 95

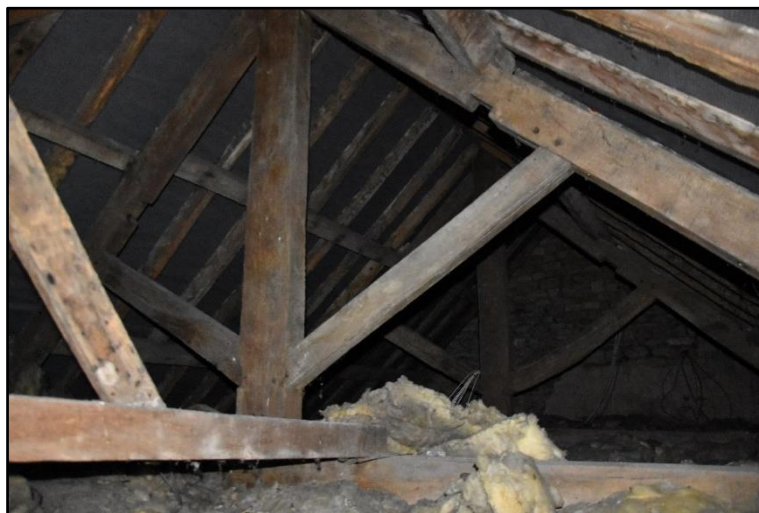
This roof is accessed from a small hatch in the staff kitchen (FF06) which is described below. The roof form comprises a king-post roof with two trusses of simple form constructed from robust timber, likely softwood (Fig 96).

The trusses form the roof structure with staggered purlins, which are notched over the backs of the principal rafters, two to each pitch, over which the common rafters rise to the apex. At least one empty mortise with peg hole is visible to the western lower purlin.

At the north end the hip to the roof is supported by two struts rising from two additional bridging joists which extend from the tie-beam to the wall-plate.

Roof structure over the north range, looking south-east Fig 96
