**Archaeological building recording
at The Old Red Lion
Clipston, Northamptonshire
October 2013**

DA/2013/0410

Report No. 14/61

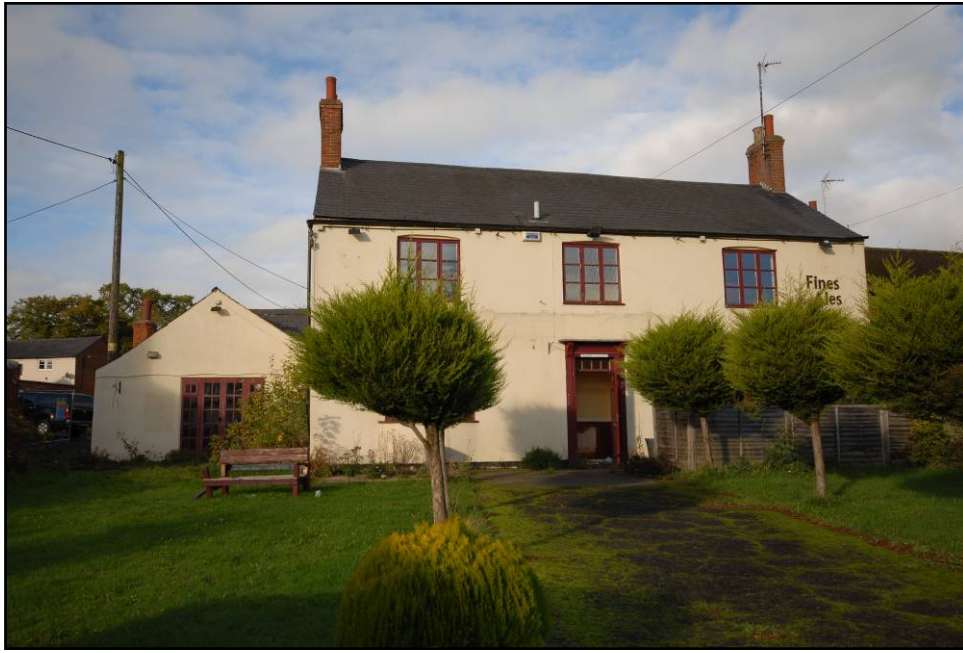
Front elevation of the Old Red Lion, looking west Fig 6

The core building comprises a rectangular plan (12.60m x 7.40m) fronting Nasby Road. It presents a two storey, three bay frontage, with the southern single storey extension visible and additional single storey extensions to the rear. The building is constructed mainly of red brick with the lower half of the north elevation and the extensions a coursed local yellow-orange ironstone, a typical building material in the area (Figs 6-9). A photograph labelled pre-1920s shows bare brickwork. The pub had been whitewashed, visible on earlier photographs dating to the 1960s and 1970s. By the turn of the century the east elevations of the house and extension and south elevation of the house were rendered and painted light beige.

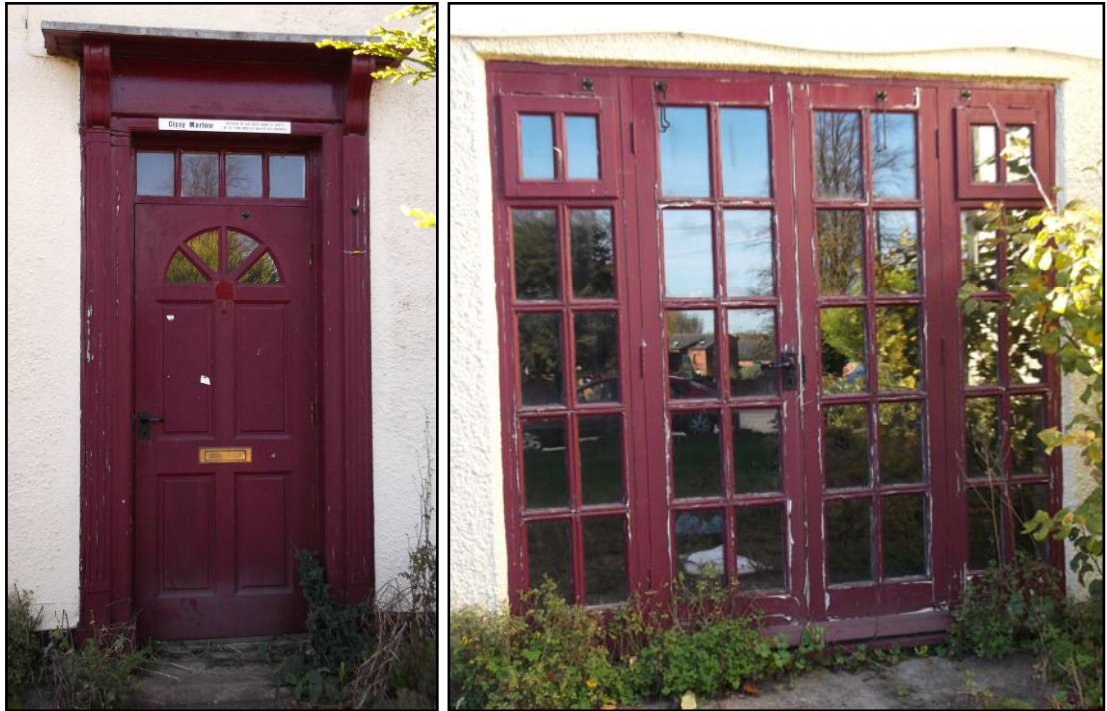
The main entrance and French doors, looking west Fig 10

The main entrance is through a central doorway with a wooden moulded frame, a panelled door with a fanlight, and a transom window (Fig 10). There is also a set of French doors exiting from the restaurant area to the front of the pub (Fig 10). An application for their installation was made in 1994. All exterior woodwork has been painted the same burgundy red colour.

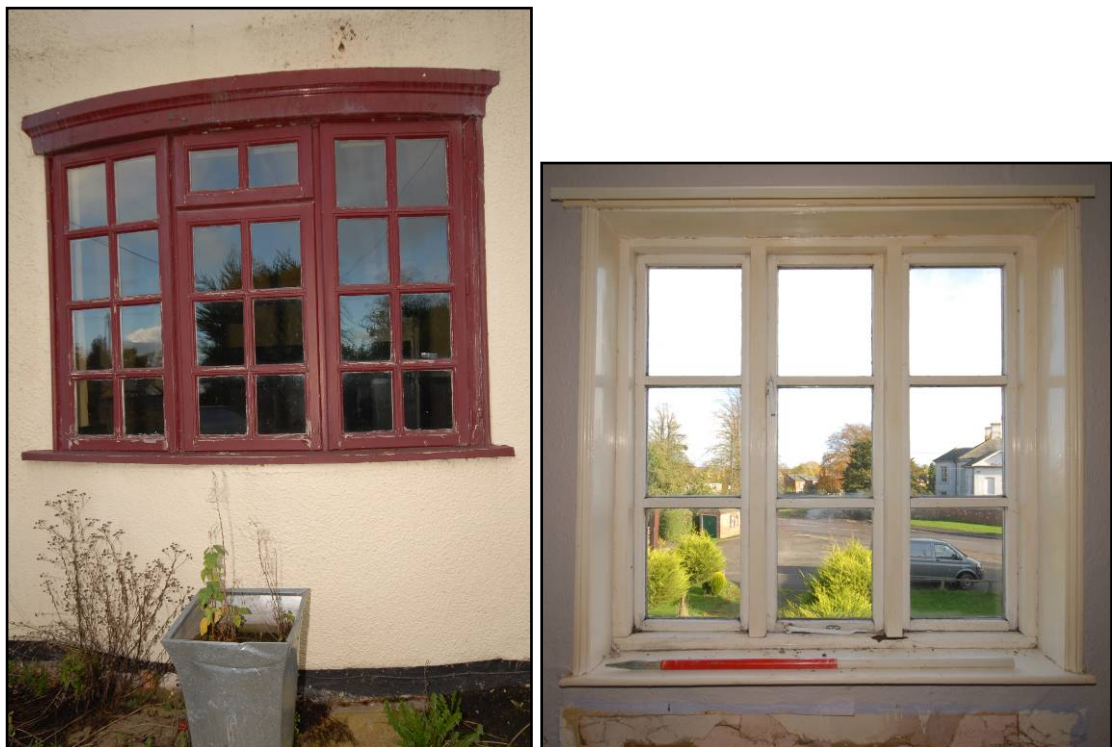
New bow window and first floor windows Fig 11

The wooden encasement windows are not original. The windows are typically nine-light with the central panel opening (Fig 11). Also the two cant bay windows visible on the Ordnance Survey maps (Figs 3 and 4), the old photographs, and the aerial photograph (Fig 5) have been altered to bow windows (Fig 11).

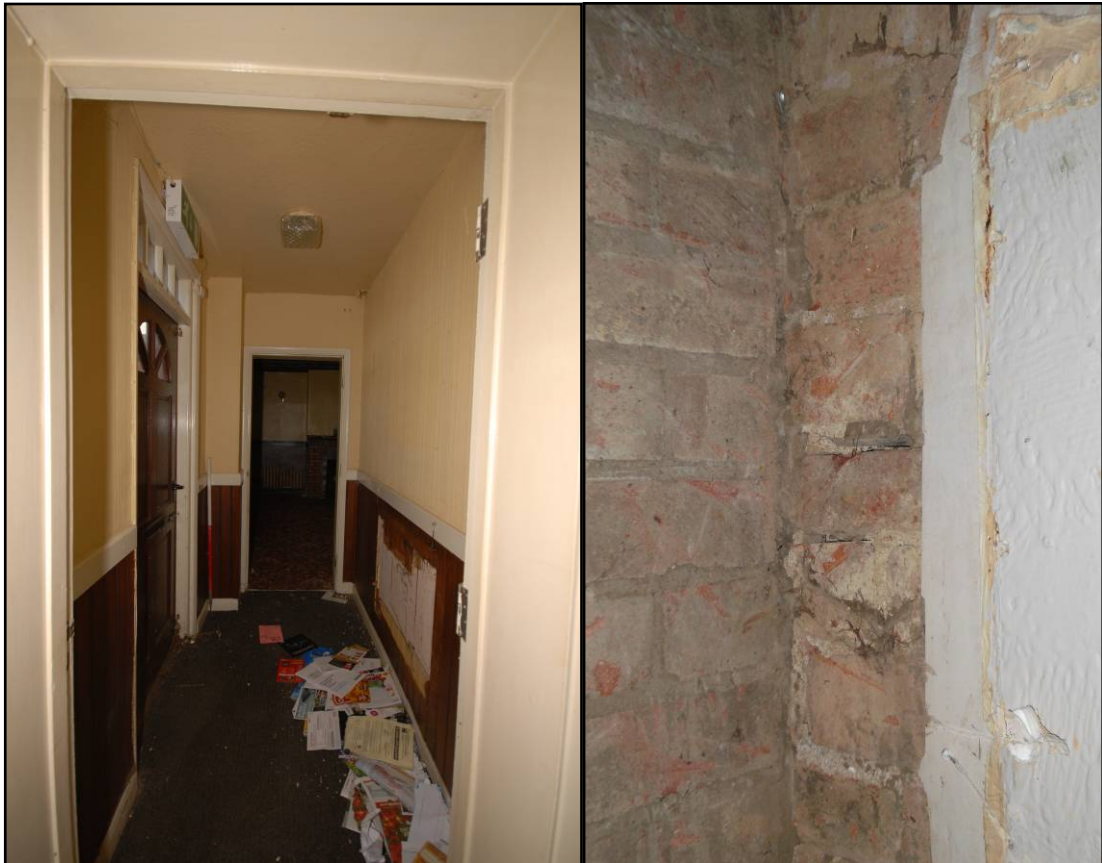
Lobby, looking south and the different brick work of the western wall (left) Fig 13

Originally the front entrance would have let into a central hallway running most of the length of the building. Due to the extensive remodelling and the presence of plaster on the walls it was not possible to discern where the access to the Lounge and the Bar would have been before the western wall created the lobby. The removal of plaster on the rear of the wall revealed it to be different brick work (Fig 13).

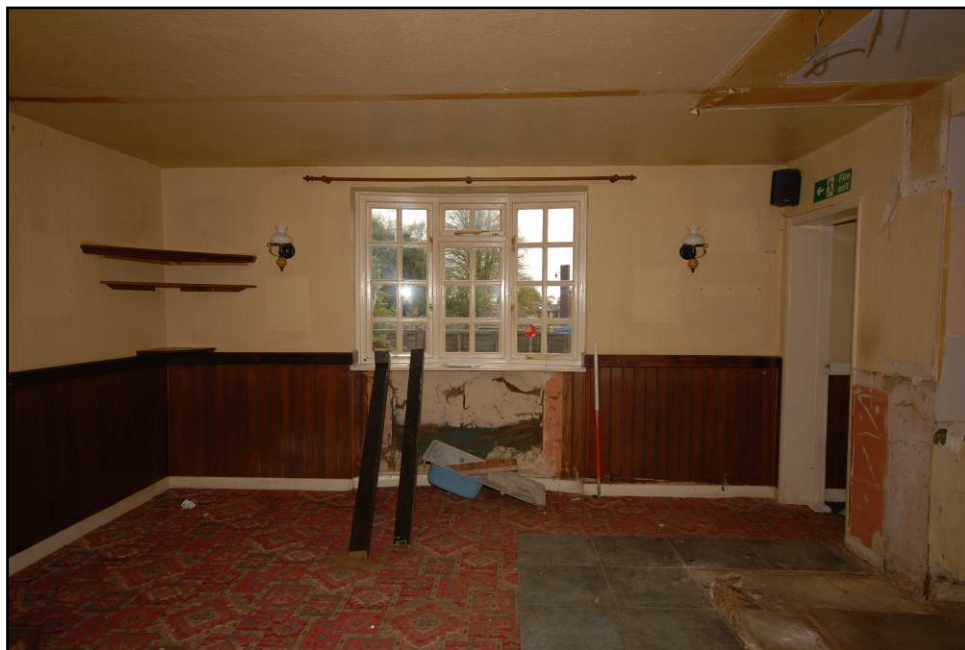
The Bar area, looking east Fig 14

The Bar area formed the northern part of the building (Fig 4). The lower part of the walls were clad in dark brown stained tongue and groove pressed MDF type imitation panels capped with dark brown painted dado at a height of 1m. The remainder of the walls and the ceiling are beige painted woodchip wallpaper. In a hole in the ceiling the original lath and plaster construction could be observed. Two dark brown stained pine beams, arranged north to south, were fixed to the ceiling as a decorative detail. The concrete floor laid with a red patterned carpet, except around the bar and fireplace grey ceramic tiles had been laid (Figs 14-18).

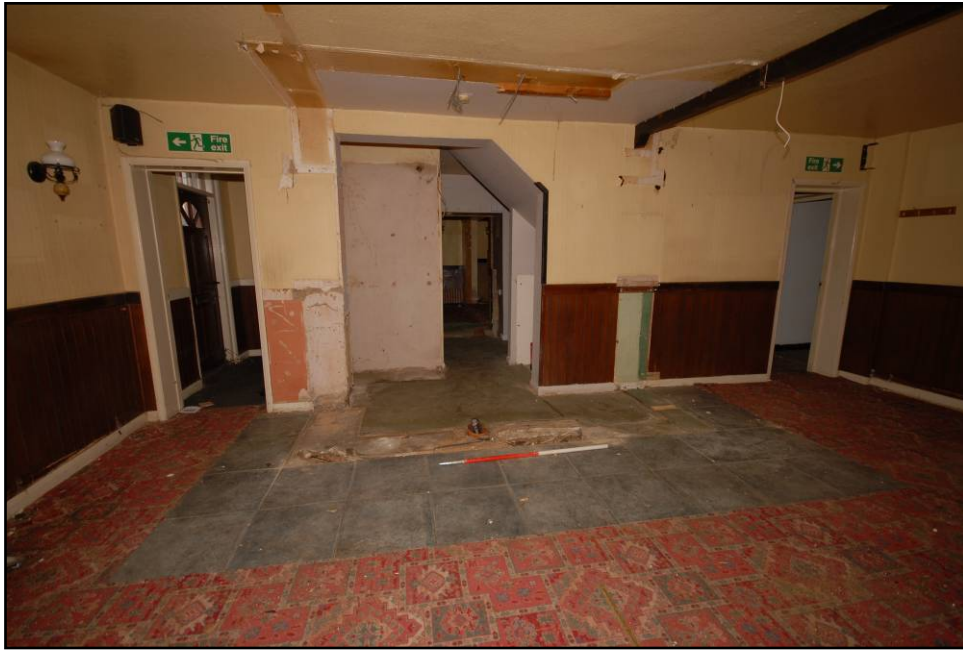
The Bar area, looking west Fig 15

A bow window is in the eastern wall (Fig 15). The southern wall has two doors and a part of the wall has been removed to allow for the new Servedy (G9) configuration (Fig 15). There would have been a bar top and an overhead bar occupying the space, these fitting had been removed prior to the visit. Group photographs taken in the 1950s/60s (located on the parish council's picasa webpage) appear to show the bar to be located along the western wall (Fig 16).

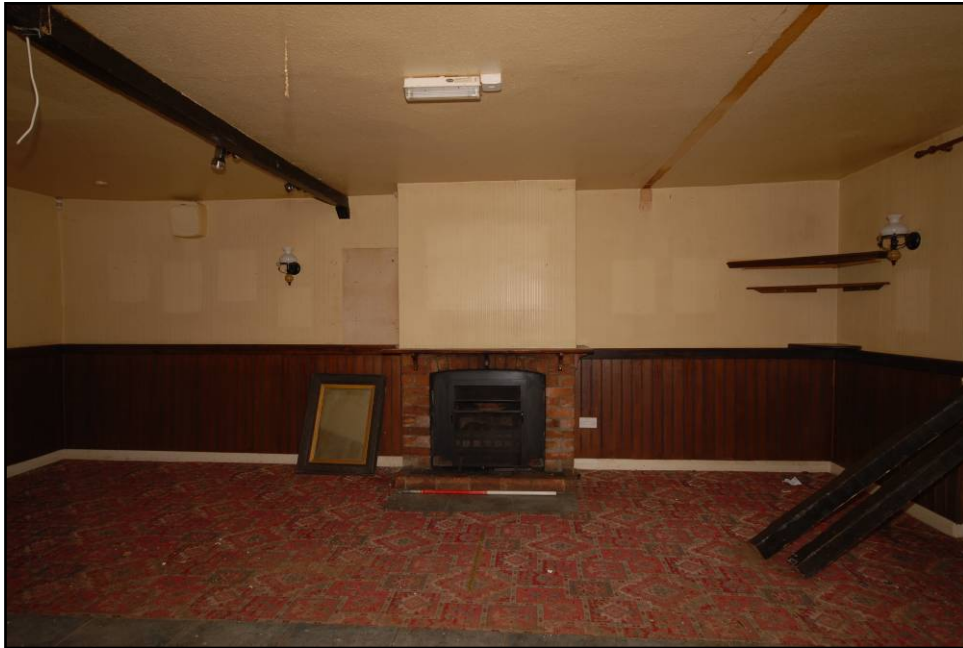
The Bar area, looking north Fig 17

A chimney breast is on the northern wall slightly of-centre (Fig 17). The lower part comprised exposed brick work with a brick hearth and an inserted iron grate and surround for the open fire (Fig 18). There was also a varnished pine shelf in the north-eastern corner where the television would have been.

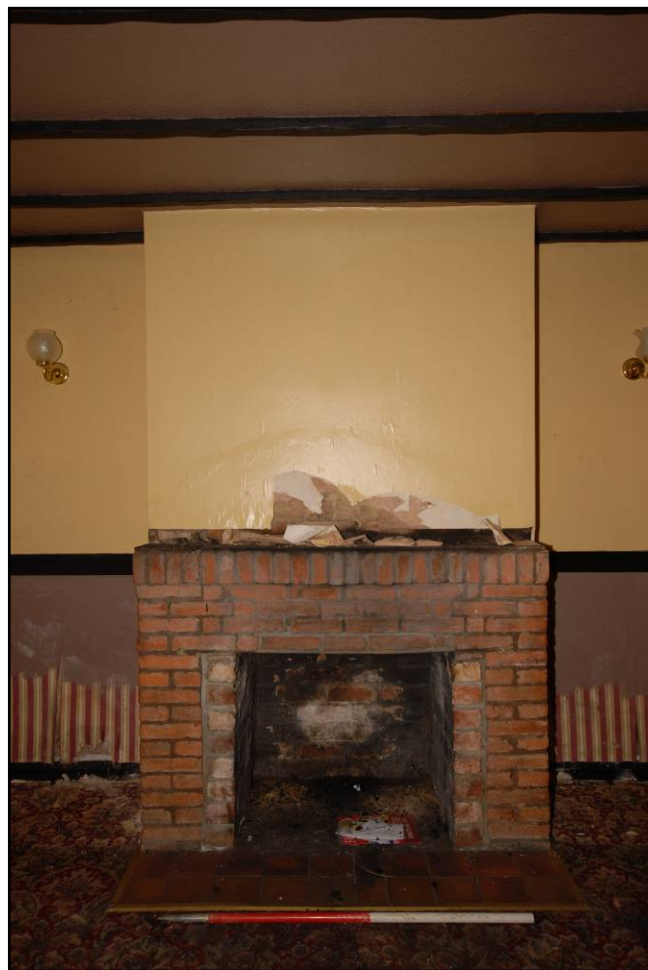
The fireplace in the lounge, on southern wall Fig 24

A chimney breast (Fig 24) is in the southern wall in the centre of the western part (G8). The lower part comprises protruding exposed brick work with a tile hearth for the open fire. The mantelpiece that would have sat on the ledge of the brickwork was missing. The opening had been narrowed on both sides.

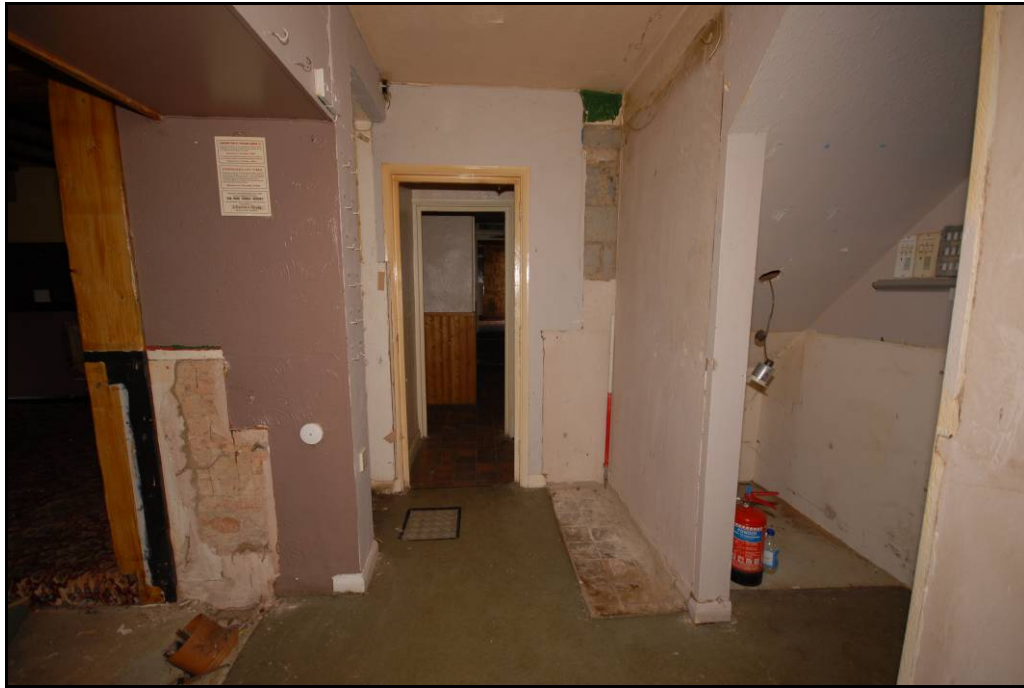
The Servedy, looking west Fig 25

The Servery (9G) is a relatively new created space (Figs 12 and 25). It is situated between the Lounge and the bar area. To create the space the stairs were altered, they used to run in the opposite direction from the current arrangement; straight up from the front to the back of the pub. The walls supporting the new stairs were constructed of breeze blocks. Two opposing bars are situated in the Lounge (G8) and the Bar (G10), where the walls were knocked through (Figs 12 and 15). Access was gained through door from the Lounge and the corridor at the back of the pub.

The floors are green lino covering quarry tiles in the centre, the possible hall and concrete with plastic tiles in the rooms covered in. The old quarry tiles were in places still visible; this made the change in wall and stairs arrangement noticeable. The walls were plastered brick painted. The bar had been removed at time of visit.

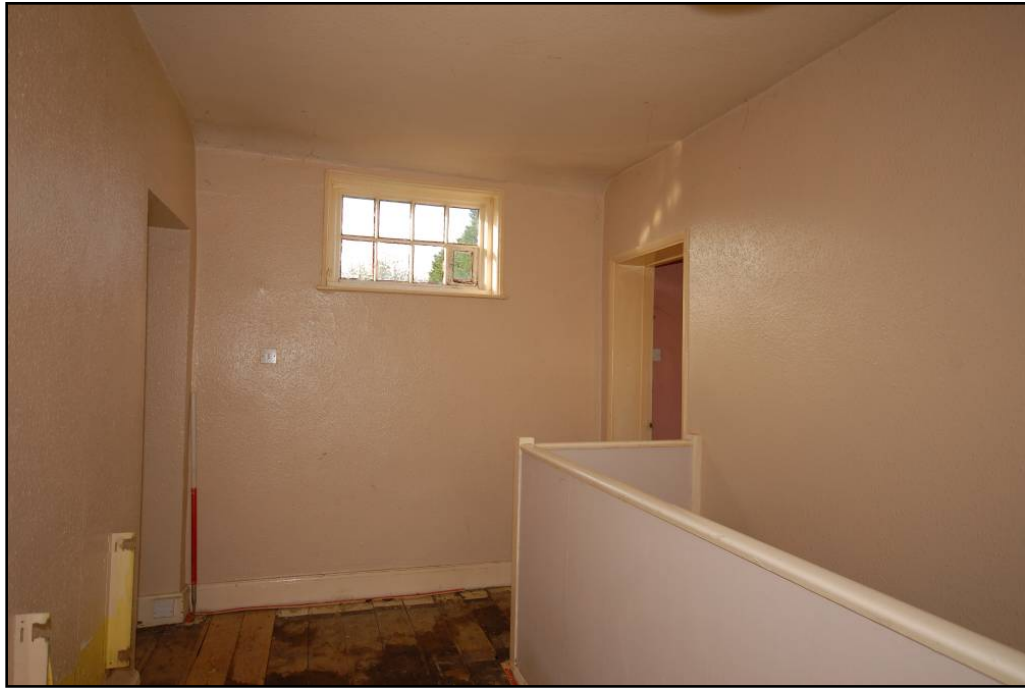
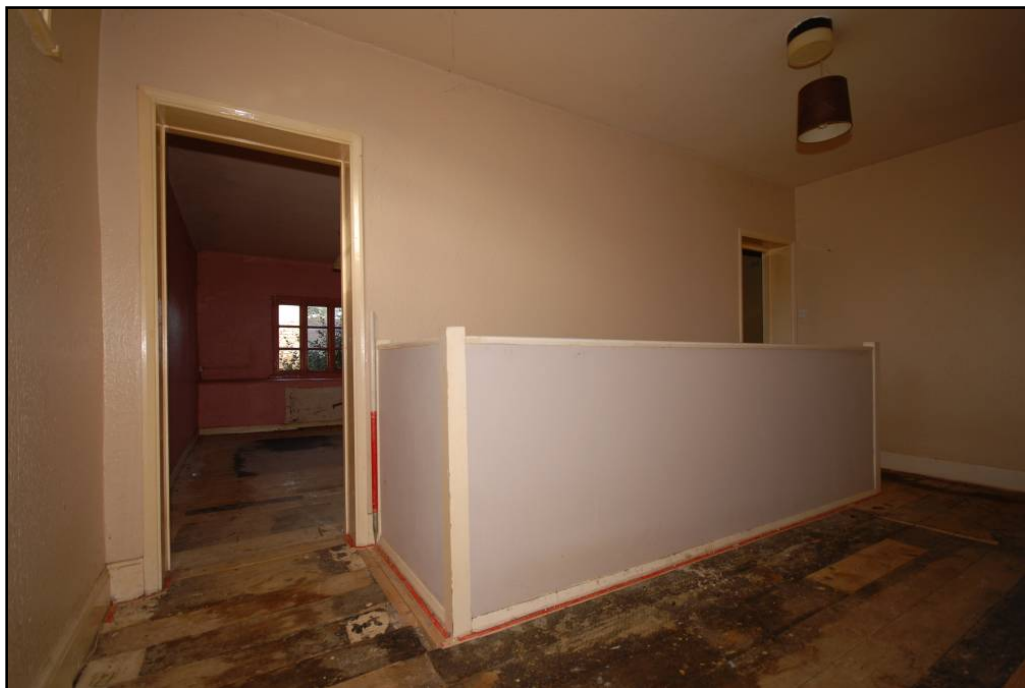
The landing (U1) is located centrally on the first floor. The walls and ceiling are covered in woodchip wall paper painted beige with a white ceiling. The flooring is bare pine floorboards that had been stained dark brown at some point, but recently probably covered in carpet. Due to the remodelling of the stairs the floorboards have been lifted and in places replaced (Figs 26 and 27).

Landing, looking west Fig 26

Landing, looking north-east Fig 27

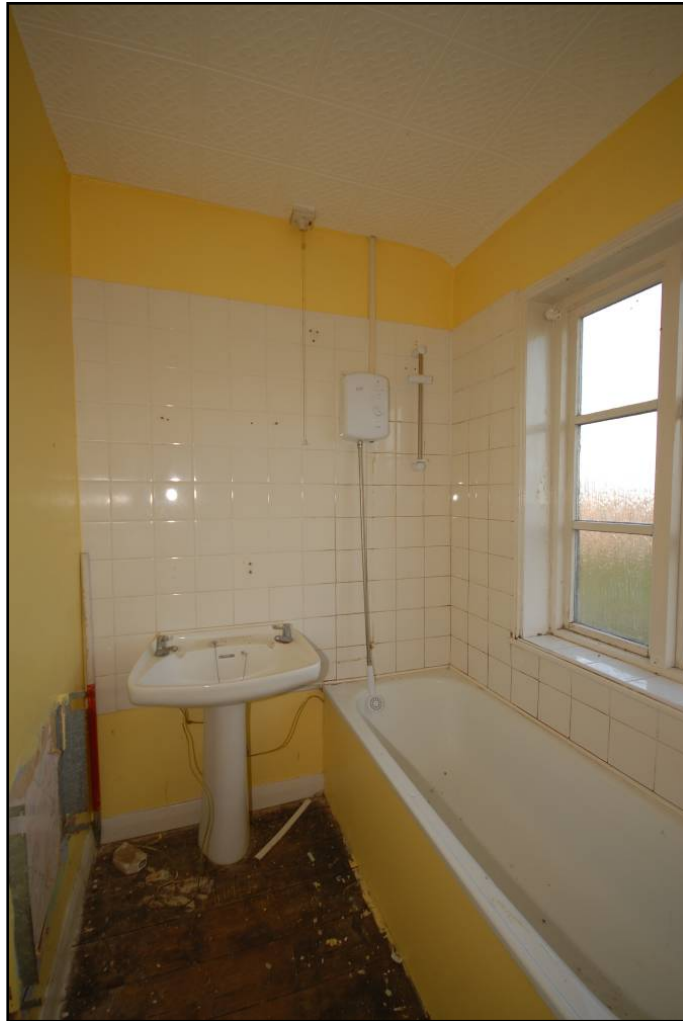
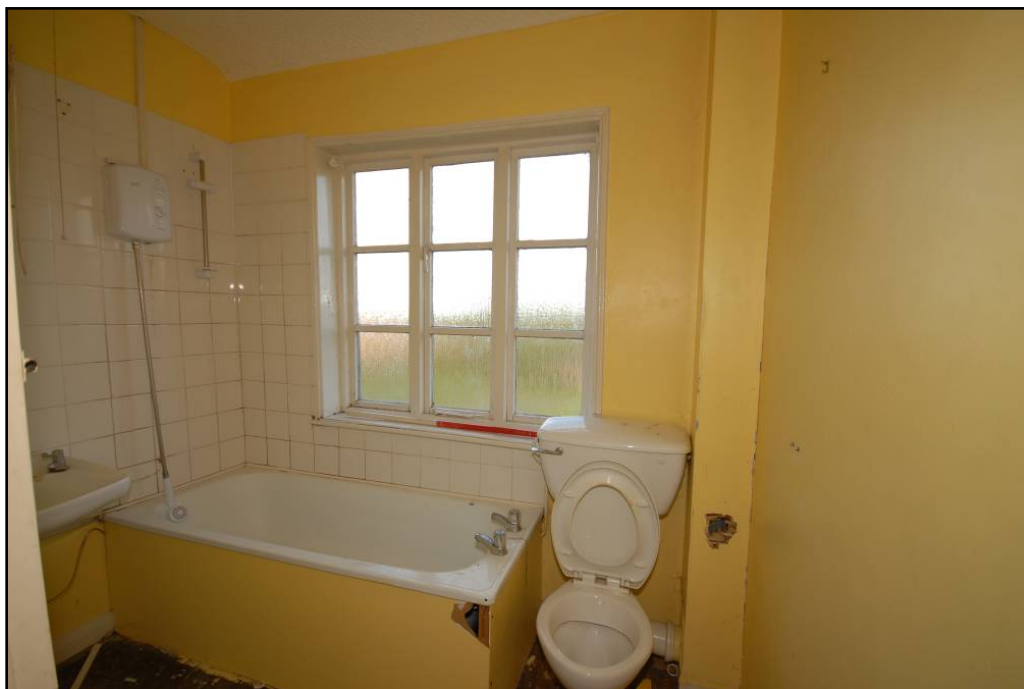
The bathroom was created by blocking the eastern part of the landing. The bathroom contained a modern white bathroom suite comprising a bathtub with an electric shower, a skink and a toilet. White tiles are on the northern and eastern walls above the sink and bath, otherwise the walls are painted bright yellow and the ceiling white (Figs 40 and 41).

Bathroom U6, looking south Fig 40

Bathroom U6, looking east Fig 41

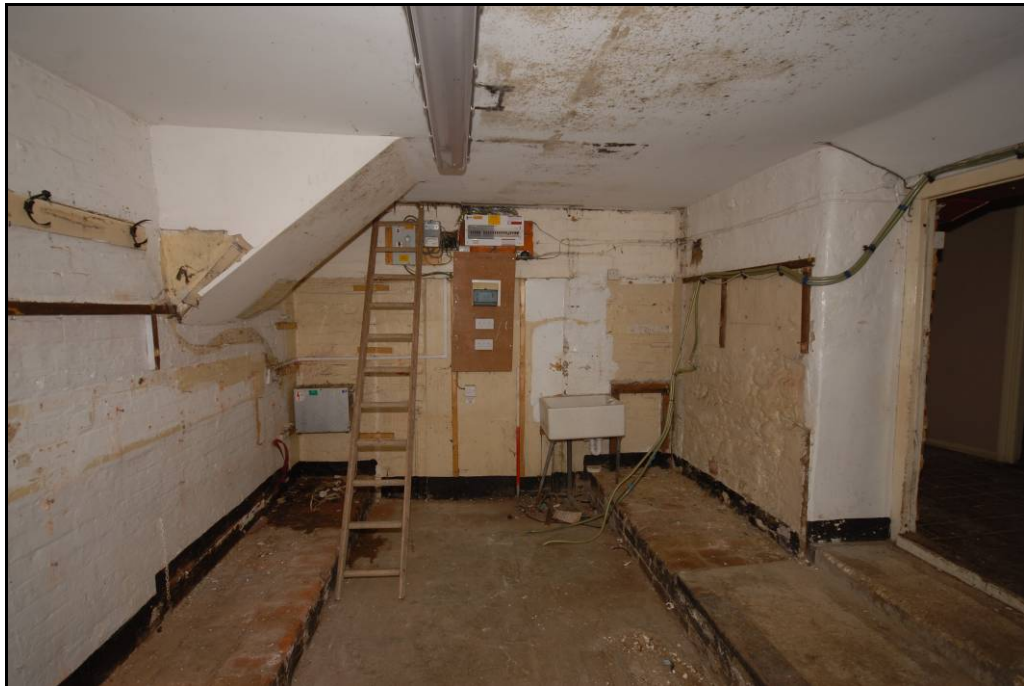
Cellar, looking south Fig 42

The cellar to store the beer is on the south-western side of the main building (Figs 42 to 45). The walls were constructed of brick with the western wall in stone, internally they are painted white. The ceiling is plaster and lath painted white and the floor is concrete. Along the western, northern and part of the eastern walls were ledges 0.60m and wide 0.30m high for the beer kegs to stand. The western and eastern ledges are brick and the southern ledge, probably later, was constructed of concrete covered with plasterboard.

The entrance is a door from the back of the main pub building. In the centre of the southern wall is a blocked door, which probably got built up when the Restaurant (G4) was built. This may have been the original exit and beer delivery point. This was replaced by a wide and low doorway in the western wall, which had steps down over the ledge onto a brick square protected by wood (Fig 43). In the south-western corner is a ceramic sink and electricity board (Fig 42). Some of the pipes for the beer were still in place.

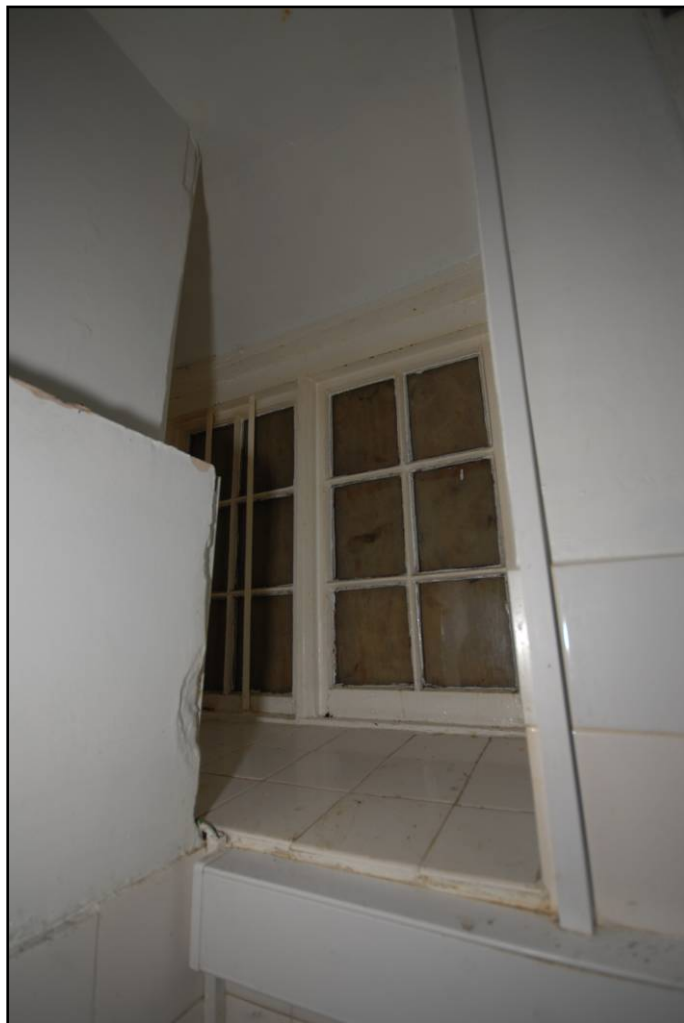
Kitchen window, looking west Fig 50

The kitchen is to the north of the cellar (Fig 12). The internal walls are constructed in brick and the two external western and northern walls are stone covered in plasterboard and tiled with white tiles. The quarry tiles on the floor were covered with dark grey plastic (Figs 47 to 49). A brick fireplace was built in the south-western corner of the kitchen, partially blocking a window. Also a small window into the corridor was blocked (Fig 50). More recently an appliance had been installed in there. The six light kitchen windows were not replaced with the others in the building. Each window is also secured by two vertical bars (Fig 50).

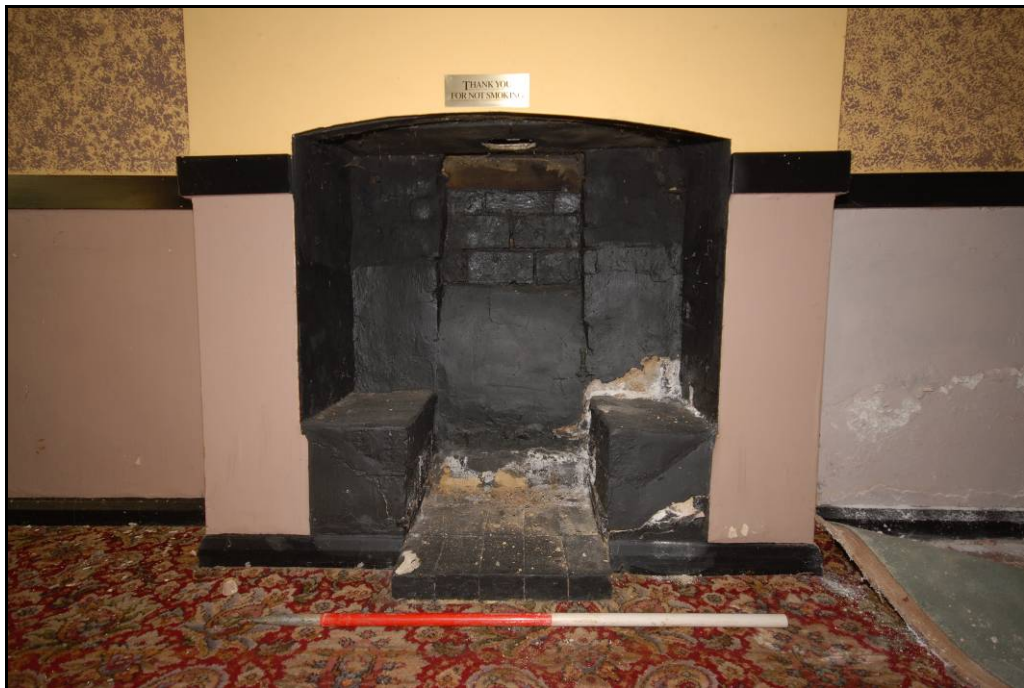
The fireplace in the Restaurant Fig 54

A chimney breast is on the southern wall off-centre. It comprises black painted brickwork and hearth. It had an appliance inserted – either a wood burner or a gas heater, the hole for a flue was in place (Fig 54).

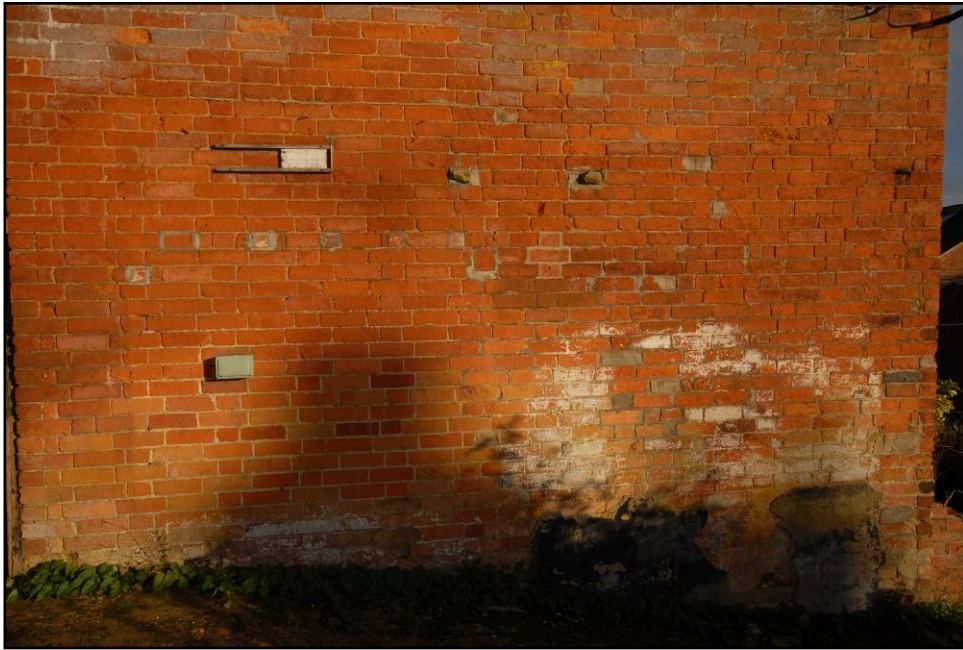
Rear of store with evidence of other buildings, looking east Fig 59

The store is depicted on the 1885 Ordnance Survey map and on the 1968 Ordnance survey map. The building is probably of 19th century date. The earlier maps also suggest further buildings had been to the back of it (Figs 3, 4 and 58). On the rear of the store are closed beam slots, change in brick colour due to differential exposure to the elements, white wash and plaster (Fig 59). The building is located to the rear, on the western side, of the public house. It is a two-storey brick built barn with a single room on the ground floor and a single room above it.

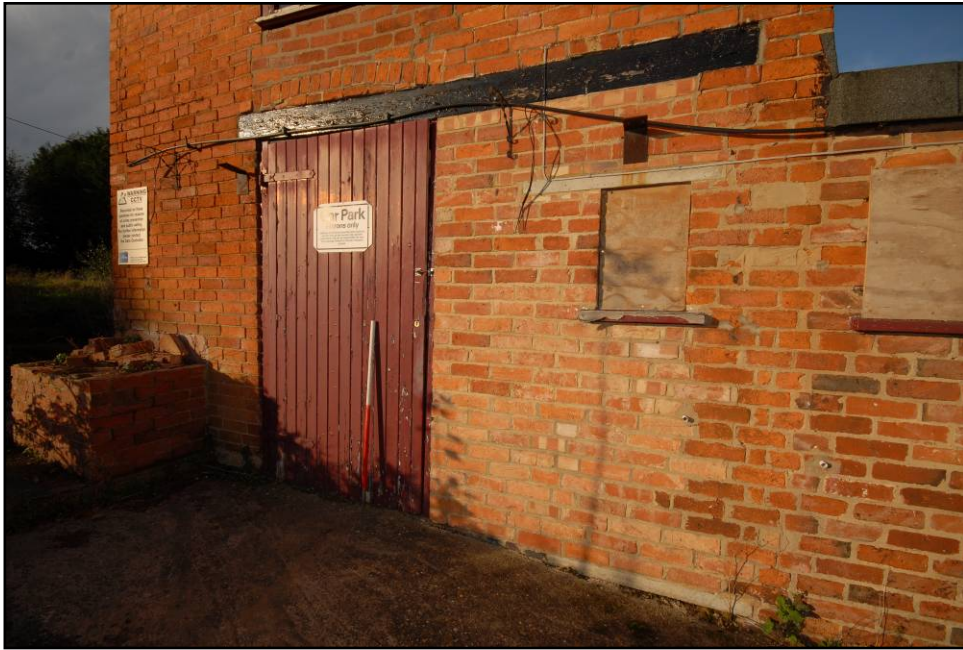
The beam of the removed barn door and inserted toilet window Fig 61

Access to the store is through a panelled braced and ledged door, painted burgundy red on the outside and black on the inside. The door way has been changed over time. The relieving segmental arch above the door lintel suggests that the building originally had a single width entrance before it was widened, possibly to allow for vehicles (Figs 60 and 61). The aerial view shows the wider door still to be in place in the second half of the 20th century (Fig 5). This arrangement was changed back to a narrower door, but leaving the wooden lintel of the wider barn door in place.

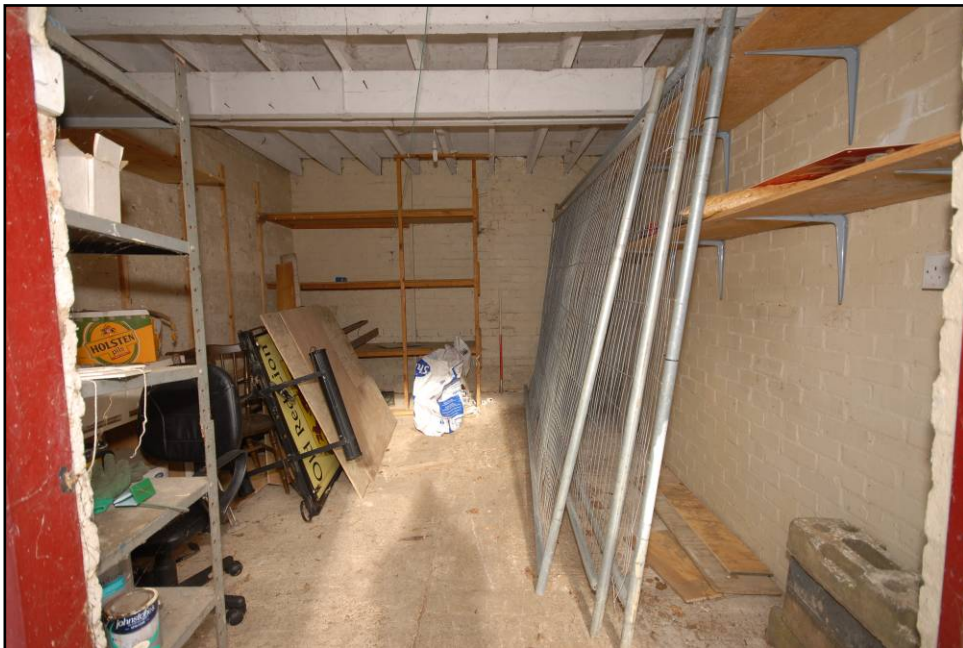
Interior of the ground floor of the store, looking east Fig 62

The interior brick walls were painted with beige paint, revealing in places a previous white colour. Only shelving and storage cupboards and benches remained, including the pub sign. The ceiling is the exposed beams, joists and floor boards painted white. The floor comprises concrete (Fig 62).

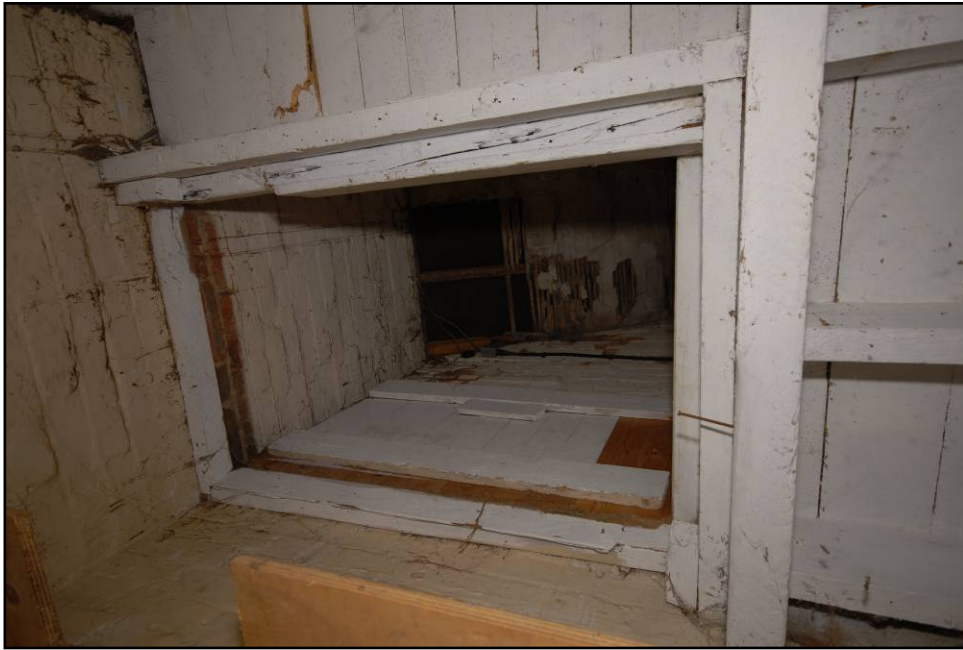
Hatch giving access to the first floor of the store Fig 63

An entrance to the first floor was through a door on the eastern side of the building, which was a later addition. The aerial photograph shows it was accessible through an external iron stairwell and in use in the second half of the 20th century (Fig 4). It was later bricked up. Currently access is through a hatch in the north-western corner of the ground floor (Figs 63 and 64). Access was not safe, but it was possible to see a fire-place and some computer equipment. There was a single 16-light casement window. The presence of closers suggests the window is in its original position; repair work with new bricks may have taken place during the door remodelling (Fig 60).

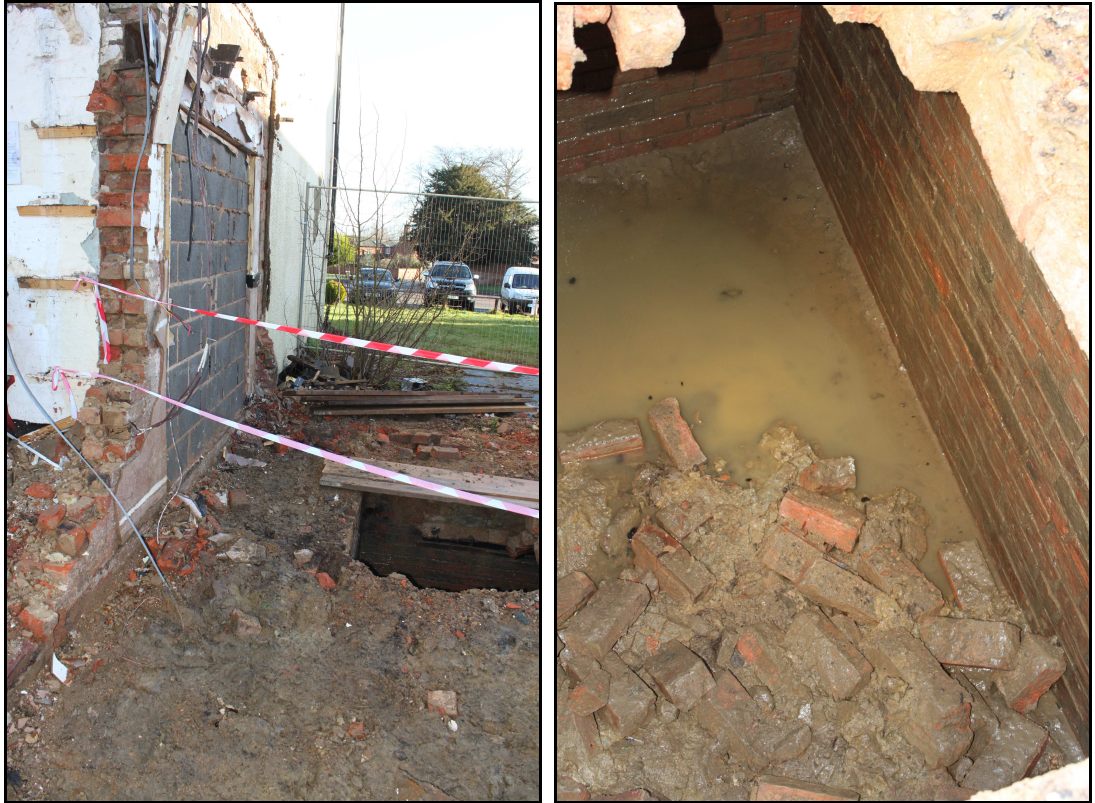
The brick lined water tank, looking north-east Fig 65

During the demolition of the Restaurant (G4) a brick lined water tank was uncovered underneath the floor (Figs 65 and 66). It was not possible to record the tank at the time, but it may be broadly contemporary with the construction of the pub.
