**Archaeological building recording and
observation, investigation and recording
at Rectory Farm, Sulgrave, Northamptonshire
February 2014**

Planning permission: S/2013/0567/FUL
Listed building consent: S/2013/0568/LBC

Report No. 14/78

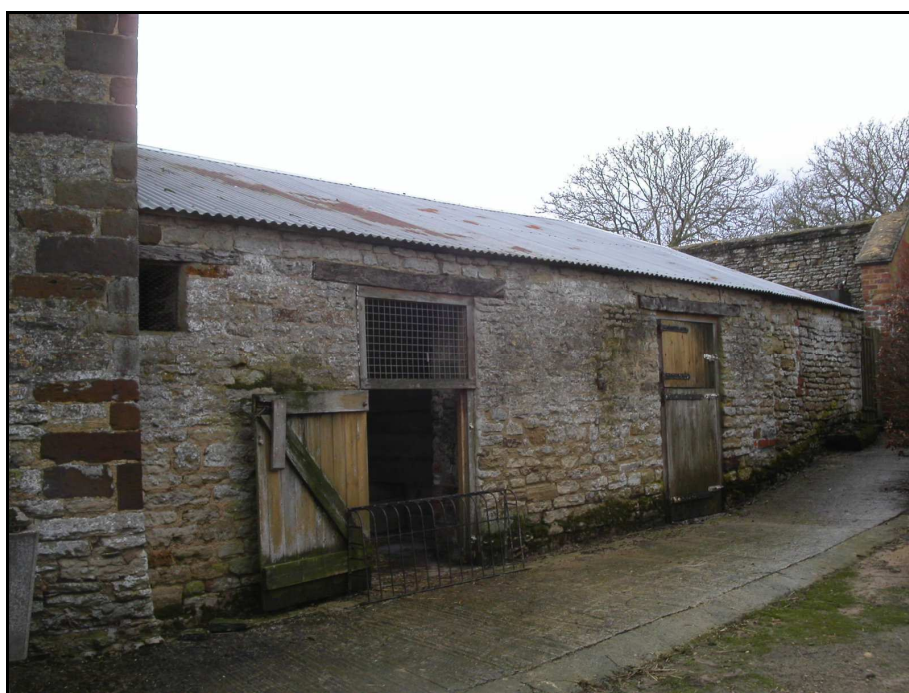
North-west elevation into courtyard (C Middleditch) Fig 3

The space between the outbuilding and the old threshing barn was later infilled, creating a space that was subdivided by a timber partition. There are two wooden braced and ledged barn doors with a wooden lintel on the north-western front elevation. There are two small windows on each elevation next to the threshing barn. A larger window opening on the rear of the building has been blocked with stone on the outside and brick internally, the wooden lintel also was removed.

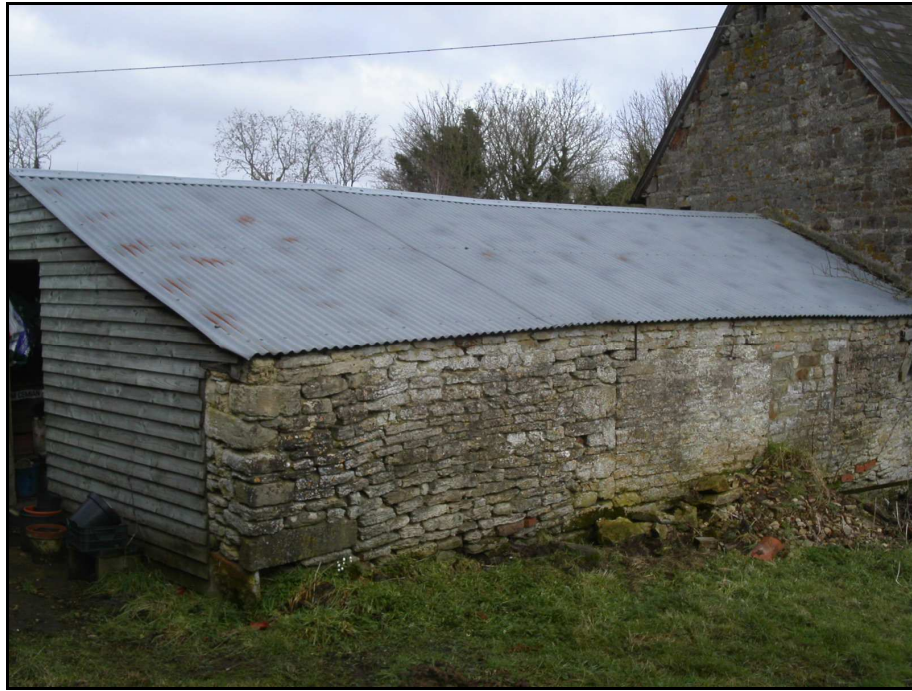
South-east (rear) elevation (C Middleditch) Fig 4

The following report is based on information provided by Mr C Middleditch. The outbuilding is a curtilage listed building. It is situated within the courtyard of Rectory Farm and constructed against a large former threshing barn (Figs 3 to 6). The single storey outbuilding is constructed of two leaves of coursed light and mid yellow-grey limestone, possibly with rubble infill. The concrete floor is at two levels, higher in the south-western building.

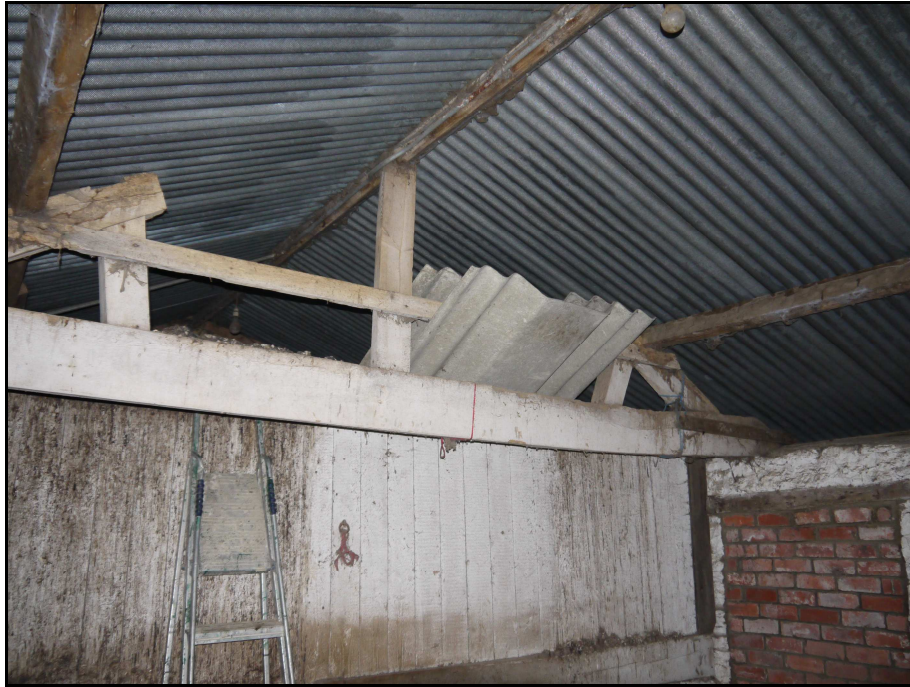
Remains of original truss and modern roof construction (C Middleditch) Fig 7

The roof has been replaced, possibly from a slated roof, as suggested by its low roof pitch evident from the surviving truss (Figs 7 and 8). The present corrugated iron is carried on timber purlins, which are supported by the central gable and from the beam on the wooden partition. Alongside the surviving truss, a cross beam and the wall plates remain (Middleditch 2013a and b).

The pitch of roof, evident from the surviving truss, may have originally been slated. It was suggested, with the arrangement of the stable doors, that the subdivided central part of the building had been used for stabling. The owners believe that the end section was used as a pig sty (Middleditch 2013a and b).

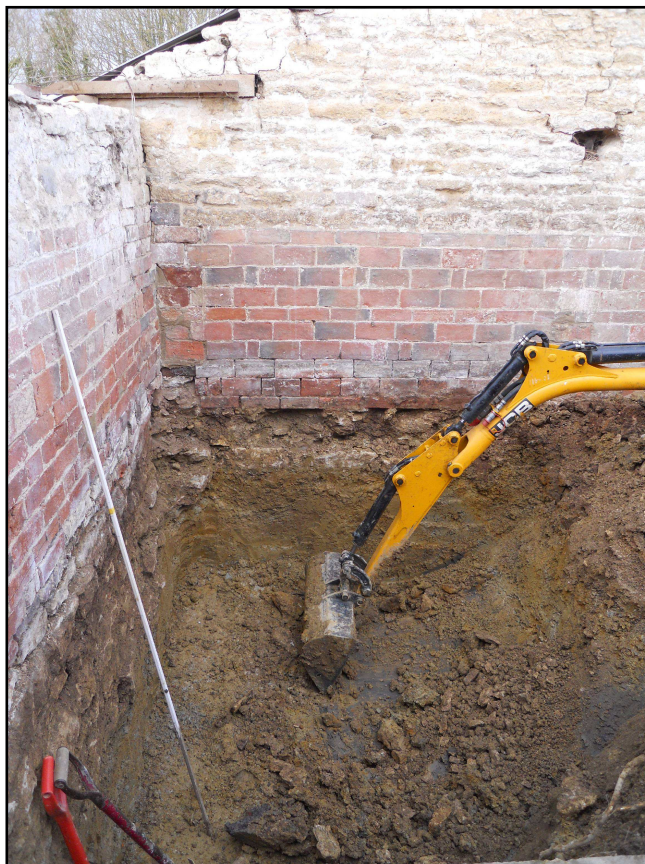
The excavation of the floor in the former garden store, looking east Fig 9

Formation level for the new lower floor was c 0.30m below the concrete floor in the north-eastern part of the building and c 0.50m below the concrete floor in the old garden store (Figs 9 -11). The soil comprised mid grey organic silty clay (102) overlain by a re-deposited layer of yellow-orange clay (101), which is still visible in the north-western corner where the organic silty clay dips. This was capped by loose brown soil on which the concrete was laid.

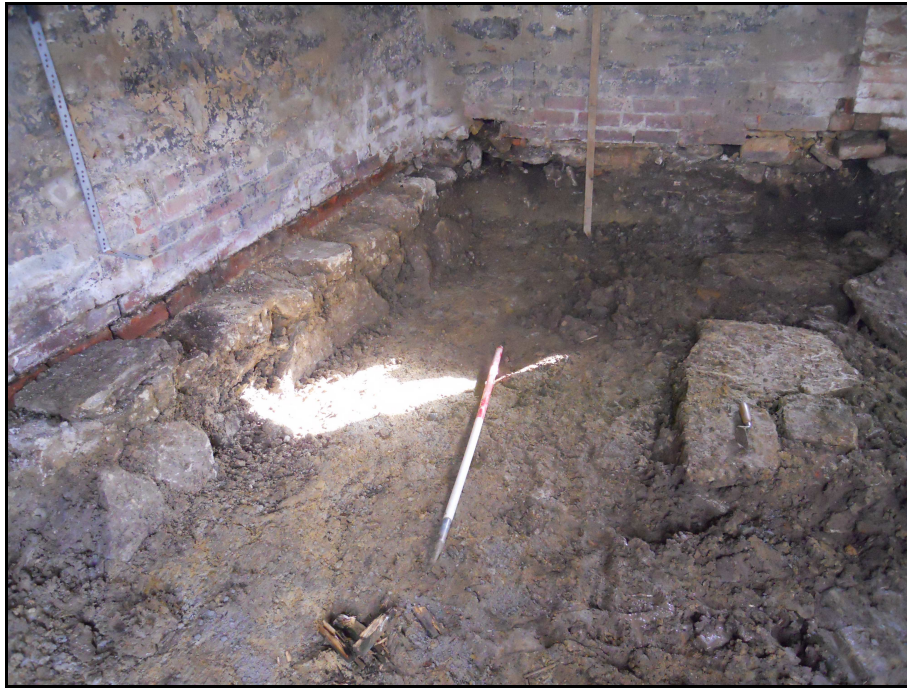
Wall foundation (104) and stone slabs (103), looking south-east Fig 10

Along the old threshing barn wall is a row of vertical stones (104) capped by horizontal stones lying on the grey clay (102), which formed part of the footings for the barn wall. At a distance of c 1.5m from the barn wall four stone slabs (103) were uncovered, also lying directly on top of the grey clay (102). Below the rear wall of the outbuilding is a small area of coursed stones to the left side of the stone slabs (104) and a patch of loose dark soil to the right overlain by stone and brick rubble.

The archaeological observation, investigation and recording of the machine excavation of the groundworks associated with the lowering of the floor level as part of the conversion of the outbuilding to a self contained annex. An organic clay layer was uncovered at formation level, sloping south-west, the ground was levelled with yellow-orange clay. Along the barn the base of a stone-wall was uncovered. In the area of the wooden partition four stone slabs were uncovered, this may be the base of a stone-lined drain or the base for the footings of a partition wall.
