**Historic Building Recording  
at Clint Hill Farm  
Hanging Houghton  
Northamptonshire  
April 2014**

Report No. 14/106

**HISTORIC BUILDING RECORDING AT  
CLINT HILL FARM, HANGING HOUGHTON  
NORTHAMPTONSHIRE  
APRIL 2014**

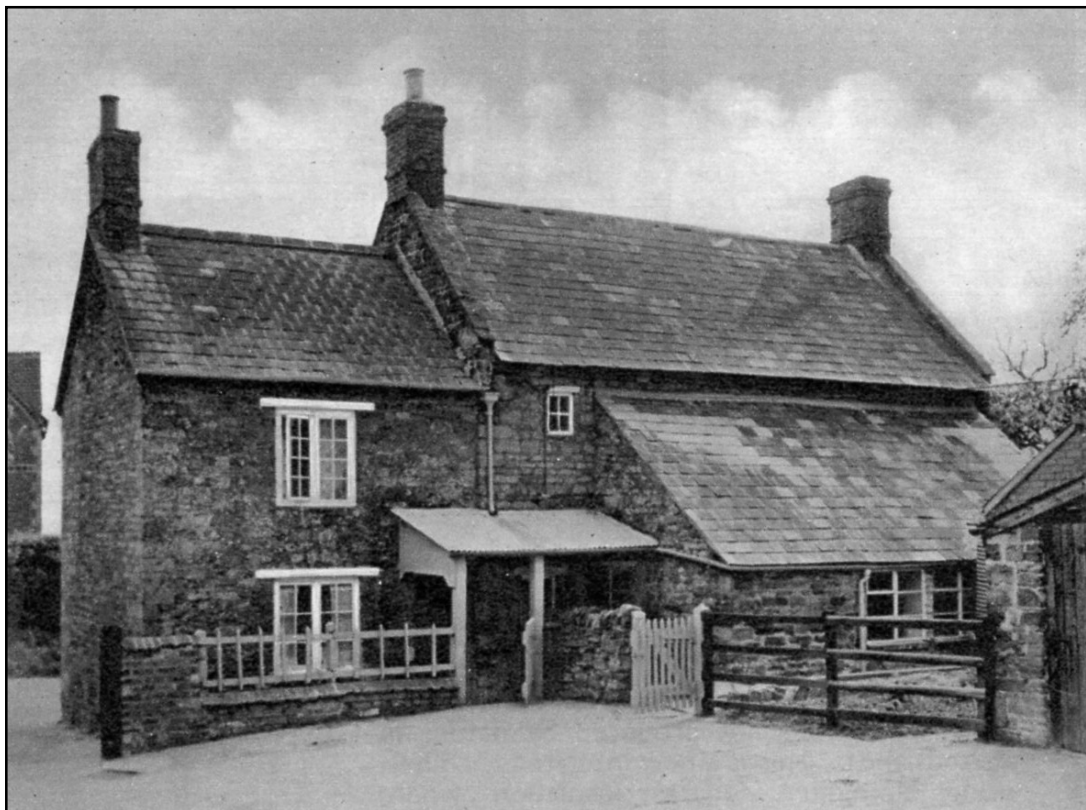
View of the north elevation of the farmhouse (photograph dated to 1954) Fig 5

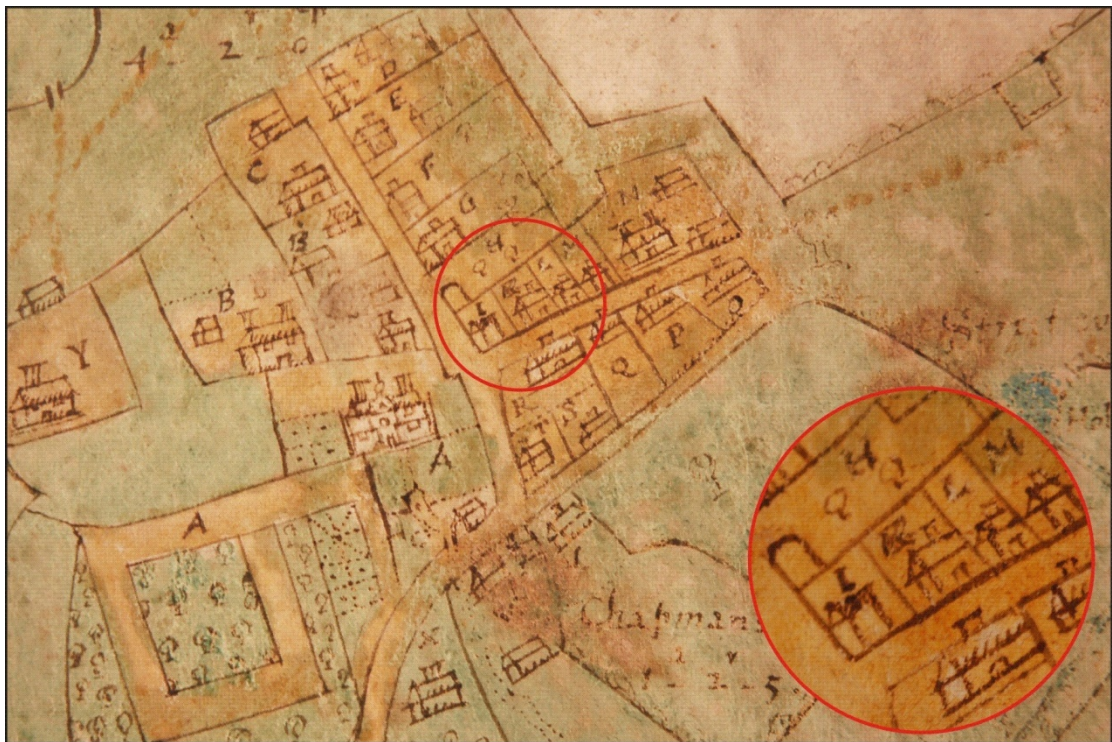
A fairly simplistic map with abstract, exaggerated depictions of structure, this map shows an earlier structure with gabled roof and central chimney (possibly a central smoke bay) located on the site of the current farmhouse. Interestingly, this map also depicts the former medieval manor and gardens, prior to its desertion in the late 17th century.

Coloured survey for Earl of Manchester, 1655 Fig 6

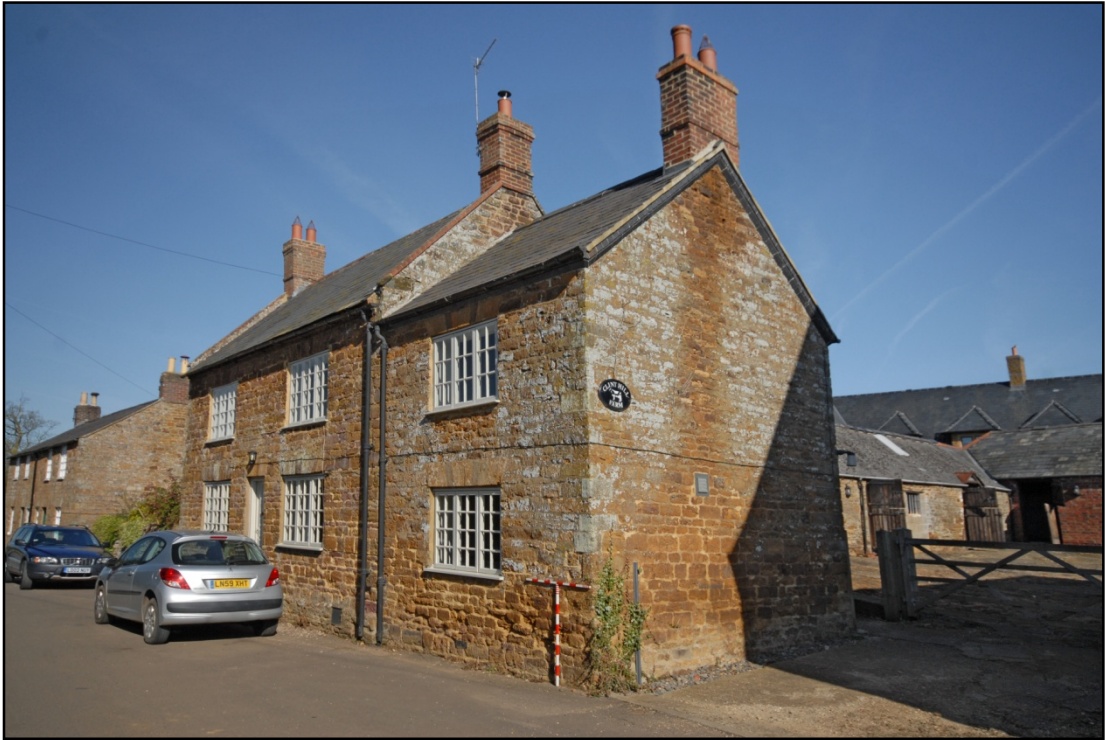
The south and east elevations of the farmhouse, looking north-west Fig 13

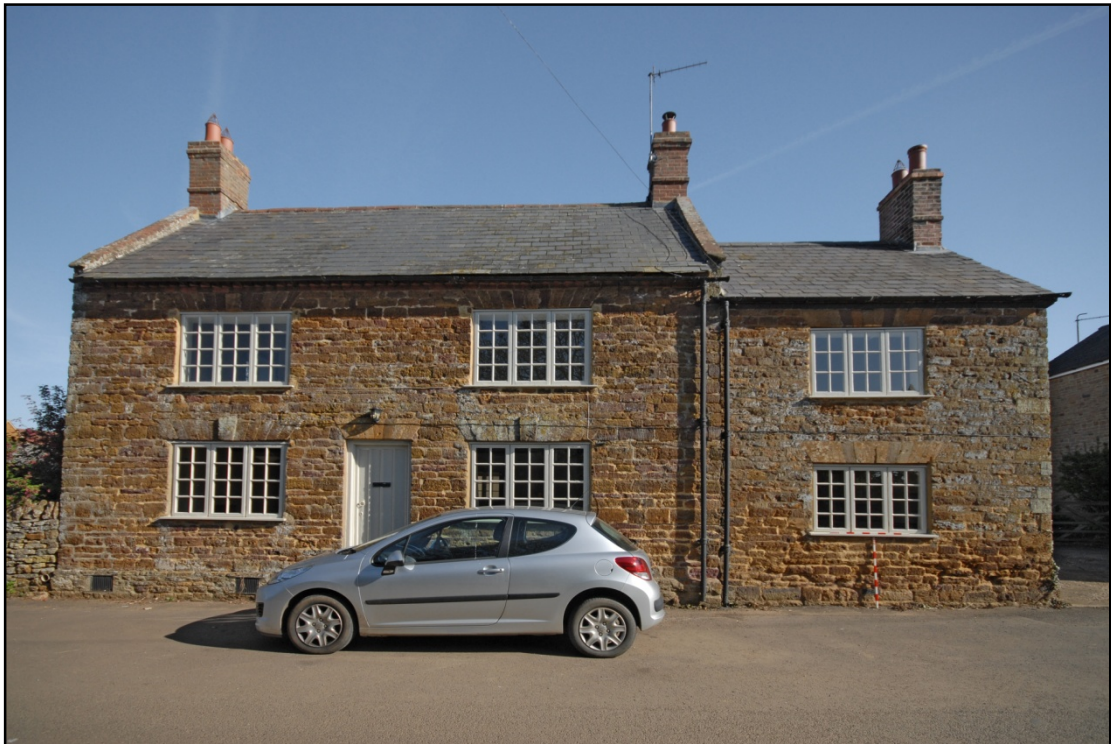
The Manor Road elevation presents three bays with regular fenestration of 12 light, single pane, casement windows, the central casement being side hung (Fig 14). Internally, these windows have deep recesses with splayed reveals (Fig 33). These are set within stone surrounds with tapered arch and projecting keystone over (Fig 16). Window ironmongery comprises iron peg stays with “monkey tail” window handles. The windows are largely modern replacements throughout. The main entrance, central to the original extent of the building, is a ledged and battened door with expanded end strap hinges. A simple, cast iron boot scraper is adjacent to the door step.

The principal elevation of the farmhouse, looking north Fig 14

The farmhouse has an east-west alignment fronting directly onto Manor Road (Fig 2). It is constructed largely of coursed sandstone and ironstone, sourced locally with welsh slate tiles on the roof. The two phases of construction are readily apparent by a drop in the roof line which marks the join between the earlier building and its 19th-century extension (Fig 14). The earlier structure has red brick, dog tooth dentils at the eaves and the later build has a simple wall plate of dark blue-black bricks. Three brick chimneys are present, two at the gabled ends of the original extent of the building and one at the east gable of the later extension (Fig 14).

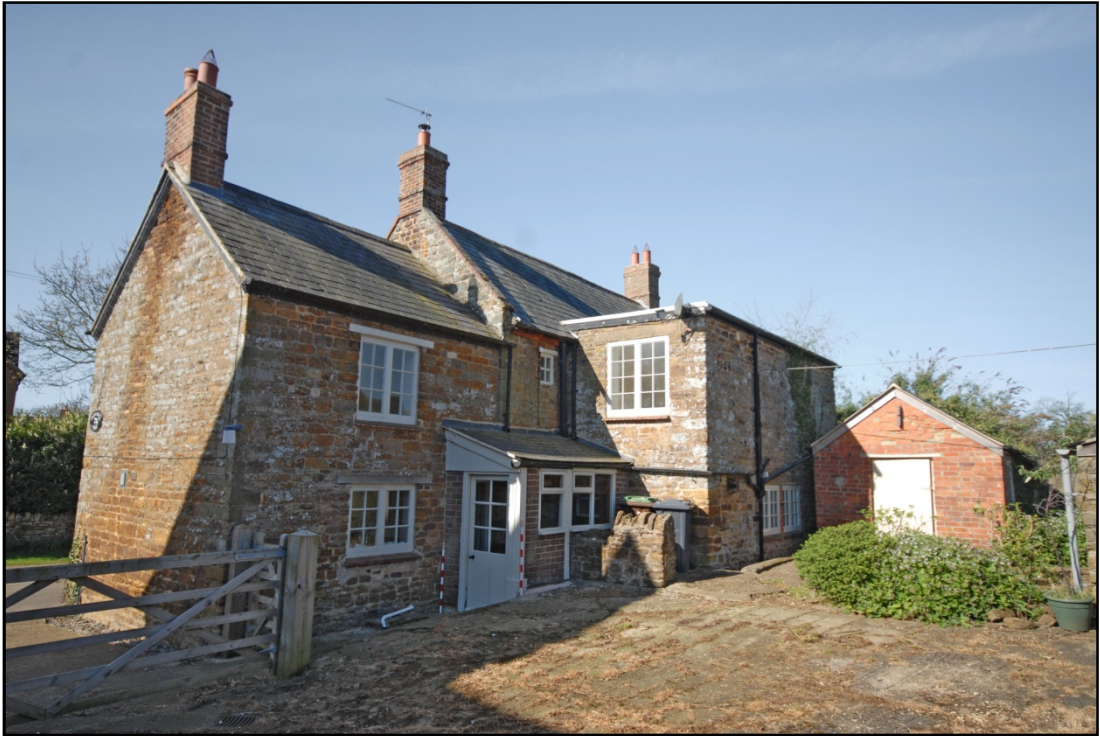
The rear of the building is accessed through a porch which leads into the Kitchen (Fig 17). A former door blocked in brick formerly led into the Bathroom (Fig 19). A small window has been inserted into this blocking.

The north elevation of the farmhouse, looking south    Fig 17

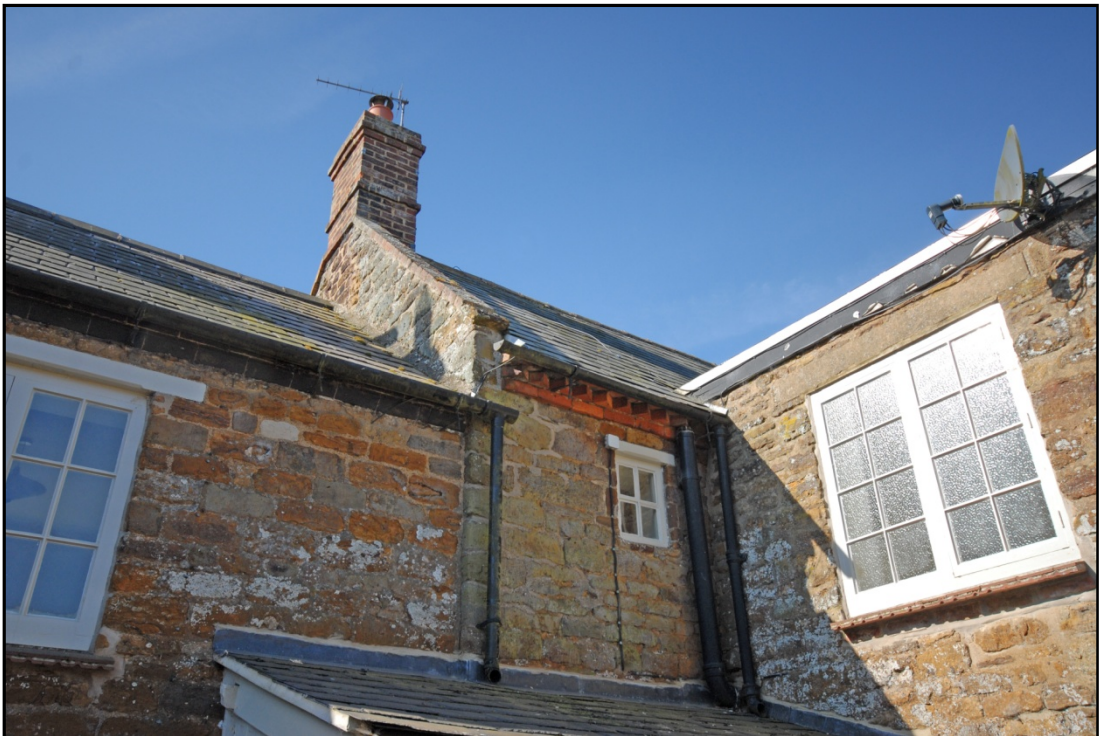
The three main phases of construction visible on the north elevation    Fig 18

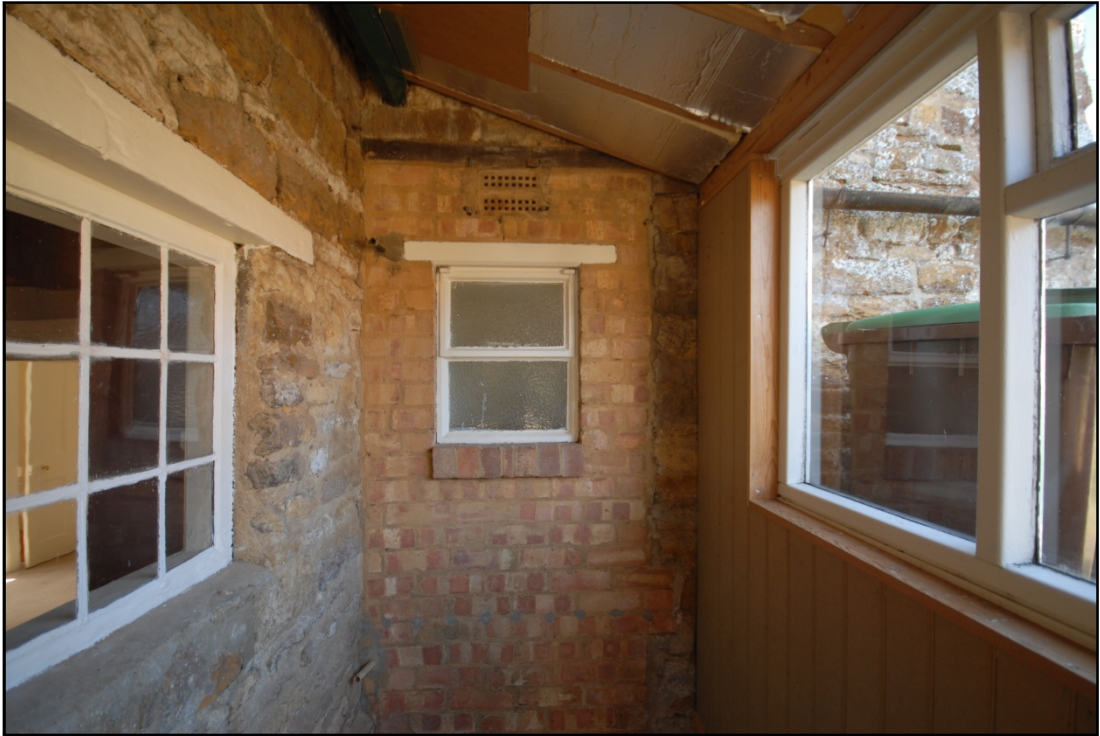
The north porch, showing blocked door, looking west Fig 19

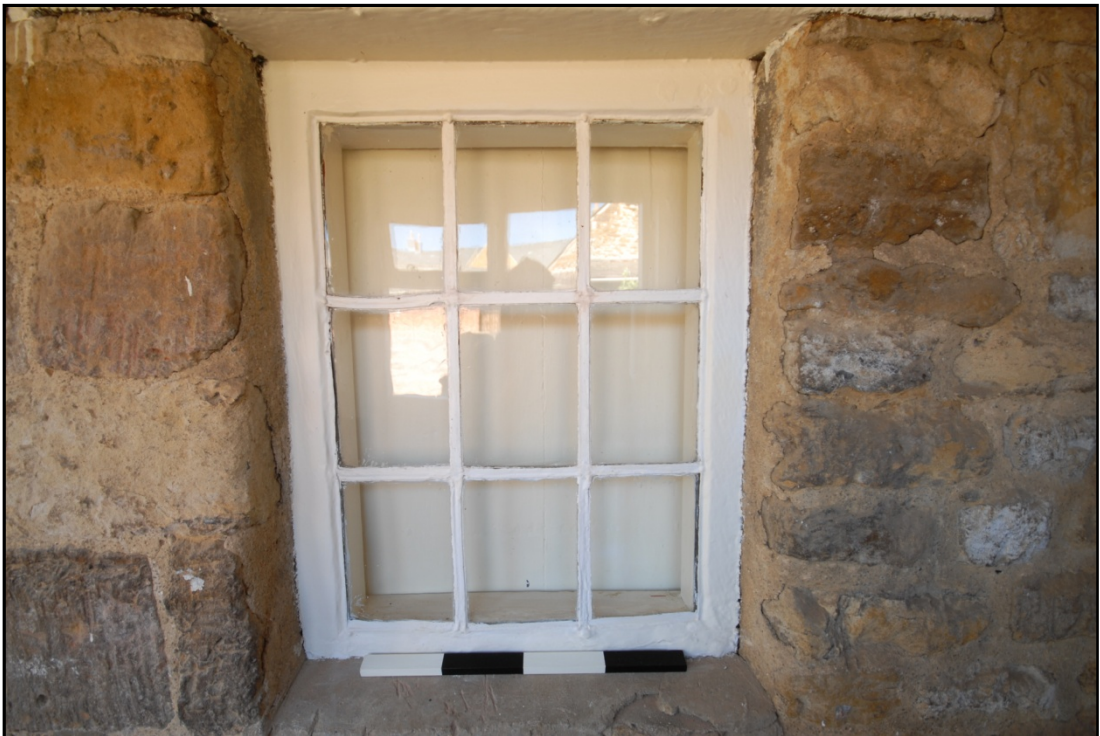
fixed nine light window with wooden shutters looks out into the porch and yard (Fig 20). Central to the room, a timber beam with chamfered stops, aligned east-west, carries the joists for the first floor (Figs 24 & 25).

Small window with shutters looking from the north Porch into the Inglenook Fig 20

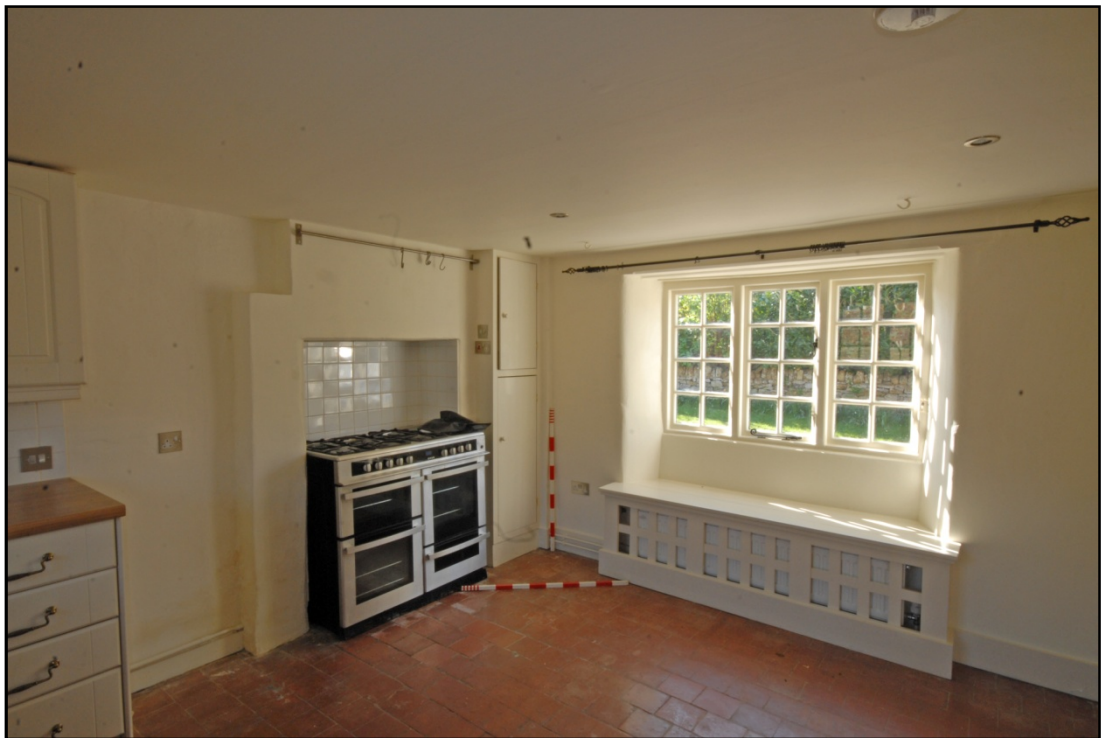
The Kitchen comprises the entire ground floor footprint of the 19th century extension of the main structure (Fig 11). The former fireplace opening is now occupied by a modern cooker and is set off centre to the room (Fig 21). A casement window with six lights looks to the south and a large recessed window with splayed reveals and window seat covering a radiator opens onto Manor Road (Fig 21). The floor is of red quarry tiles.

The Kitchen, looking south-east    Fig 21

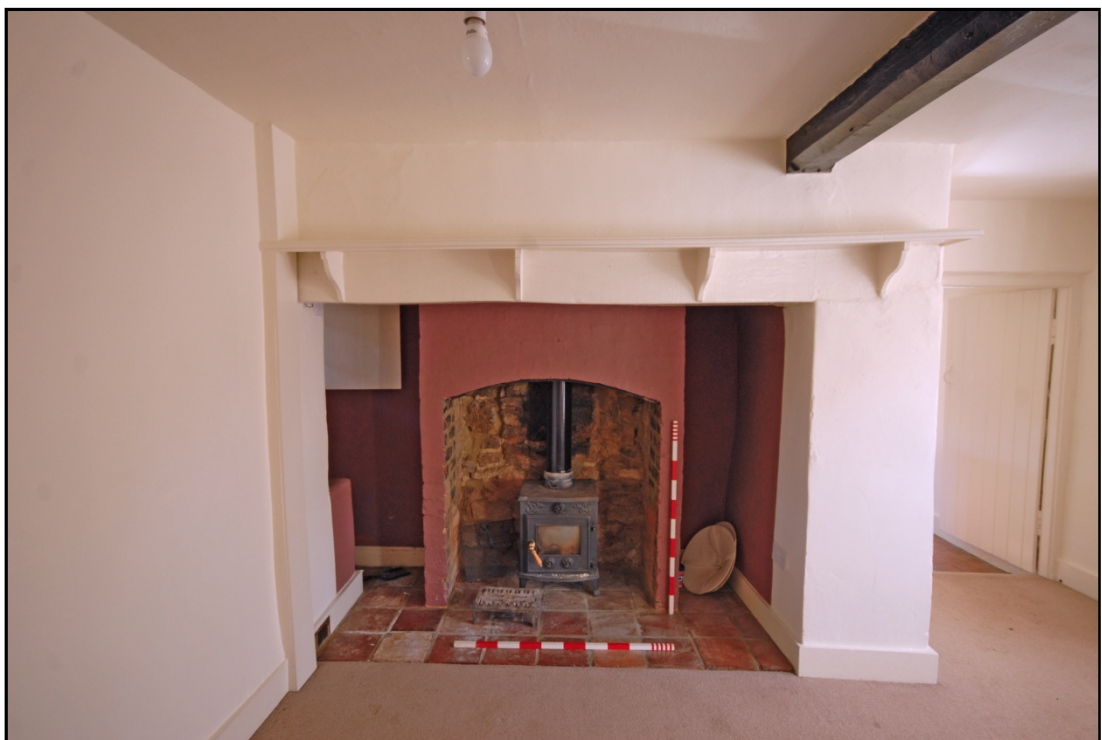
The Inglenook fireplace in the Dining Room    Fig 22

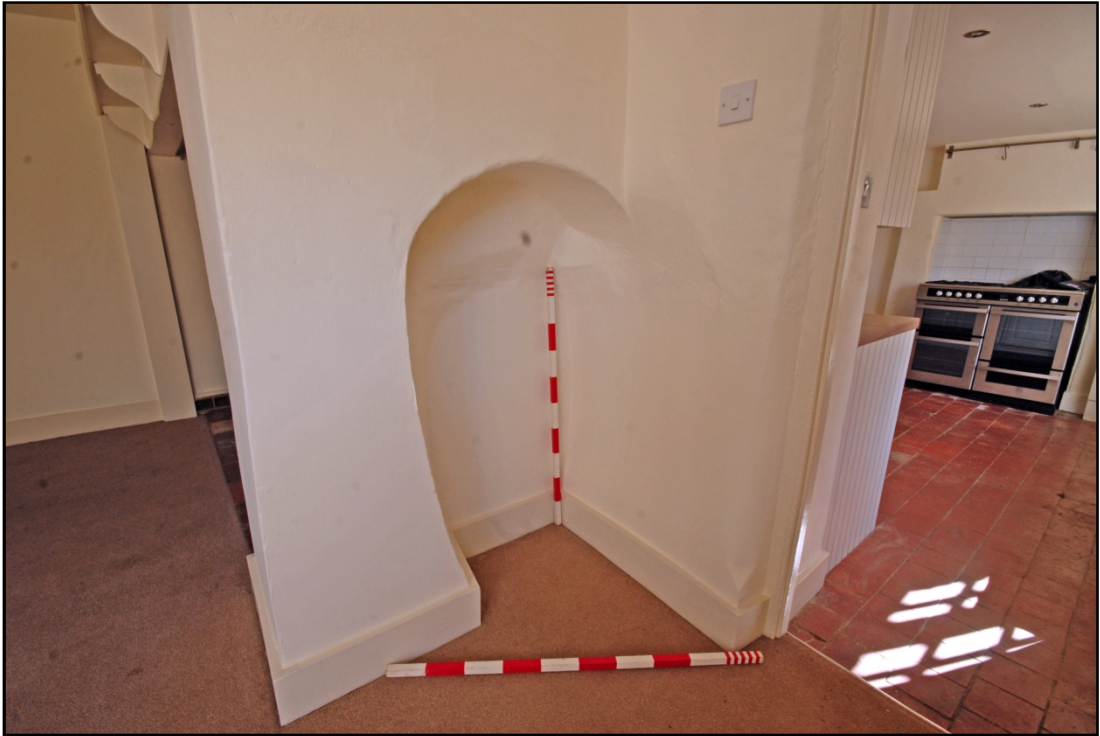
Former bread oven to the side of the Inglenook fireplace    Fig 23

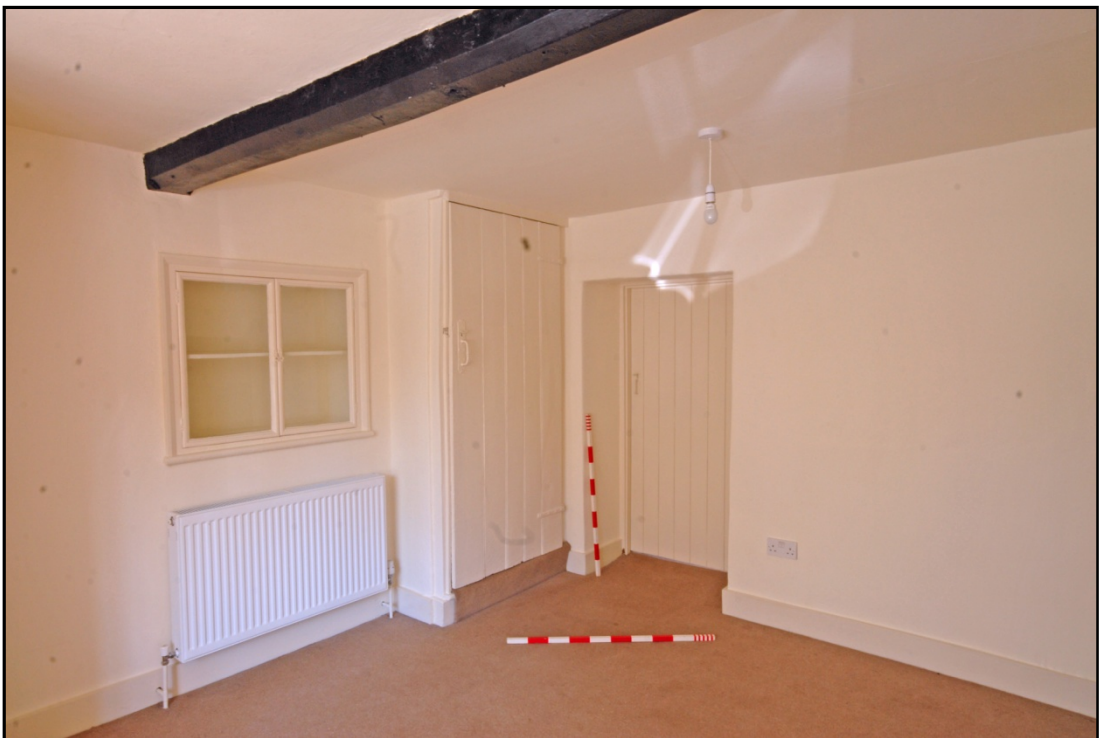
A small cupboard with side hung windows is recessed into the west wall of the room adjacent to the staircase which extends a short distance into the room (Fig 24). The stair is enclosed from the room by a plank and batten door.

The Dining Room, with doors to the Bathroom and stairs, recessed cupboard to the left and beam with chamfered stops over    Fig 24

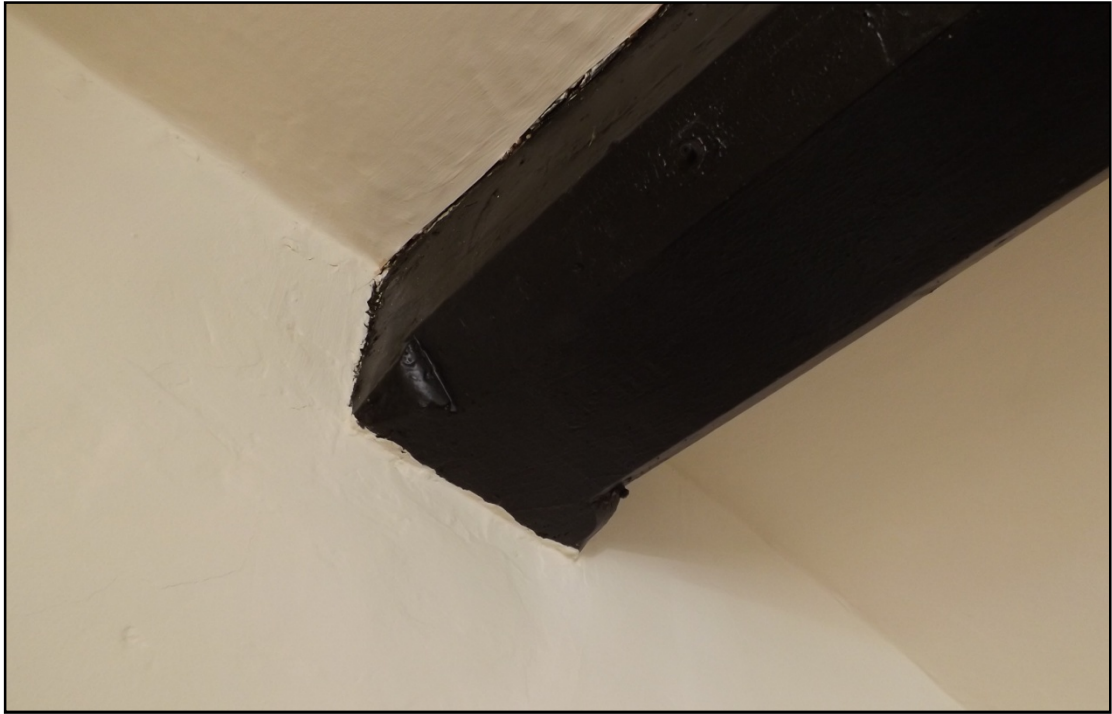
Detail of the Dining Room beam with chamfered stops Fig 25

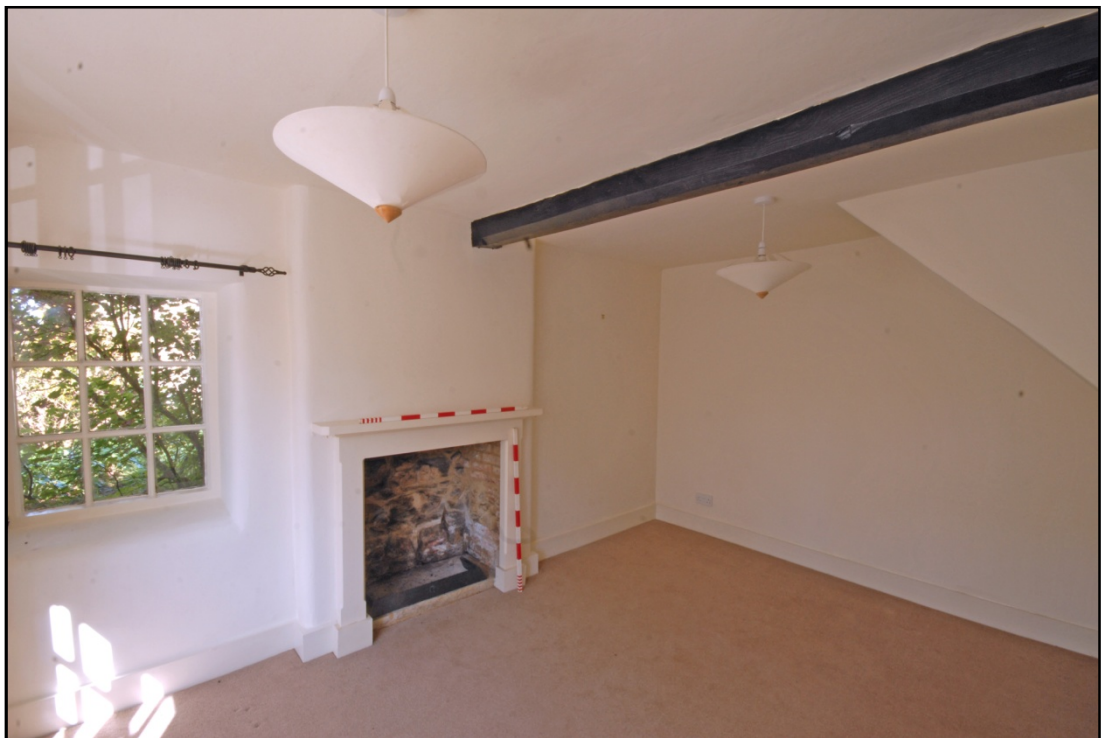
A simple four panelled door separates the Dining Room from the main entrance. The short wall to which it attaches is a later addition to create an enclosed space around the entrance (Fig 11). Another panelled door with transom window over leads from the entrance hall into the Living Room which comprises the western half of the original structure. A fireplace with modern surround is central to the west wall (Fig 26). An east-west beam with chamfered stops is slightly off centre to the room supported at its west end by the chimney breast. A square, fixed, nine light window looks west adjacent to the chimney breast (Fig 26).

The Living Room, looking north-west Fig 26

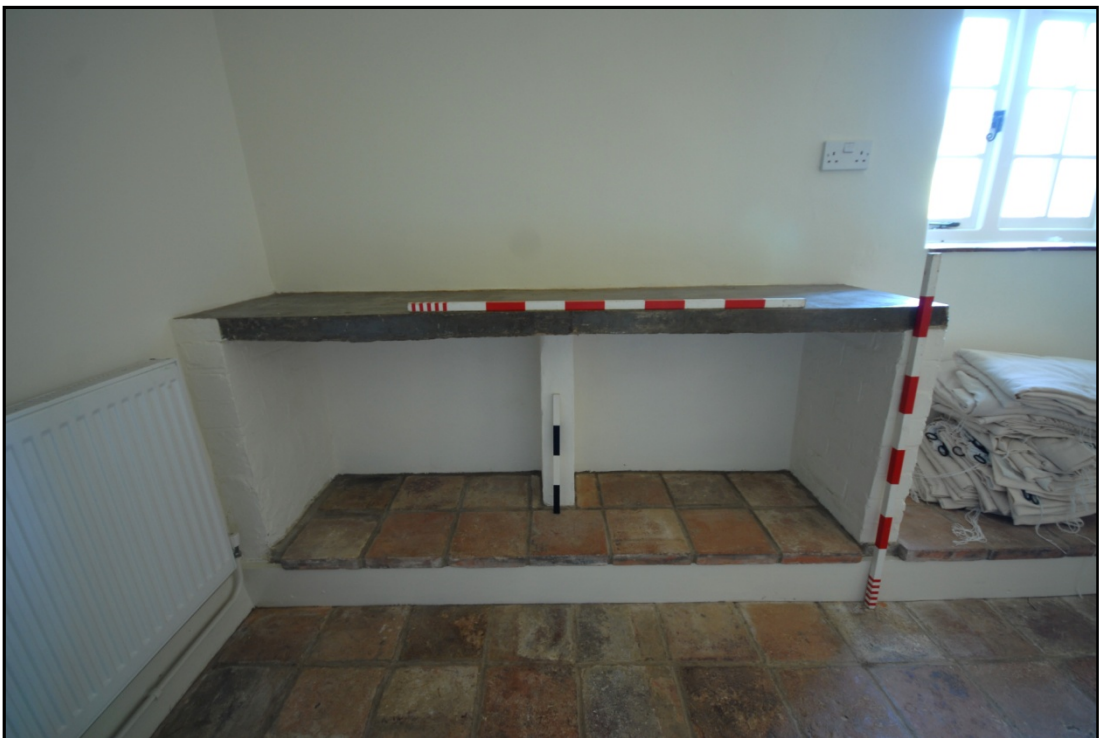
Detail of the slate shelf in the Dairy Fig 28

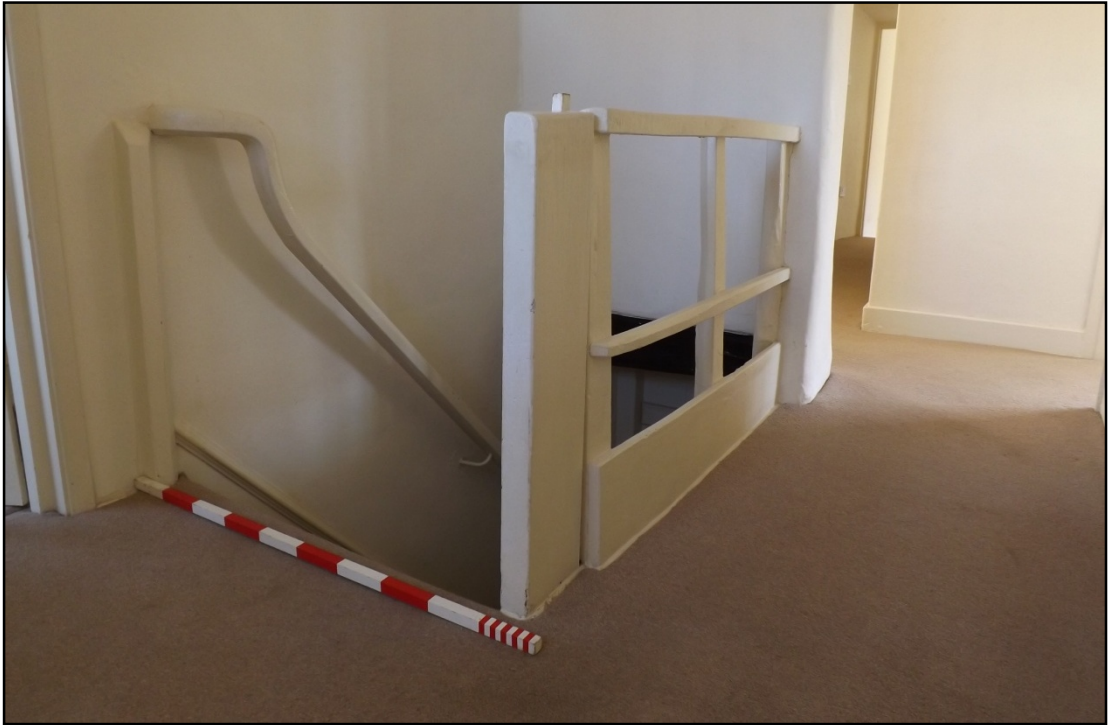
The first floor of the farmhouse is occupied mainly by Bedrooms and a single bathroom. Access to this level is via a straight stair from the Dining Room. A timber banister with railings separates the staircase from the landing (Fig 29).

The stair banister and railings Fig 29

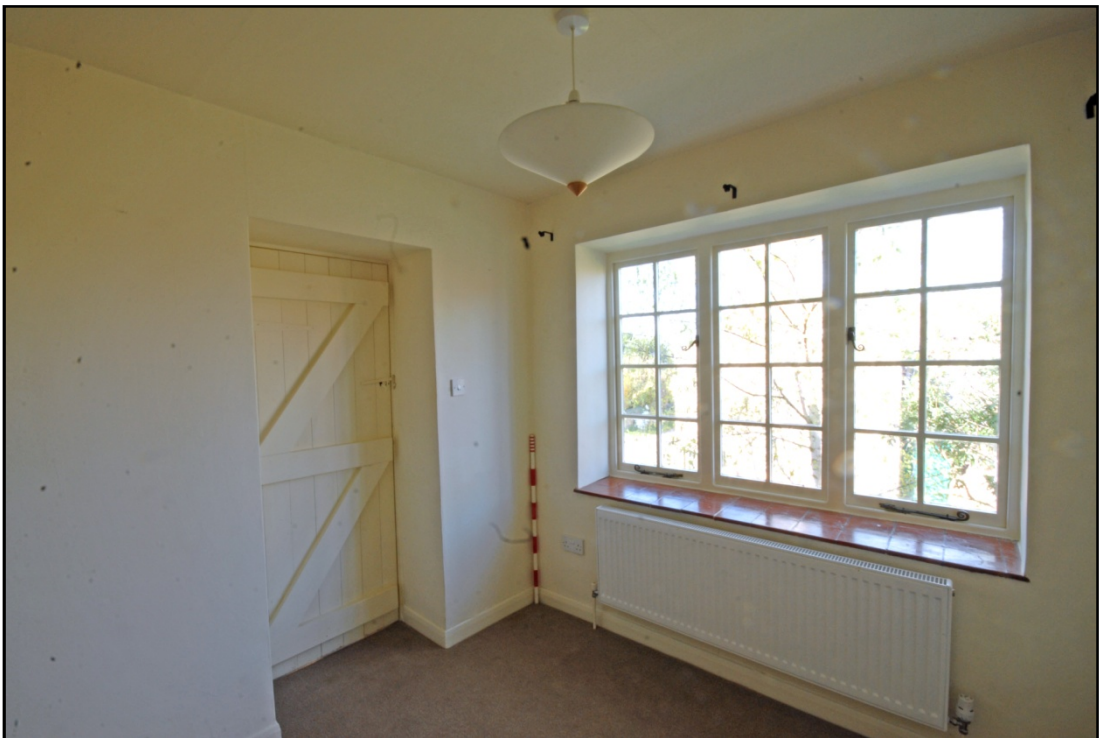
Immediately north of the landing, Bedroom 4 is within the post 1950s extension. It is a plain room with a large eight light window, two casements side hung, the central fixed. A modern ledged and battened door with diagonal bracing encloses the room from the landing (Fig 30).

General view of Bedroom 4, looking south-west Fig 30

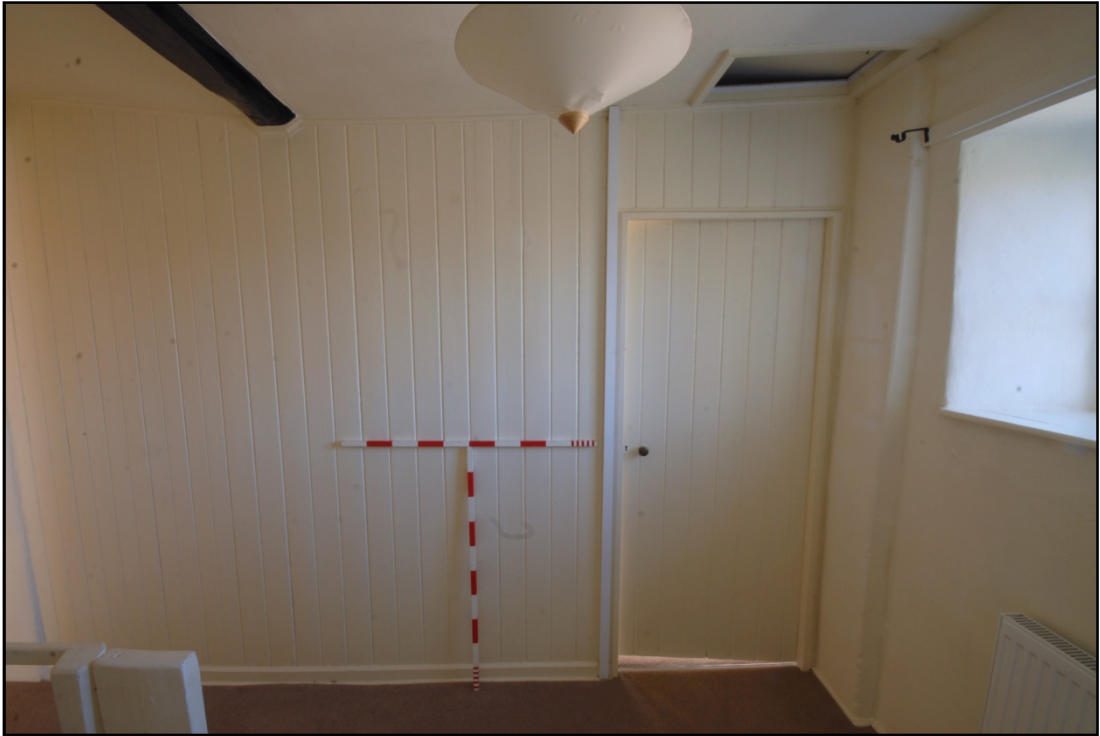
Modern stud partitions create a corridor linking the east and west of the level and separating it from Bedrooms 2 and 3 (Fig 31). A ledged, braced and battened door with rim lock and simple strap hinges opens into Bedroom 3 from the landing (Fig 32). A large window opening, deeply recessed with splayed reveals, containing three casements of eight lights each looks south onto Manor Road (Fig 33).

The stud partition separating the landing from Bedroom 3, looking south Fig 31

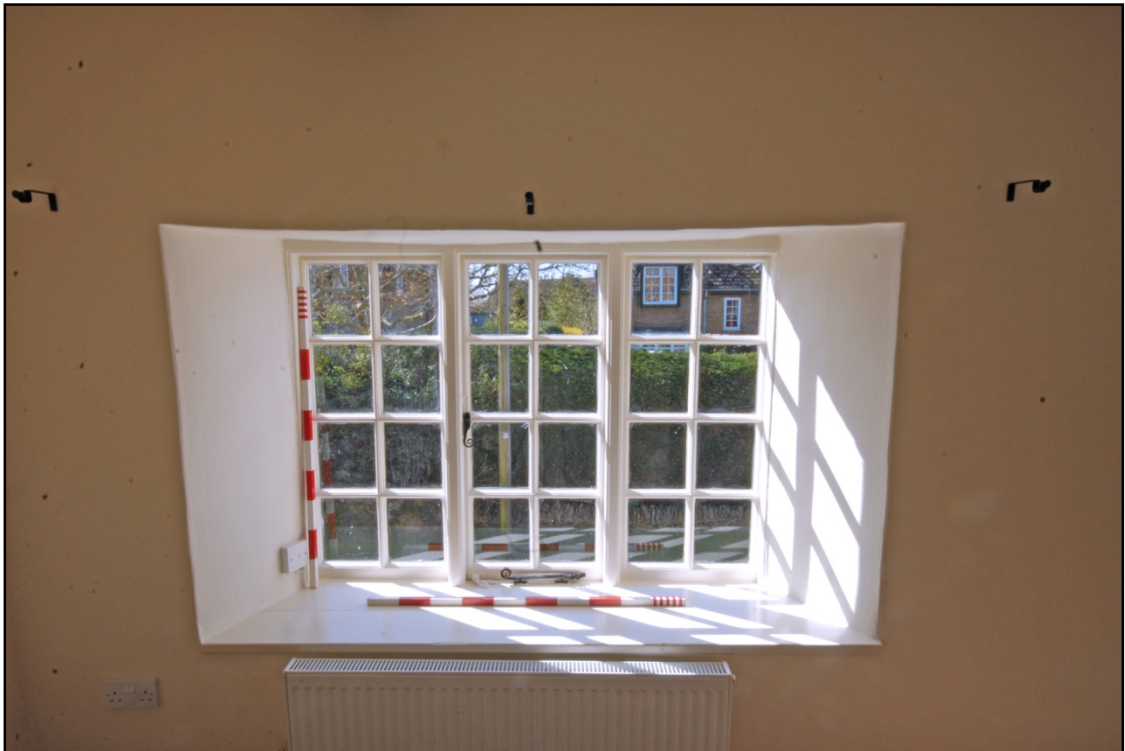
Bedroom 3, detail of the window, looking south Fig 33

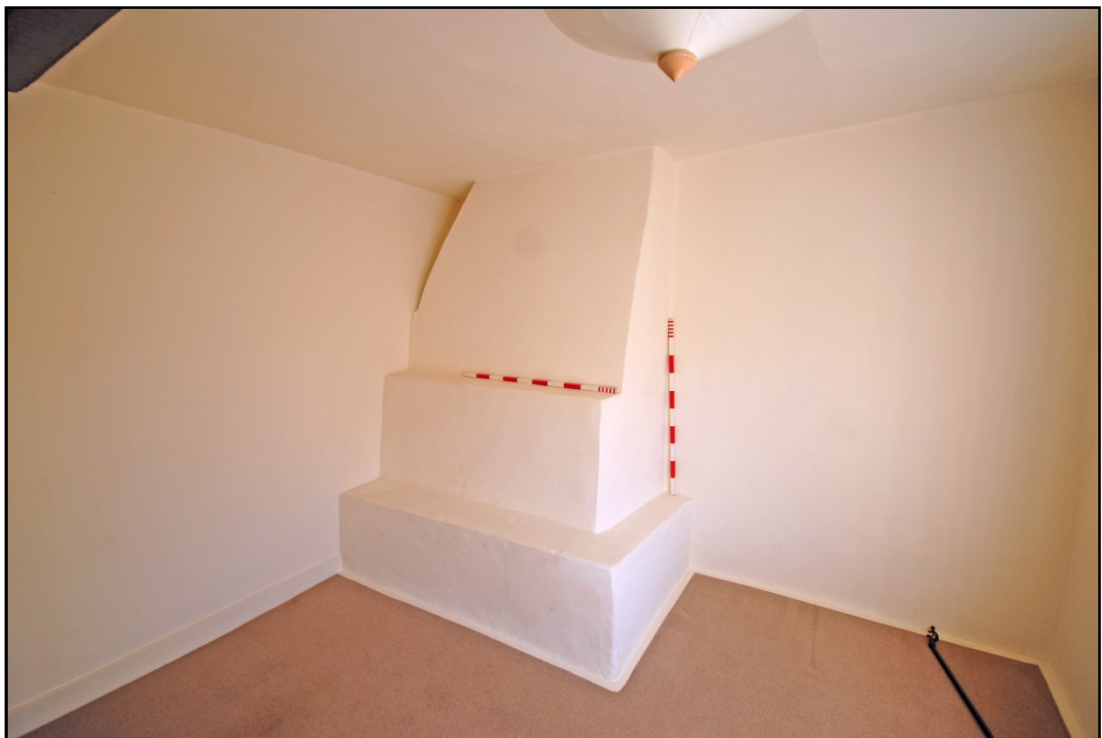
The chimney breast in Bedroom 2 Fig 34

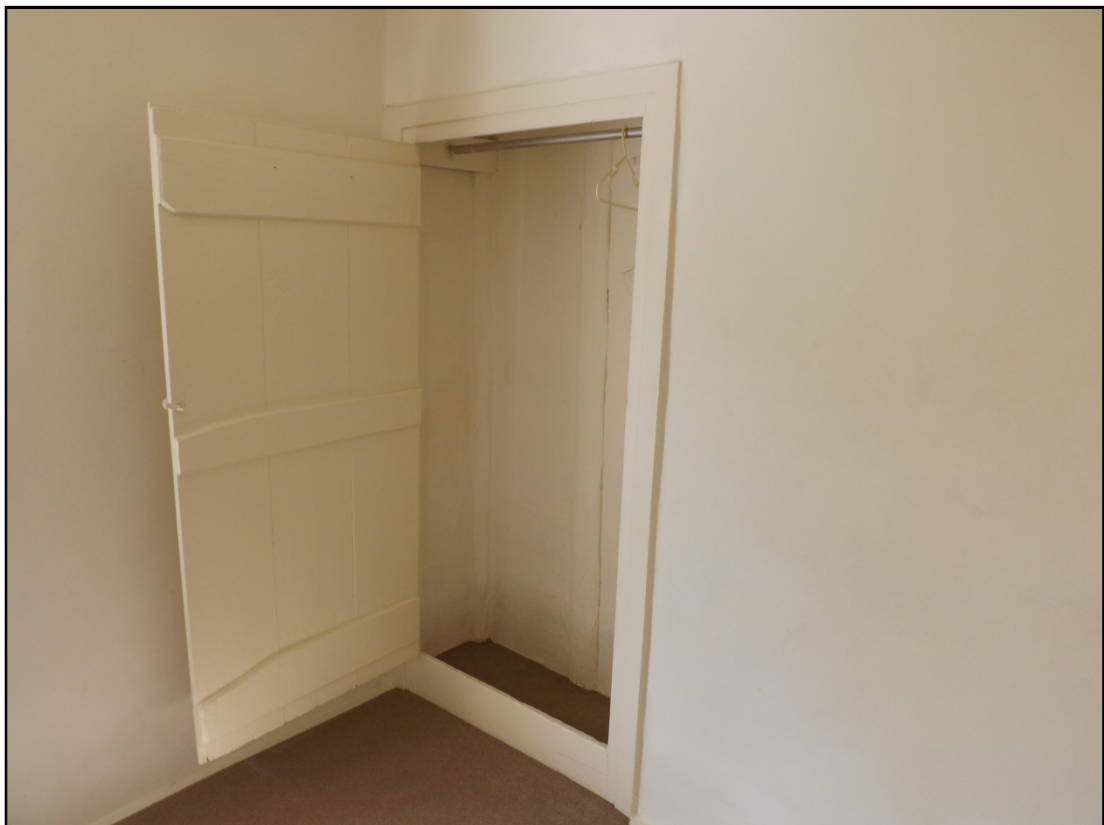
Prior to the construction of the east extension and creation of the corridor, access between Bedrooms 2 and 3 was through a door opening in the corner of the two rooms which has now been blocked and serves as a cupboard in Bedroom 2 (Fig 36).

Former doorway between Bedrooms 2 and 3, now a cupboard    Fig 36

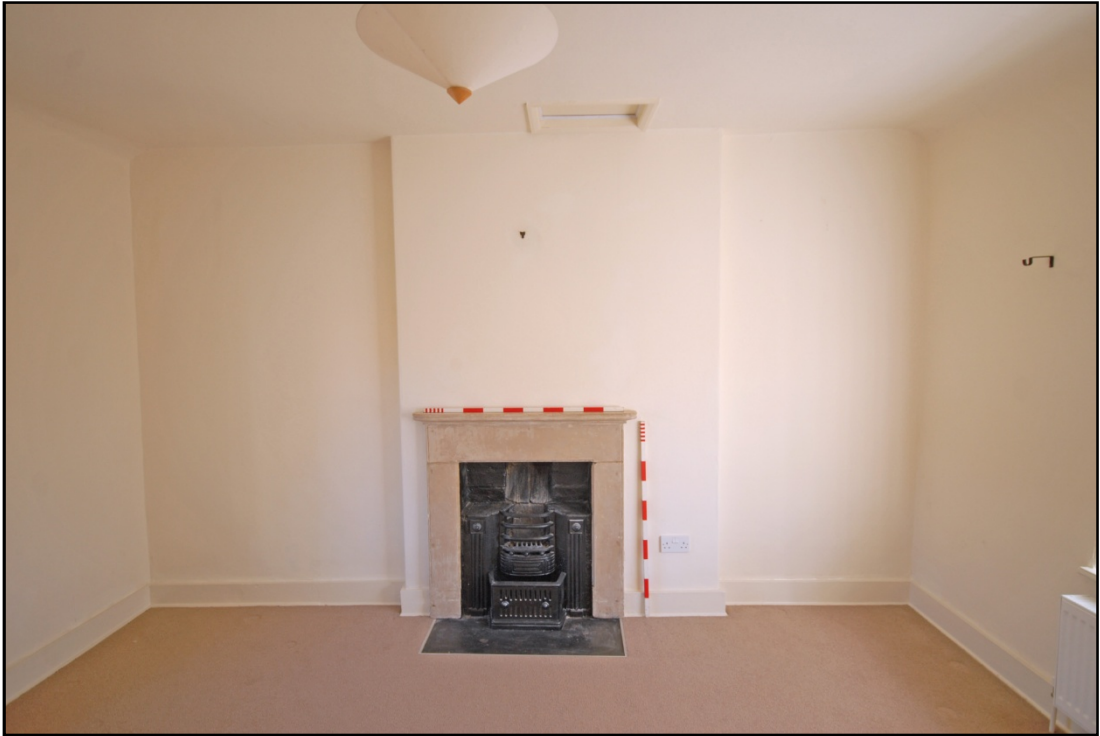
Bedroom 1, the east wall with fireplace off centre to chimney breast Fig 37

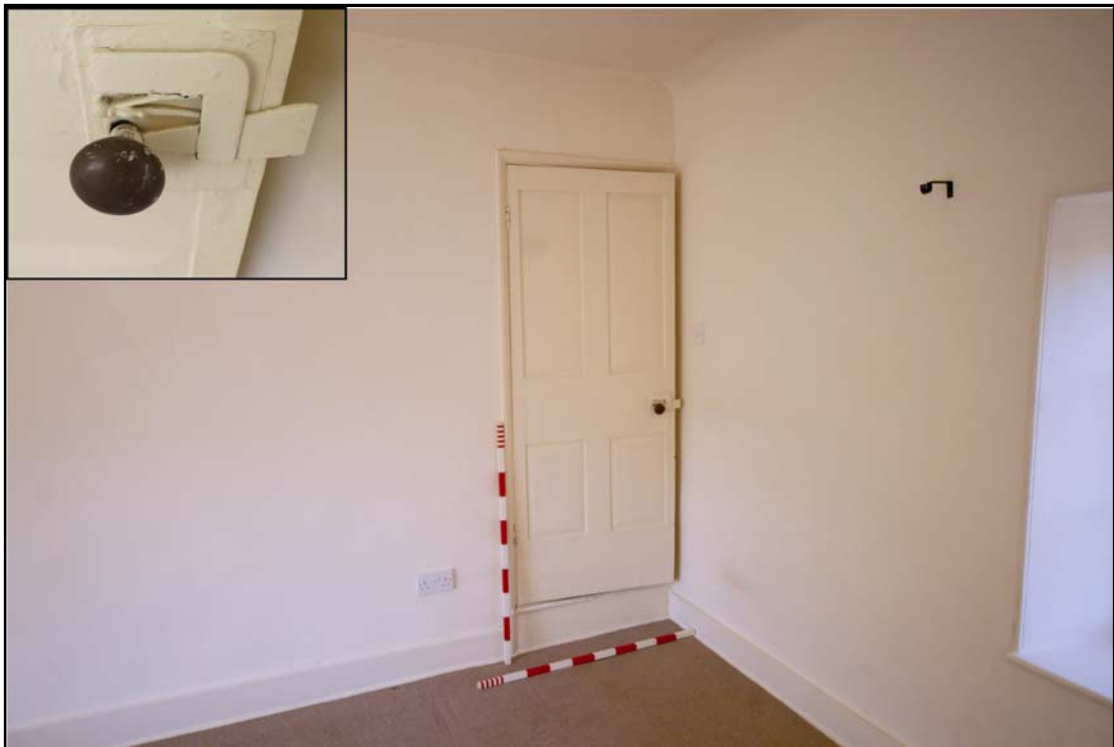
Bedroom 1 currently serves as the master bedroom and occupies the entire first floor of the east extension. A cast iron fireplace with modern surround is positioned off centre to the chimney breast which is central to the eastern wall (Fig 37). A large window looks south onto Manor Road and a smaller window casement window looks north towards the yard. The room is separated from the corridor by a panelled door with spring latch (Fig 38).

Bedroom 1, door with detail Fig 38

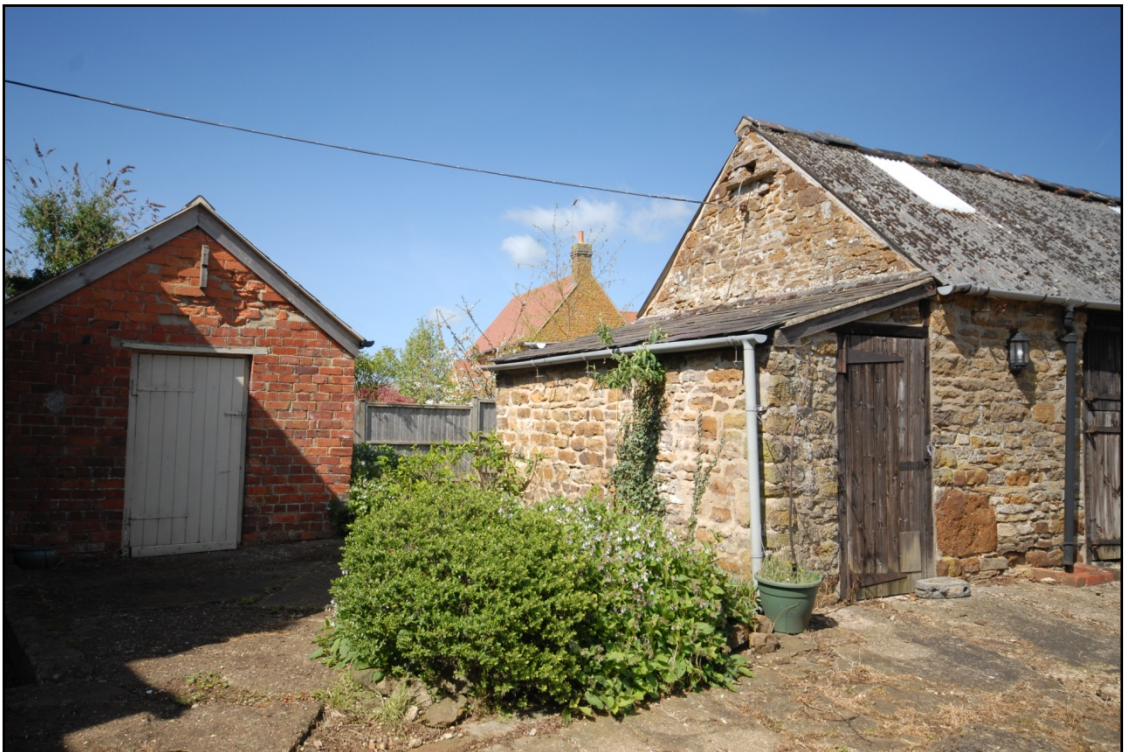
This is a small, square outbuilding measuring c2.5m x 3m (Figs 11, 42 & 43). The main fabric of the structure is of red brick in stretcher bond and the floor is of concrete. A square, fixed, single light window looks north from the north wall. It has a simple gabled roof of welsh slate with a tile ridge. A long strip of reduced ground separates room G1 from the main farmhouse which rests upon a stone plinth in this area. This structure was likely constructed in the mid 20th century and appears on the Ordnance Survey map of 1965 (Fig 10).

Rooms G1 and G2, looking north-west Fig 42

At the time of this survey this room, which measures c2.5m x 1.5m was utilised as a wood store (Figs 42 & 44). It has a modern ledged braced door and a concrete floor with a single pitch welsh slate tile roof over. The room is constructed of coursed sandstone and ironstone rubble with mortar. Map evidence suggests that room G2 has a later construction date than room G3 which it abuts (Fig 8).

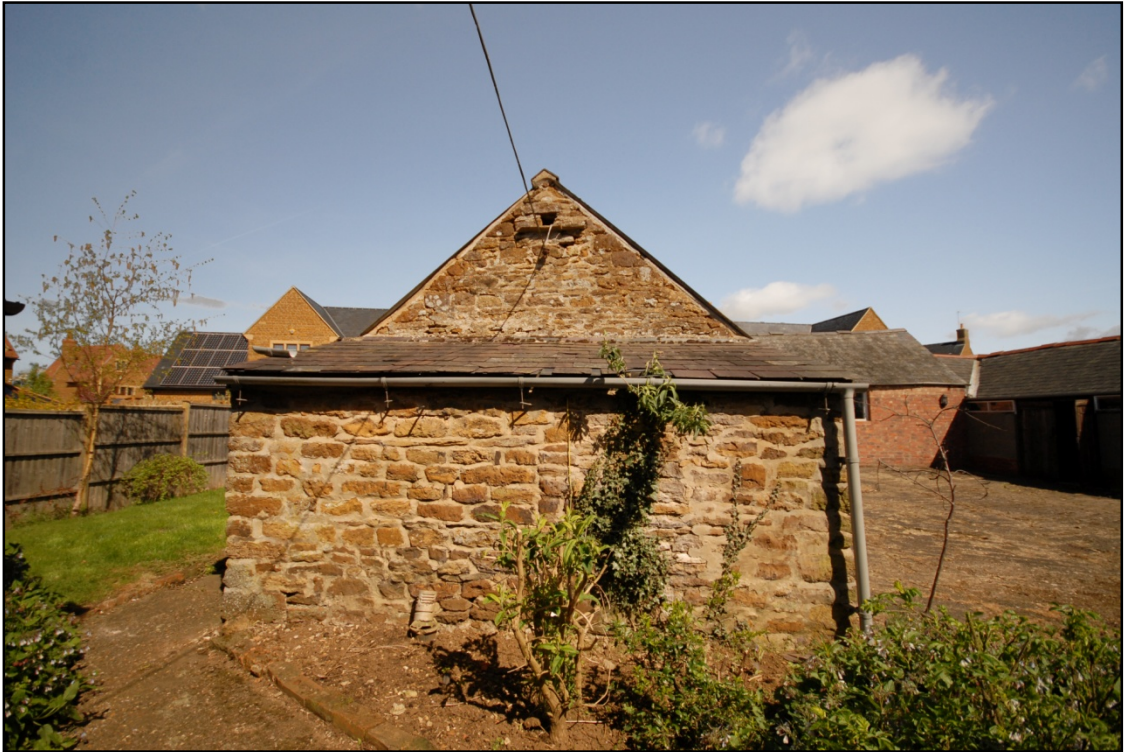
The south elevation of rooms G2 and G3    Fig 45

This a small room, measuring c1.5m x 1.5m was used as an outdoor WC at the time of this survey. It can be seen on the First Edition Ordnance Survey map of 1884 (Fig 8) and a vertical join can be seen on the external face of the south wall where it abuts room G2 (Fig 45). Room G3 shares a welsh slate, single pitch roof with room G2.
