**Historic Building Recording  
at Clint Hill Farm  
Hanging Houghton  
Northamptonshire  
April 2014**

Report No. 14/106

**HISTORIC BUILDING RECORDING AT  
CLINT HILL FARM, HANGING HOUGHTON  
NORTHAMPTONSHIRE  
APRIL 2014**

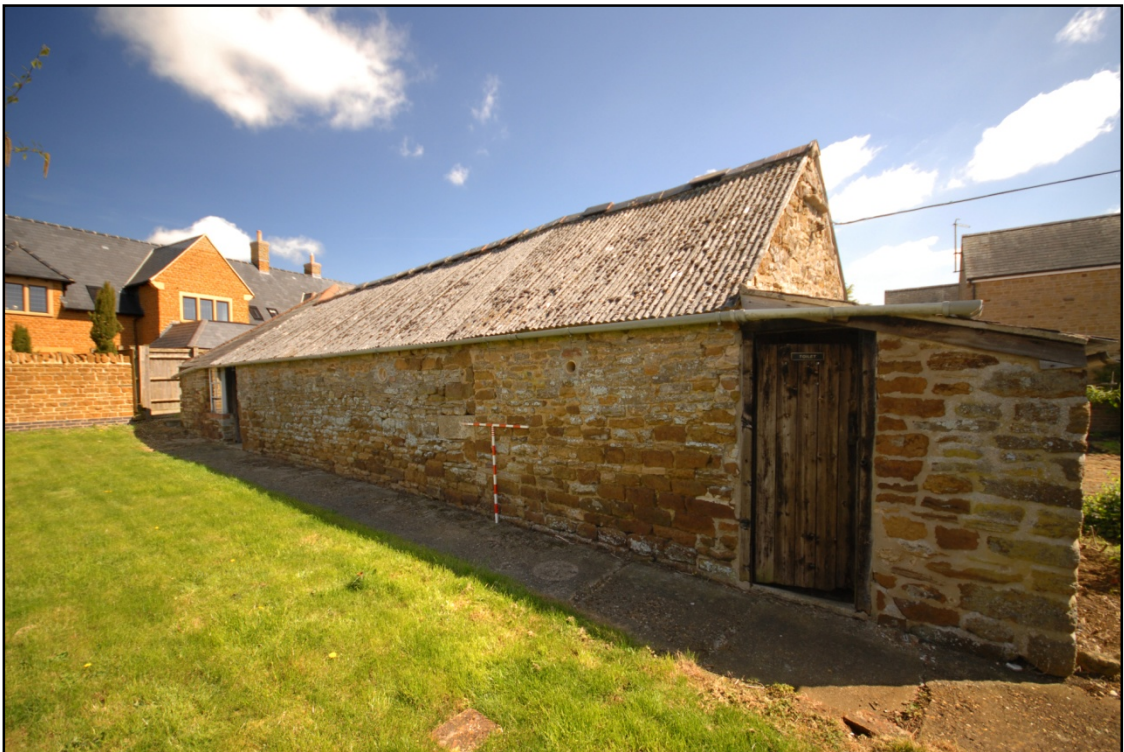
The west elevation of rooms G3-G6, looking north-east    Fig 46

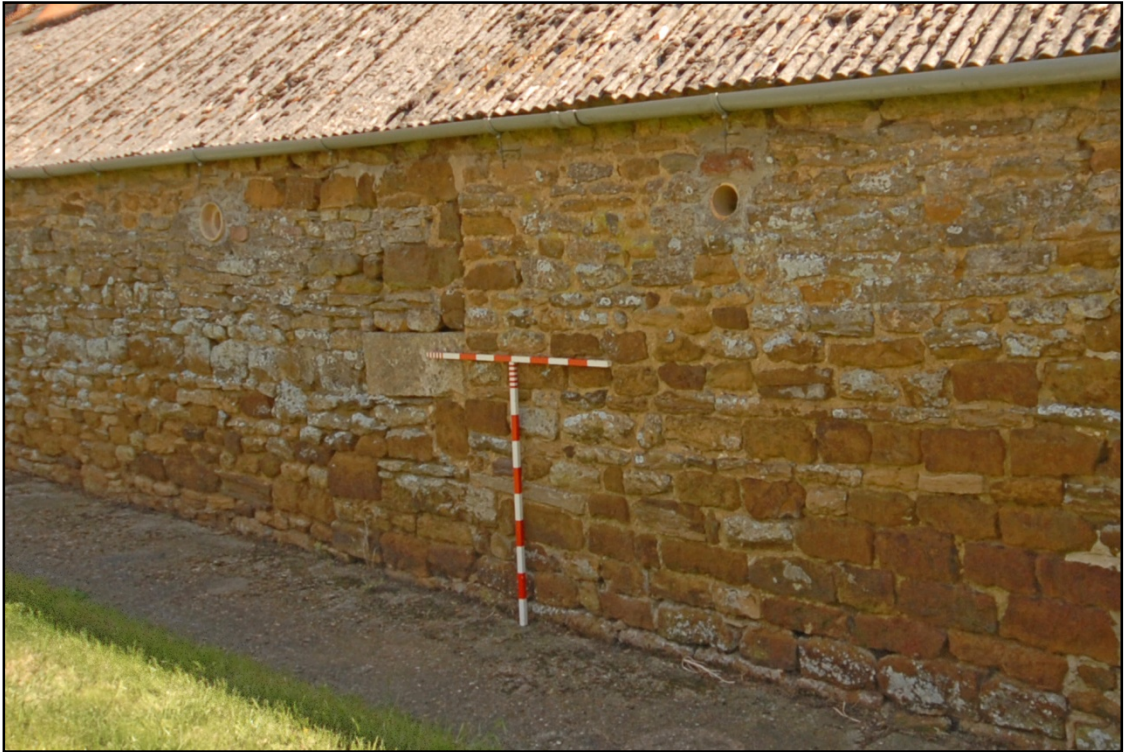
The vertical join between rooms G4 and G5, looking north-east Fig 47

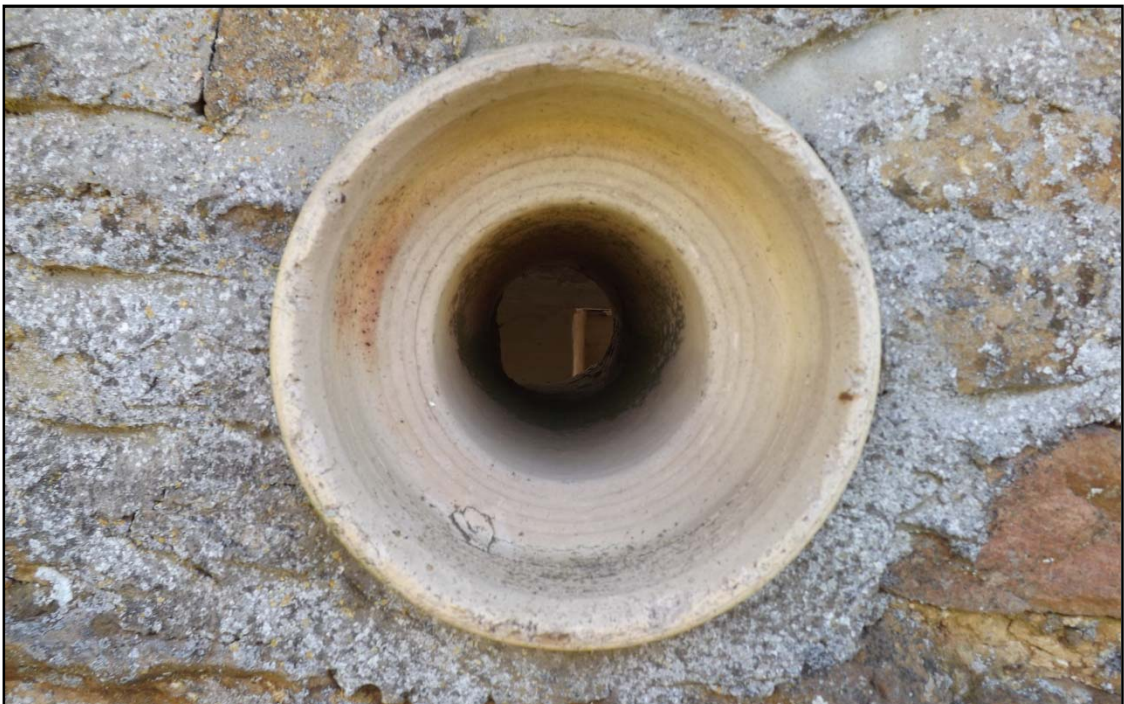
Detail of land drains used for ventilation throughout the ranges Fig 48

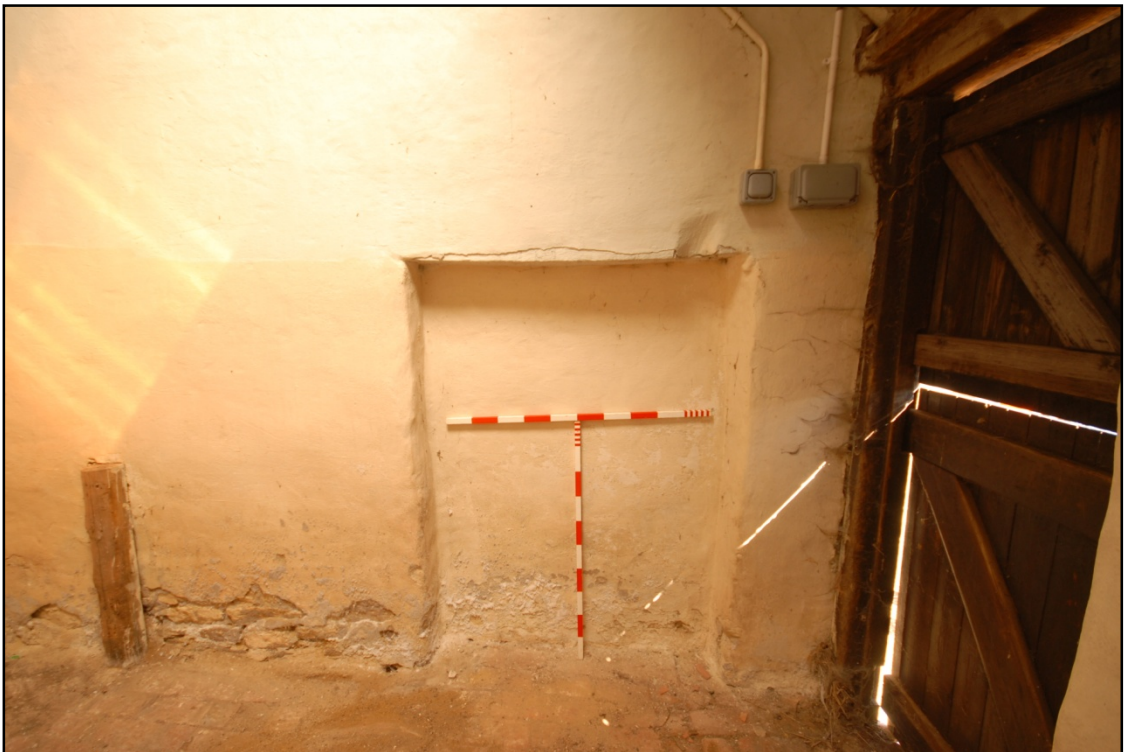
Room G4, showing the blocked door Fig 50

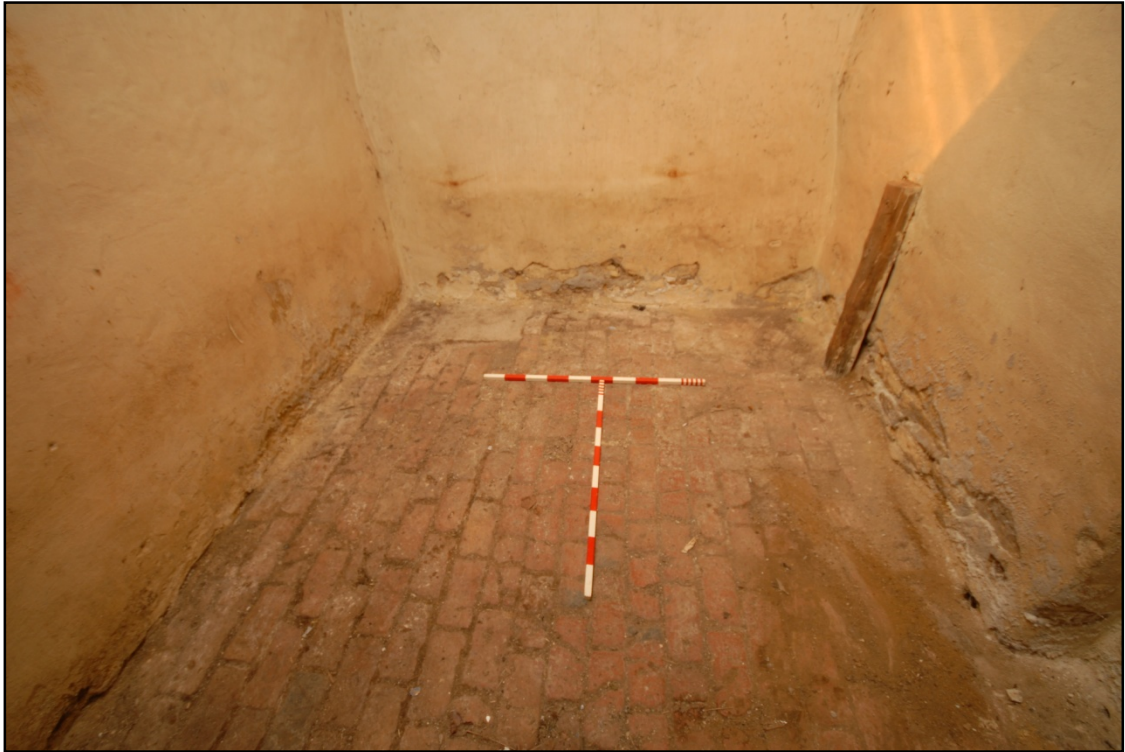
Room G4, the brick floor    Fig 51

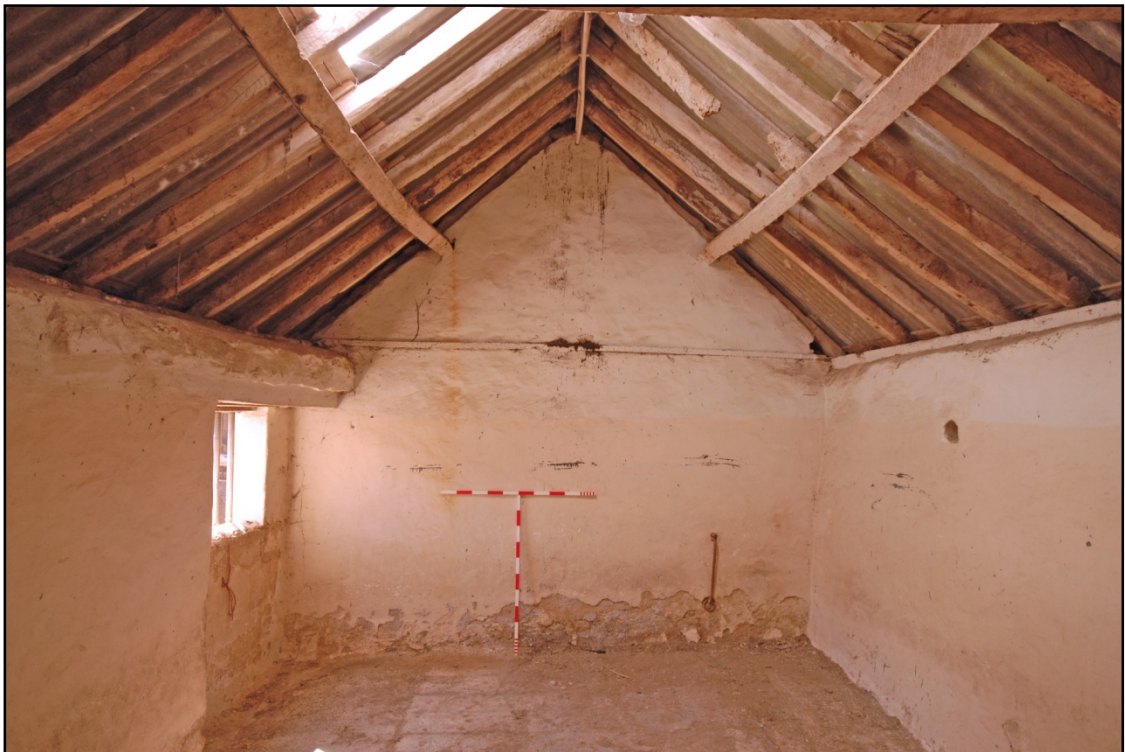
The roof structure is simple with corrugated asbestos sheeting laid over roughly shaped rafters which are supported over a single pine purlin central to each pitch (Fig 52). A single length of timber supports the rafters at the pitch of the roof. Two tie beams provide support for the purlins. The asbestos roofing suggests that this range was re-roofed in the early-mid 20th century.

Room G5, looking south    Fig 52

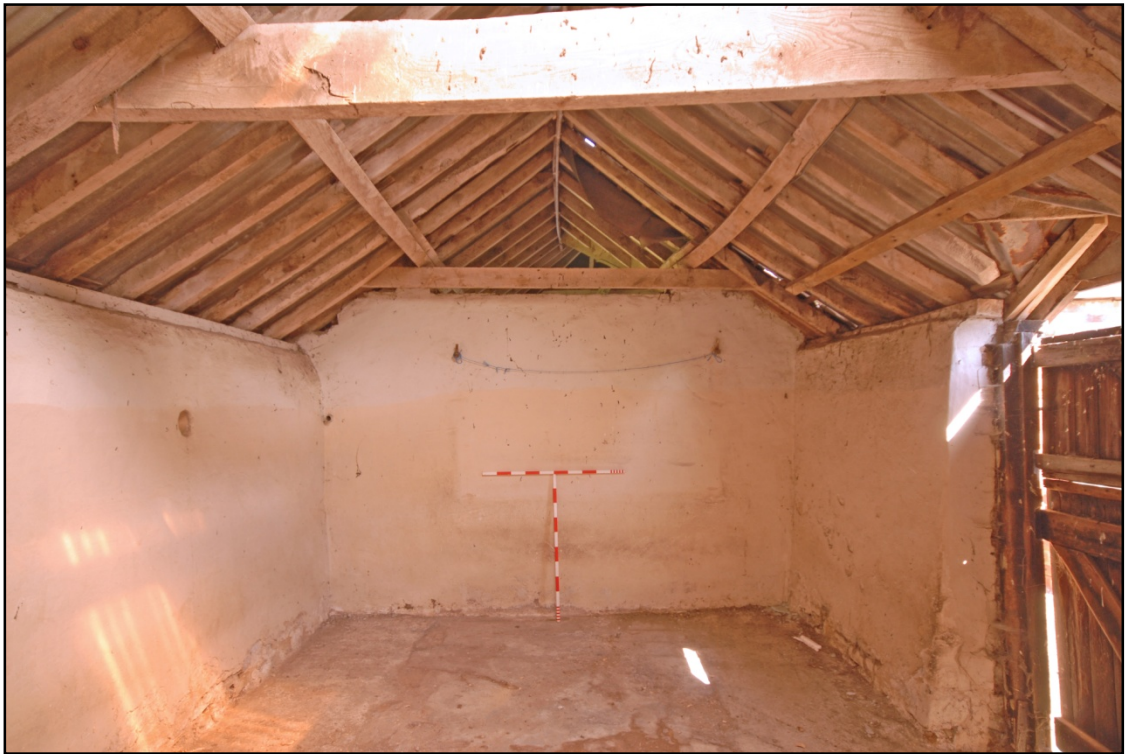
Room G5, looking north towards the breeze block partition Fig 53

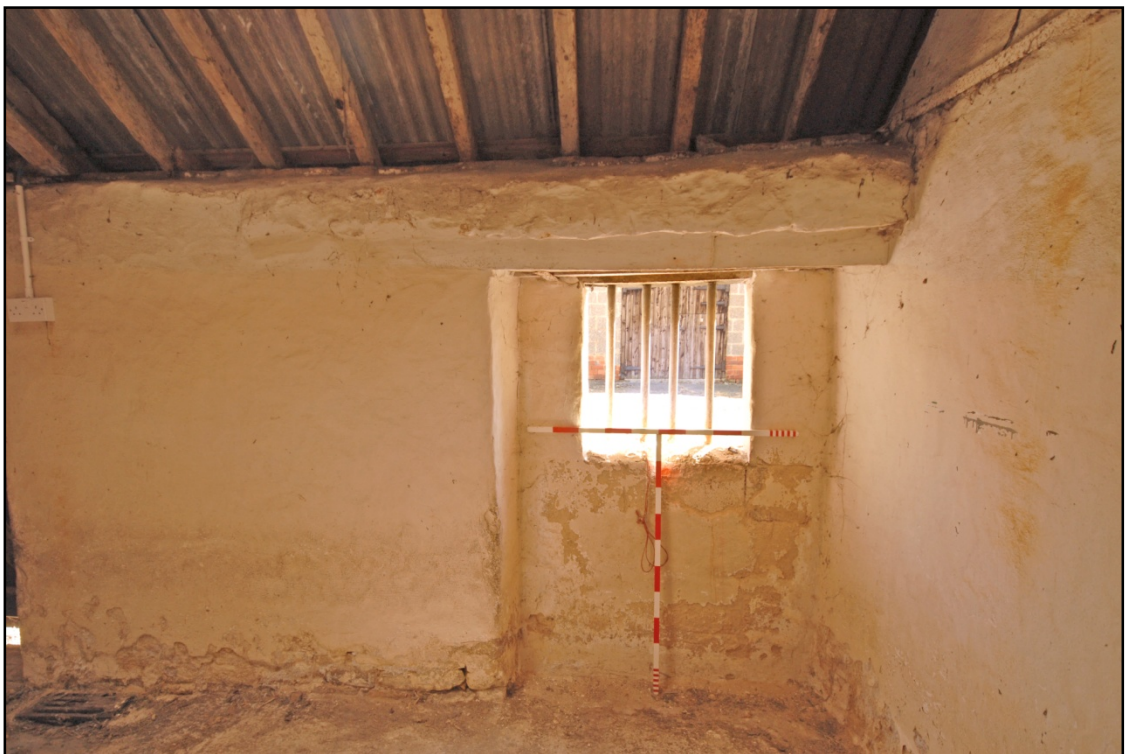
The blocked door in room G5, looking east. Note the beam over Fig 54

A single skylight on the eastern pitch of the roof provides additional lighting for the room. There were formally three doorways into the room, two of which have been blocked. A small window with iron bars has been inserted into the eastern blocking (Fig 54). The single remaining doorway has a modern, pine stable door with timber, pitched ventilation over. A roughly hewn timber beam supports the roof over the former doorway (Fig 54). This beam pre-dates the later roof and relates to the original construction of the structure.

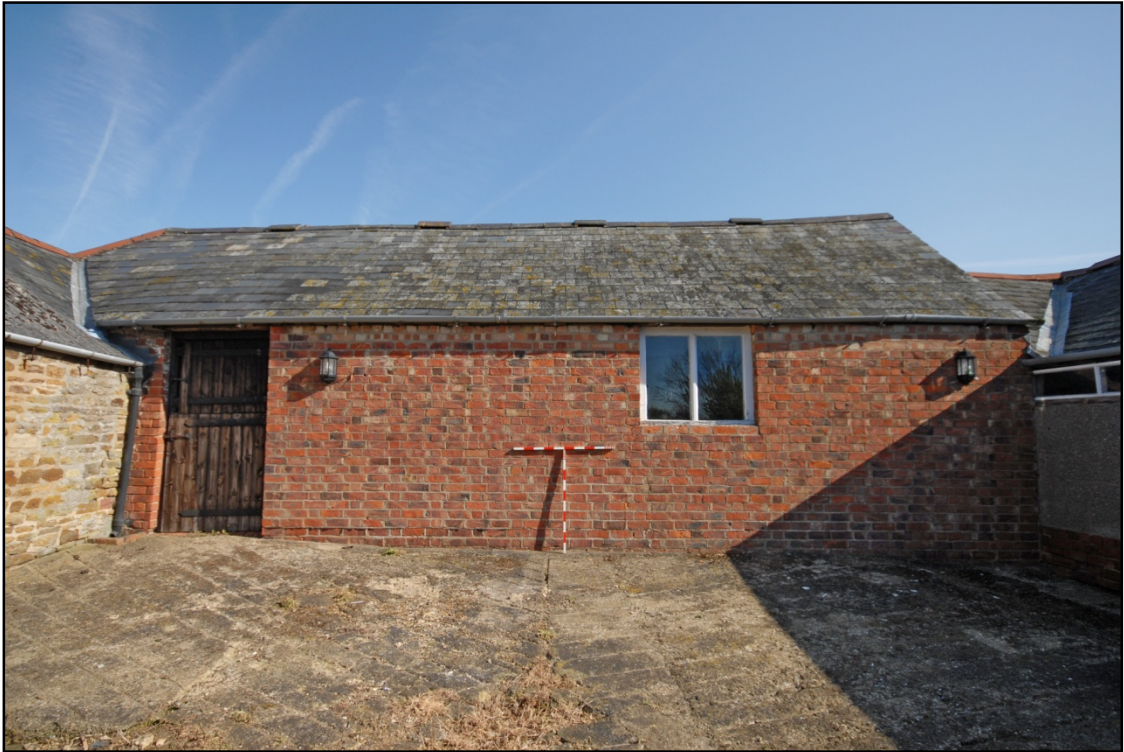
The northern range can be dated to the mid 19th century and comprises one single storey room aligned east-west, measuring c13.5m x 4.5m (Figs 39 & 55). The north, east and western walls of room G6 are constructed of coursed sandstone and ironstone rubble in contrast to the south wall which is of red brick in Flemish garden wall bond. The floor is of concrete screed over brick.

The north range, room G6, looking north Fig 55

A gabled roof of slate tiles, hipped at the western end, runs the length of the range and continues for a short distance at a lower height over room G5 (Fig 40). This is supported by a simple structure of pine rafters carried on timber wall plates with purlins and tie beams (Figs 56 & 57). Iron ties are also present stretching between the rafters. Modern repair work can be seen at the hipped end of the roof with replacement ridge tiles and flashing, contemporary with the construction of the eastern range in the mid 20th century (Fig 55).

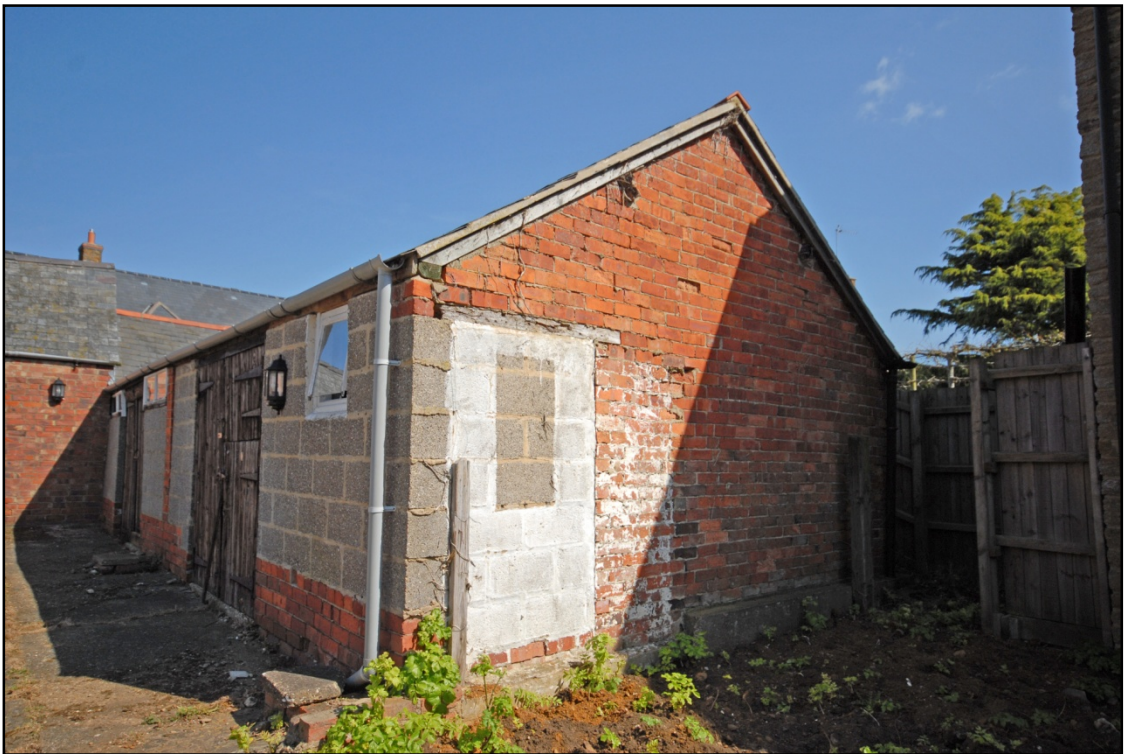
A blocked door in the south wall formerly allowed access to a smaller outbuilding which abutted the east range (Fig 60).

The east range, the south elevation, showing the blocked door Fig 60

The east range is latest phase of construction, dating to the early - mid 20th-century. It comprises two rooms, G7 and G8 (Fig 39). A smaller structure abutting room G8 was demolished in the late 20th century. The range is constructed of machine made red brick in stretcher bond with later breeze block infilling and blocking on the west and south elevations (Figs 59 & 60).

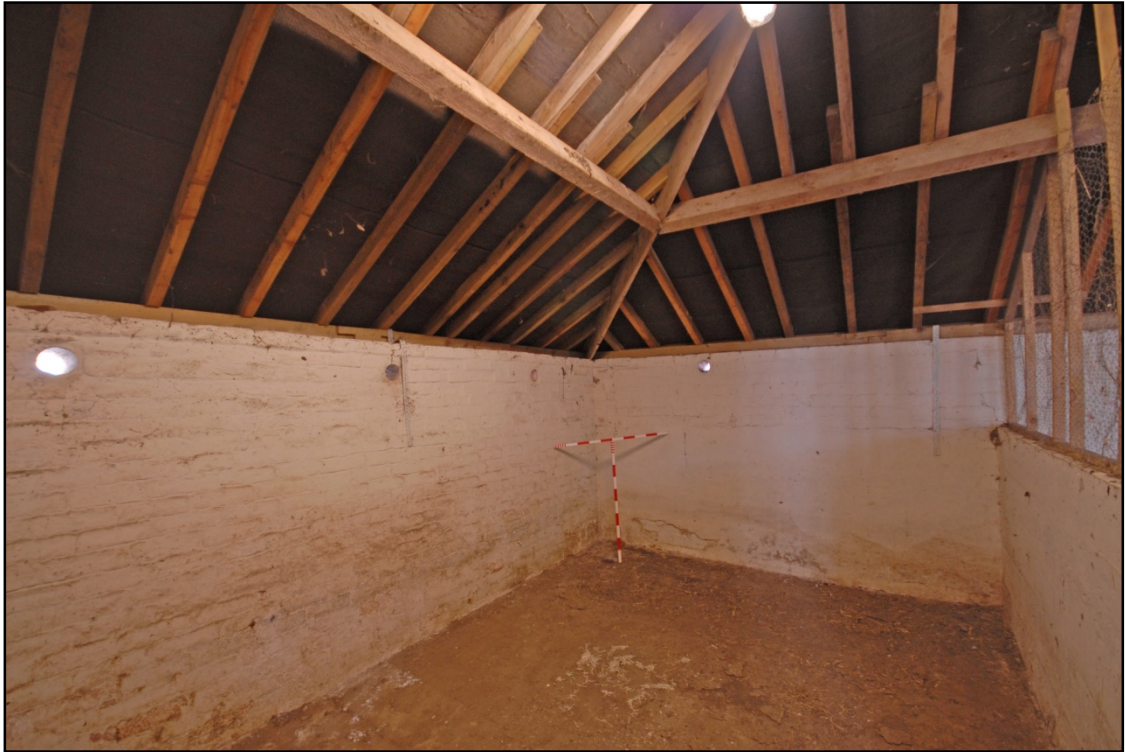
This is the most northerly room, measuring c10m x 4.5m (Fig 39). A light timber and mesh screen encloses the northern extent of the room, most likely for keeping chickens (Figs 61 & 62). The remainder of the room has been partitioned by mid height concrete stall divisions. The floor is of concrete with a shallow drain running north south, central to the room.

Room G7, the northern partitioned area Fig 61

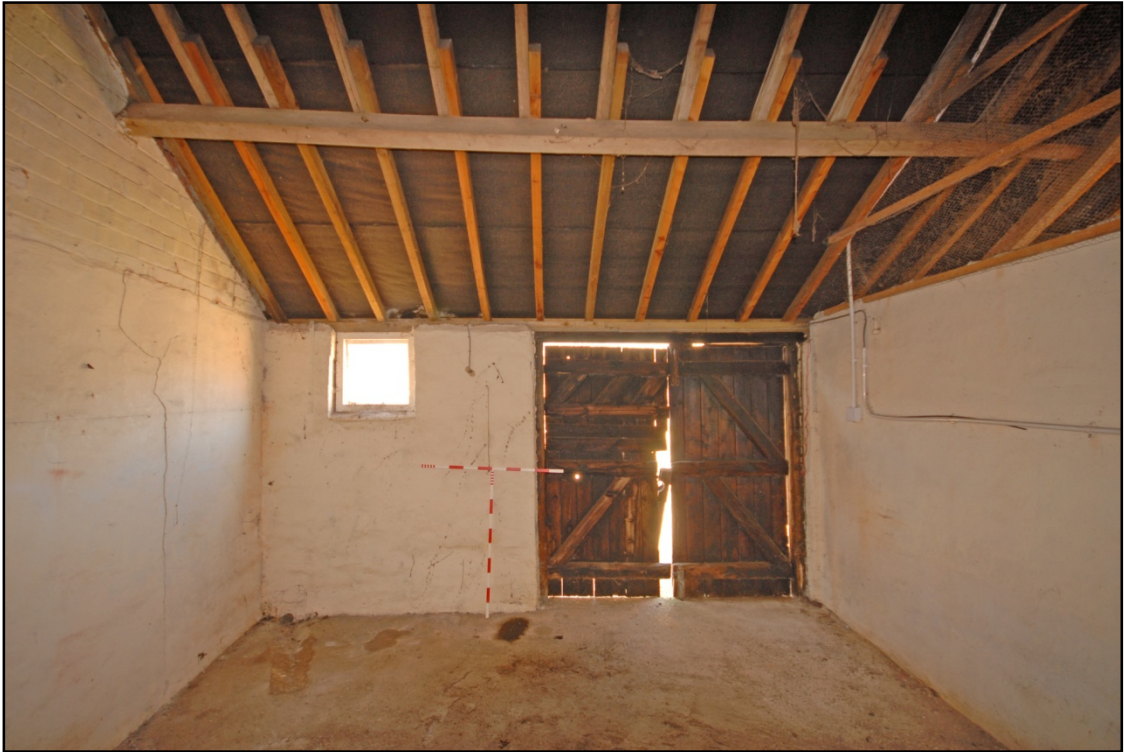
This is a square room measuring c4.5m x 4.5m (Fig 39). The room is fairly featureless with a concrete floor and double doors opening onto the yard (Figs 64 & 65). A fixed, single light window also looks onto the yard (Fig 65). The room shares its roof structure with room G7.

Room G8, general view of the interior, looking west    Fig 65
