**Archaeological Watching Brief during works  
at the Old Slaughter House, Springbank  
Medbourne, Leicestershire  
May 2013 and May 2014**

Report No 14/107

**ARCHAEOLOGICAL WATCHING BRIEF DURING WORKS AT  
THE OLD SLAUGHTER HOUSE, SPRINGBANK  
MEDBOURNE, LEICESTERSHIRE  
MAY 2013 AND MAY 2014**

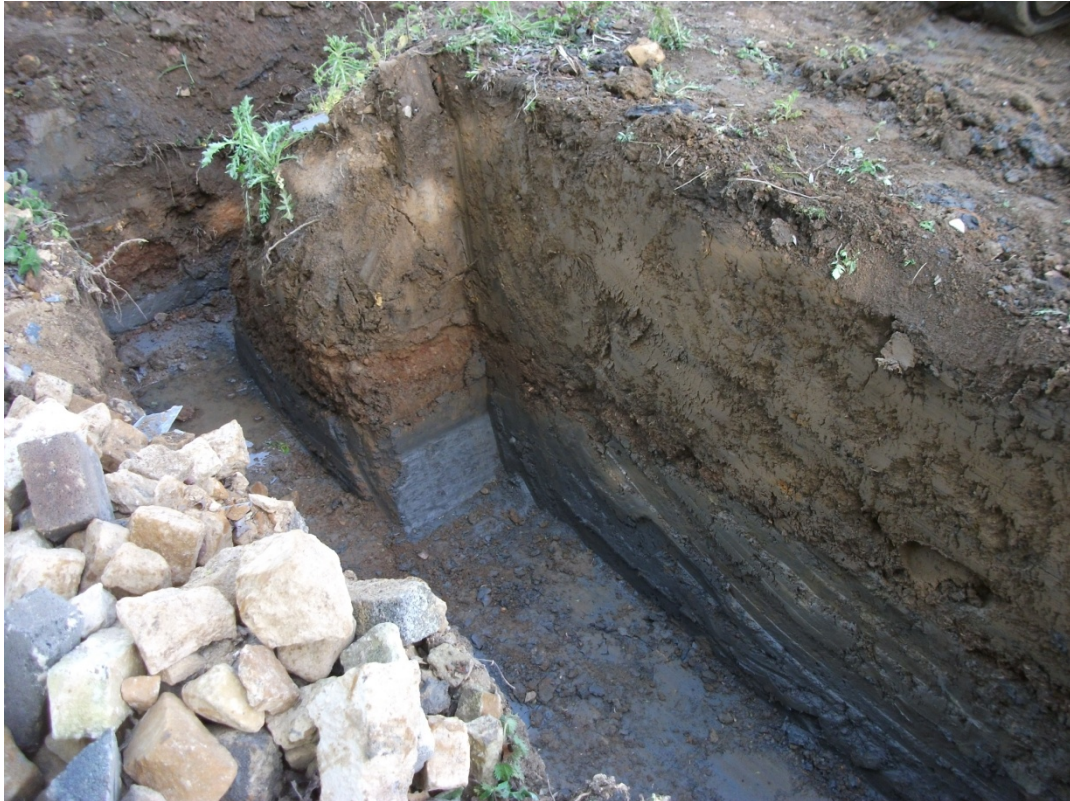
An excavated house foundation trench, showing the sequence of geological strata  
Fig 3

The underlying geology of mid grey-brown mudstones was observed throughout the development area. It was overlain by 0.05-0.10m of mid black-brown sandy clay subsoil, which was overlain by 0.20-0.30m of dark black-brown sandy clay garden soil. Both soils were truncated in places due to the previous building activity and subsequent garden landscaping.

The house foundations were cut to a depth of 2.20m showing the sequence of underlying geology (Fig 3).

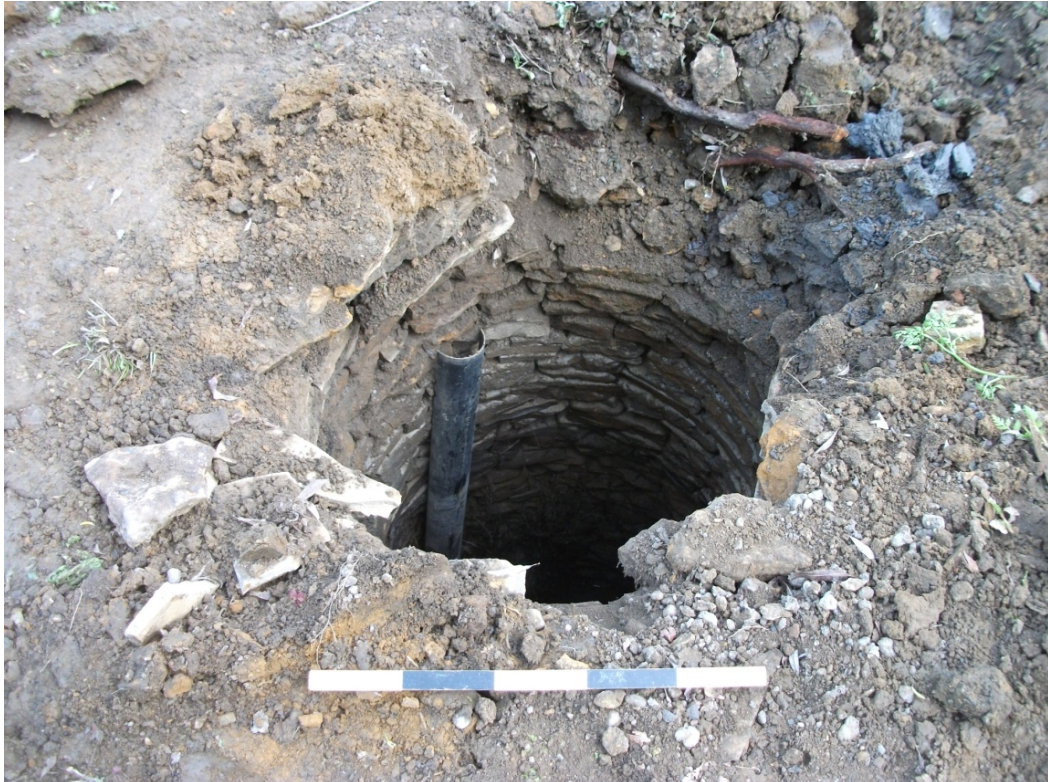
Fig 4

Located in the middle of the development area was a stone-lined well [5] (Fig 4), 1.10m in diameter and 2.50m deep. It was lined with undressed ironstone blocks and was capped with a large fragment of ironstone. The well was not backfilled and water was present at its base.

The well probably served the old slaughter house, probably going out of use when it was connected to the mains water; it had been capped with a large fragment of ironstone and covered with garden soil.

Stone-lined well [5]

The well has been backfilled with concrete for the new development.
