**Archaeological building recording at
2 Bridge Street, Brackley
Northamptonshire
May 2014**

S/2012/1583/FUL and S/2012/1584/LBC

Report No. 14/120

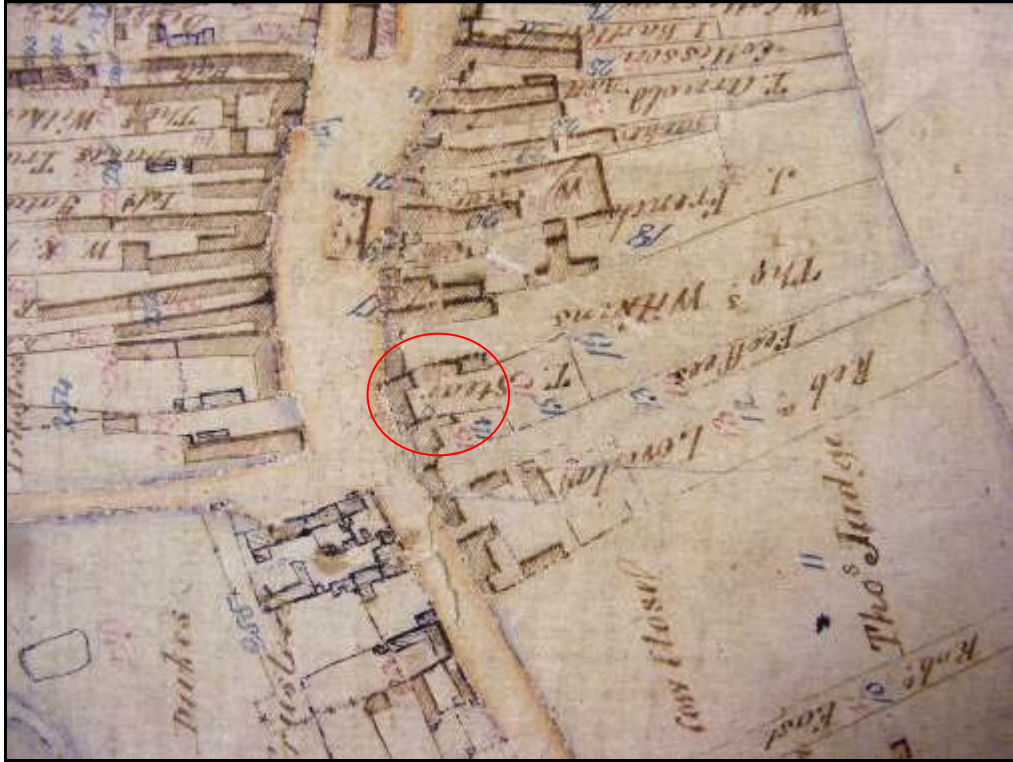
1830 map Fig 3

A cartographic search revealed maps dating to the early 19th century. The 1830 map depicts an L-shaped house fronting the street with two barns to the rear (Fig 3).

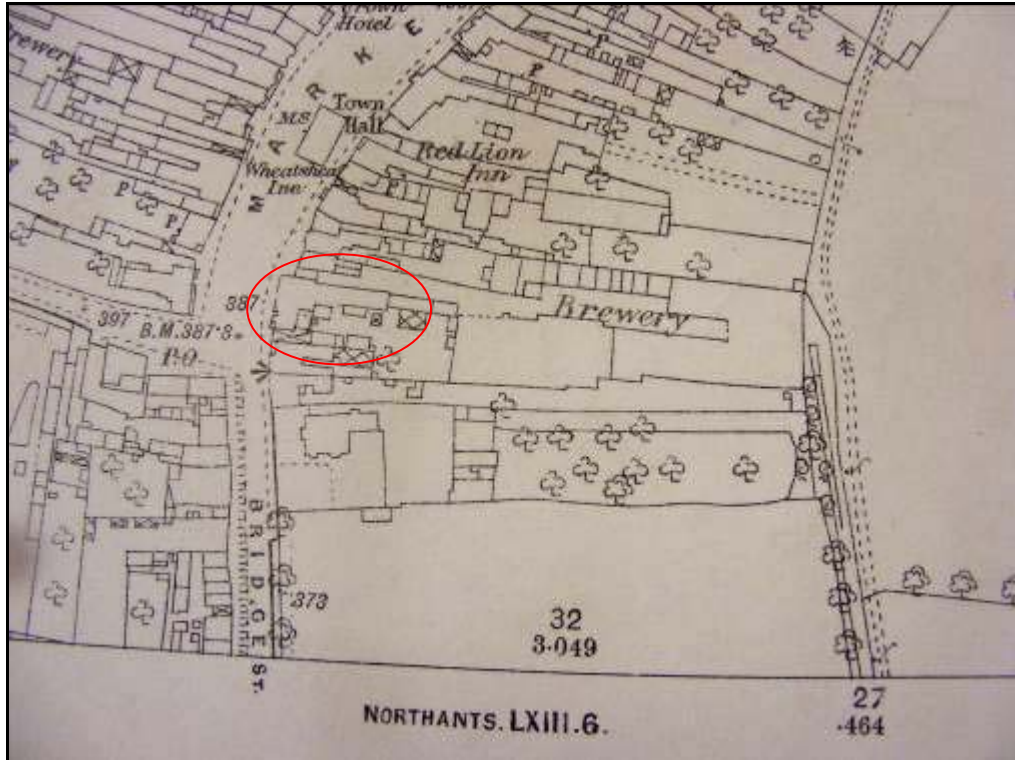
1880-82 Ordnance Survey map Fig 4

The 1880-82 Ordnance Survey map still show the basic building outline, but as one mass. There are the two barn extensions to the original building and smaller outbuildings and a new building to the east (Fig 4).

The British listing record dates the frontage to the 18th century with an older core (see above). An estates map dating to 1760 only depicts a rectangular building parallel with the road and no building to the rear (SNC 2011). By 1830 the main building is depicted to have an L-shape with two buildings to the rear (Fig 3). The later Ordnance Survey maps show this still in place with a third building to the rear and several extensions and a detached outbuilding (Figs 4 and 5).

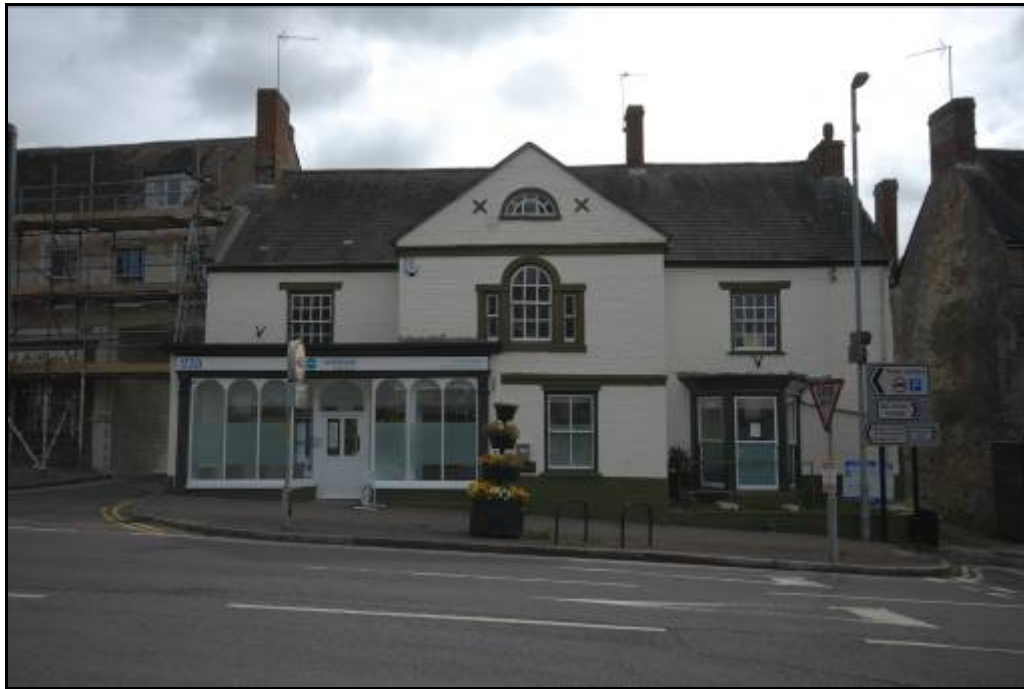
Frontage, looking east Fig 7

The building presents a three bay two storey frontage, the central bay protruding with a semicircular lunette window (Fig 16). Below, the first floor is a Venetian window with sash windows to either side in the northern and southern bays. On the ground floor an 18th-century shop front covers the northern bay and part of the central bay, this is also the main access. A sash window remains off-centre in the central bay. The southern bay has a three cant-bay window (Fig 7). The building is constructed of coursed stone with brick alterations and repairs; the front and northern side are painted white with the windows and decorative details painted dark green. The rear and the northern side are bare stone, the north-eastern corner is constructed as a coach corner (Fig 8). The roof is slate. The building is in use by the Dental Surgery and therefore not further discussed below.

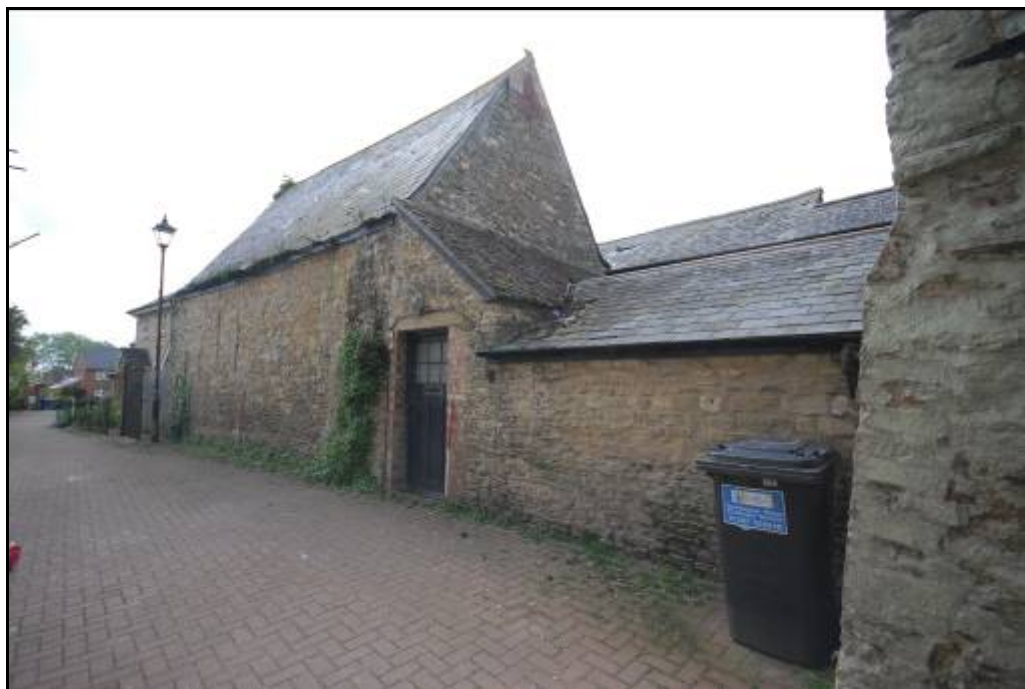
North elevation from Brewery Walk, looking south-east Fig 11

To the rear is a barn with extensions, all internally connected. The construction is of a mix of stone and brick. The northern wall of the barn along Brewery Walk is roughly coursed limestone; it had been re-pointed with a grey-beige mortar, which made it difficult to discern any changes between potential building phases (Fig 9). The western end is single storey with a door inserted at a later date with a concrete lintel and brick surrounding the door jamb (Fig 10). To the west of the door is a window blocked with stone externally (Fig 11).

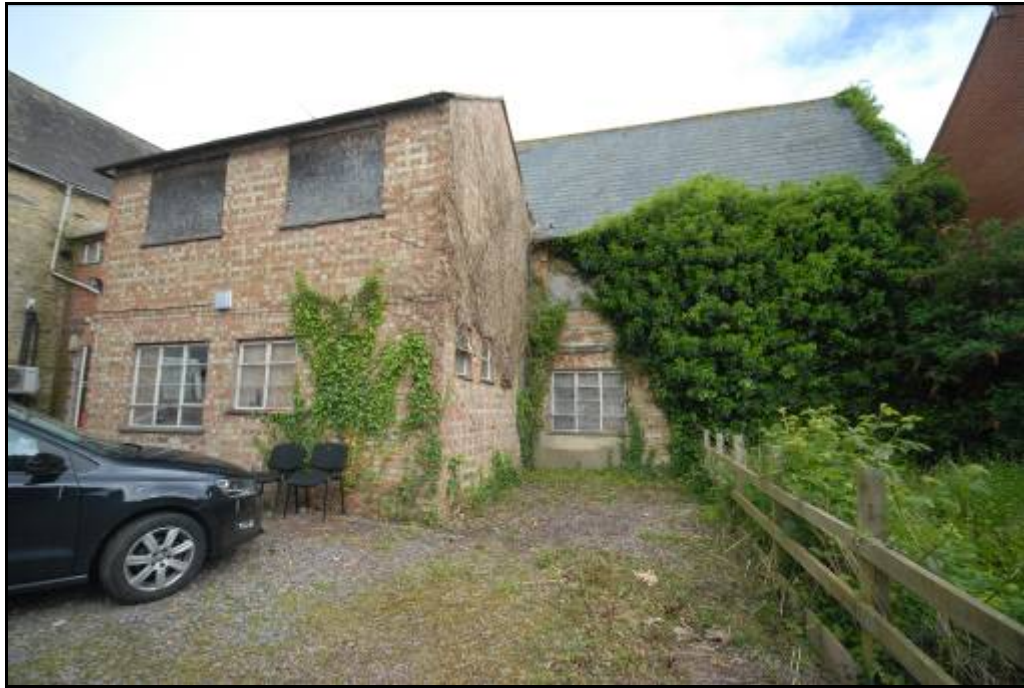
South elevation, looking north-west Fig 12

The eastern part of the barn was two storey, the eastern gable was a boarded stone wall, which had been rendered and painted beige; quoins were only visible on the first floor level (Fig 9). The western gable end of the building was bare stone, possibly original (Fig 11). The southern elevation of the barn could only be partly seen due to ivy and comprises a mixture of stone and brick, later alterations could be noted with the use of a mottled light red/beige brick (Fig 12).

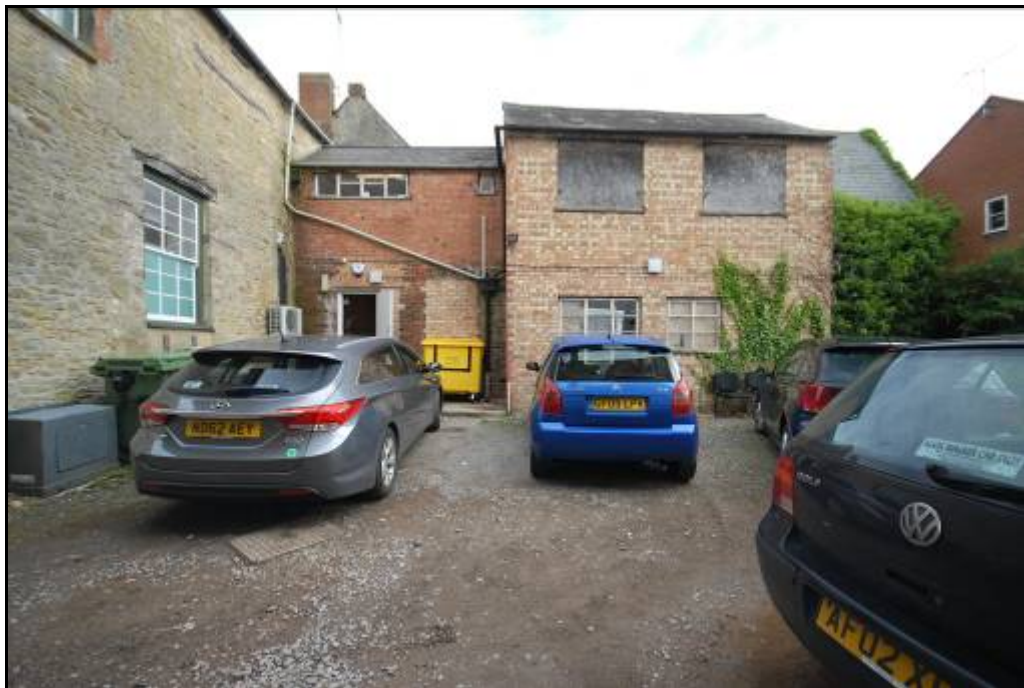
South elevation with courtyard, looking north Fig 13

On the southern side are two brick extensions, both two storeys high (Fig 13). The first one to be constructed butted against the main building and underwent two phases of alterations. It was initially a single storey building constructed of blue engineering bricks and dark red bricks in English garden wall bond, with the first floor extension in red brick with a Flemish bond. More recently the doorway was made narrower and the arched window was blocked with a mottled light red/beige brick (Fig 14). The upper floor is not further discussed as it was in use at the time of the visit.

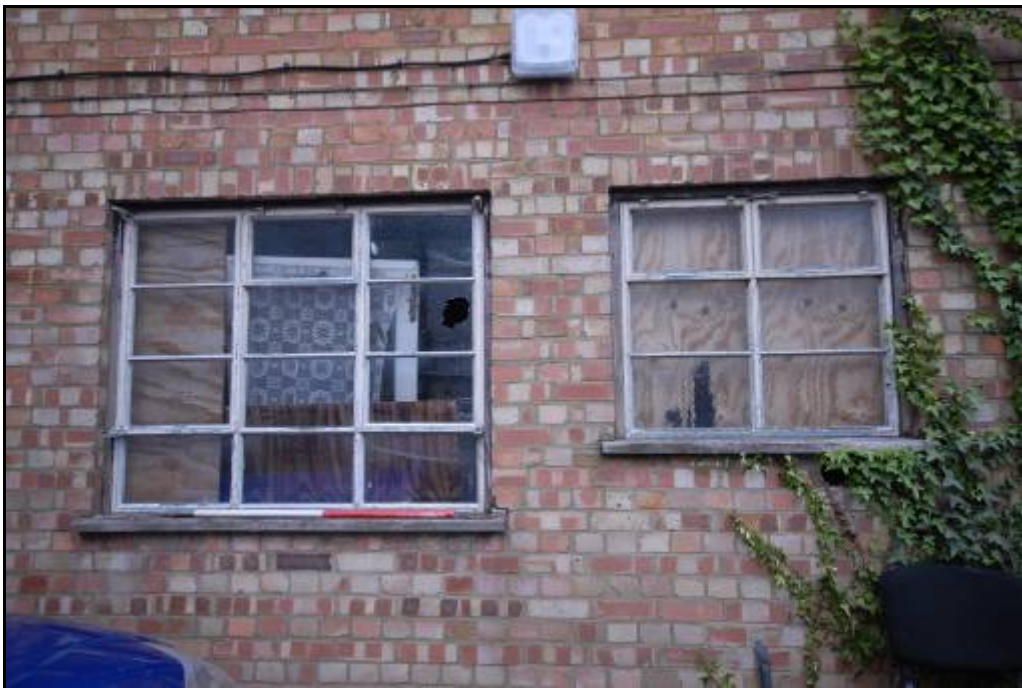
Crittal style windows Fig 15

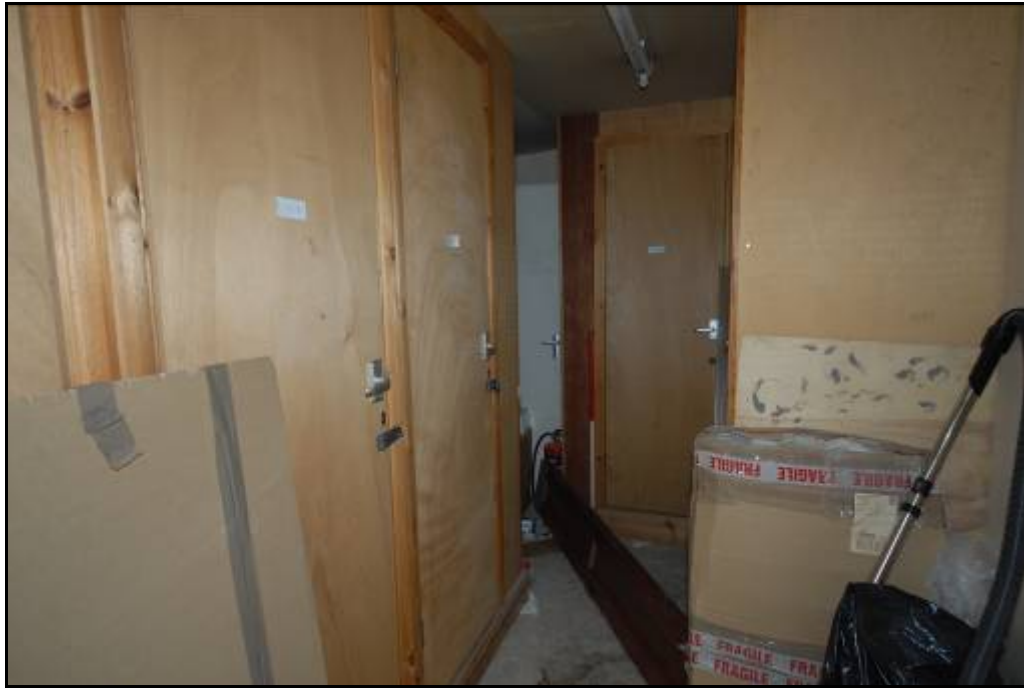
Rear access, through a wooden fire door clad in decorative plastic tongue and groove effect plastic sheet, lets into a narrow room, which acts as a corridor between the main house and the buildings and extensions to the rear. The walls are built up with floor to ceiling cupboards constructed of plywood/MDF (Fig 17). There are two further fire doors, a wooden door through to the surgery and another to the outbuildings. The floor is covered in screed; through gaps within the old floor tiles could be noted coloured red, black and light beige (Fig 18). The ceiling was covered with plasterboard.

Room 1, looking east Fig 17

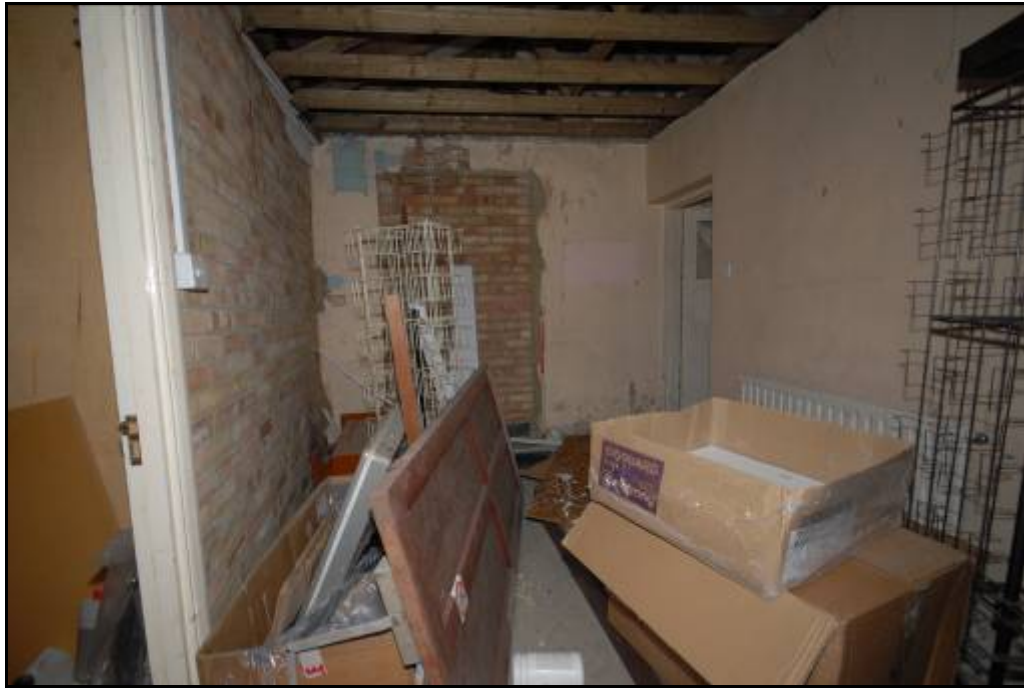
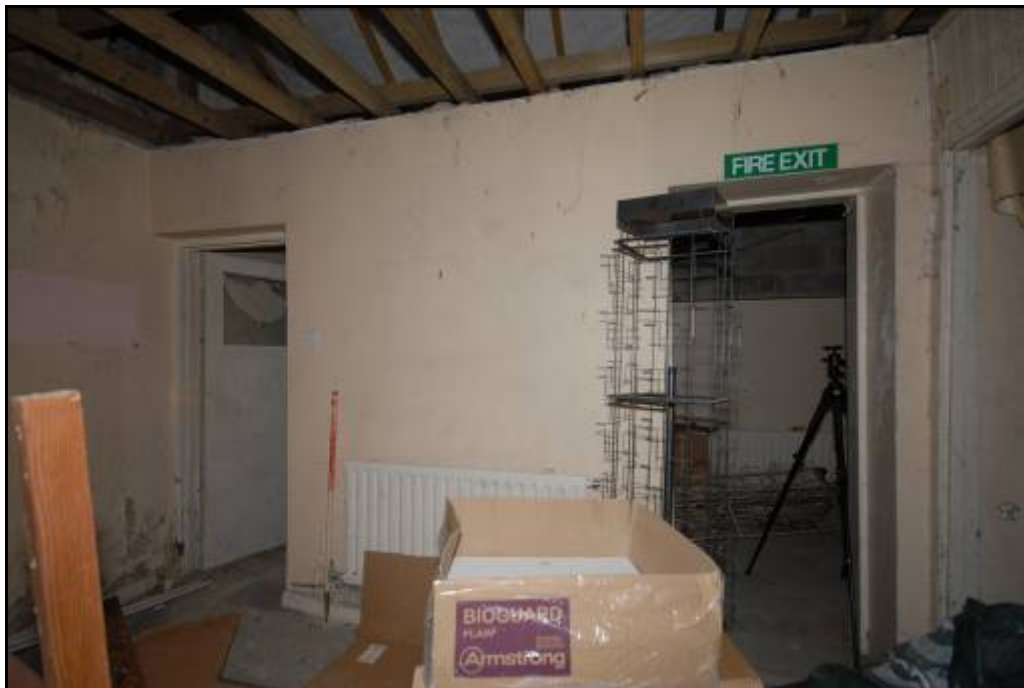
The southern wall is bare brick with the western and northern walls beige painted plaster (Figs 19 and 20). On the eastern side the room is partitioned from the stairwell (room 5) and hallway (room 6) by a beige painted wooden partition (Fig 21). There are two doorways on the northern wall, these lead into two further rooms 3 and 4, the door to room 4 was designated as a fire exit (Fig 20). The door into room 3 has a flush surface on both faces and a single light window. A doorway into the main house is bricked up, the step up into the other building remains (Fig 19). The floor is concrete on hardcore, the ceiling consists of exposed tie beams with the light fitting fixed directly onto the beam.

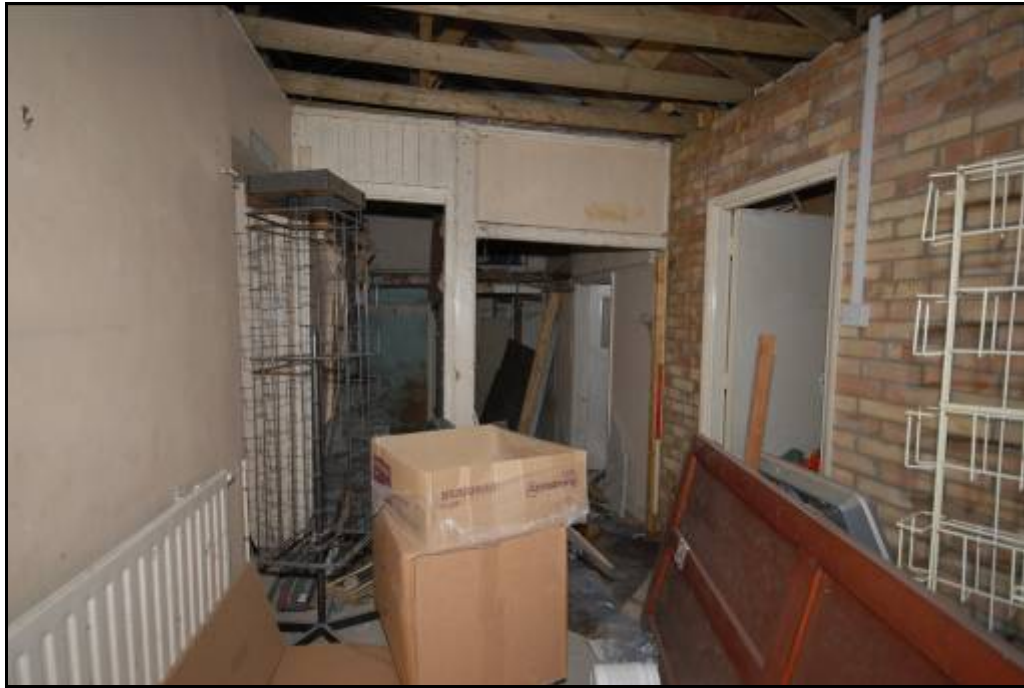
Room 2, looking east Fig 21

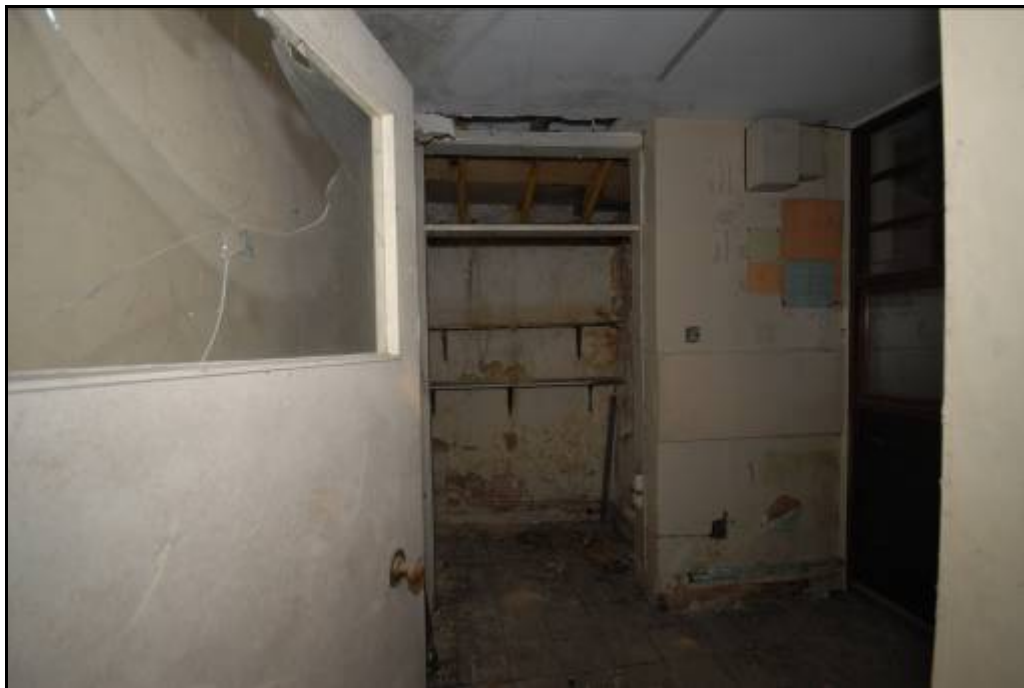
The room was, together with room 4, probably used as a reception area. The walls are beige painted plaster or plaster board. The plaster over the stone work is up to 400mm thick. An inbuilt storage cupboard is situated in the north-western corner of the building, which has two shelves (Fig 22). The floor is concrete laid with grey square plastic tiles. The ceiling is covered with plasterboard and has an attic hatch. A dark brown wooden partition separates rooms 3 and 4 allowing the receptionist, in room 3, to deal with visitors (Fig 23).

Cupboard in room 3, looking north Fig 22

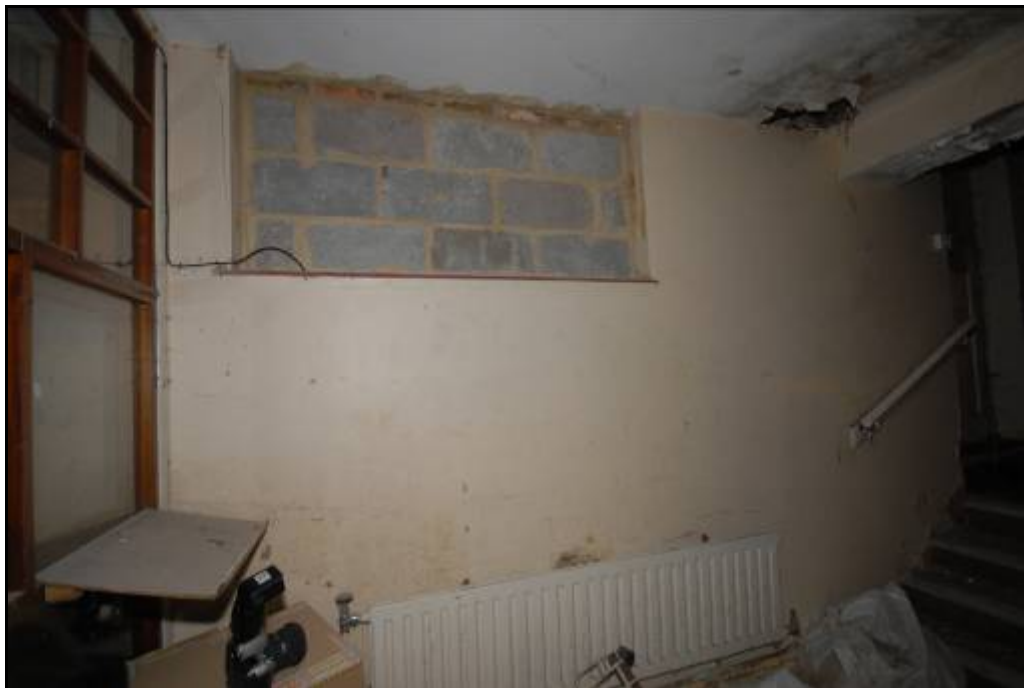
Blocked window in room 4 along northern wall Fig 24

The walls are beige painted plaster and plasterboard. A window in the northern wall was blocked with breeze blocks, the window ledge was laid with red quarry tiles (Fig 24). The floor is concrete and the ceiling was covered in plasterboard.

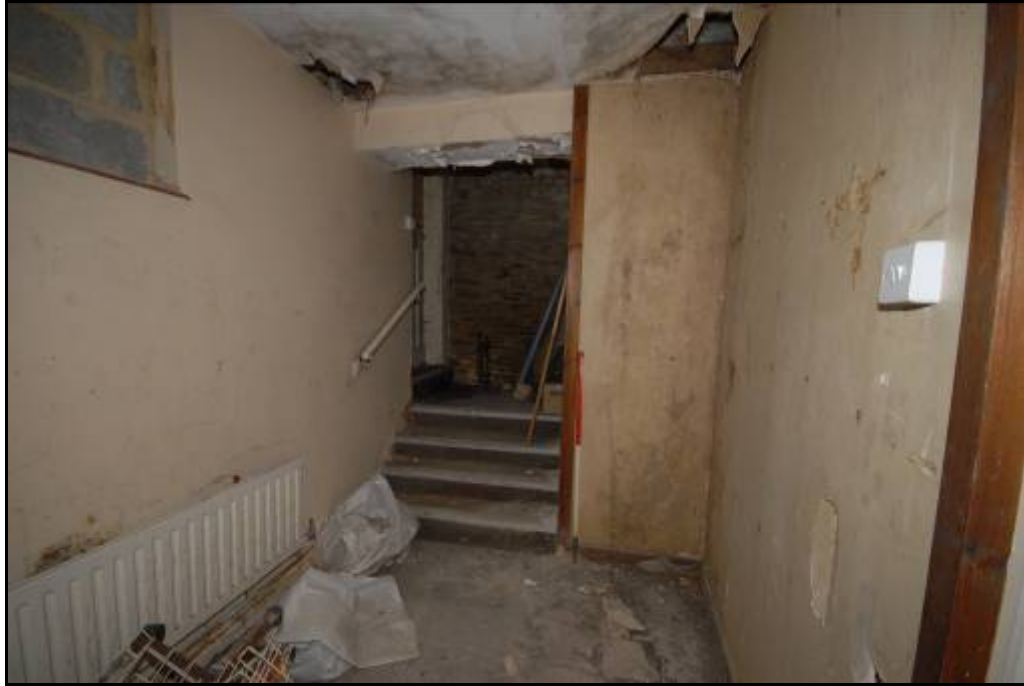
At the eastern end of the room are four steps leading up to an exit onto Brewery Walk (Fig 25). The eastern and southern walls by the exit are exposed roughly coursed stone walls; the ledge in the recess within the southern wall was laid with red quarry tiles (Fig 26). The wooden panelled door has a boarded six light wire glass at the top. The door is furnished with a door closer, a letter box, a door knob internally and externally, and two locks (Fig 27).

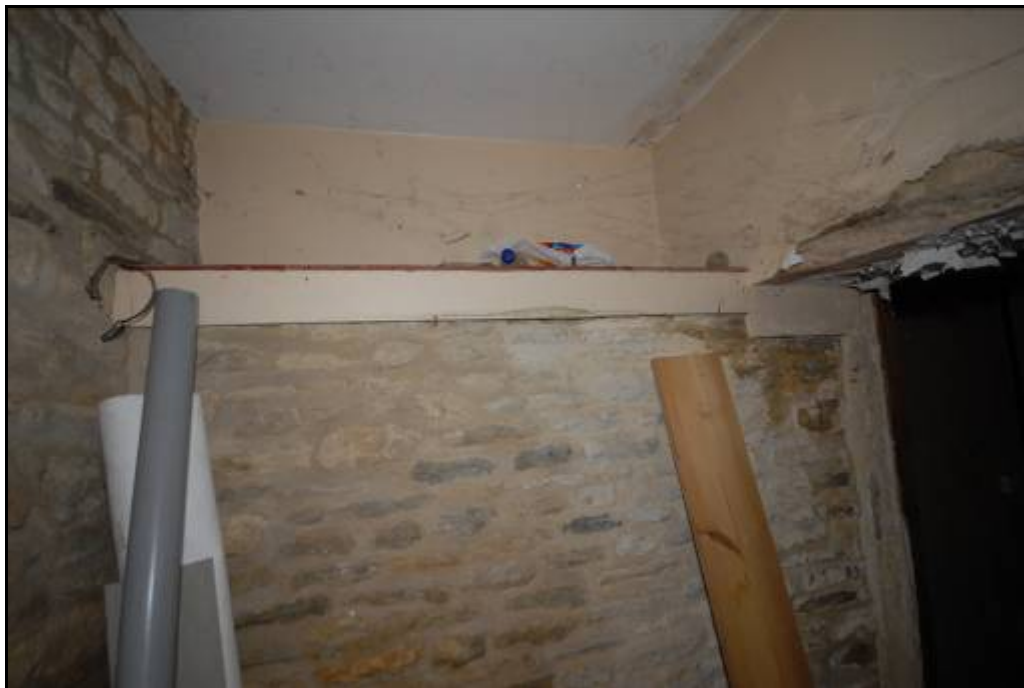
Exposed stonework with ledge, looking south Fig 26

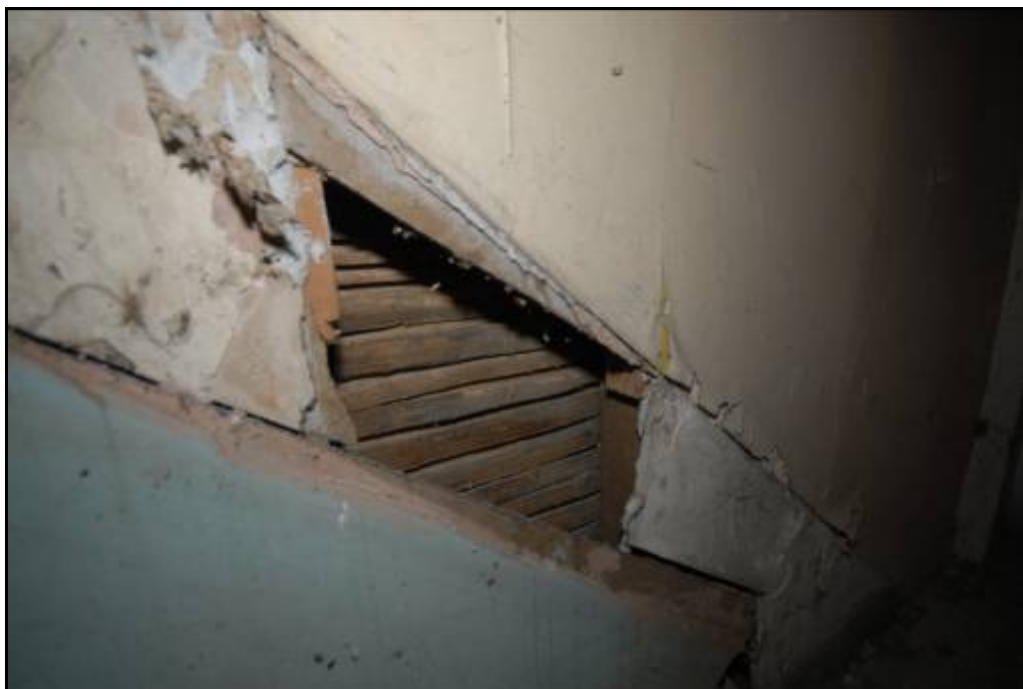
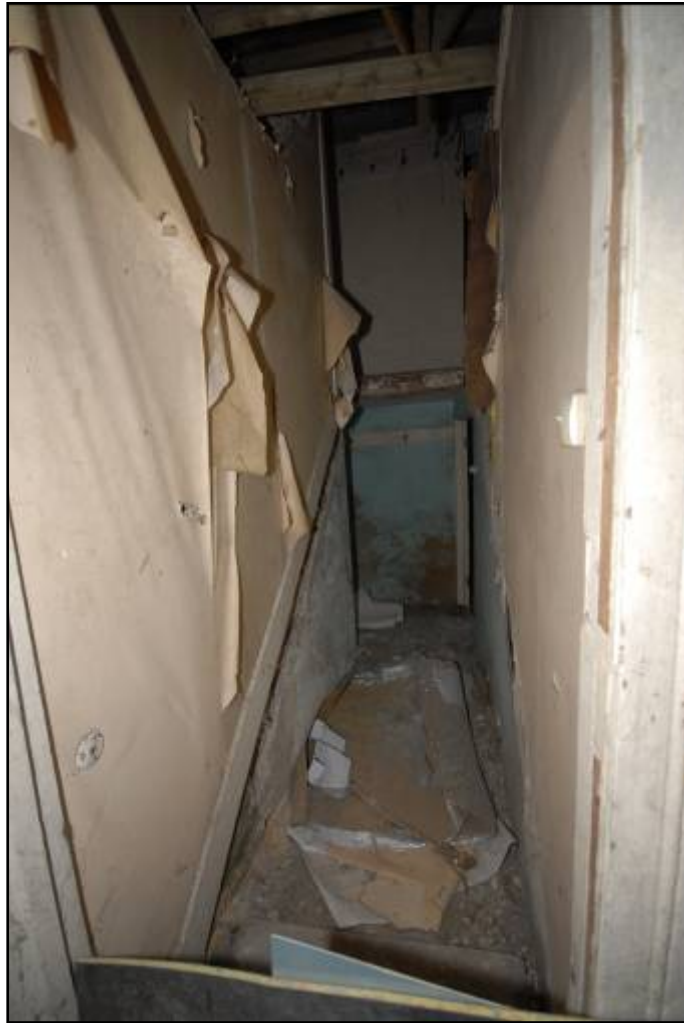
This area is separated from the hallway (room 6) through a lath and plaster stud wall (Fig 28), the outer wall is plastered stone. Underneath the stairs is a storage area, a step up had to be taken from the lower lying hallway (Fig 29). The walls are painted light blue. The stairwell had been removed prior to the visit; this space had been wall papered and painted beige (Fig 30). The floor is concrete.

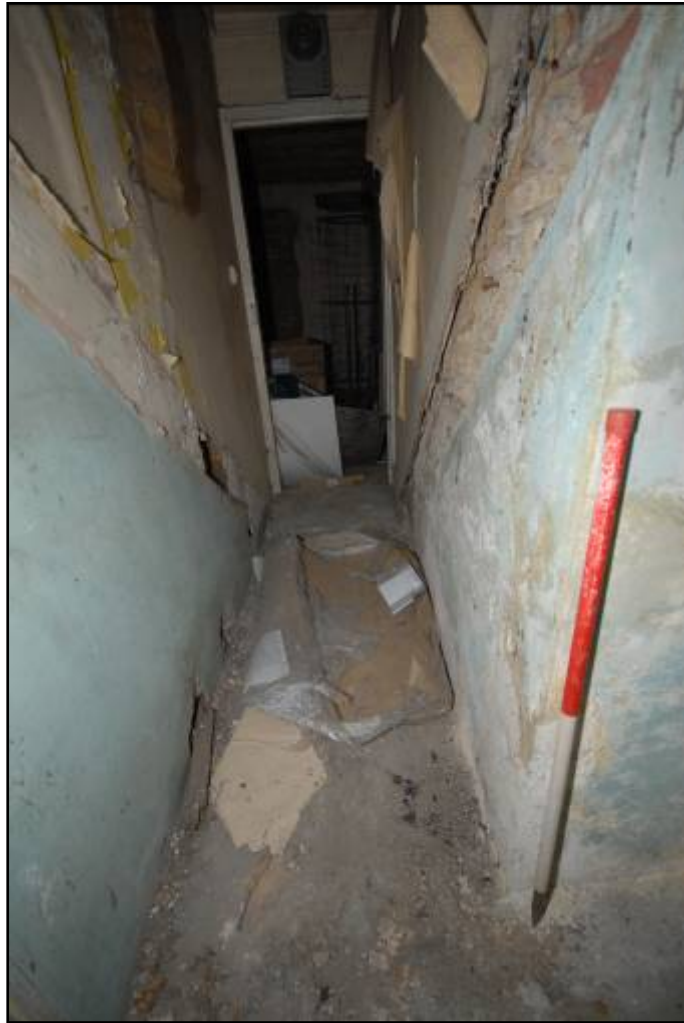
Cupboard under the stairs, looking west Fig 29

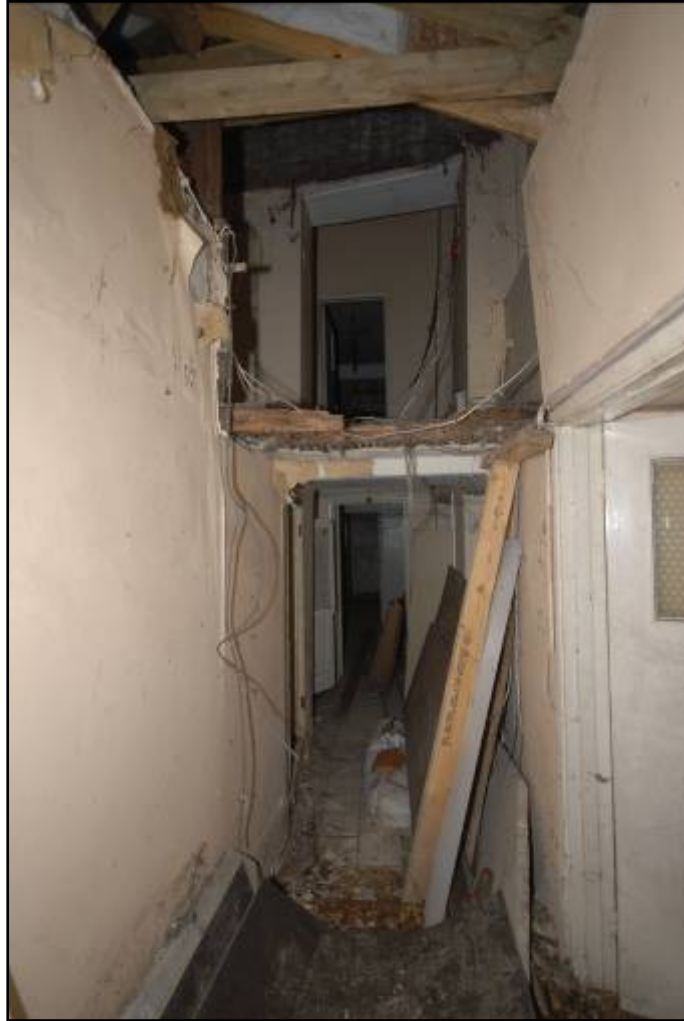
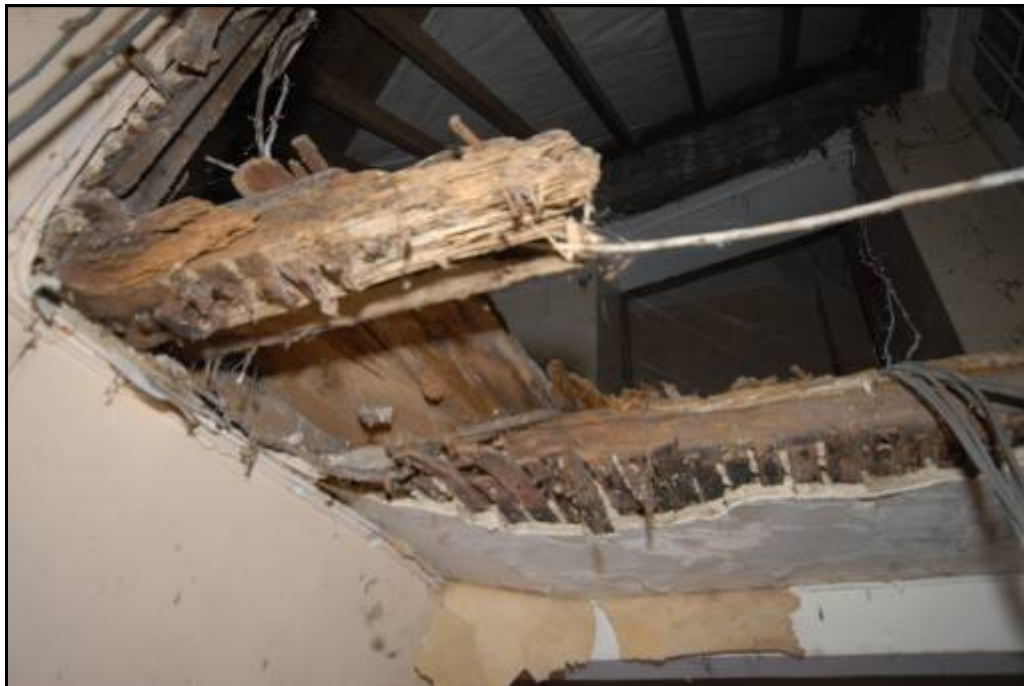
The hallway leads into the storage room 7, kitchen/womens toilets 8, and mens toilets 9. The walls are plaster board painted beige. The floor is concrete laid with grey plastic tiles (Fig 31). There is a step down after the store room door, rooms 7 to 11 are at a lower level than the rooms 1 to 5. The ceiling, partially missing, is made with lath and plaster (Fig 32).

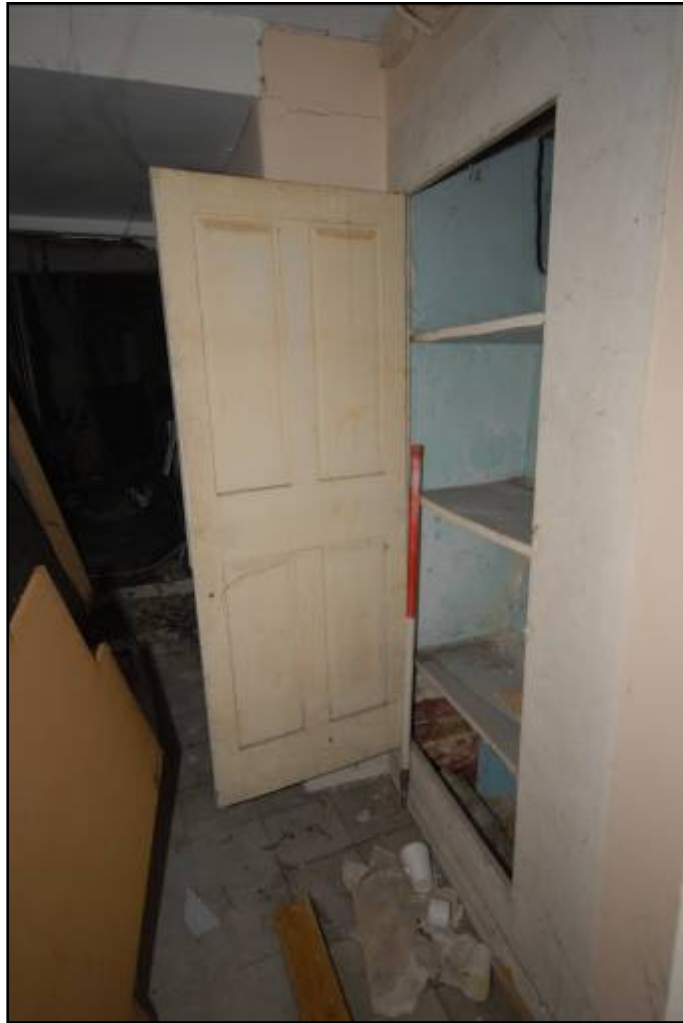
Cupboard in the hallway Fig 33

At the eastern end of the hallway, opposite the men's toilets is a small cupboard set within the stone wall. A wooden panelled door was still in place with an '*Offices, shops and railway premises 1963*' poster displayed on the outside. The inside of the cupboard is painted light blue and has three white painted shelves in place (Fig 33).

Between room 10 and the rear door in room 4 and the stairwell 5 is a space that could not be accessed. On the outer northern elevation around this area damp and plant growth can be noted. From hallway 6 a storage cupboard is recessed into this space.

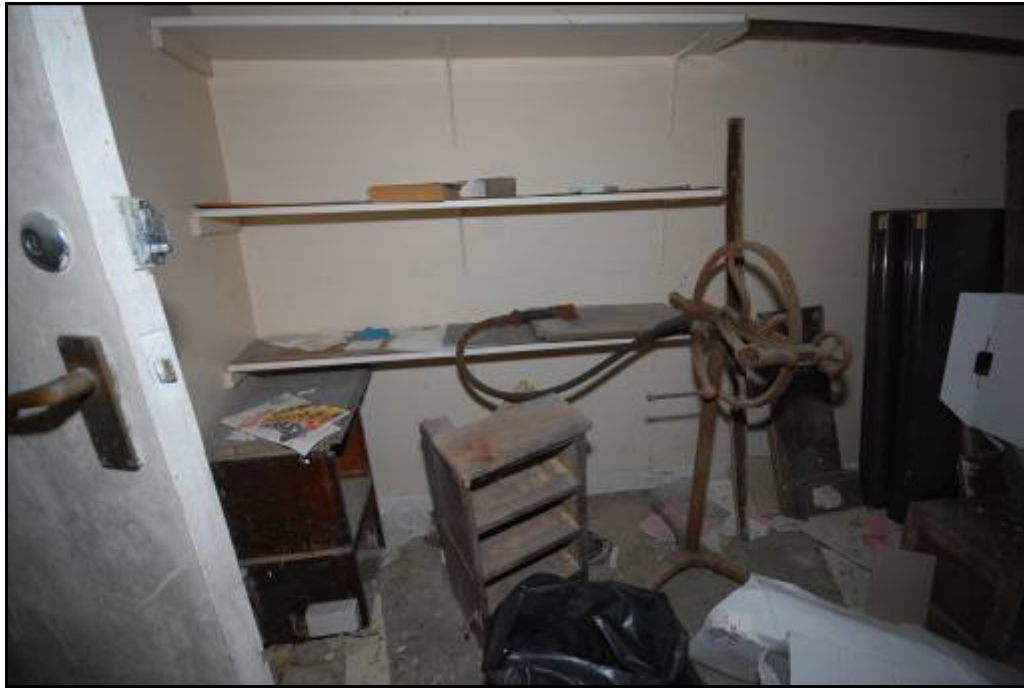
Sheep shearing machine and shelves with Bronnley magazines Fig 35

This room, along with the kitchen and toilets (rooms 8 and 9), comprise the extension. There is a single step down into the room spanning the entire width of the room. Full access to the room could not be gained due to the stored objects. The white gloss painted door has a flush surface on both sides with a single light glass window. The door has a bronze coloured lever handle and a key lock. The walls of the room are painted beige. The floor is concrete laid with grey tiles and the ceiling is wallpaper painted white (Fig 34). On the left side of the door are three shelves, sitting on the shelves are a few Bronnley magazines, Yellow Pages and an office catalogue dating to the 1980s. A sheep shearing machine was found in the room (Fig 35).

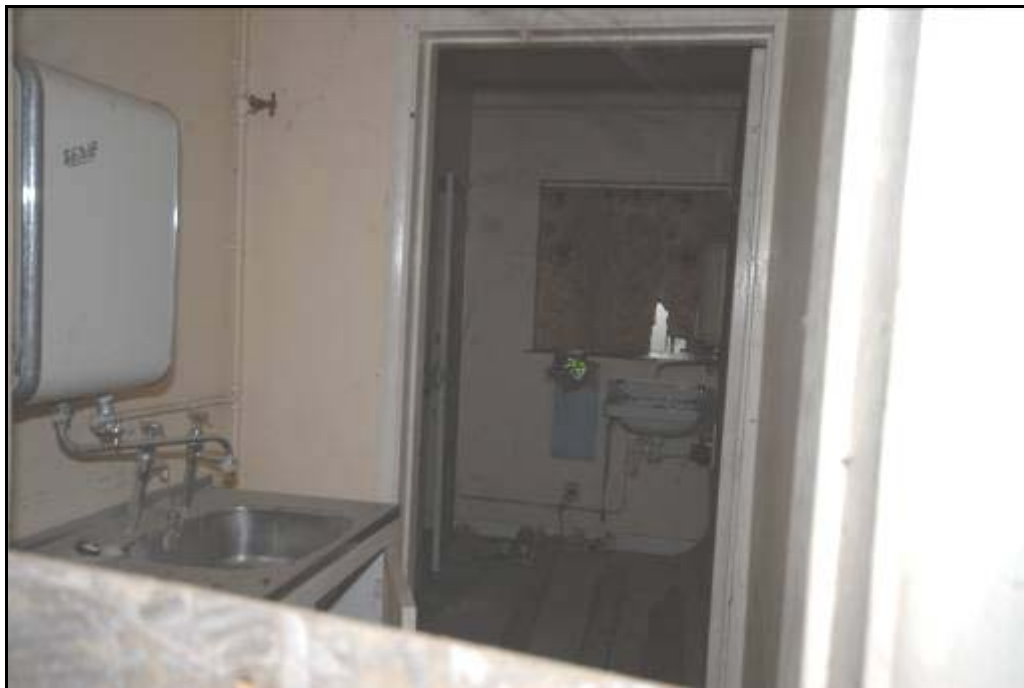
Kitchenette with Ladies behind, looking south Fig 36

These rooms could not be accessed due to boards blocking the doors. A kitchenette is situated before the women's toilets (Fig 36). The area comprises a kitchen cupboard with a stainless sink and electric hot water unit fixed to the wall. The women's toilets are accessed through the kitchen. There are two toilet booths and a ceramic sink with a hot water unit. The men's toilet is accessed directly from the hallway. The white painted door had a ripple effect window. The room has two windows. The floors in the toilets are concrete and the walls were painted beige.

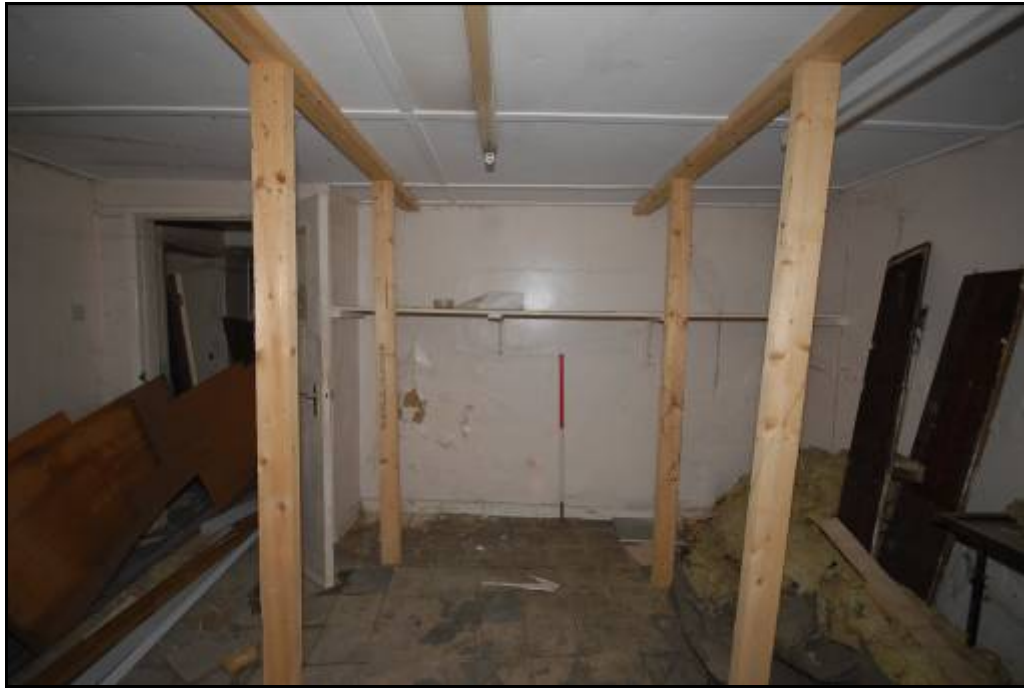
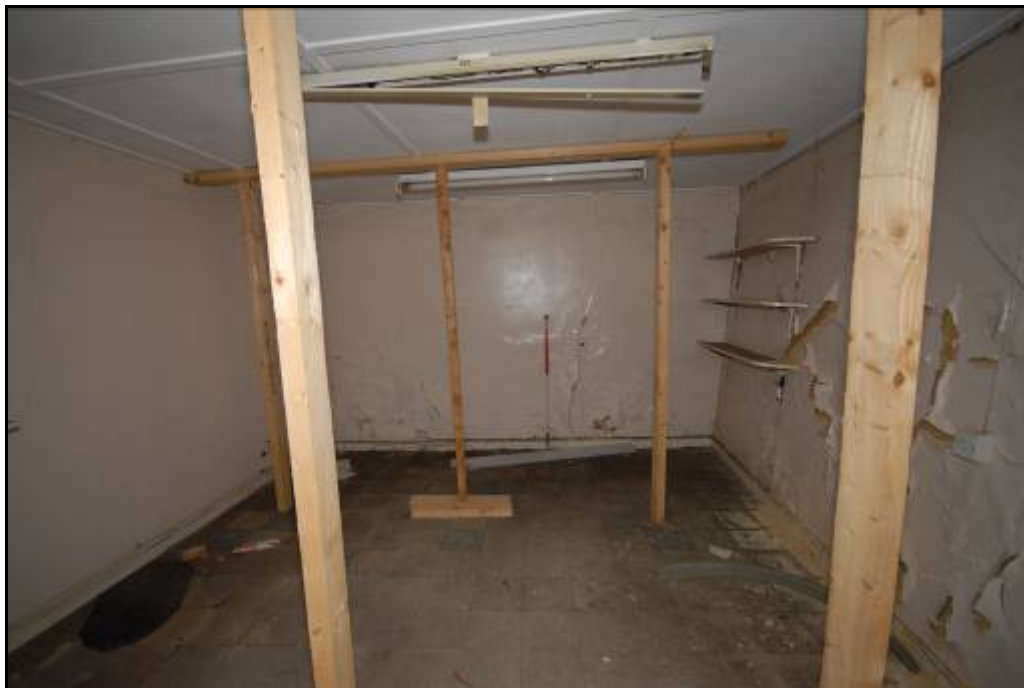
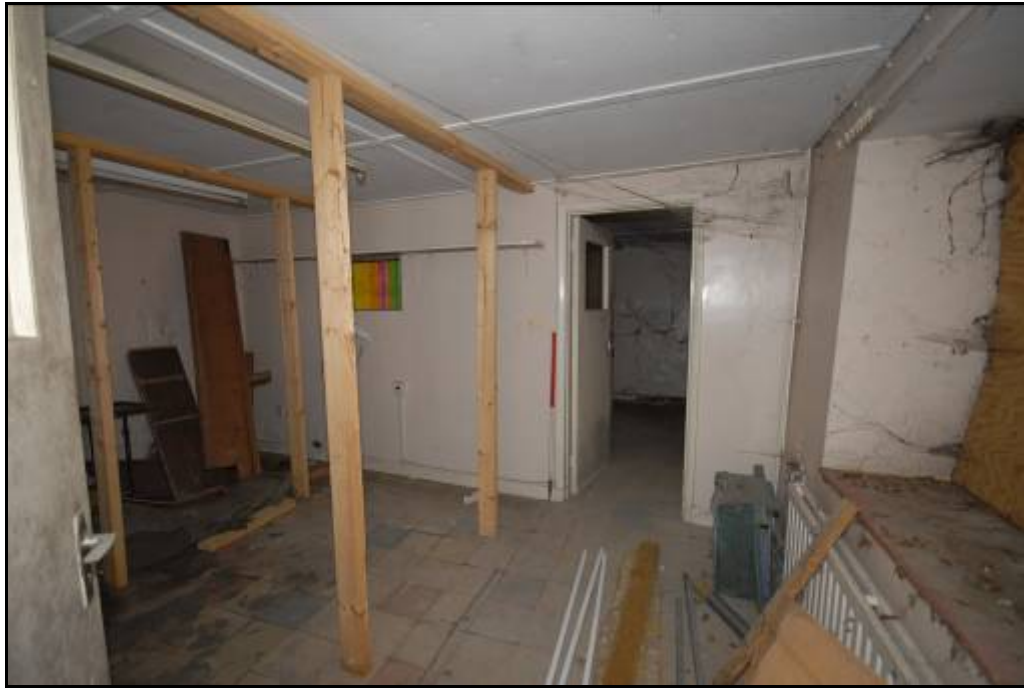
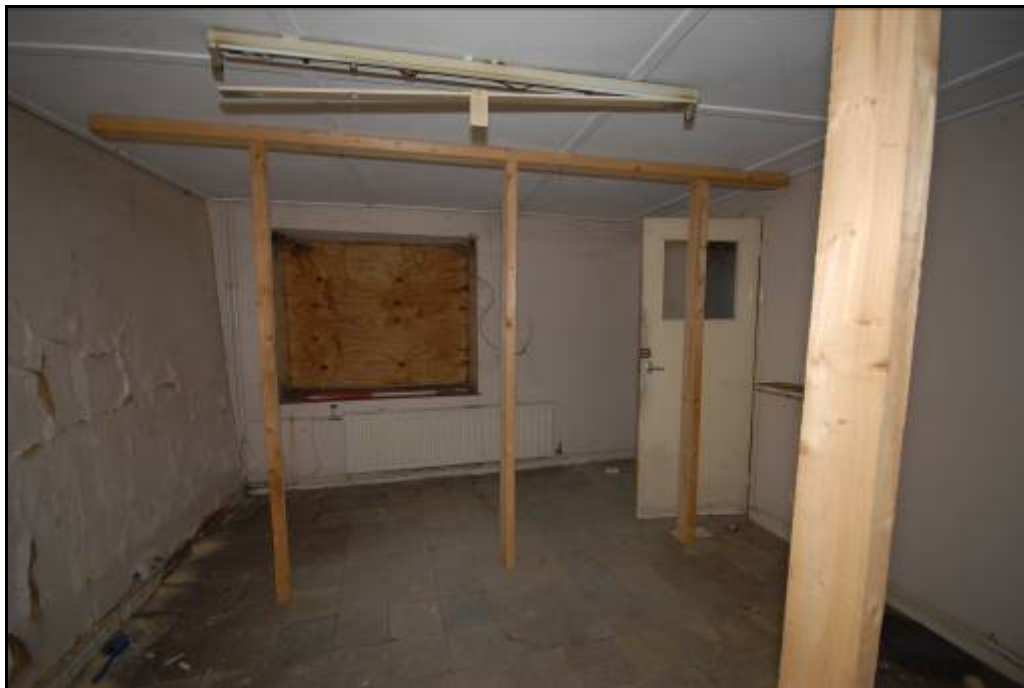
Rooms 10 and 11 (Figs 37 and 38) are situated in the most easterly of the buildings. The walls are beige painted plaster boards. The wooden flush doors have a single light window. Room 11 is accessed through room 10 (Fig 39). Each room has a single window in the southern wall, metal framed with twelve lights, the window sills were laid in quarry tiles (Fig 40). The floors are concrete with grey and red square plastic tiles. The ceiling is plaster board painted white. As the first floor is unstable, the ceiling is propped up by wooden beams (Figs 37-40).
