**Archaeological building recording at
2 Bridge Street, Brackley
Northamptonshire
May 2014**

S/2012/1583/FUL and S/2012/1584/LBC

Report No. 14/120

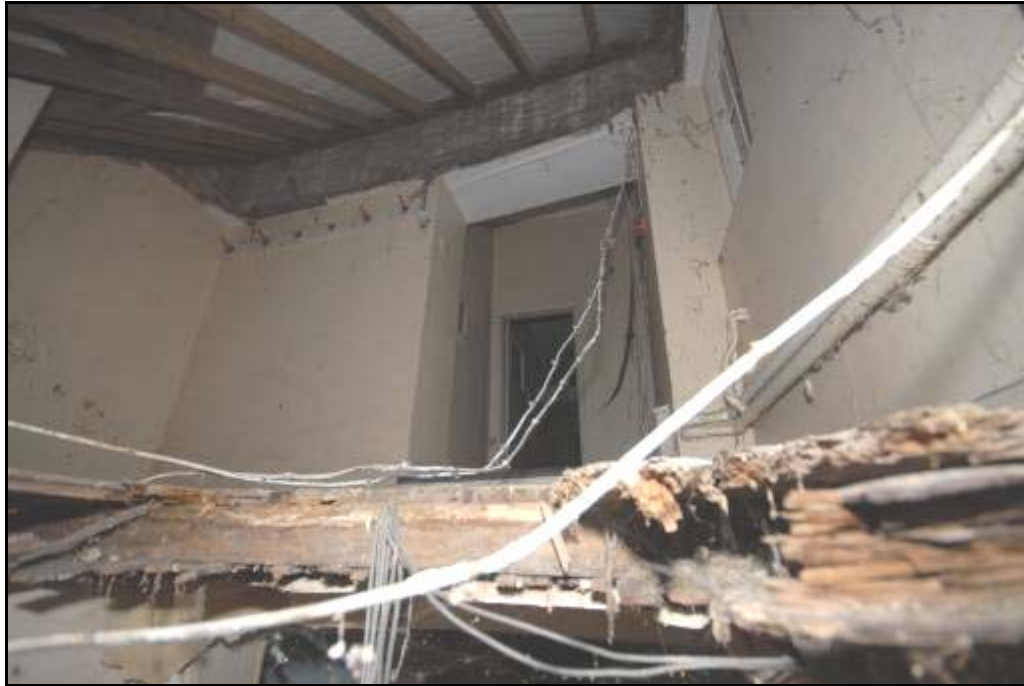
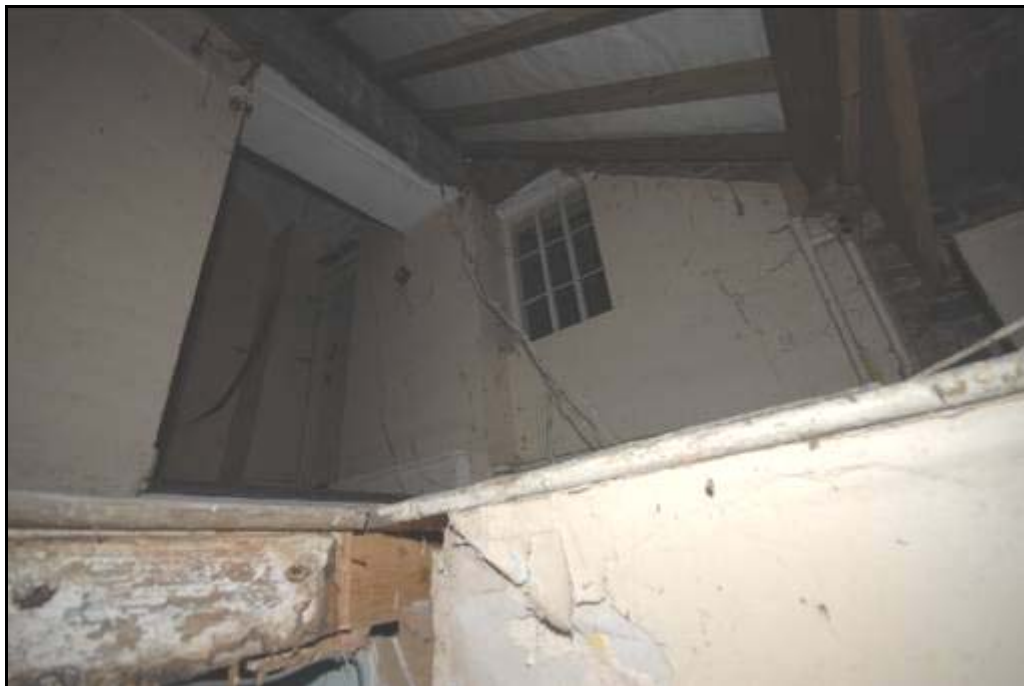
Photographs were taken looking through the gap left behind after the removal of the staircase (Figs 42 and 43).
