An archaeological test pit evaluation at The Compleat Angler Hotel Marlow, Buckinghamshire July 2014

Report No. 14/139

An archaeological test pit evaluation was undertaken by MOLA at The Compleat Angler Hotel, Marlow, prior to the proposed development of the site. One test pit was excavated within the footprint of the proposed development. Alluvial deposits were revealed, overlain by several levelling layers probably linked to the construction of the car park. Cut into the higher layers was a cable trench from the last century. No further archaeological finds or features were recorded.

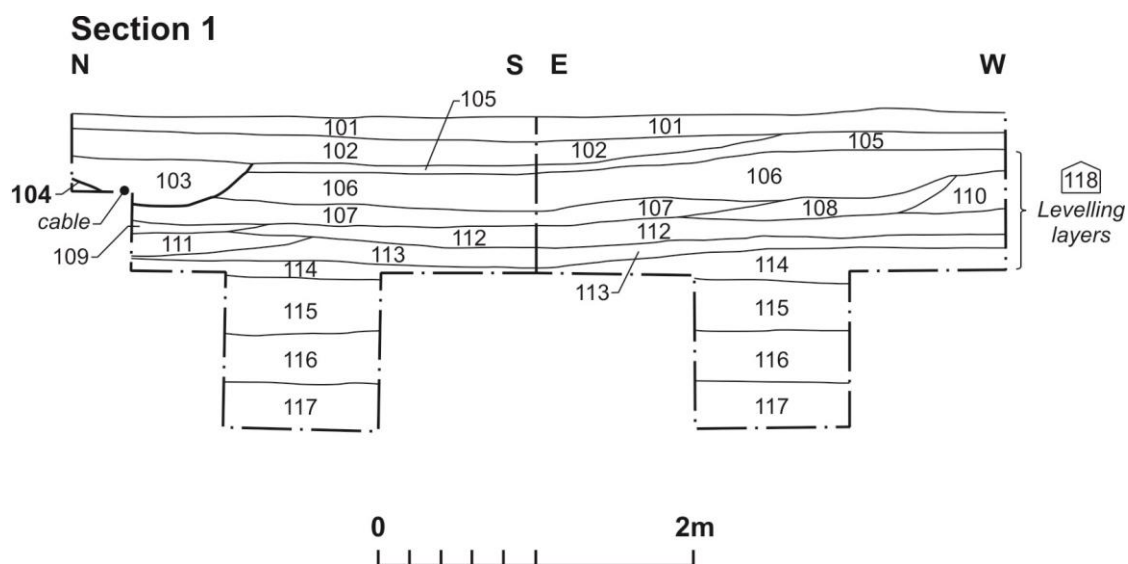
West facing and north facing sections of test pit Fig 3

The test pit was excavated to a maximum depth of 2m and the natural substrate was not observed (Figs 3 – 5).

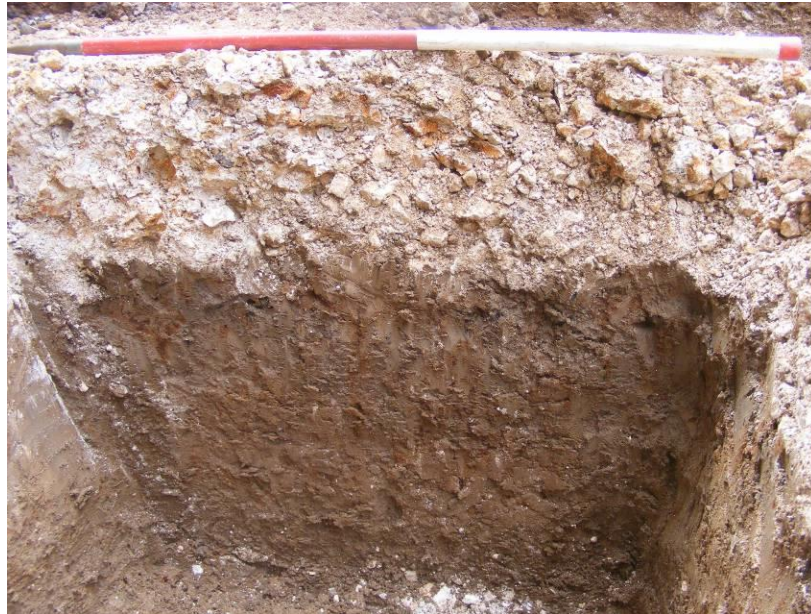
Section of lower test pit, looking south Fig 4

The lowest observed deposits (117) and (116) were of mid to dark brown-grey silty clay, 0.32m thick, and extending below the limit of excavation. These were overlain by a thick layer (115) of light pink-white crushed chalk, up to 0.30m thick (Fig 4).

The lower deposits of silty clays within the test pit likely relate to alluvial deposits from the Thames, which are believed to have ceased their regular build-up during the 15th century (Robinson 2011).

The thick layer of chalk overlaying these was likely a capping deposit to cover the alluvial deposits. The multiple layers of sandy gravels and thin layers of chalk are levelling deposits probably relating to the construction of parts of the hotel in the mid 17th century or the later use of the area as a car park. These layers consisted of very clean material, with little or no man-made inclusions, suggesting the importation of clean natural material for this specific purpose. These layers probably extend across the entire car park site, with slight variations in material. Deposition of these materials appears to have occurred from the west and south, suggesting dumping from the higher, drier ground.

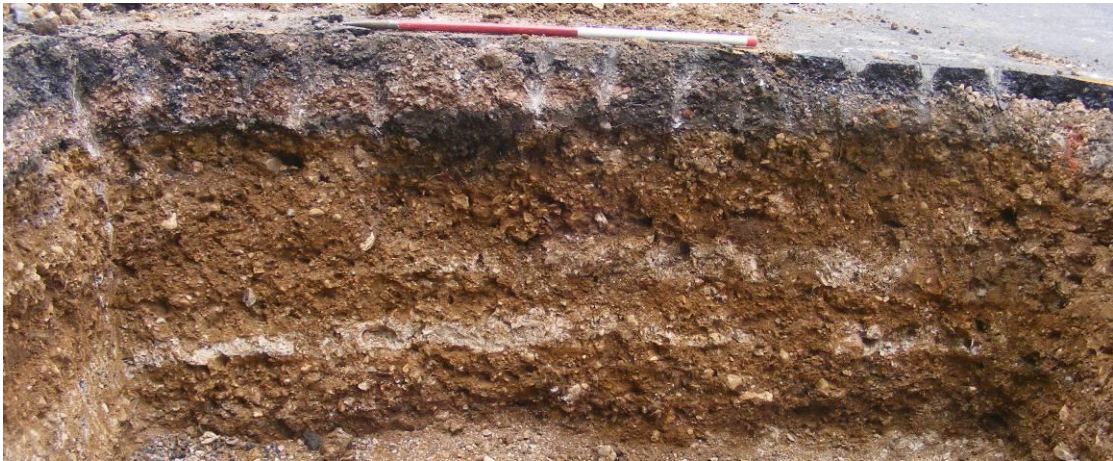
Section of upper test pit, looking south Fig 5

Above this was a series of levelling deposits (106) – (114) consisting of nine varying layers mid orange clayey sandy gravels, and light pink-white crushed chalk, with a total depth of 1.00m. Above this was a layer of dark grey-black clay (105), 0.20m thick, overlain by a layer of light red sand with 80% small-medium stone fragments, up to 0.15m thick. This was overlain by tarmac 0.1m thick (Fig 5).

Cut into layer (105) and the upper layers of [118] was a linear cable trench [104], aligned north-east – south-west, 1.17m wide and 0.25m deep, with a fill (103) of dark grey-black clay with 1% small gravels. This feature also has a disused cable running along its base.

The small cable trench cut into the upper levelling deposits dating to some time during the 20th century, with the stone and tarmac layers post-dating this.
