Archaeological Trial Trench Evaluation and Archaeological Monitoring at the former Star Service Station, Huntingdon Road Cambridge March and June 2014

Planning reference: 110876FUL

Report No. 14/141

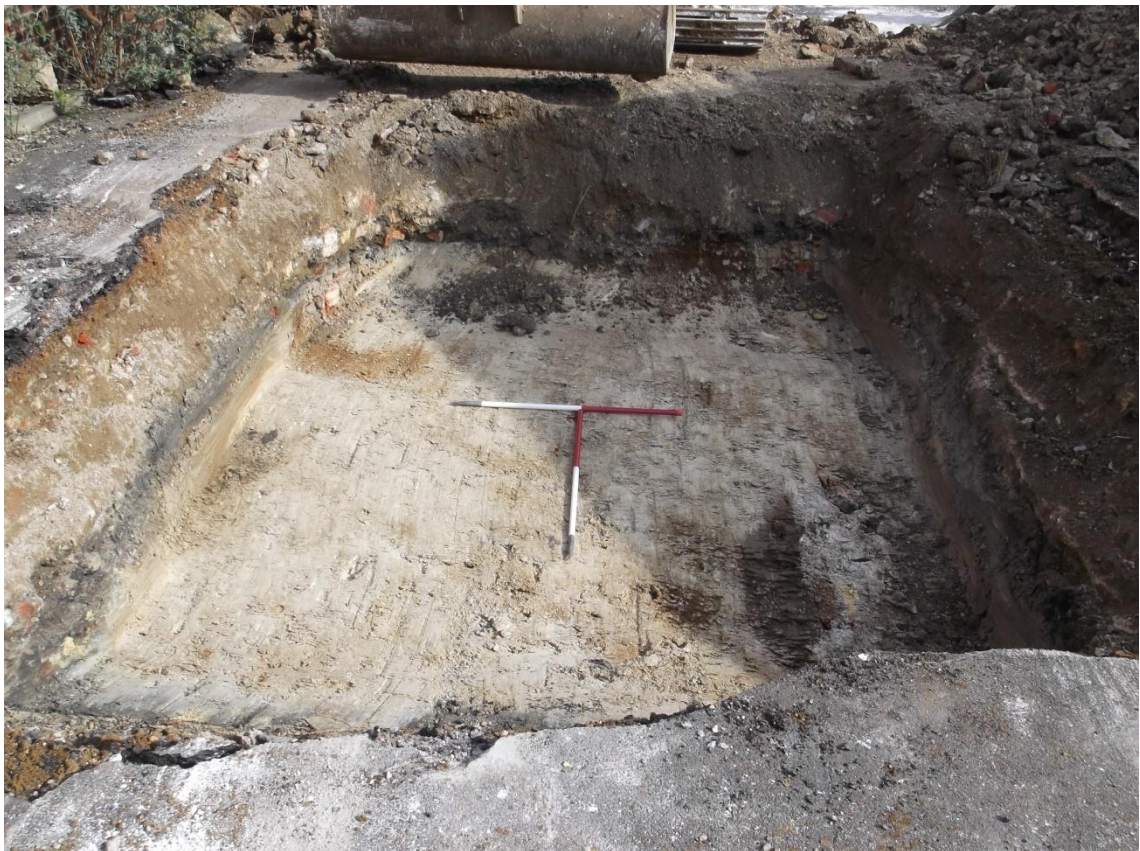
Trench 1, wall trench [107] and overlying demolition layers, looking east Fig 4

The tarmac forecourt surface (101) was 0.03m thick and overlay an 0.15m thick brownish-orange bedding layer (102). This sealed a sequence of three demolition/levelling layers (103-5) approximately 1m thick all containing rubble hardcore and incorporating portions of previous tarmac surfaces (Fig 4).

A wall trench [107], 0.4m wide and aligned east to west (Fig 3) was observed cutting into the natural chalk and sealed below rubble layer (105). The wall had been previously removed and the trench was filled with rubble (106) including some light whitish-yellow brick fragments (Fig 4).

The wall foundation in Trench 1 is likely to relate either to the late 19th-century domestic property, Chestnut House, or to the early 20th-century garage that replaced it.

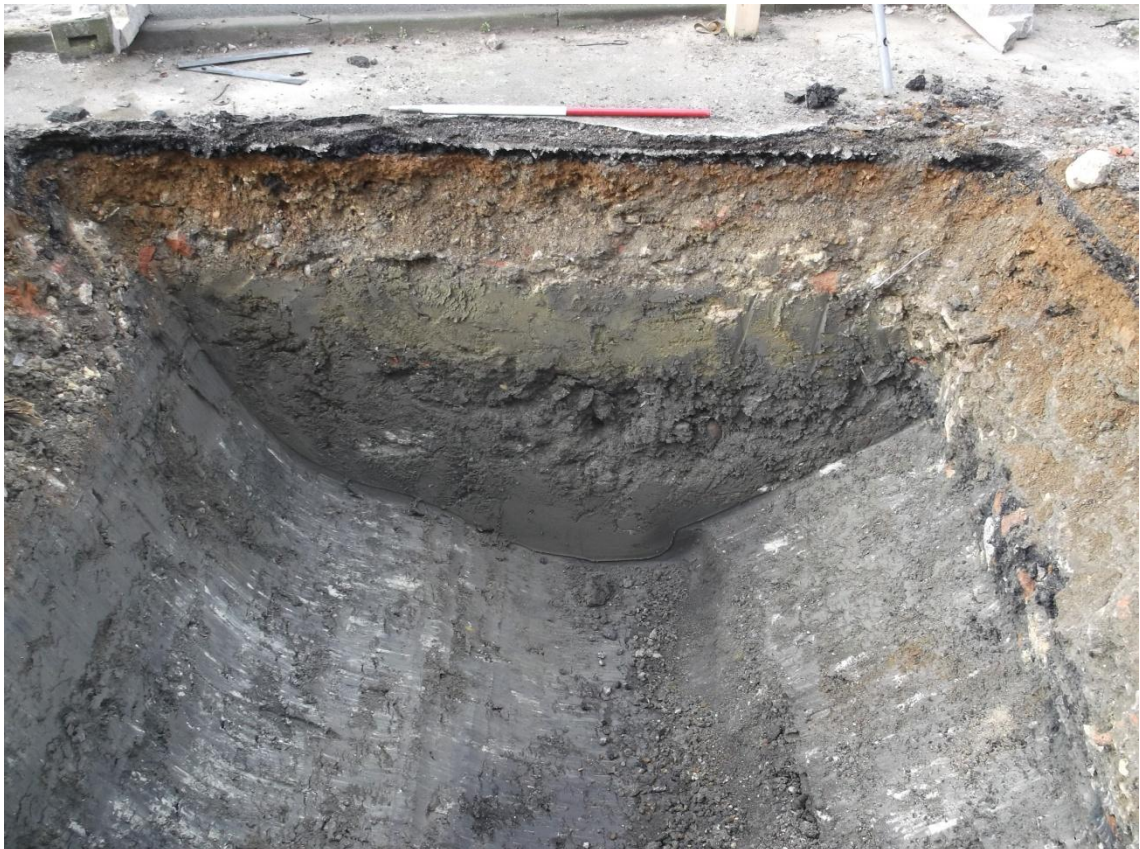
Trench 2, upper backfill of pit [206] and levelling layers, looking north-west Fig 5

The upper part of the sequence was identical to that in Trench 1 with tarmac (201) overlying a bedding layer (202) that in turn overlay demolition/levelling layers. In this trench two such layers were observed (203 and 204) similar in composition to the layers in Trench 1 and measuring 0.54m thick (Fig 5).

The levelling layers sealed a backfilled modern pit [206] that extended across the majority of Trench 2. The pit measured 2.64m deep and was filled with dark grey silty clay containing demolition rubble contaminated with fuel (Fig 5).

The extensive, deep pits recorded in the south-west part of the site contained fuel contaminated backfill are likely to relate to previous fuel storage tanks.

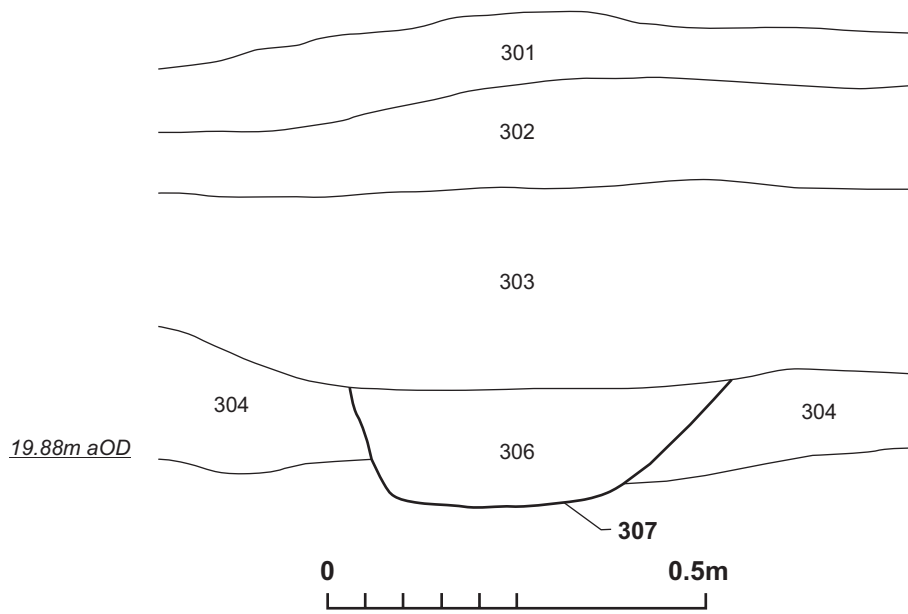
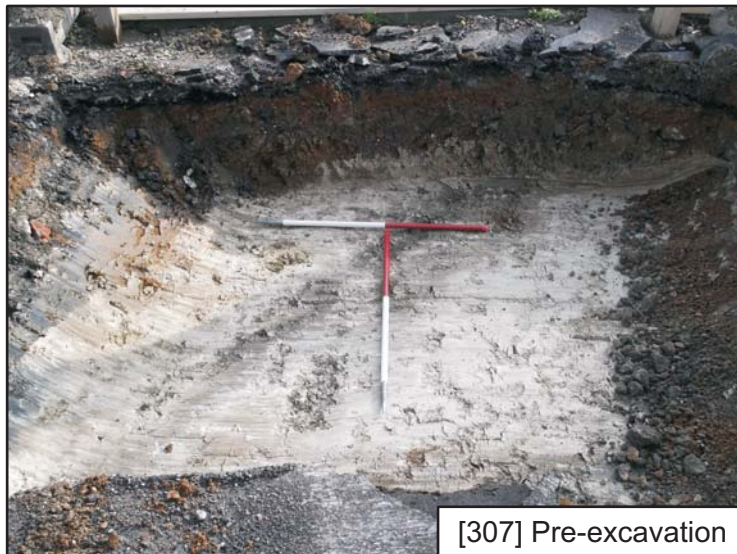
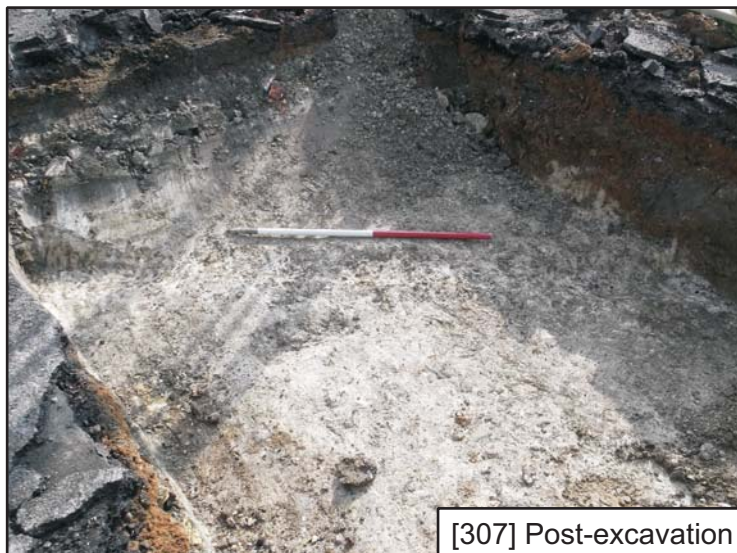
Trench 3, ditch [307], section and views pre and post-excavation Fig 6

The upper part of the sequence was identical to that in Trench 1 with tarmac (301) overlying a bedding layer (302) that in turn overlay a single demolition/levelling layer (303). This layer, 0.12m thick, contained less rubble than the other levelling deposits elsewhere on the site (Fig 6, Section 1).

The levelling layer sealed a heavily truncated linear ditch [307] aligned north-east to south-west that extended across the trench (Fig 6). The ditch measured 0.40m wide and 0.18m deep with steep truncated sides and a flat base (Fig 6, Section 1). The fill (306) contained three sherds of mid to late 12th-century AD pottery.

The 12th-century medieval ditch [307], recorded at the southern end of the plot, had been truncated almost to its base and no other associated features were identified. It was aligned perpendicular to the Huntingdon Road and is likely to be the remains of a plot or field boundary offset from the road.

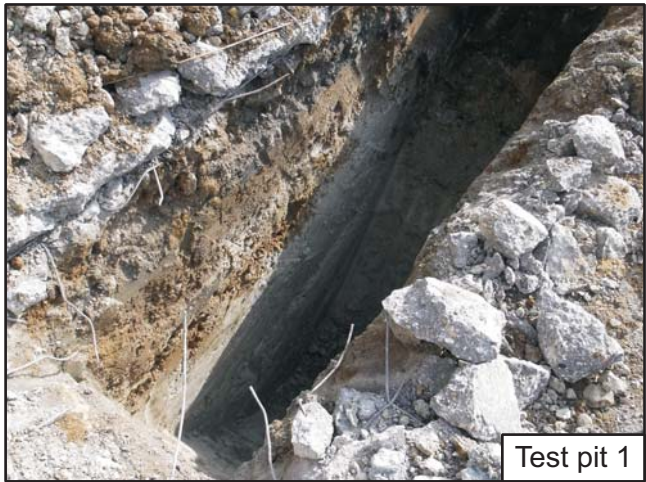
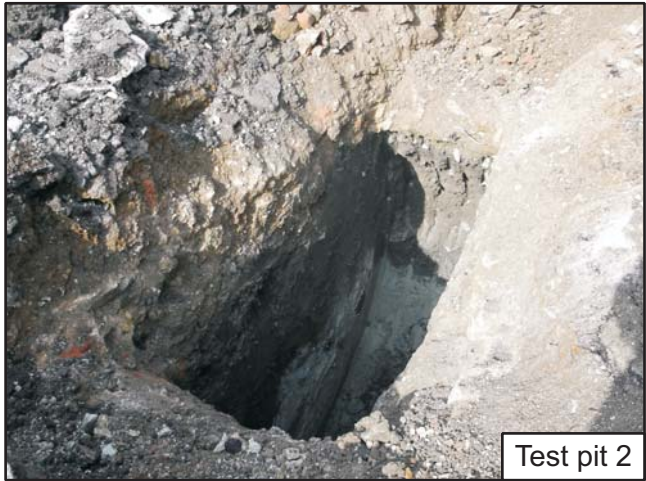
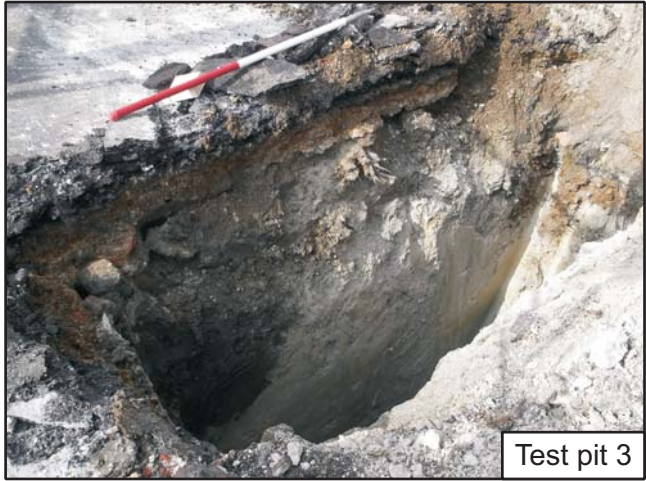
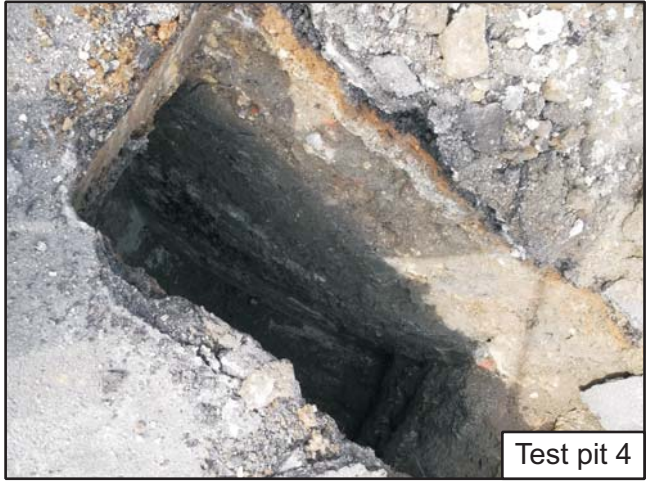
Views of test pits 1 - 4 Fig 7

This pit was located to the south-west of the garage building and aligned north-west to south-east. The sequence comprised a layer of reinforced concrete (1001) above bedding layer (1002) above two demolition levelling layers (1003-1004). These layers, measuring 0.79m in total, were directly above the natural chalk horizon (Fig 7).

This pit was located two metres to the north-west of Trench 2 and aligned north-west to south-east. It revealed the same sequence of activity as Trench 2, pit [206] was shallower at 1.50m deep (Fig 7).

This pit was located immediately to the south-east of Trench 2 and aligned north-west to south-east. The sequence was again identical to Trench 2 and Test pit 2 with the forecourt surface and demolition/levelling layers sealing the backfilled modern pit [206]. The pit extended for 1m from the north-west limit of the test pit and measured 0.7m deep with a near vertical south-eastern edge (Fig 7).

This pit was located to the south of Test pit 1 and aligned north-east to south-west. The sequence comprised a layer of tarmac (4001) over bedding layer (4002) that sealed two demolition/levelling layers (4003-4004) with a total depth of 0.59m. These layers sealed a backfill deposit that extended across the test pit measuring 1.8m deep (Fig 7). It was dissimilar to the fill of pit [206] seen in Trench 2 and Test pits 2 and 3 and therefore may have been the fill of another deep modern pit.

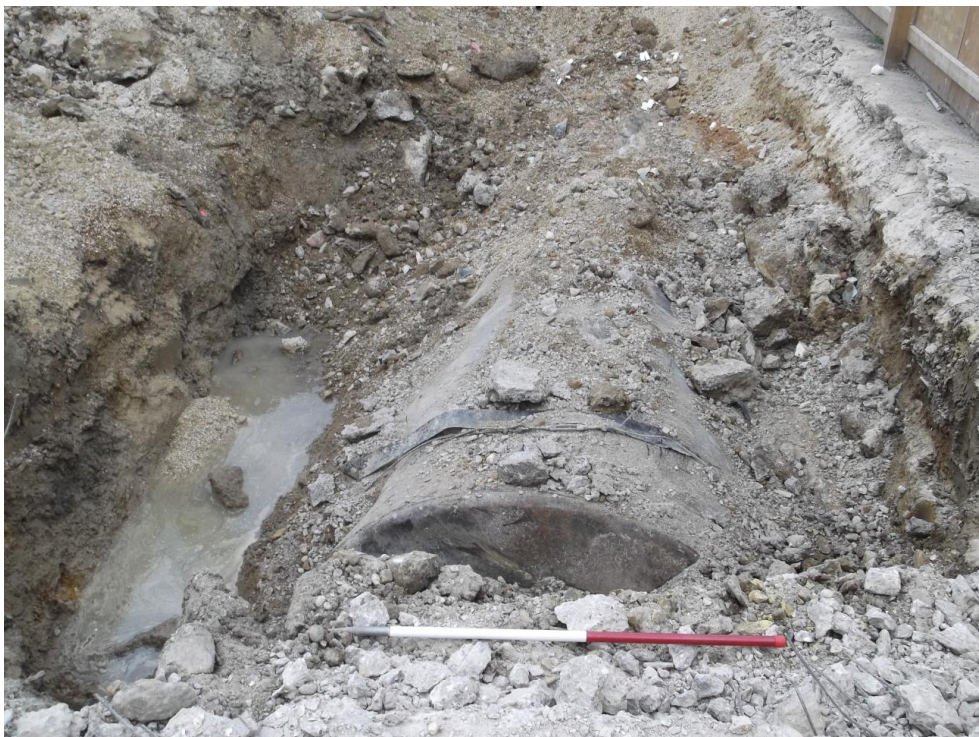
Fig 8

No surviving archaeological horizons remained within the monitored area (Fig 3), the insertion of fuel tanks and associated infrastructure had removed all material to a depth of in excess of 1.3m (Fig 8).

Fuel tank removal, looking north
