**A Programme of Archaeological
Observation, Investigation and Recording at
St Margaret's Church, Ward End
Birmingham
May 2013 – July 2014**

Report No. 14/175

NGR: SP 113 886

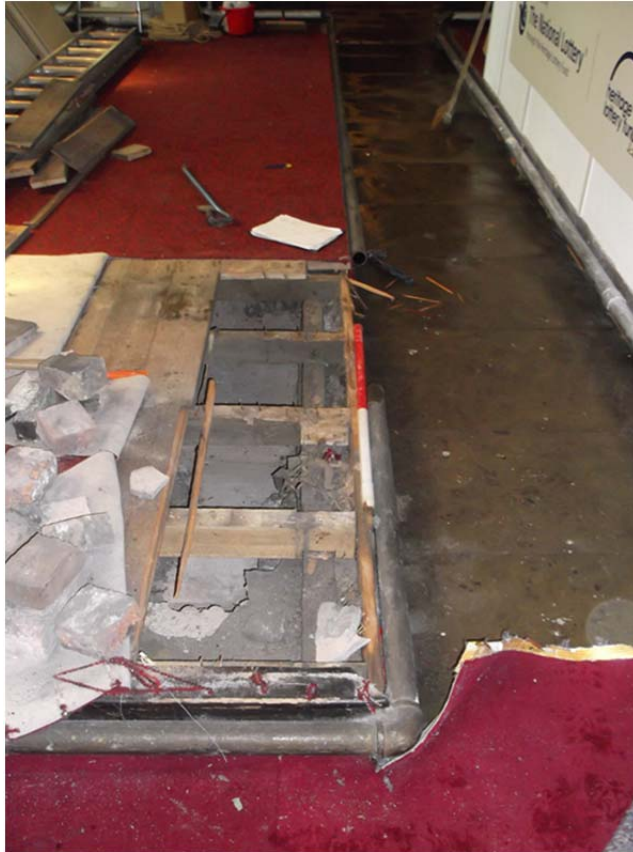
General view of test pit 1 Fig 4

Test pit 1 (Figs 2, 4 and 5) measured 2m x 1m and was located within the church to determine the depth at which the crown of the underlying crypt vault lay beneath the exiting floor. On lifting the present timber floorboards a void was revealed with the crown of the vault lying 0.51m below. No pre-modern archaeological deposits or artefacts were present.

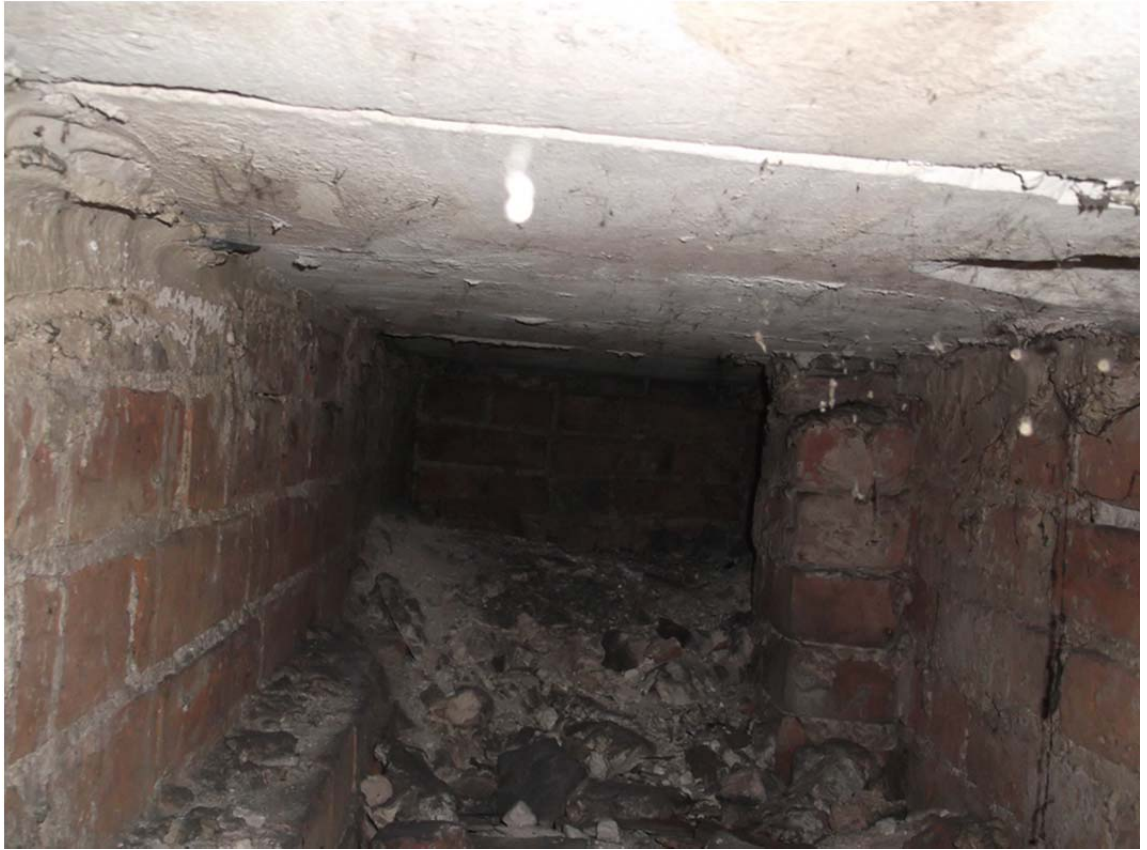
The void beneath the flag floor, test pit 1 Fig 5

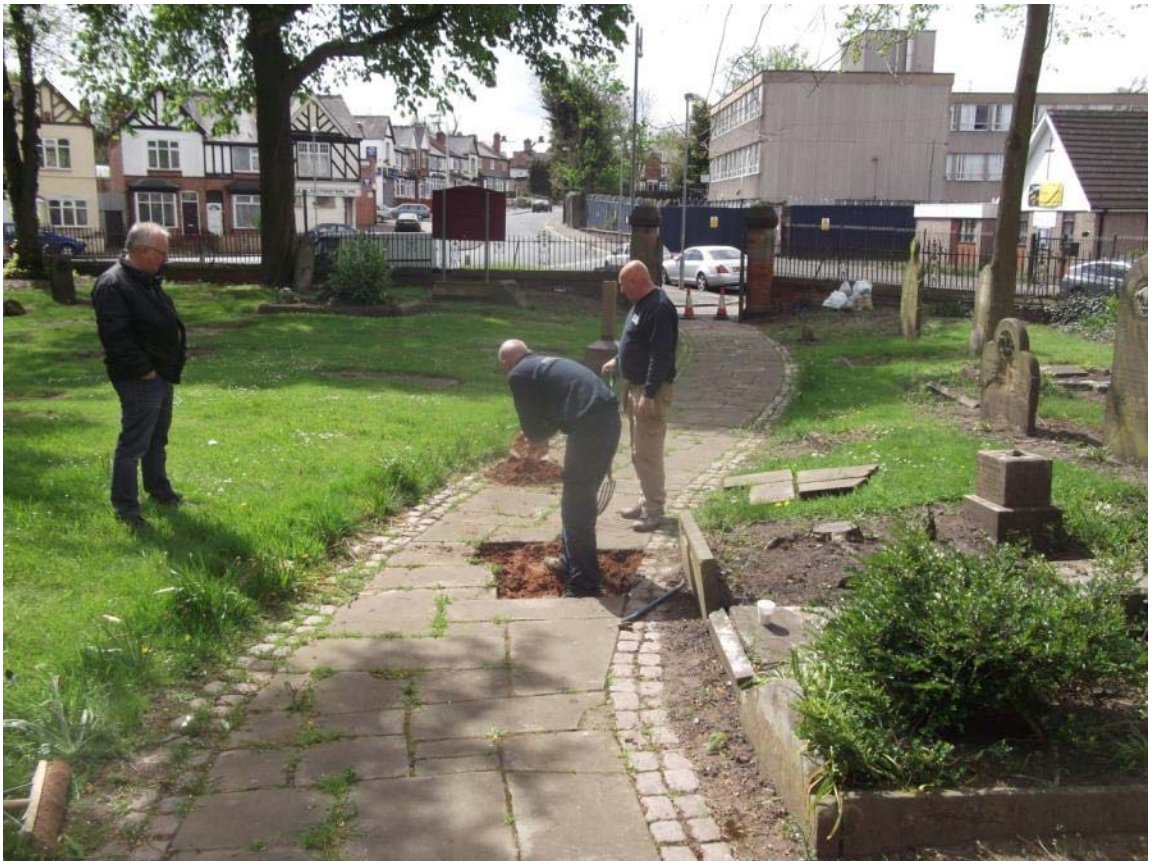
Test pit 5, looking south Fig 6

Located on the main footpath into the churchyard test-pit 5 (Figs 2, 6 and 7) measured 1m by 1m deep. A mixed stratigraphy comprising grey-white sand and gravel with occasional small fragments of limestone. No archaeological deposits or artefacts were present.

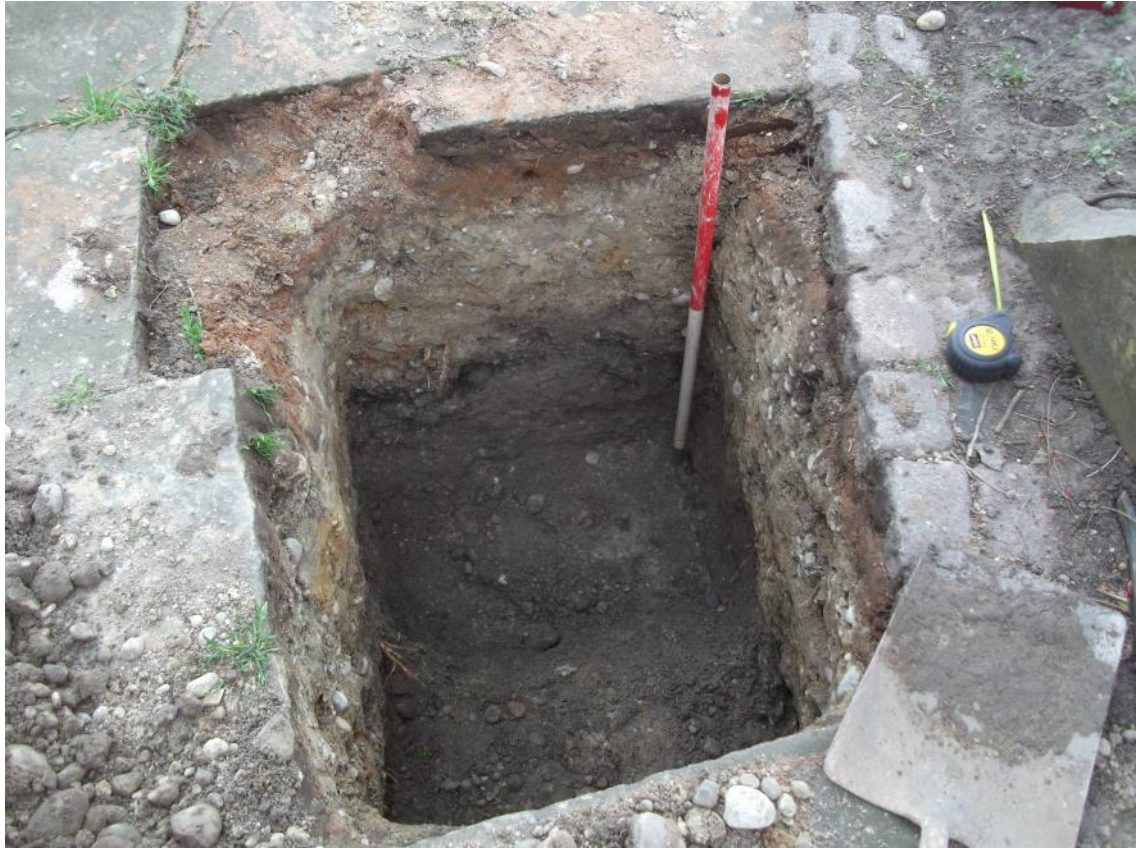
Test pit 5 after excavation Fig 7

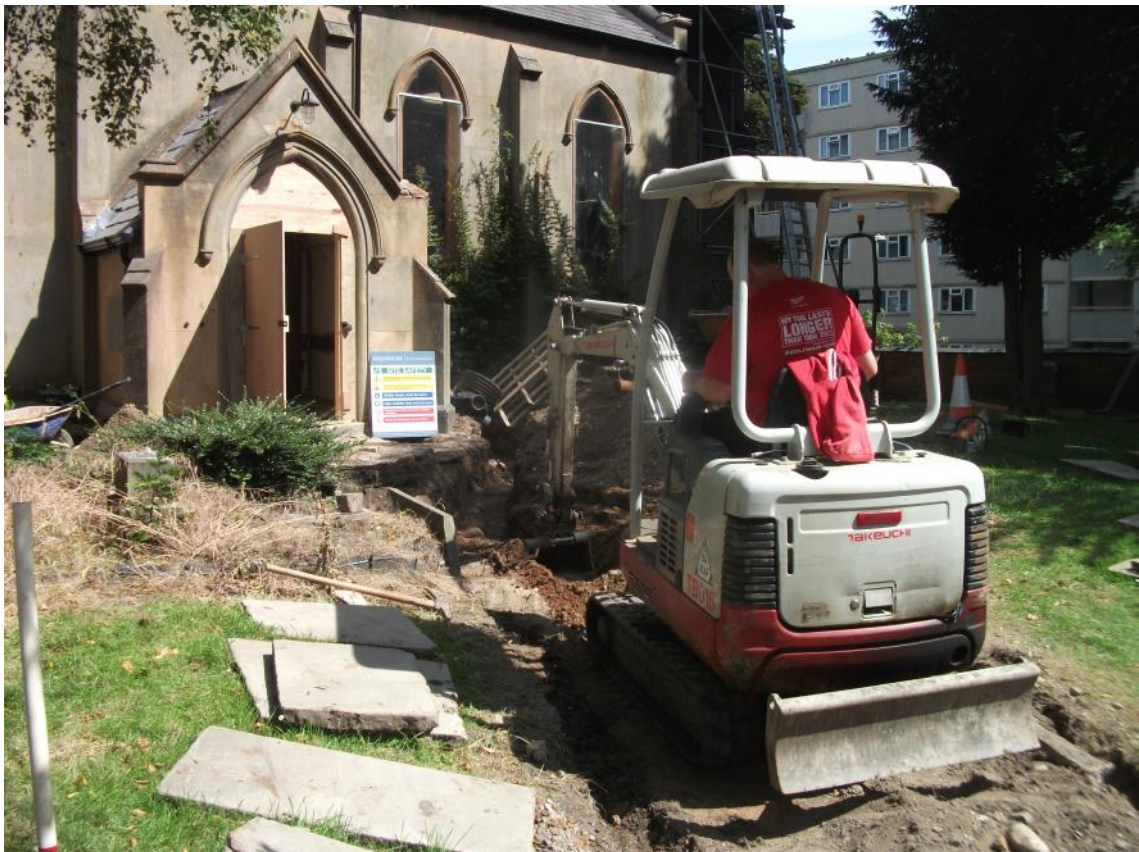
General view of the excavation of the service trenches, looking north Fig 8

The service trenches (Figs 2, 8 and 9) were excavated using a combination of 360° mini excavator and hand tools and were excavated to a maximum depth of 0.70m below present ground level by 0.30m wide. A new soak-away was excavated at the front of the south porch, this measured approximately 0.90m by 1.20m, and was excavated to a maximum depth of approximately 1.90m (Figs 2 and 10).

A service trench was excavated from the south gate of the churchyard extending up to the east side of the south porch. This was excavated to a maximum depth of 0.70m below present ground level. A disturbed stratigraphy was recorded for the full depth of the trench, comprising sandy loam, comprising grey-brown sandy loam, with pockets of orange-red sand and gravel. This was cut by a modern gas pipe and a lead water pipe (Fig *). no archaeological deposits or artefacts were present.

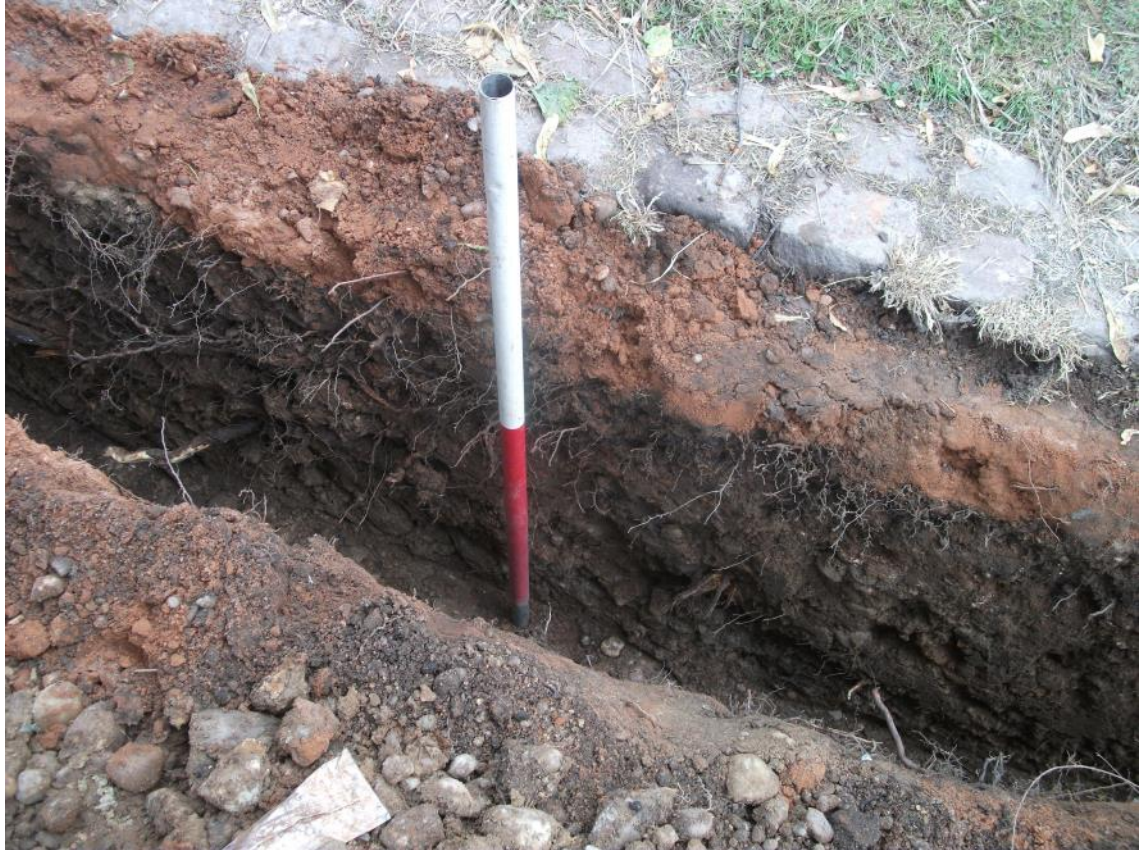
The stratigraphic sequence in the service trench Fig 9

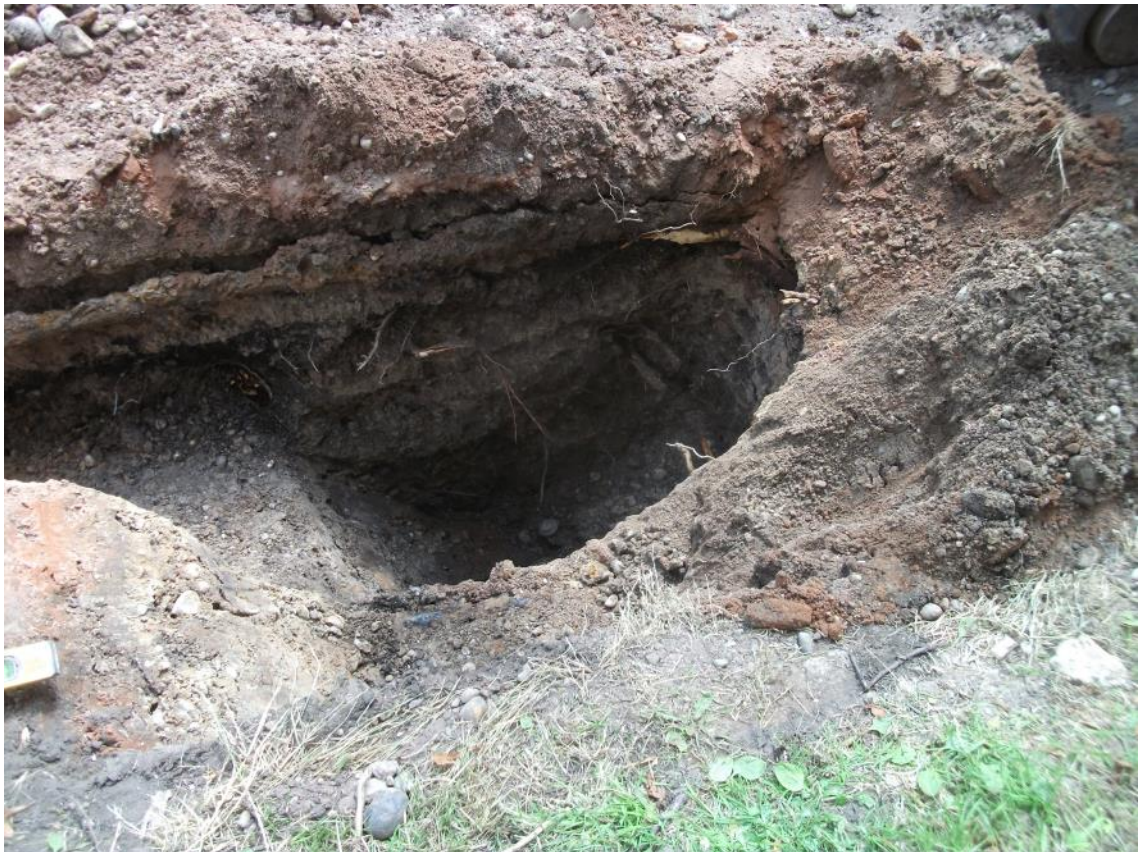
The new soak-away Fig 10

The new soak-away was excavated on the line of the new service trench. The natural substratum was encountered at a depth of approximately 1.45m below present ground level, and comprised pale-grey-brown sand and gravels, this was overlain by mid brown sandy loam, up to 0.25m thick. This in turn was overlain by grey-brown sandy loam, containing occasional small fragments of modern ceramic building material. No archaeological deposits or artefacts were present.
