# **Archaeological test pit investigation on land adjacent to the Fosseway Syston, Leicestershire September 2014**

Report No.14/193

*MOLA Northampton was commissioned by Leicestershire County Council (LCC) to carry out an archaeological investigation and observation on land adjacent to the Fosseway, north of Syston, Leicestershire. Initially, two test pits were to be excavated, but one was unable to be excavated due to its proximity to the main carriageway. A single test pit, 2.0m by 1.0m was excavated to 1.35m. The stratigraphy was found to be made up of a succession of deposited layers of build up relating to the modern road. No features of archaeological interest were uncovered.*

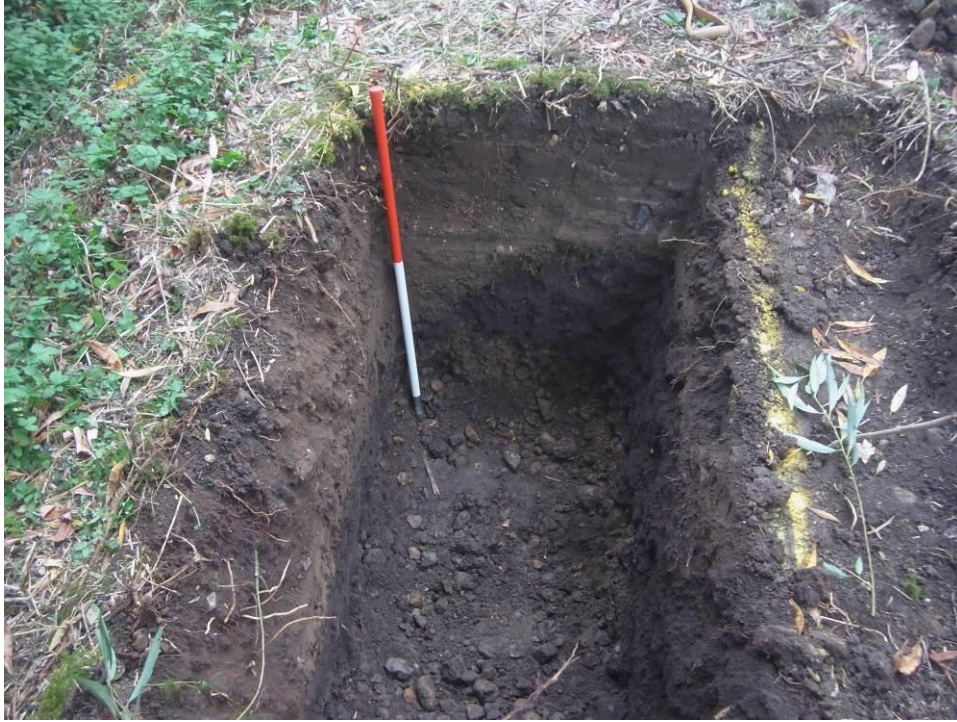
Test pit 1 excavated to top of layer (104), looking south Fig.3

Test pit 1 was excavated to a depth of 1.35m where a layer of blue-grey clay (105) was encountered. It is possible that this was the natural underlying geology, but is more likely a layer of colluvium (Figs 3-6).

A deposit of stone mixed with modern material (104), 0.50m thick, overlay (105).

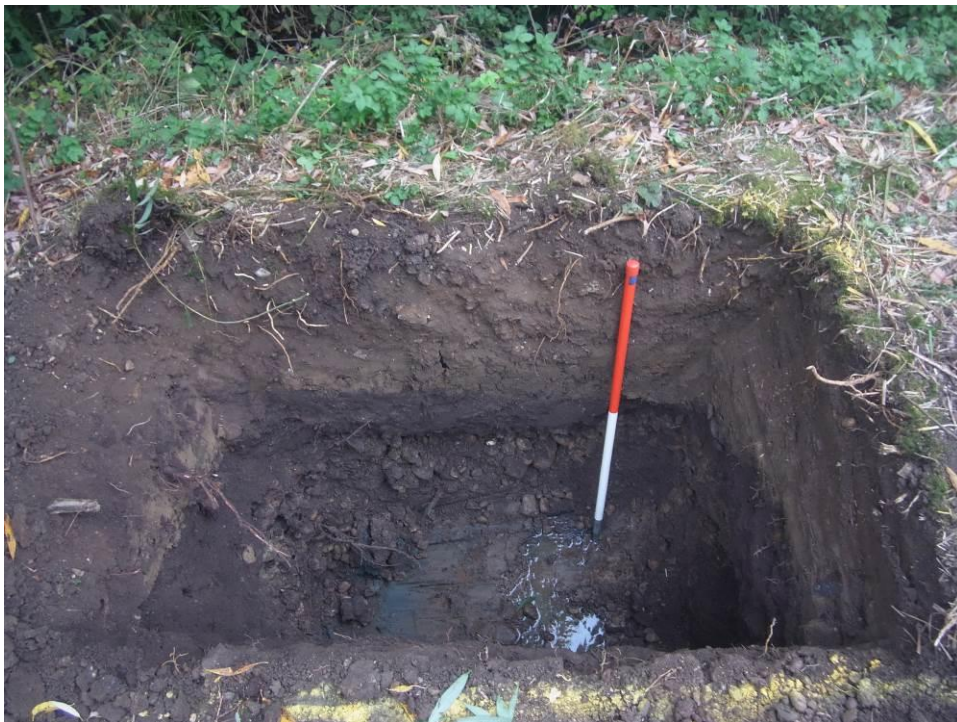
Test pit 1 fully excavated, looking east Fig.4

The substantial amount of water outflow from the sides made it unsafe to enter the test pit.

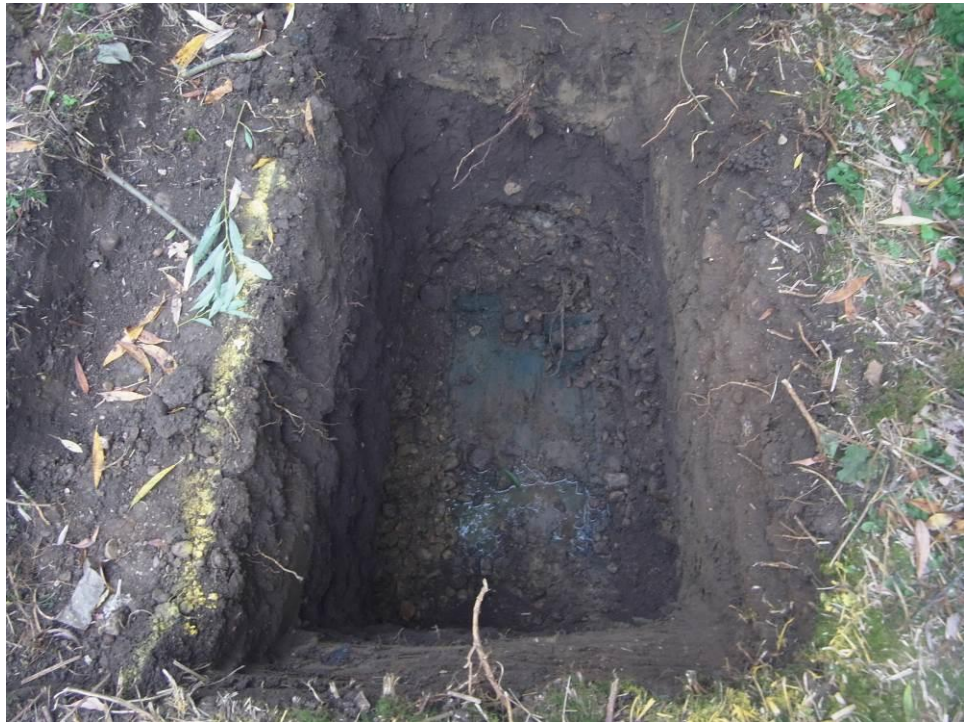
Test pit 1 fully excavated, looking north Fig.5

No archaeological features or finds were observed.

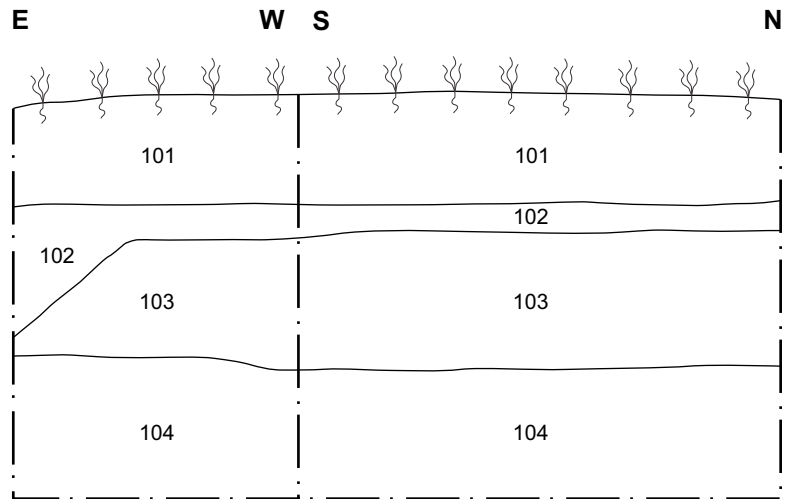
### Test Pit 1 - Section 1

Overlying (104) was modern makeup layer 0.15-0.40m thick (103). It comprised black-brown silty clay with a high percentage of 'industrial' waste such as; brick, glass, metal fragments, metal wire, coal, charcoal and 'clinker'

Covering (103) was a second makeup layer consisting of mid brown clay (102). It contained infrequent small stone inclusions, occasional brick fragments and charcoal inclusions, 0.15-0.45m thick.

The topsoil (101) was 0.30m thick. It comprised dark brown silty clay with rare charcoal inclusions and infrequent small stone.

A total of four layers were evident. Three layers were identified to be modern man-made deposits. The topsoil layer 101 was possibly a result of silt being deposited on the edge of the road from the clearing the drainage ditch. Layer 102 has likely accrued through the same processes. Layer 103 is a deposit of industrial waste with the remains of red brick, coal, charcoal, metal wire/fragments and 'clinker', all of which dated to late post-medieval/modern. There is a clear slope between layers 102 and 103 (Fig 3 and 6) indicating that 103 is modern makeup deposit containing waste material in order for the modern Fosseway road to be built upon. Layer 104 is filled with loose sub-rounded stone, with inclusions of late post-medieval to modern material, such as brick, glass, wire and 'clinker'. A layer of blue-grey clay was at the base of the test pit, it is uncertain whether this represents the underlying geology or a layer of deposited colluvium. All the layers indicate that the ground was built up with successive layers of deposited material in order to create the modern road, possibly to avoid flooding from the nearby river, which potentially masked or destroyed any archaeological deposits such as the remains of the Roman road.
