**An archaeological trial trench evaluation  
at 43 Watling Street, Potterspury  
Northamptonshire  
August 2014**

Report No. 14/202

© MOLA Northampton  
Project Manager: Jim Brown  
Site Code: ENN 107487  
NGR: SP 7546 4329

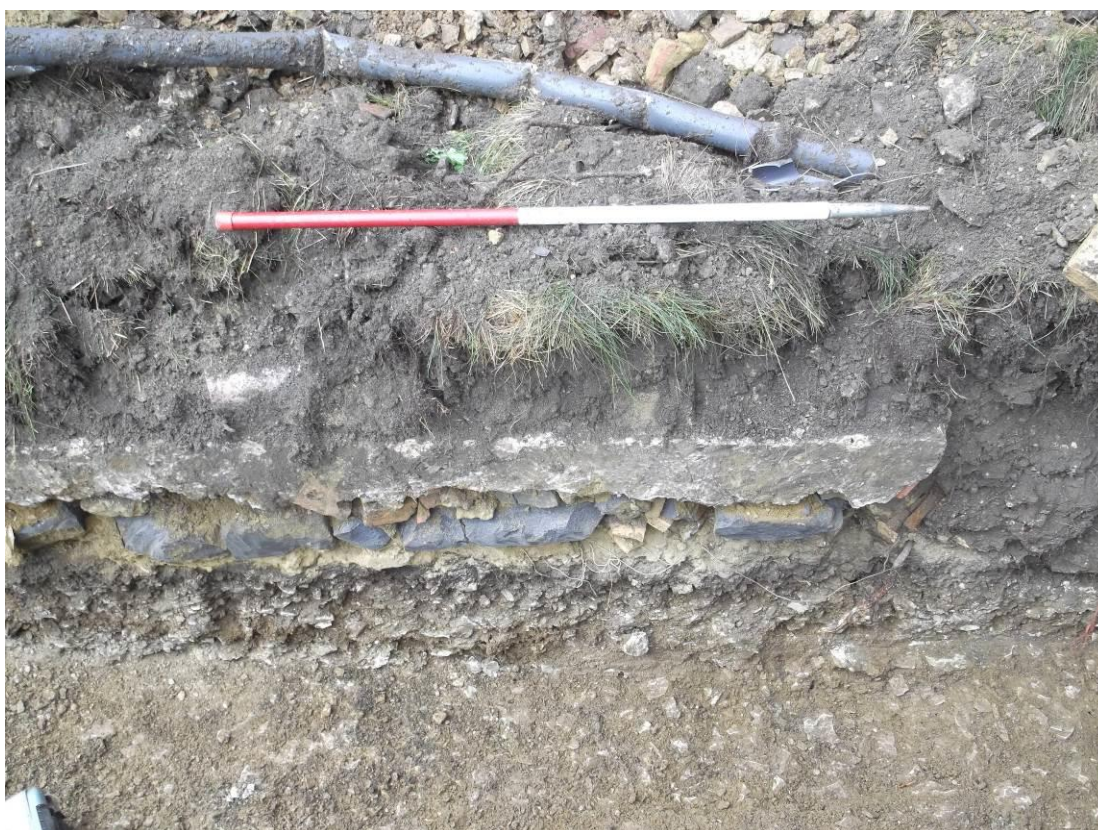
Trench 1 section, looking north-west Fig 3

The natural substrate was limestone with some patches of mid orange-brown slightly silty clay between 1.0m and 1.2m deep. This was overlain by mid grey-yellow mixed silty clay and limestone subsoil, 0.20m thick, and black-brown silty clay topsoil, 0.20m thick. This represents a previous ground level as this was overlain by 0.30m of yellow-brown silty clay and limestone, with frequent fragments of brick, tile, plastic and other modern material, probably deposited as a levelling layer after the construction of the 1970s building.

This made ground abutted a concrete slab, 0.15m thick, that was exposed in the north-western section of the trench. The slab was 4.5m long and lay on a base of sand and modern thermal bricks. This structure may have been a foundation base or possible yard surface and abutted the buried topsoil and cut into the buried subsoil.

To the north-east of this structure the made ground was a lot thicker, 0.90m, and there was no buried topsoil and only a small amount of subsoil. The made ground and concrete slab were overlain by mid grey-brown sandy silt topsoil, 0.30m thick, which was probably laid as part of landscaping after the construction of the 1970s building (Figs 2 and 3).

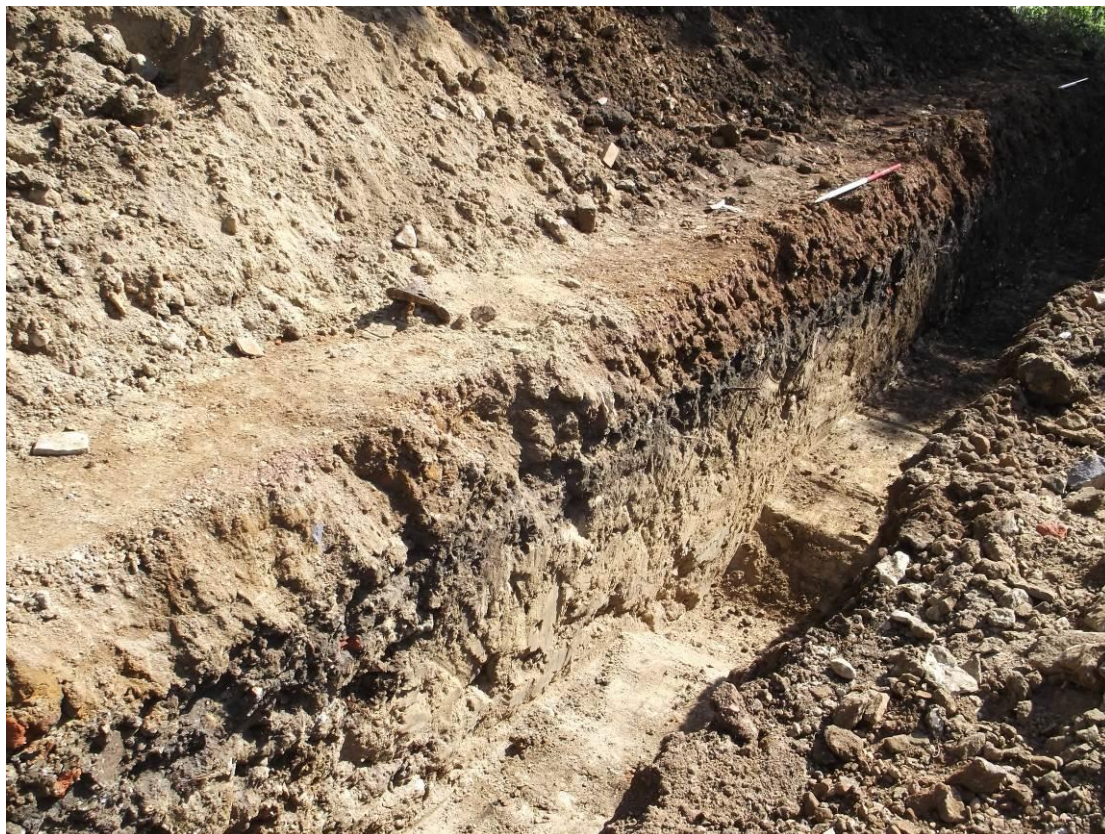
Trench 2, pit [208], looking east Fig 4

The general stratigraphy was similar to that of Trench 1. The natural limestone substrate overlain by a subsoil of orange-brown slightly silty clay mixed with limestone, (205), 0.35-0.45m thick. This was topped by a buried topsoil the same as that in Trench 1, (204), 0.30m thick. Buried topsoil (204), (205) and the natural substrate were cut by a large irregular-shaped pit, [208], the full extent of which is unknown. The pit was steep sided and filled by white-yellow sand containing modern

pottery, brick, and metal. A slot was machine dug into this pit to try and establish its depth but had to be stopped at 1.9m for health and safety reasons (Figs 2 and 4).

Both the pit, [208], and buried topsoil were sealed by a levelling layer of dark grey silty sand, containing modern pottery, brick, etc., 0.20-0.40m thick. This was overlain by the car park surface which consisted of an ironstone base overlain by compacted gravel, 0.20-0.30m and 0.15-0.20m thick respectively.

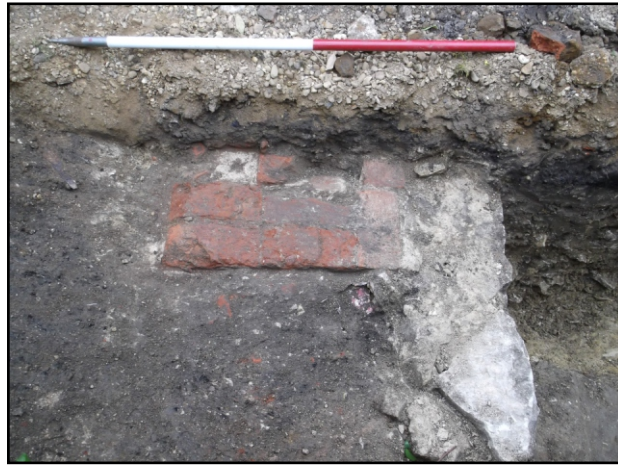
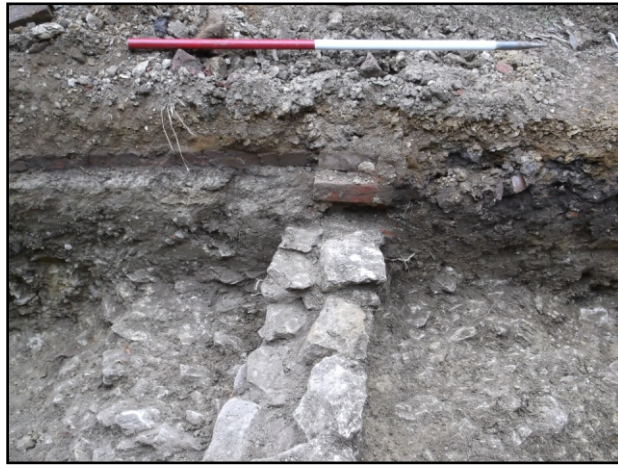
Trench 3, plan, section and photographs Fig 5

The natural substrate was overlain by the same subsoil encountered in Trench 2, (304), 0.25-0.50m thick. A small number of sherds of 19th-century willow pattern pottery were recovered from (304). However, the buried topsoil found in Trenches 1 and 2 was not present across the majority of the trench.

Subsoil (304) was cut by wall, [312], however, there was no foundation cut visible. Wall [312] was built directly onto the natural limestone substrate and consisted of three courses of roughly faced limestone blocks. The wall was on a north-west to south-east alignment and stood to a height of 0.30m. It was on approximately the same alignment to the rear wall of 'The Maltings' building to the north-west. Mortared on top of this wall were the remains of two courses of brick wall, [311]. It is uncertain whether [311] was a later remodelling of wall [312] or whether [312] was the foundation for [311]. However, wall [311] was abutted to the south-west by a sand and mortar layer, (310), which was used as a base for a tile floor, (309). Plastic was recovered from the mortar layer, (310). The modern surface, (309) was in quite poor condition and disturbed by the levelling layer, (303), which was the same as that in Trench 2, (203). As a result it was removed during the excavation of the trench (Fig 5).

The tile surface, (309), probably originally extended to another wall, [306], which was 4m to the south-west of [311]/[312], and lay on roughly the same alignment. Wall [306] consisted of two courses of roughly-faced limestone and was built on a layer of compact grey-brown clay mixed with limestone, (305), from which a fragment of 19th-century clay tobacco pipe was recovered. The relationship between (305) and the subsoil (304) was unclear within the confines of the trench. Wall [306] was abutted to the south-west by a possible brick lined drain base for a down-pipe, [307] (Fig 5).

The modern levelling layer (303) overlaid drain [307], wall [306] and the majority of subsoil (304). This was overlain by the car park layers (302) and (301), same as those present in Trench 2. The base layer for the car park, (302), also directly overlay surface (309) and wall [311] (Fig 5).

The narrow limestone walls in Trench 1 are perhaps 19th-century in date and were probably the walls of a small out-building shown on historic maps from 1884 to 1958. The tile surface and brick additions are probably from remodelling of this structure in the late 19th or early 20th centuries.
