Historic Building Recording at The Old Rectory, Bulwick Northamptonshire

Report No. 14/204

**Historic Building Recording at
The Old Rectory, Bulwick
Northamptonshire**

MOLA carried out a programme of historic building recording on an outbuilding associated with The Old Rectory, Bulwick, Northamptonshire. The surveyed building pre-dates the mid-19th century, likely contemporary with the early 19th-century alterations of the main rectory. The building formerly functioned as a coach house, stores and stables with accommodation for coachmen over.

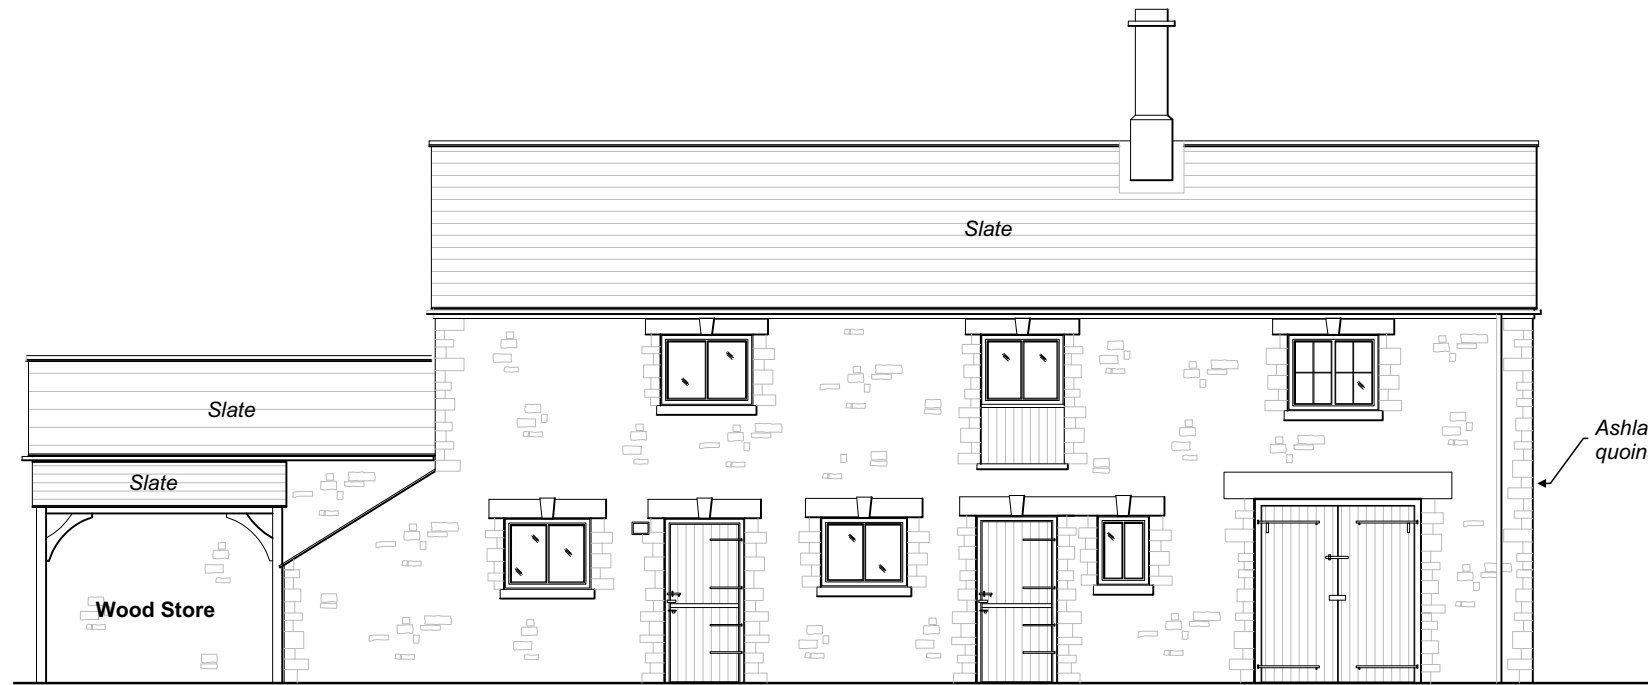
The recorded building is rectangular in plan with two smaller sheds or store rooms and a covered wood store to the east (Figs 3 and 4). At ground floor two unequal sized rooms, rooms G1 and G2, are separated by a transverse hall housing a stair that rises to first floor level. The building has an open gable roof with gables at the east and west ends (Fig 4). Both the main structure and its extensions are covered with collyweston slate tiles.

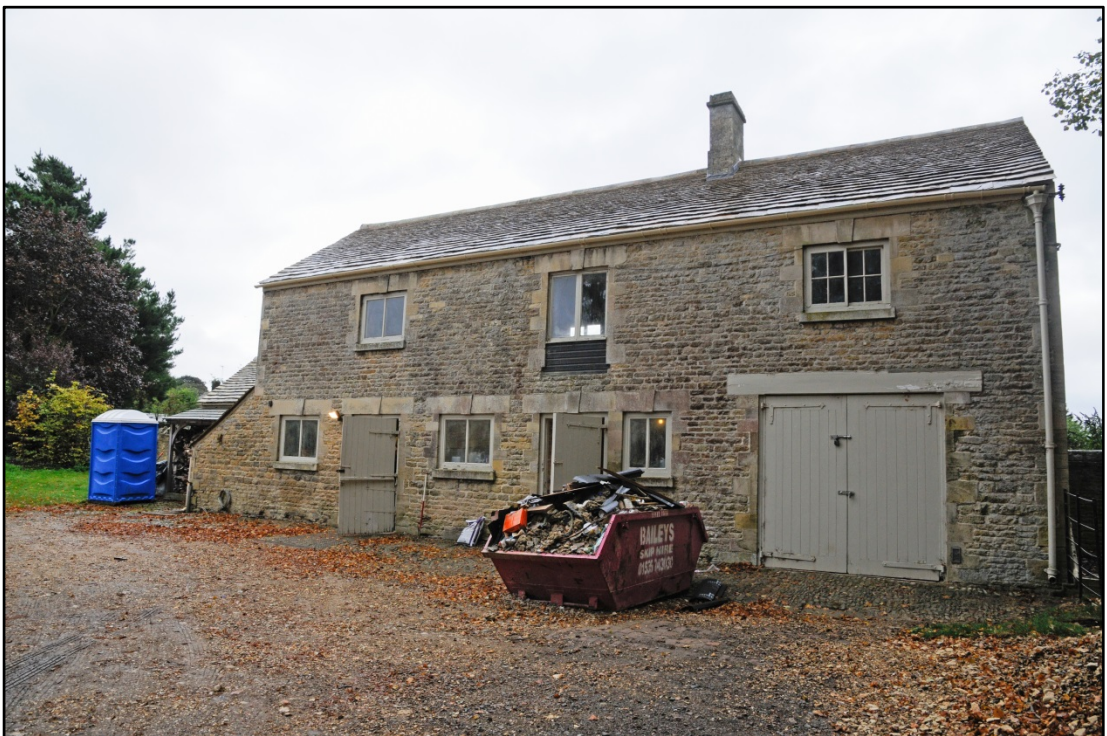
The north elevation, looking south-east Fig 6

The external elevations are constructed of squared, coursed limestone with ashlar quoins and ashlar dressings around the windows and doors. The north elevation has a somewhat irregular layout of fenestration (Fig 6). Three doors, two of a top and bottom opening stable type and the other, a central opening double door provide the only access to the ground floor rooms. The windows have plain, rectangular stone lintels with protruding keyblocks, plain stone lintels and ashlar dressings. They are of a style typical of contemporary architecture of the region. The south elevation is largely plain with two small ventilation openings at ground floor and one at first floor. A pair of windows look south from the first floor.

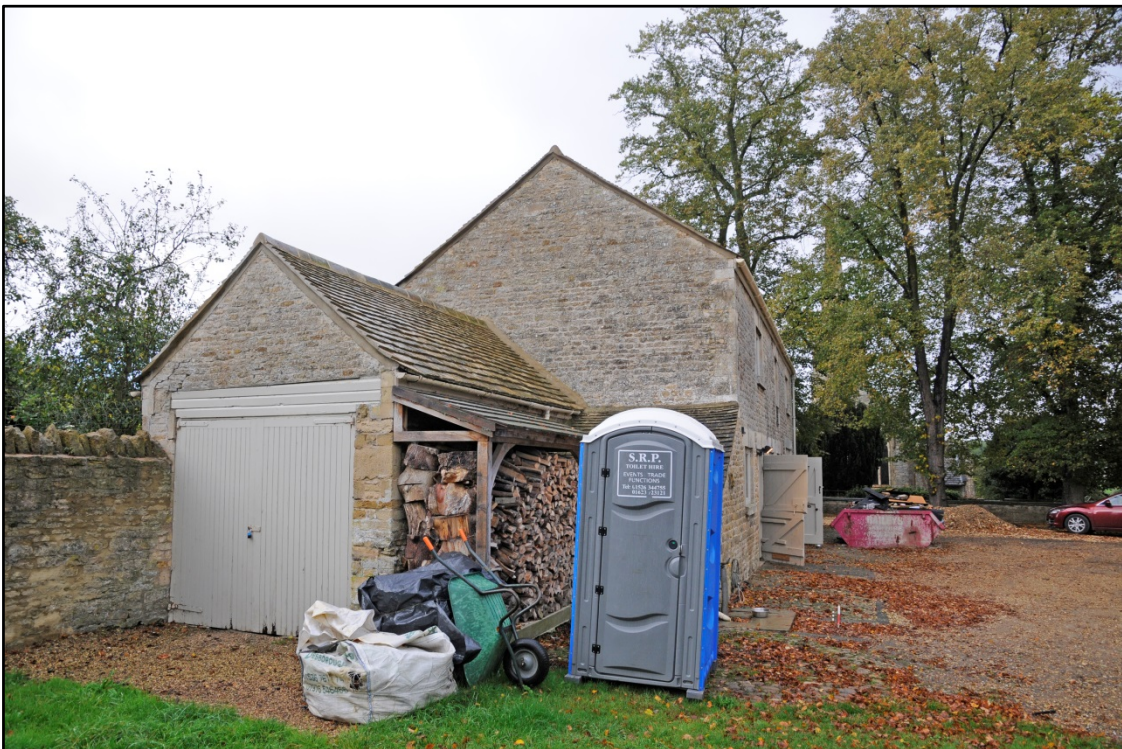
The east elevation and sheds, looking west Fig 8

Two small ground floor sheds or store rooms are constructed against the east elevation, forming an L-shape (Fig 8). A simple open wood store is built against the northern wall of the larger of the two sheds. Both are constructed of coursed, limestone with ashlar dressings. The larger shed has a gable roof while the smaller has a lean-to roof against the east wall of the main building. The interior of the sheds could not be accessed for photography. No obvious join could be seen between the main building and the sheds, thus indicating that they are contemporary rather than the sheds being later extensions to the building.

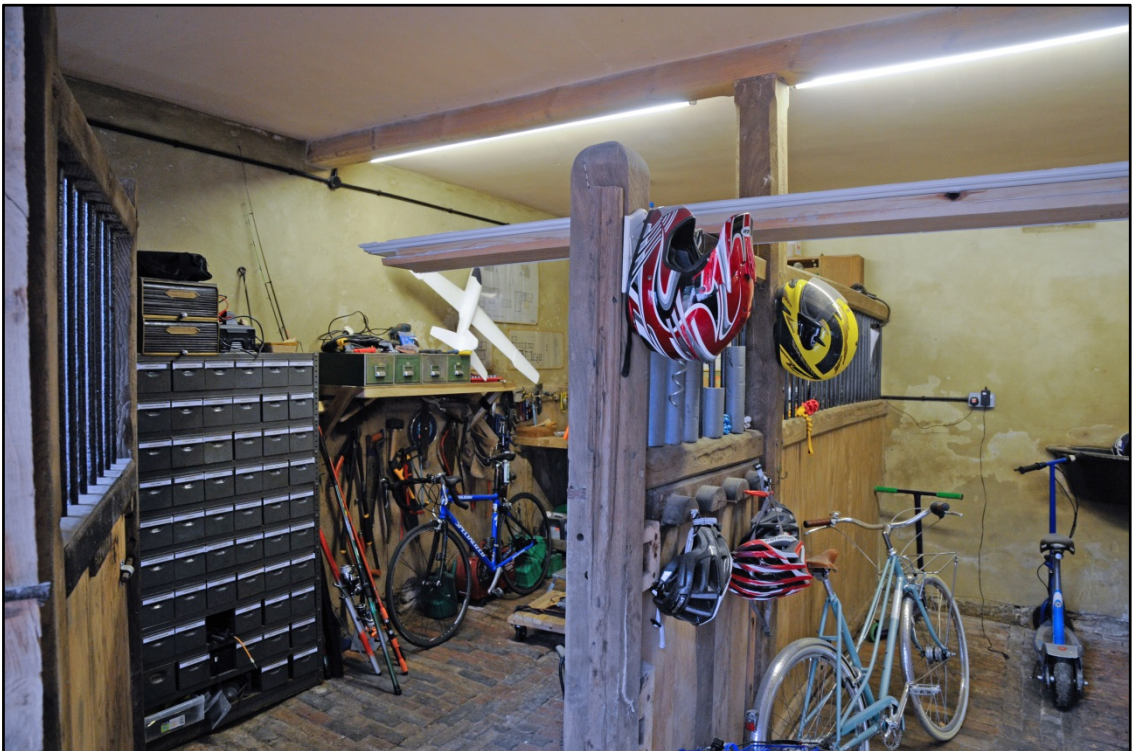
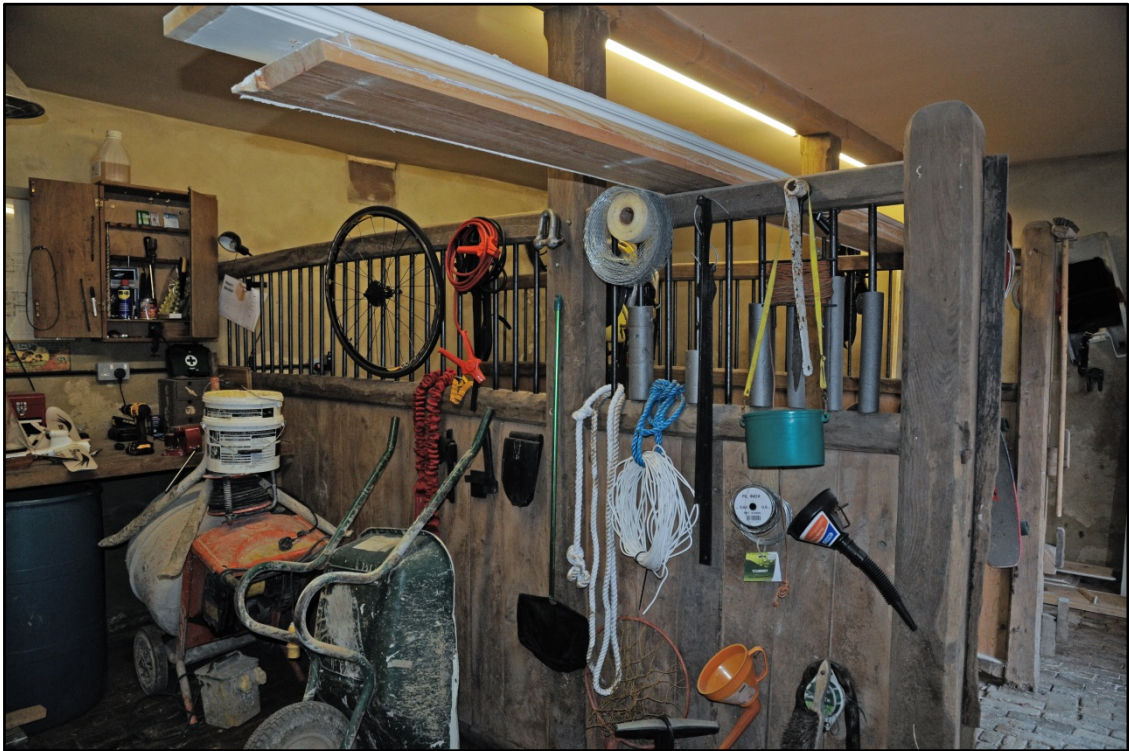
Room G1, interior, looking south-east Fig 10

The ground floor comprises two rooms, G1 and G2 separated by a central tack room (Fig 3). Room G1, the easternmost room is a former stable with two timber stable partitions surviving *in-situ* at the time of this survey (Figs 10-11). The stall partitions are constructed of upright timber planks with iron bars over. Off centre to each partition, a shaped timber post, chamfered at the top, rises from the floor to ceiling level, supporting a central joist that runs east - west to the room. This joist passes through the west wall of the room, continuing over the central wall where it meets the chimney breast.

Room G1 was in use as a workshop and storage area at the time of this survey. The room measures c6m by 5m and is plain with the walls rendered and plastered. Access is through a top and bottom opening stable door in the north wall. The door jambs have bullnose bricks internally to the room. A pair of fixed, two light windows with timber surrounds flank the door, looking north. The room has a brick floor laid east - west, stretcher side up with brick drainage gullies running north - south, central to each stall. The gullies end with cast iron grates set in cement, opening to drains below the building.

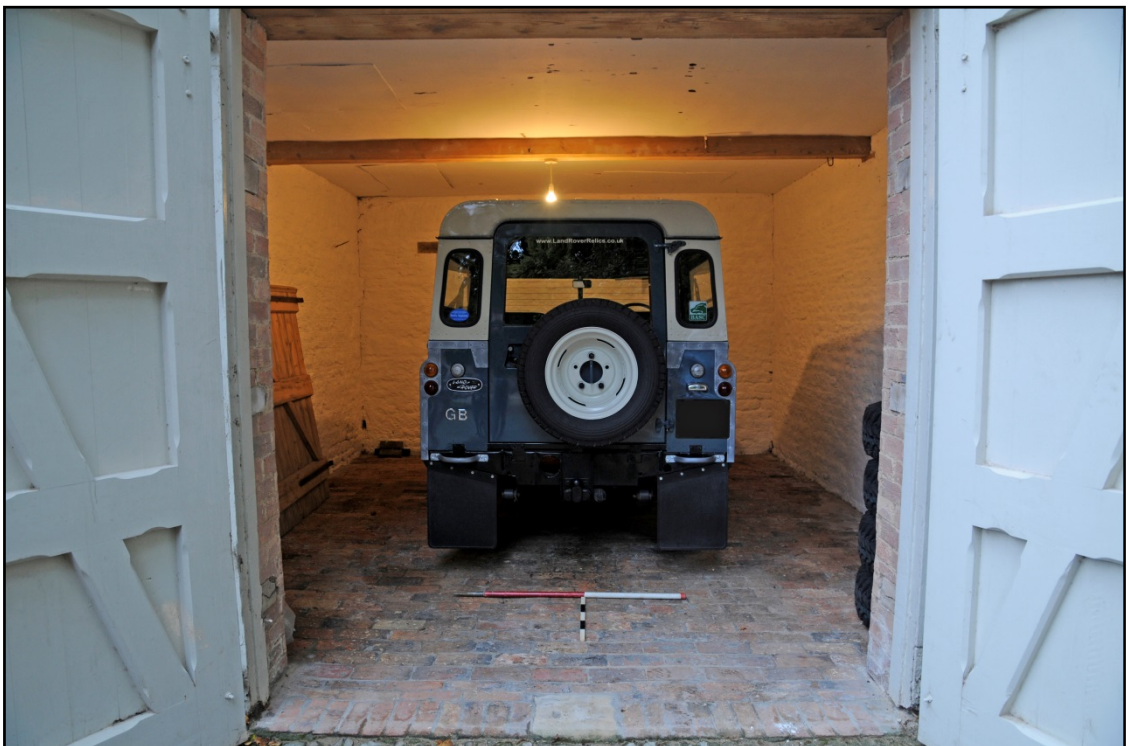
Room G2, interior, looking south Fig 12

Room G2 at the western end of the building, measures c4.3 meters by 5 meters and formerly served as a coach house (Fig 3). At the time of this survey, it was in use a

garage (Fig 12). The room is plain with whitewashed walls, a simple brick floor and modern ceiling over. A pair of square ventilation holes with iron grates were built just above head height in the south wall (Fig 13). These had timber lintels and tapered outwards. The door opening is squared but a brick relieving arch can be seen just above floor level in the room over (Fig 23).

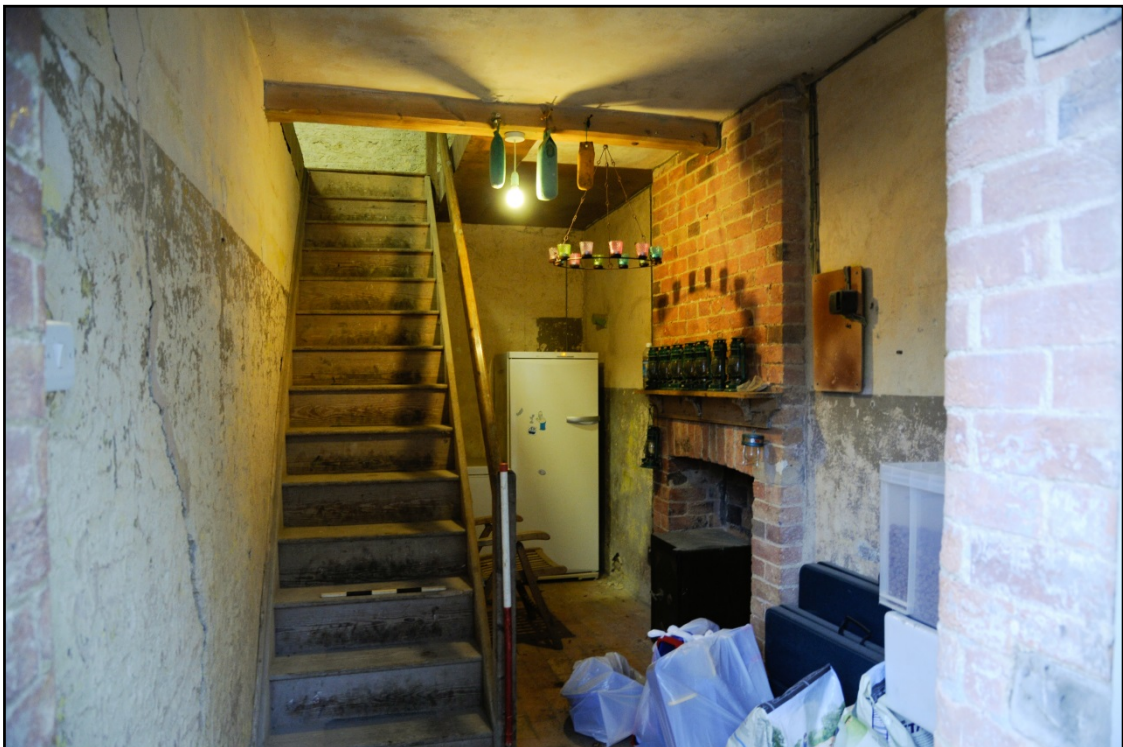
The tack room, looking south Fig 14

The central tack room is c2m wide with a stair providing access to the upper floor (Fig 14). The room is accessed through a top and bottom opening stable door in the north elevation. A brick chimney breast, central to the west wall, protrudes slightly into the room with a simple square fire opening at the base. A simple over mantle shelf is present over the fire opening. A machine sawn, pine joist which is the continuation of that seen in room G1 spans the width of the room (Fig 3). It has chamfers and fillets on the underside of the beam. As with the other ground floor rooms, the hall has a brick floor.

The stair is of a simple design with 14 pine risers and is built against the east wall of the Hall. It has a plain, pine handrail with no balusters and a simple newel post (Fig 14).

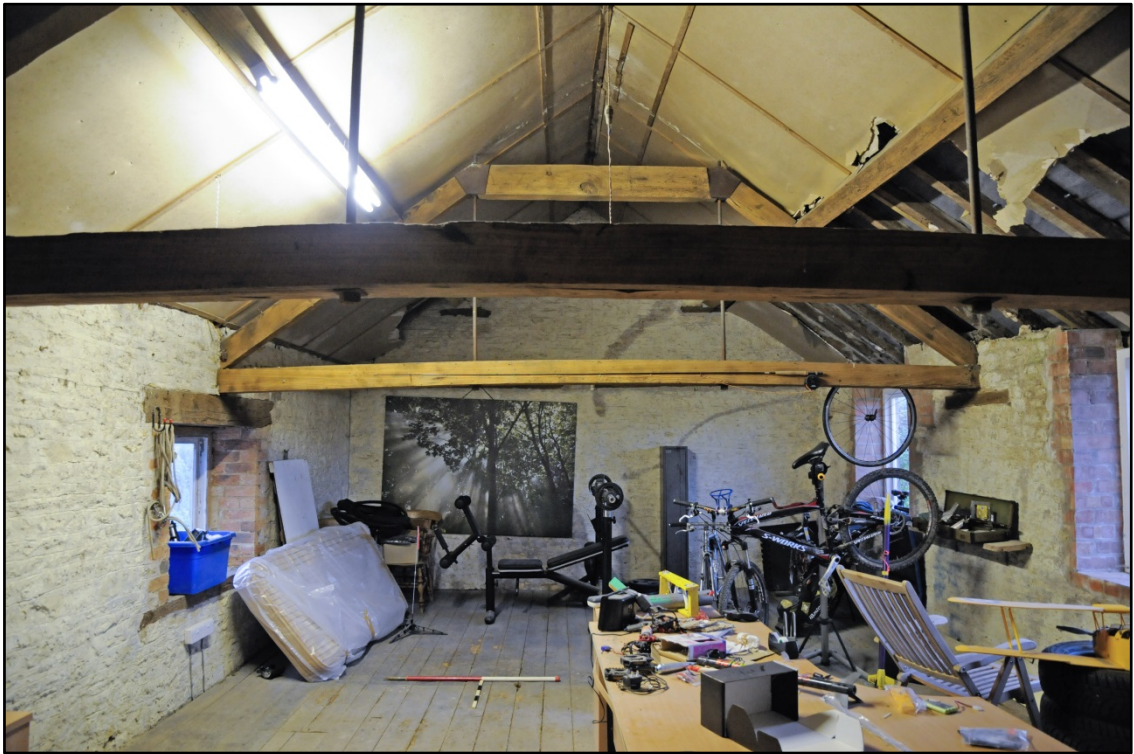
Room F1, looking east Fig 15

The walls are whitewashed internally with the red brick detailing around the windows exposed. The roof structure is of machine sawn pine with purlins carried over two queen post trusses with iron rods serving as the queen posts (Fig 15). The ends of the trusses are embedded in the fabric of the wall rather than resting on wall plates. These ends are supported in the wall by the window lintels and short timber beams.

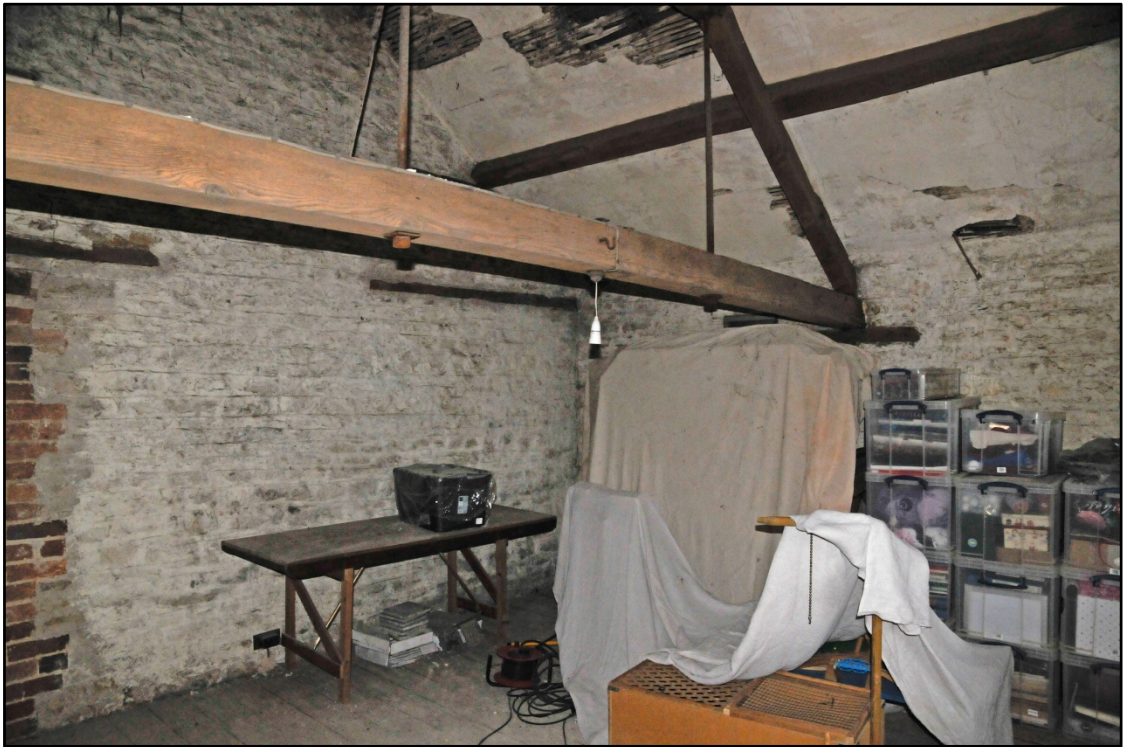
Room F2, looking south-east Fig 21

Centrally to the room, a single, exposed queen post truss with iron rods carries the purlins that support the roof (Fig 21). As in room F1, this truss is embedded in the fabric of the north and south walls, rather than resting on a wall plate. The overlying rafters are hidden above a lath and plaster ceiling. A course of bonding timbers runs the length of the north and western walls (Fig 22). Further bonding timbers can also be seen in the east wall, adjacent to the door (Fig 21).
