Archaeological Observation and Recording at Forty Hall, London Borough of Enfield January to August 2014

Report No. 14/199

Site code: FFH11

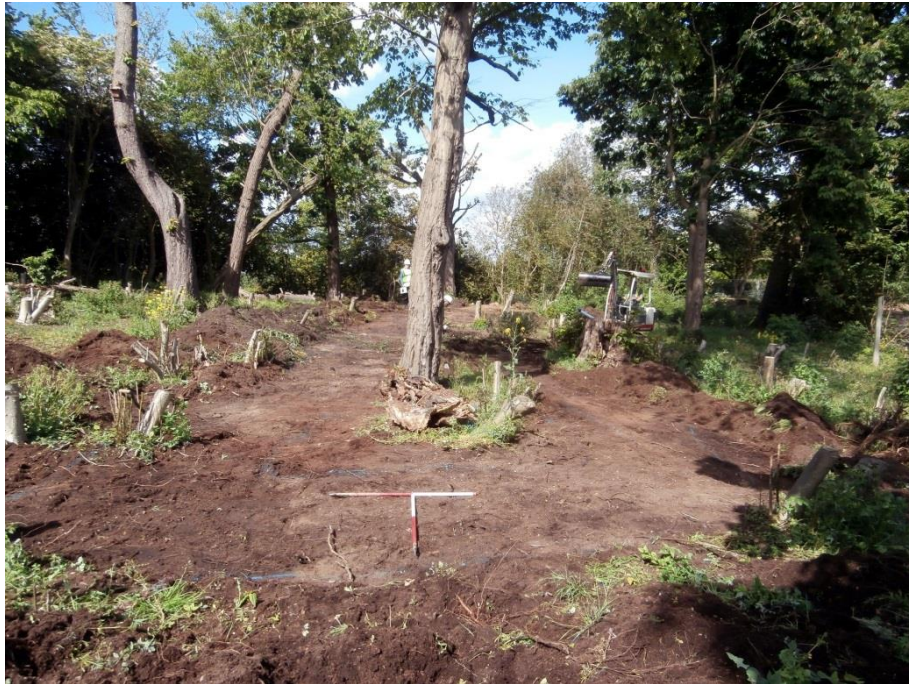
Archaeological observation of the mound comprised a strip of leaf mould, c1.5m wide and up to 0.10m deep (Fig 4). The gravel path surface was patchy in terms of survival owing to extensive root disturbance and *in-situ* mature trees trunks, which were to be retained for ecological and faunal reasons. Owing to the above the observation of this phase of work was problematical and on several occasions it was decided that the former path would have made use of the existing contours of the slope (Fig 5). Therefore mechanical excavation followed whenever possible the flatter areas.

Excavation on the Mound in progress, looking north-west Fig 4

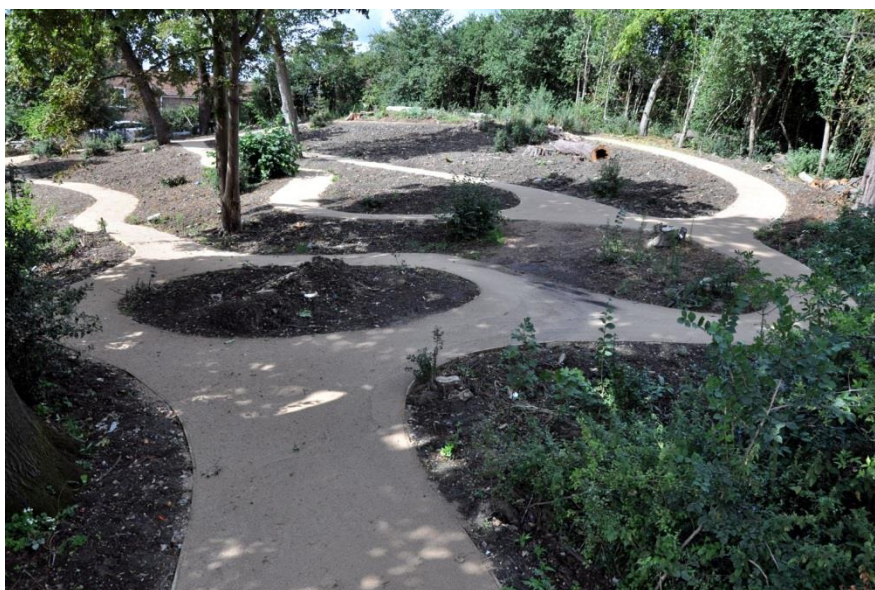
The completed mound and path, looking south Fig 5

The observation of the strip of the pathways on the Mound further defined the original line of the paths. Where the gravel surface survived it was heavily disturbed by tree and shrub roots, however, its long term survival was assured as it will be preserved under matting and a new gravel/hogging surface.

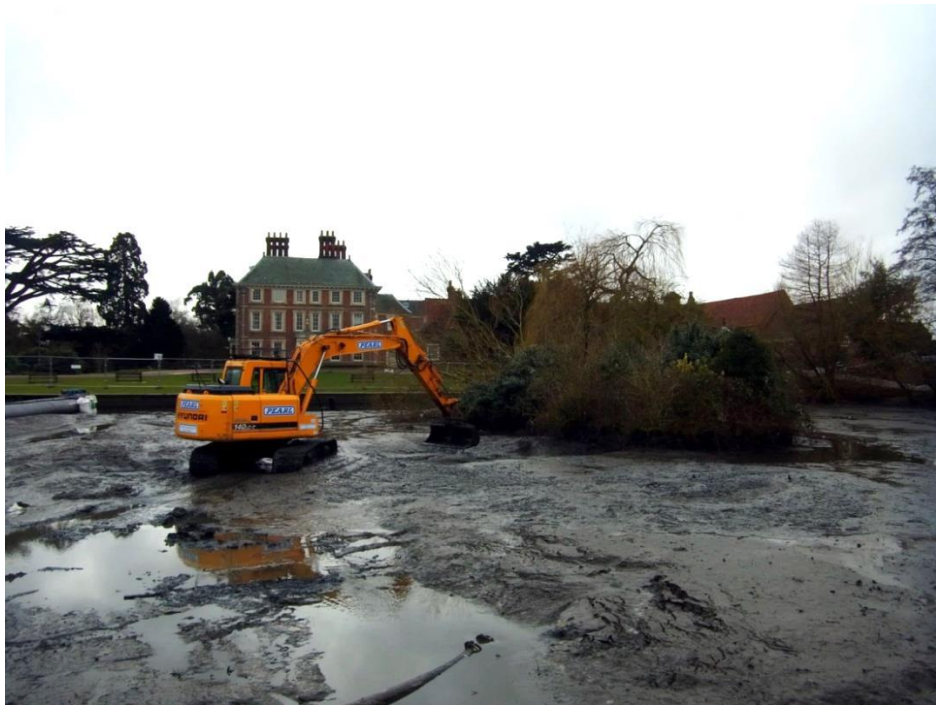
Following draining of the lake, mechanical excavation of the exposed silt (3300) was undertaken. The very dark brown-grey silt was on average 0.30m thick around the edge of the modern lake. However in the western part of the lake the basin (roughly 40m in diameter) gradually started to shelf down from 0.40m to a depth of approximately 1.0m in the centre (Fig 6). Here it was reported by the machine operator that there was a distinct lower sub-circular shaped area, approximately 20m in diameter and up to 1.0m deep. The silts were observed as overlying pockets of compact grey-yellow clay (3303) and a layer of dark brown gravel (3302). It is likely that this horizon of gravel formed the later surface of the lake.

The ornamental lake during desilting, looking south Fig 6

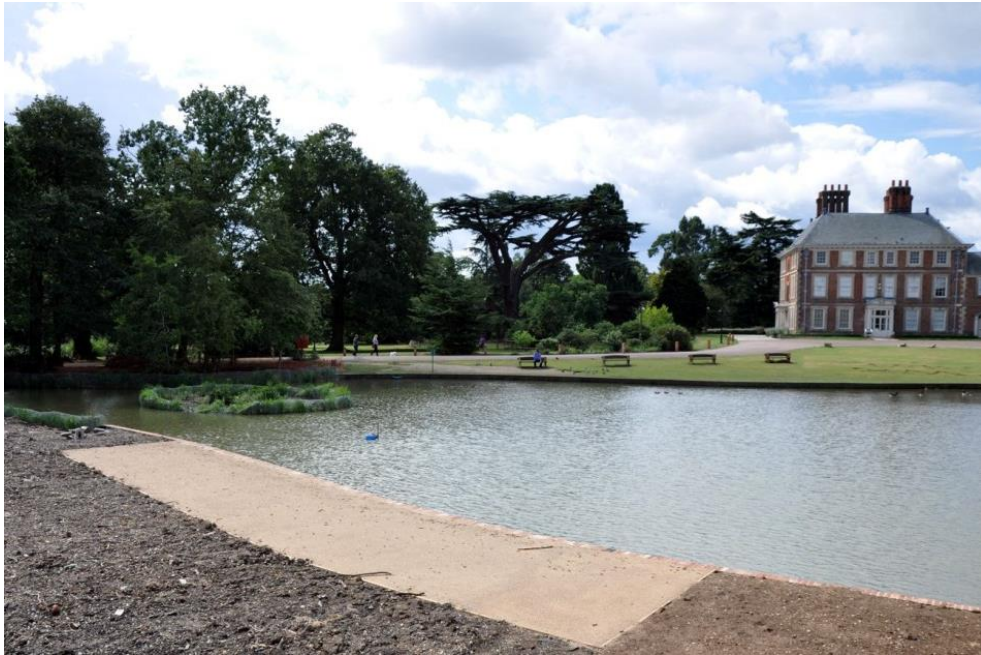
The new island and ornamental lake, looking south Fig 7

The desilting exercise of the ornamental lake comprised the removal of the later silts and did not impact on the gravel and clay lining. The island, demarcated by concrete filled sandbags, was demonstrably 20th century in date. This island was mechanically removed and re-established within the eastern side of the lake thereby opening up the vista from the house towards the northern part of the park (Fig 11), one of the key objectives of the landscaping works. Although the work in the lake did not recover any archaeological artefacts it could be suggested that the outline of the original 17th-century circular pond survives and that the lake was enlarged in the 18th century. The original lake is thought to be approximately 40m in diameter, corresponding with data gathered by LBE. There is a deeper basin (between 0.40m and 1.0m) in the centre of the lake located on a line between the hall and the lime avenue.

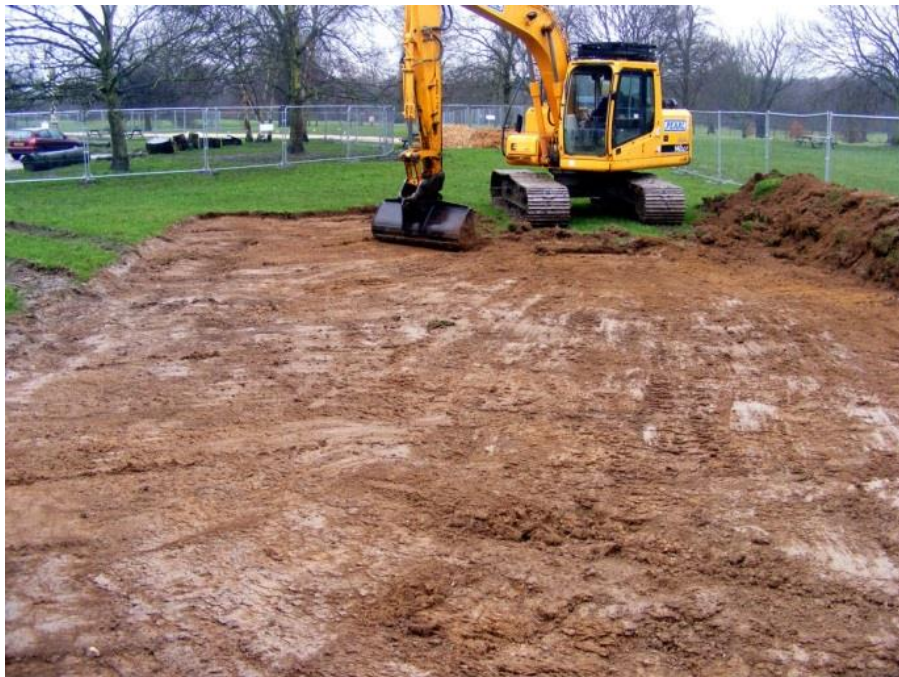
The topsoil (3200) comprised a friable very dark brown sandy loam, 0.20m thick which overlay a thin layer of subsoil (3201) of friable dark yellow-grey silty sands. In places natural gravels and clays (3202) were visible (Fig 8).

The northern lagoon strip, looking west Fig 8

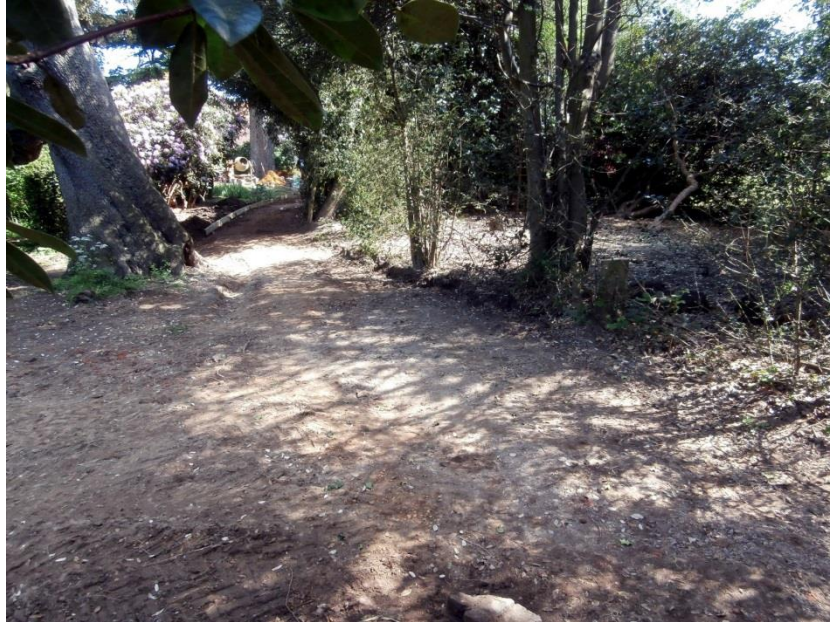
An area measuring 5.6m by 5.4m was stripped of topsoil (3501) to a depth of 0.13m around the putative western roundel in order to re expose the original path surface (Fig 2). A small area of gravel path was identified to the west of a large specimen tree (Fig 9) and a discontinuous area of brick edging (Section 5.2) was found to the east. The bricks were similar in nature to part of the enclosing walled garden.

The specimen tree (left hand side), looking east Fig 9

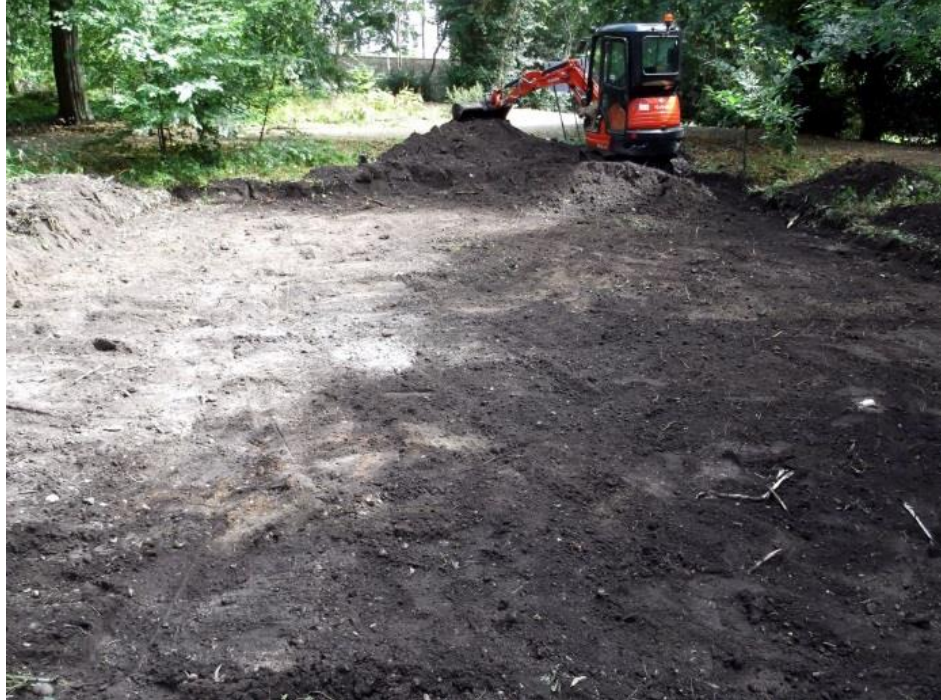
A rectangular area, 30m west to east and 8m north to south, was stripped of topsoil to 0.30m deep (Fig 10). Exposed mixed clay deposits similar to those recorded in trenches 20 (2002) and 23 (2302) (Simmonds 2013) were observed.

The Bog Garden strip, looking east Fig 10

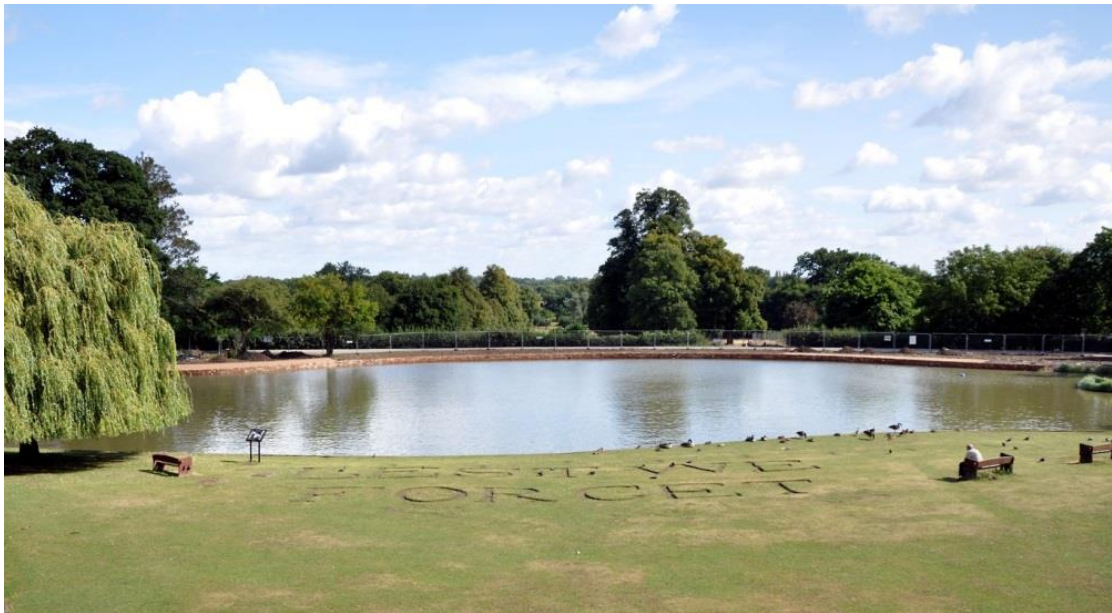
The re-established vista from the hall, looking north Fig 11
