**Archaeological observation, investigation  
recording and analysis of land at  
Oundle Lodge Farm, Stoke Doyle, Northamptonshire  
July-August 2014**

Report No 14/196

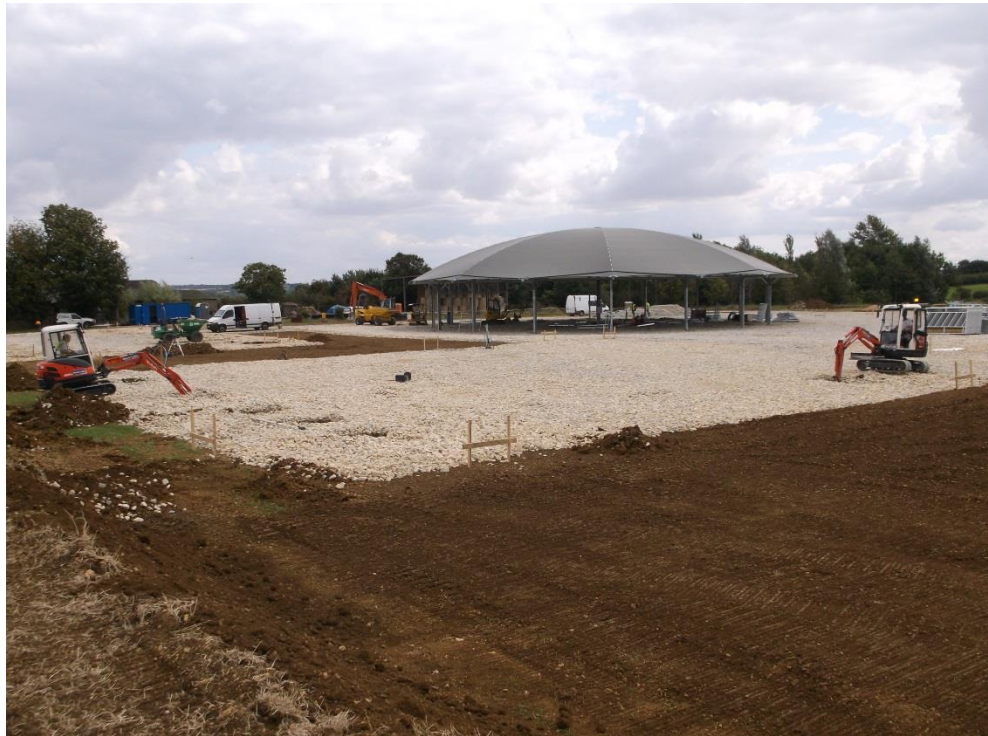
Front Cover: Site looking south-east. Excavation of stanchion trenches for building 4 in foreground, new roundhouse in middle distance.

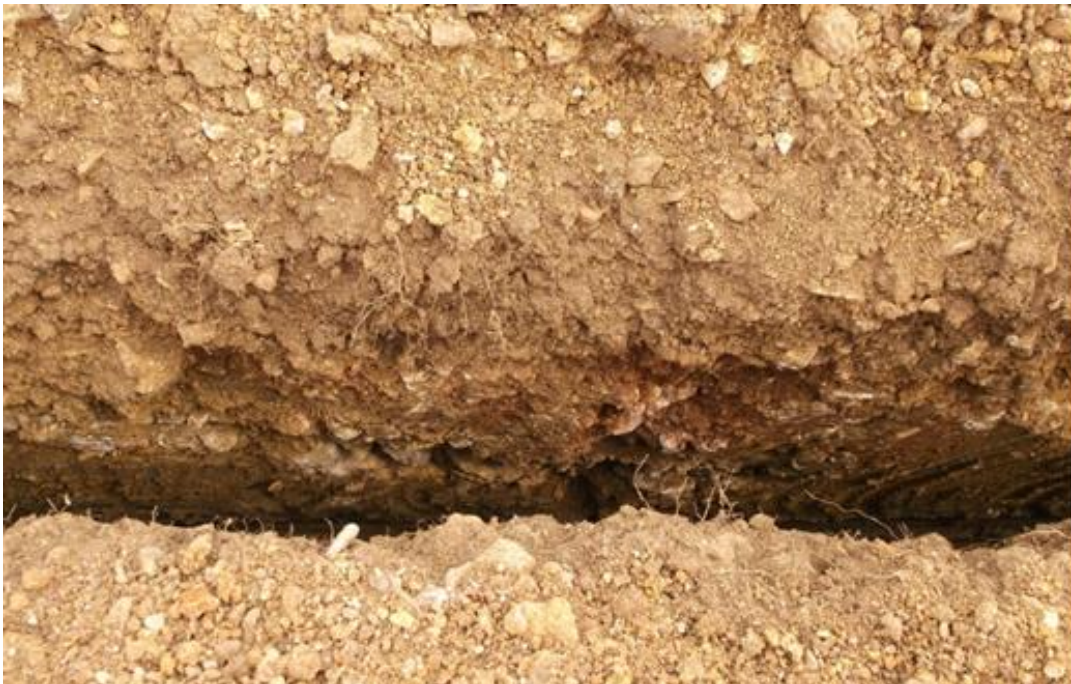
In service trench ST3 a shallow, linear ditch or gully (304) 0.5m wide by 0.45m deep, aligned north-west to south-east was observed. The ditch appeared to have a V-shaped profile. Both fills (305) and (306) were similar in appearance, with numerous fragments of re-deposited fissile limestone. However, the uppermost fill (306) appeared to contain some fragments of burnt limestone (Figs 4 and 5).

Service trench ST3, ditch 304 looking south-east Fig 5

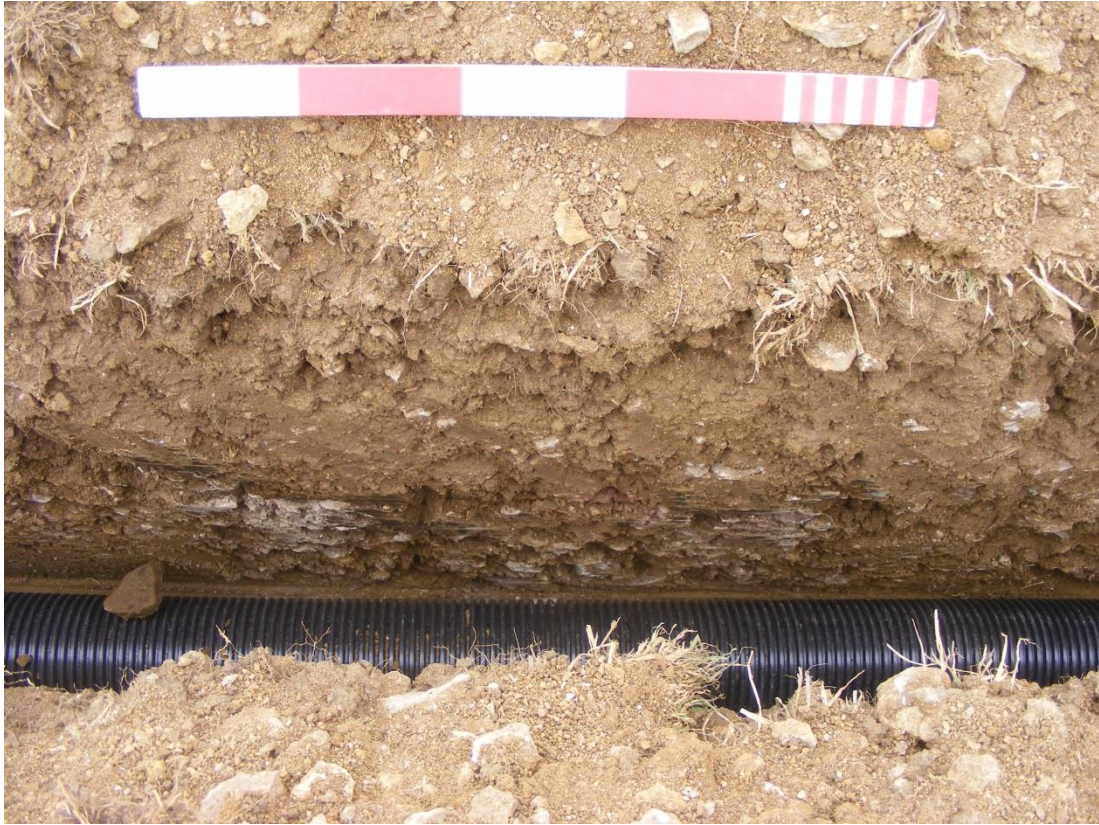
In service trench ST16 a shallow, linear, V-shaped ditch (1604) 0.8m wide x 0.45 deep, aligned broadly north to south was observed (Figs 4 and 6). The lower fill consisted mostly of re-deposited limestone (1605) and an upper fill (1606) largely consisting of mid brown silty clay. Ditch (1604) appears to correspond to a ditch revealed in the geophysical survey, forming part of the previous archaeological investigation which included trial trenching, carried out during March and April 2014 by MOLA.

Service trench ST16, ditch 1604 looking north Fig 6

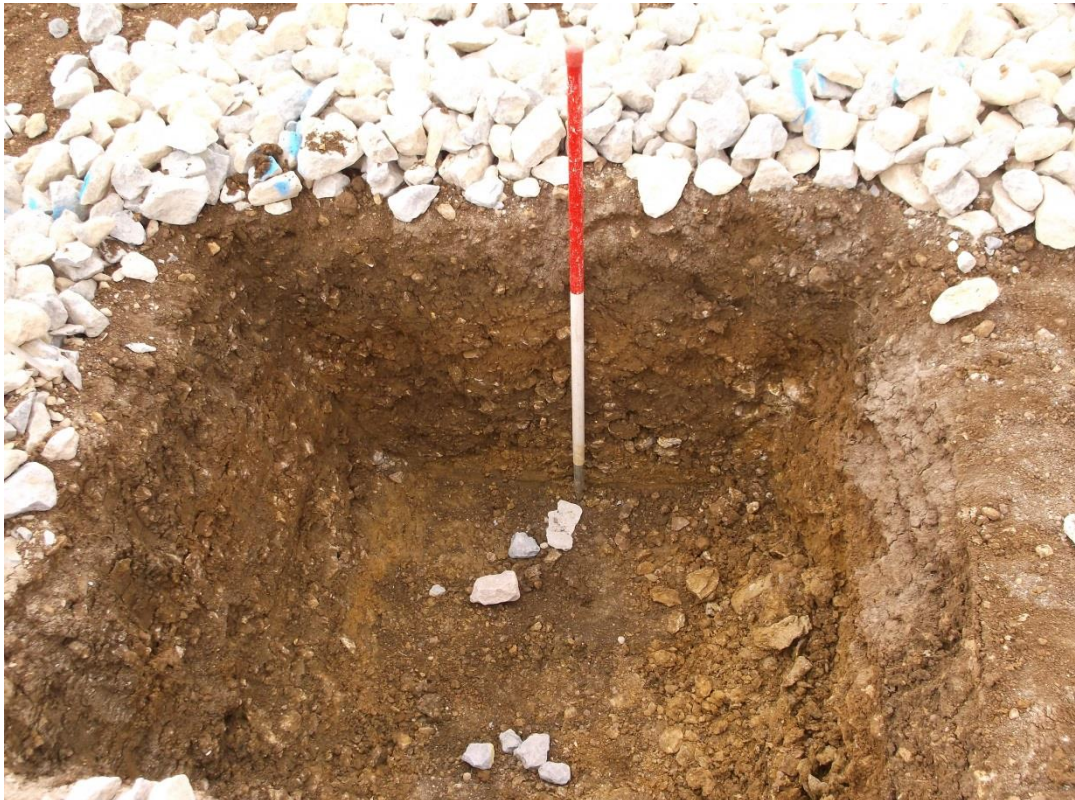
Fig 7

In stanchion trench 401, the edge of a possible ditch (4014) was observed aligned roughly north-east to south-west. The ditch (Figs 4 and 7) appeared to have a U-shaped profile filled with dark yellowish brown sandy clay loam (4014) with numerous fragments of re-deposited limestone. Ditch (4014) appears to be in the same location as an isolated stretch of ditch revealed during the geophysical evaluation (Fig 4)

Stanchion trench T401, possible ditch 4014, looking south.
