**Trial Trench Evaluation
on land at 10 Boat Horse Lane, Crick
Northamptonshire
October 2014**

Report No 14/206

MOLA was commissioned by Welland Design and Build Ltd to carry out archaeological trial trenching on land at 10 Boat Horse Lane, Crick, Northamptonshire prior to proposed development of the site. Two trenches were excavated. No archaeological remains were uncovered, apart from modern deposition and disturbance; no pre modern finds were present.

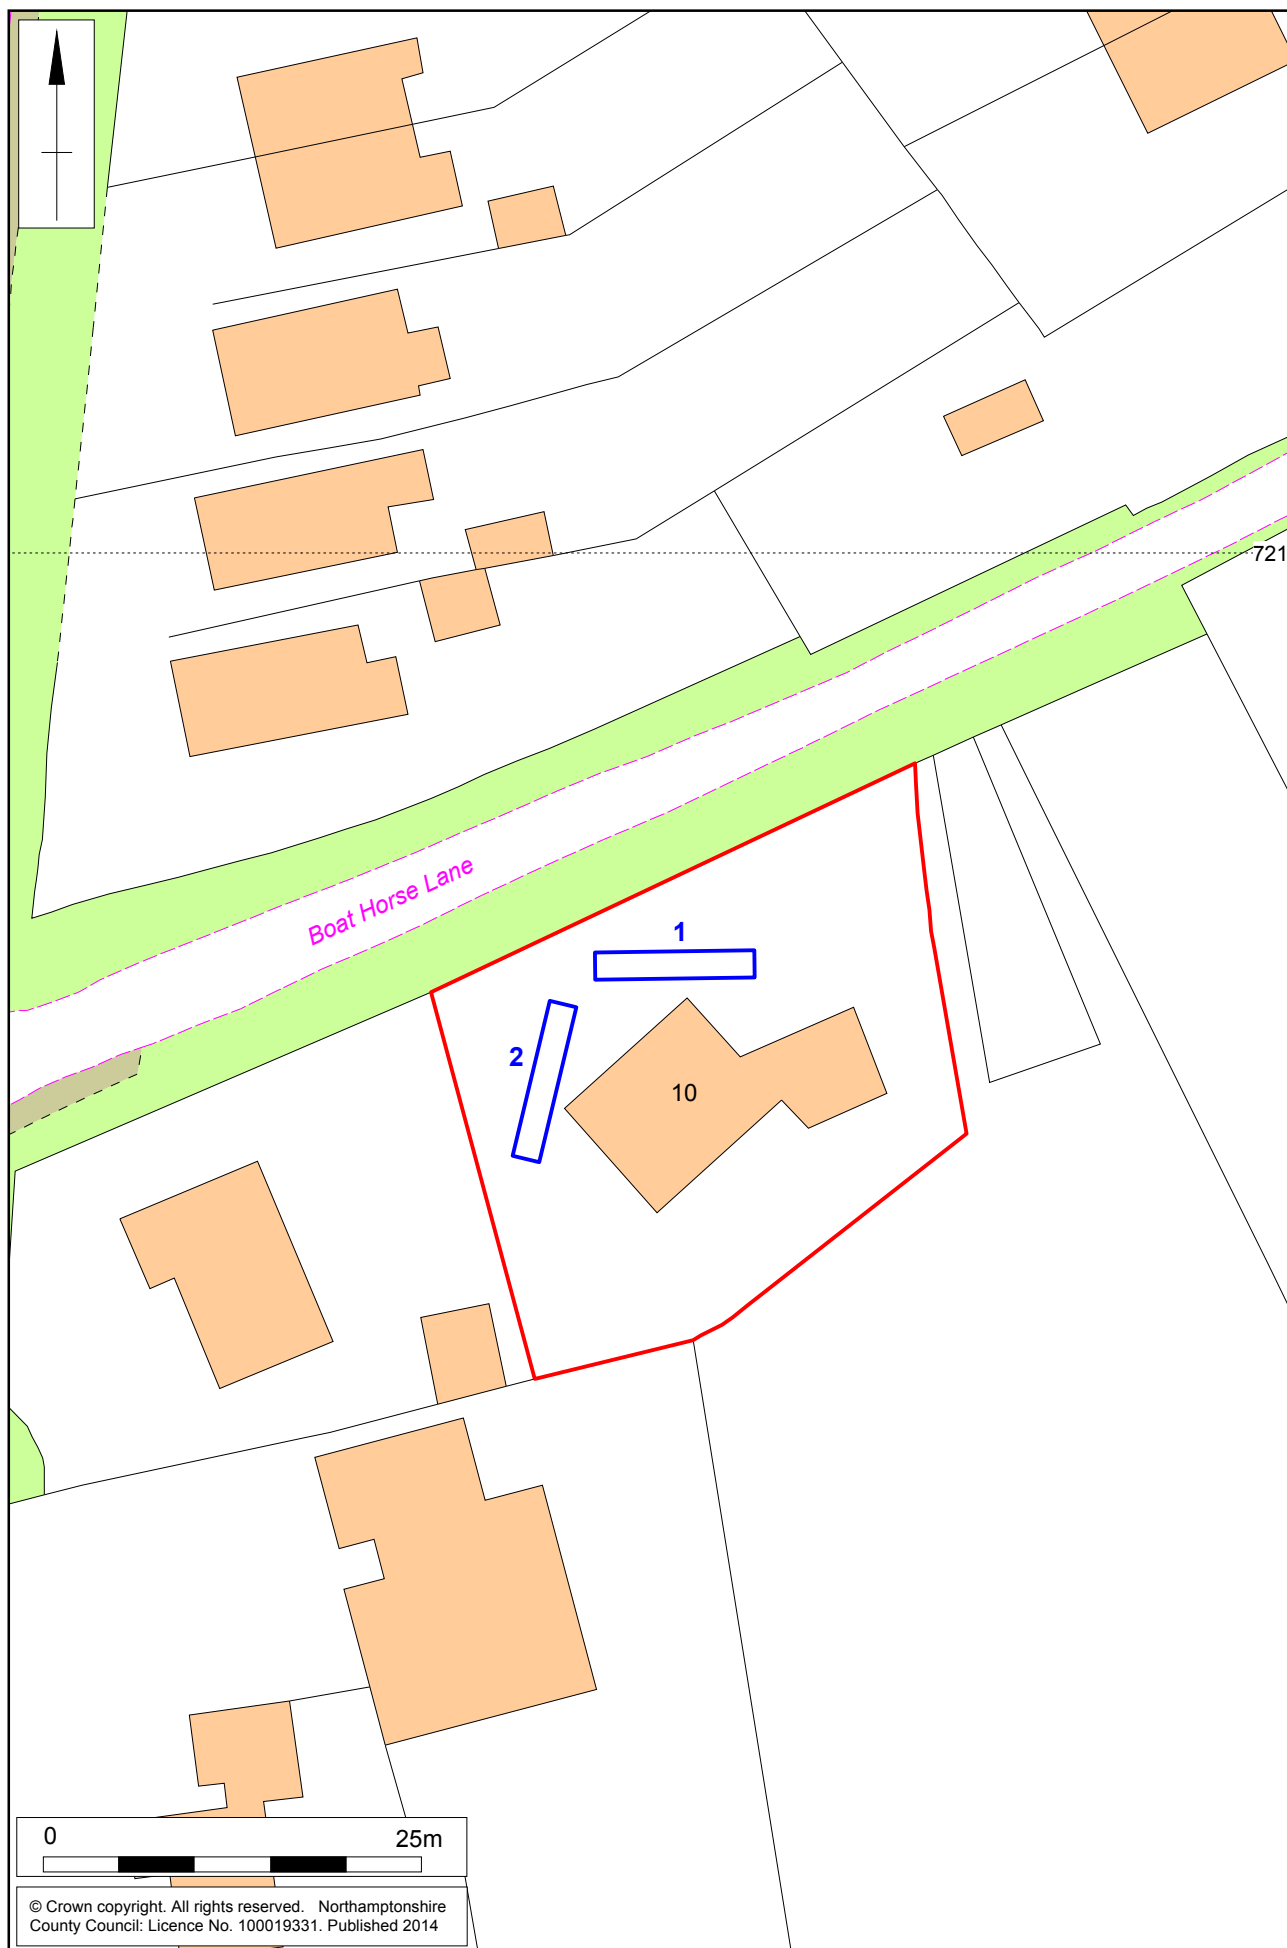
Excavated trenches Fig 2

Two trenches were excavated using a mechanical excavator fitted with a 1.6m-wide toothless ditching bucket (Fig 2). The topsoil and subsoil were removed under archaeological direction to reveal natural substrate. The topsoil and subsoil were stacked separately at the side of the excavated area. All procedures complied with MOLA Health and Safety provisions and MOLA Health and Safety at Work Guidelines.

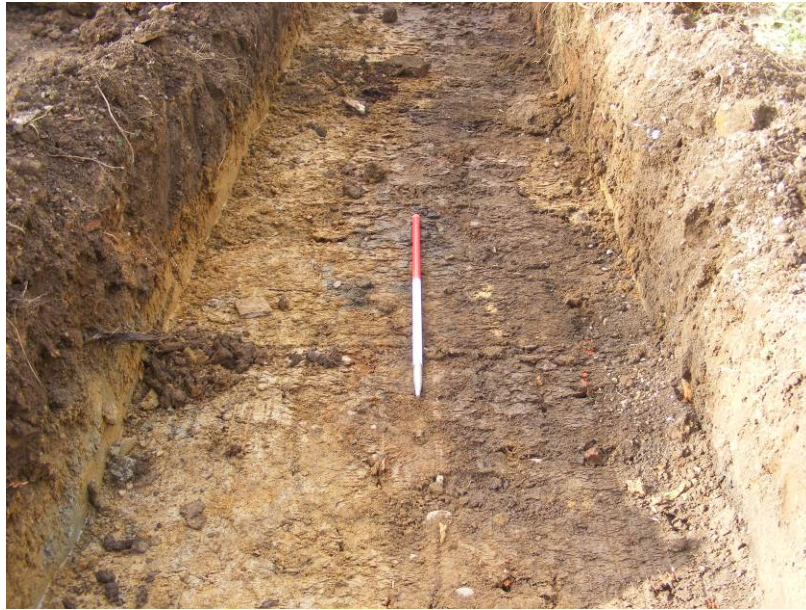
Make up layer 106 (dark material to right), looking west Fig 3

Trench 1 contained nothing of archaeological interest and the ground in the trench appeared to be almost entirely made up, with the northern half of the trench being made ground. Successive layers appeared to be deposited to build up the ground in front of the dwelling in order to negate the slope and create more garden/drive space (Figs 3 and 4). All of the layers contained modern debris.

Trial trench evaluation on land at 10 Boat Horse Lane has demonstrated that no archaeological remains are present within the evaluation area and the ground has been heavily disturbed by rooting and modern intrusions; with some of the land adjacent to Boat Horse Lane being built up in order to create more space for the modern dwelling's garden/drive.

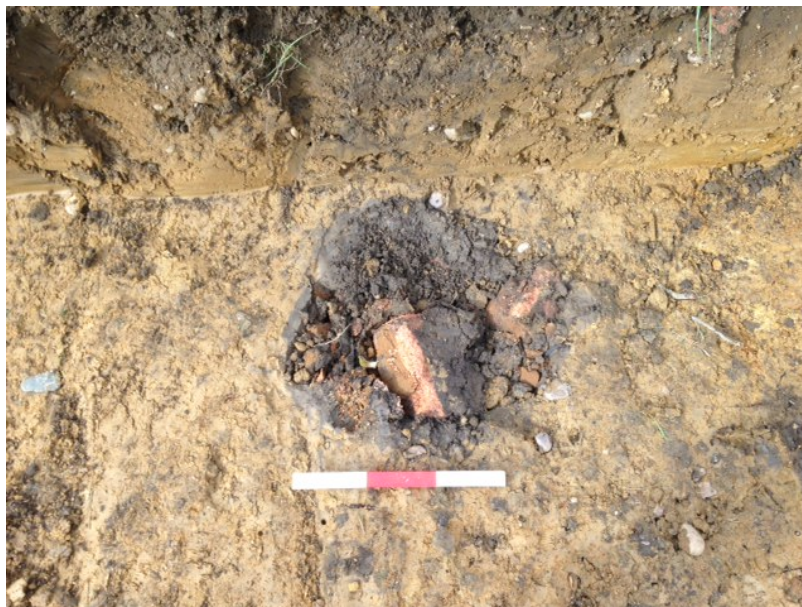
Fig 5

There were modern features and tree root disturbance associated with the previous land use (Fig 5 and 6).

Modern pit [207], looking west

Trench No.	Length, width & alignment		Surface height, NW end (aOD)	Depth & height of natural (aOD)
2	SW-NE 1.6m x 10m		142.43m	0.60m 141.83m
Context	Context type	Description	Dimensions	Artefacts/ Samples
201	Topsoil	Friable grey silty sand.	0.20m thick	-
202	Subsoil	Friable yellow-grey clayey silt with occasional small stone inclusions	0.30m thick	-
203	Fill of [204]	Firm mottled grey-brown clay. Heavily disturbed by rooting.	-	-
204	Tree root	Tree root disturbance.	0.50m wide	-
205	Natural	Friable-firm yellow-brown clay with moderate small stone and pebble inclusions.	-	-
206	Fill of [207]	Friable mid brown silty sand and modern bricks.	0.40m width, 0.40m length.	-
207	Modern Pit	Circular modern pit filled with modern brick.	0.40m width, 0.40m length.	-

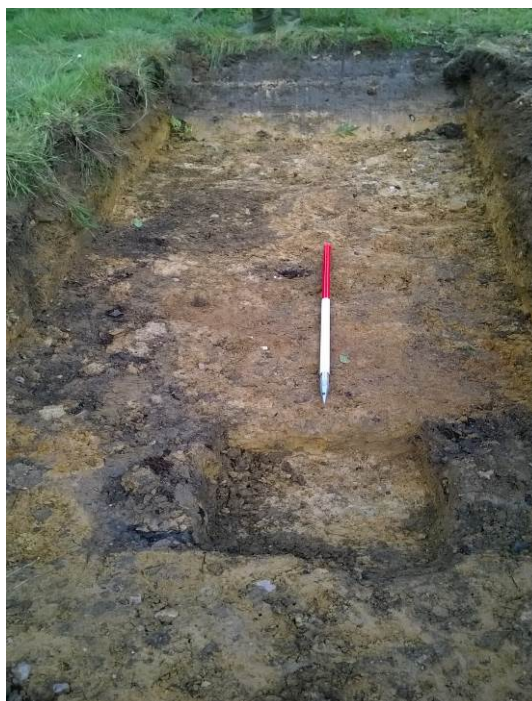
Tree root disturbance in Trench 2, looking south west Fig 6

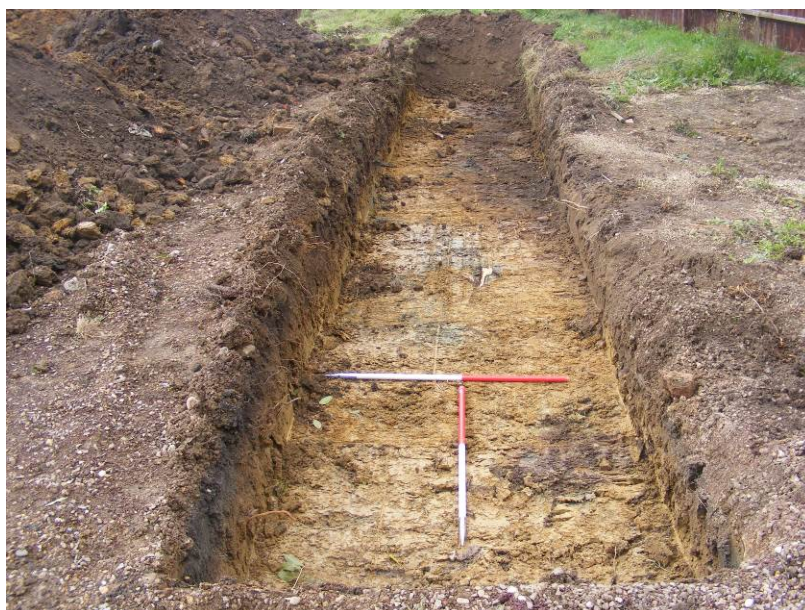
Fig 7

Trench 1, looking west

Trench No.	Length, width & alignment		Surface height, NW end (aOD)	Depth & height of natural (aOD)
1	W-N 1.6m x 10m		142.57m	0.60 – 0.80m 141.77m
<i>Context</i>	<i>Context type</i>	<i>Description</i>	<i>Dimensions</i>	<i>Artefacts/ Samples</i>
101	Made layer	Gravel (driveway)	0.10-15m thick	-
102	Made layer	Firm black silty clay. Moderate brick inclusions. Visible for c 4m from east end of trench	0.15m thick	-
103	Buried/deposited topsoil	Friable grey clayey-silt. Root disturbance throughout and moderate brick inclusions.	0.25-0.55m thick	-
104	Made layer	Firm black silty clay. Moderate small stone inclusions. Visible for c 3m in centre of trench.	0.30m	-
105	Natural	Friable-firm yellow-brown clay with moderate small stone and pebble inclusions.	-	-
106	Made layer	Firm dark grey clayey silt containing modern debris i.e. brick, glass, charcoal, tile, metal fragments etc. Abuts natural, used to negate slope/create more space.	-	-

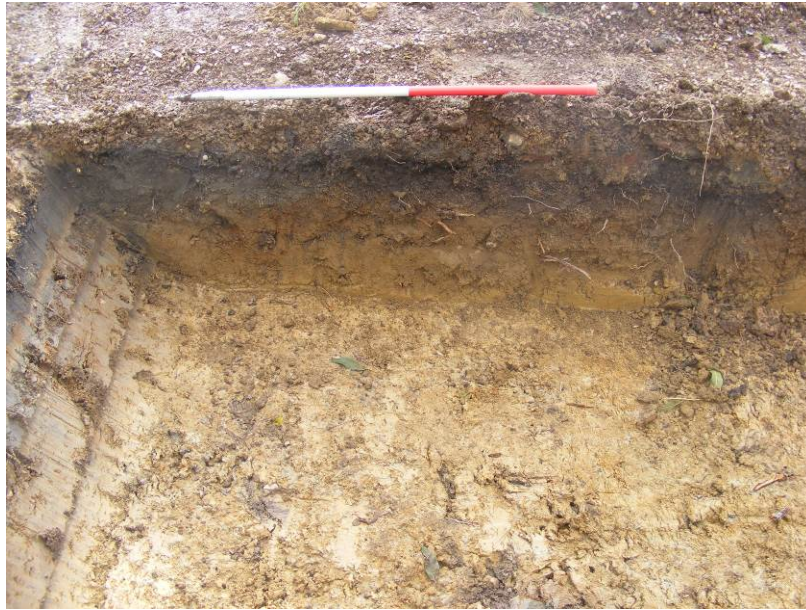
Trench 1 representative section, looking north Fig 8

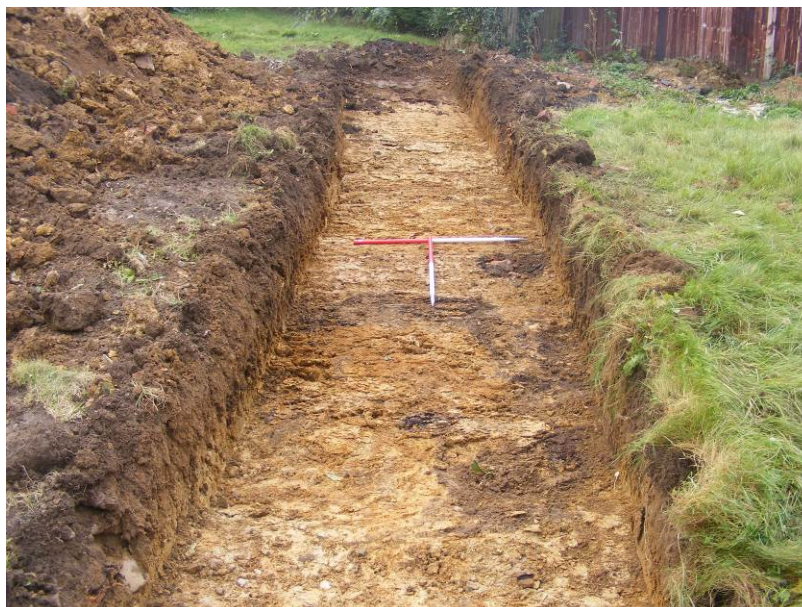
Trench 2, looking north-east Fig 9
