**Archaeological observation, investigation
and recording for remediation
works at the former gasworks site
Towcester Road, Northampton
July-September 2014**

Report No. 14/208

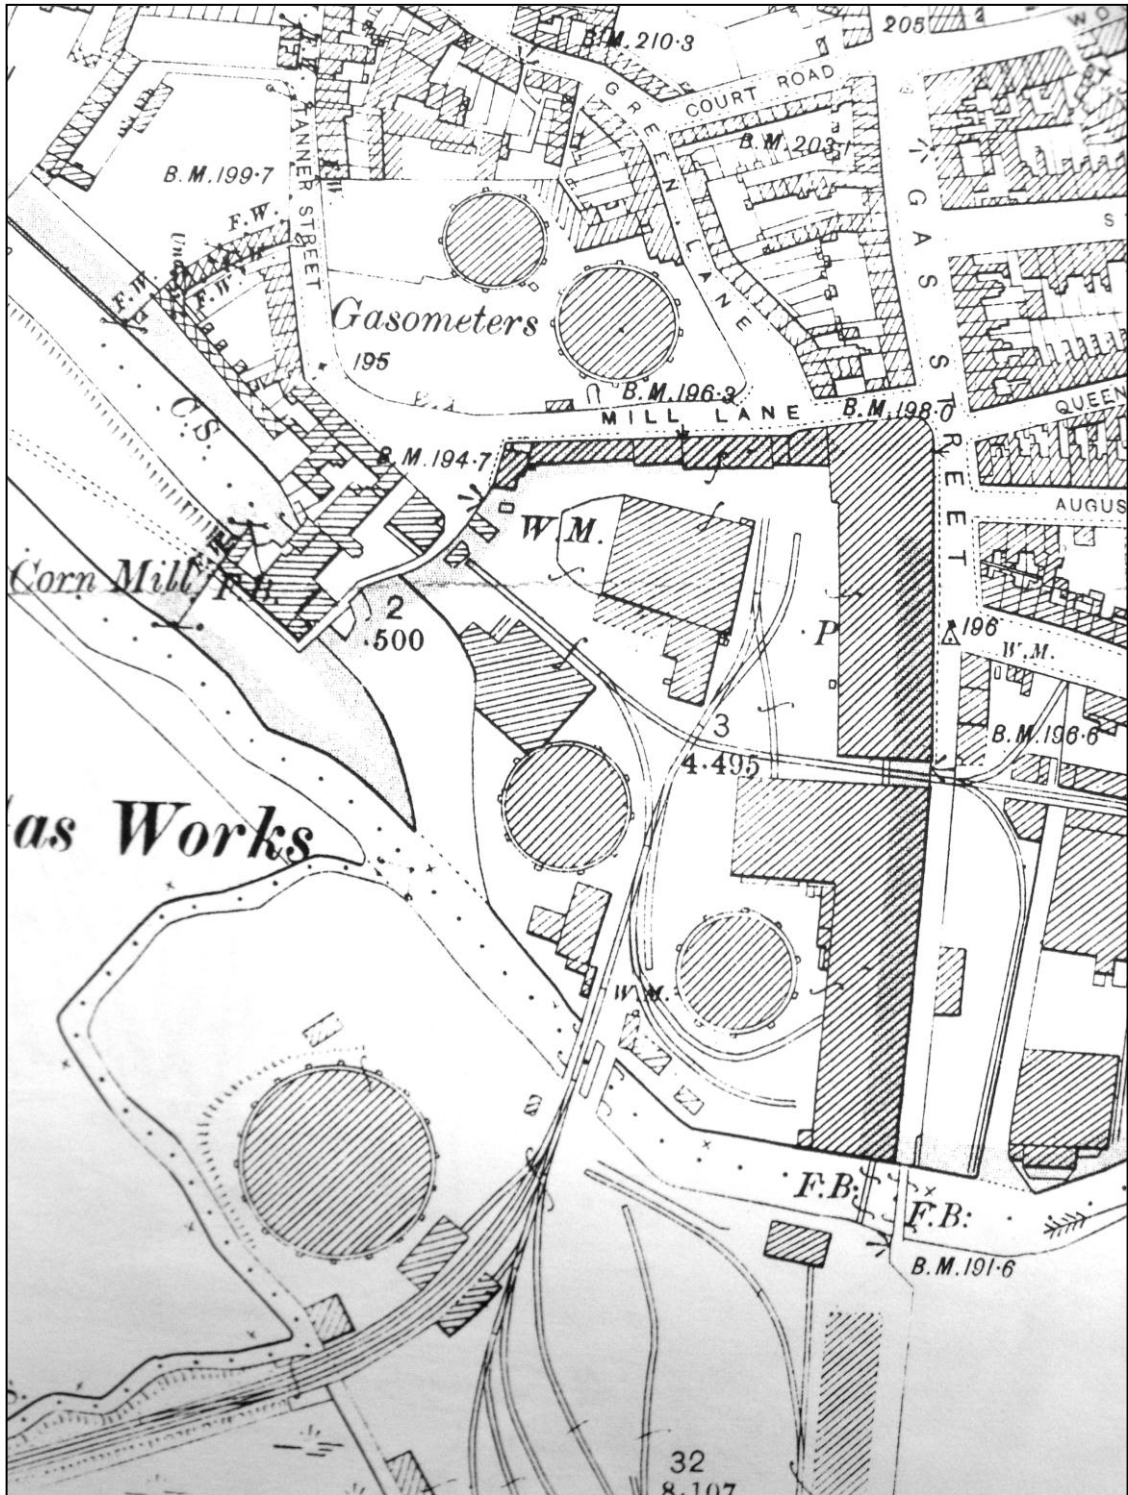
Ordnance Survey map, 1901 Fig 5

By 1901 minor additions had been made to the works (Fig 5). Some buildings were expanded and modified, and a further gasholder and workshop were constructed south of the river, together with extension of the rail network to include an area of sidings, which was rapidly developed during the war years (Fig 6).

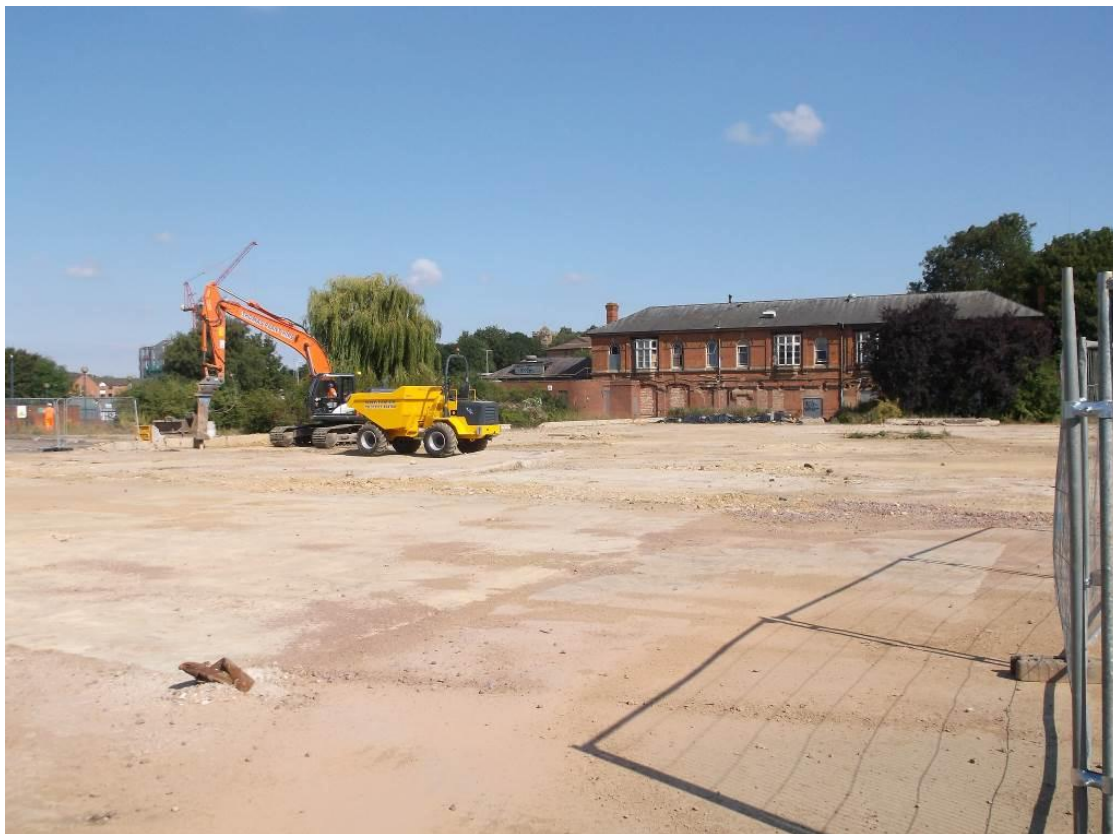
Concrete slab, extant gas building and willow tree, looking north-west Fig 8

The fieldwork was undertaken to monitor the deposits encountered in targeted areas during the mechanical removal and decontamination of soils for the remediation works at the former gas works. A large area to the centre north of the site was cleared of reinforced concrete slab and beams, which were the foundation layers of the former service buildings from the 1980s onwards (Fig 8).

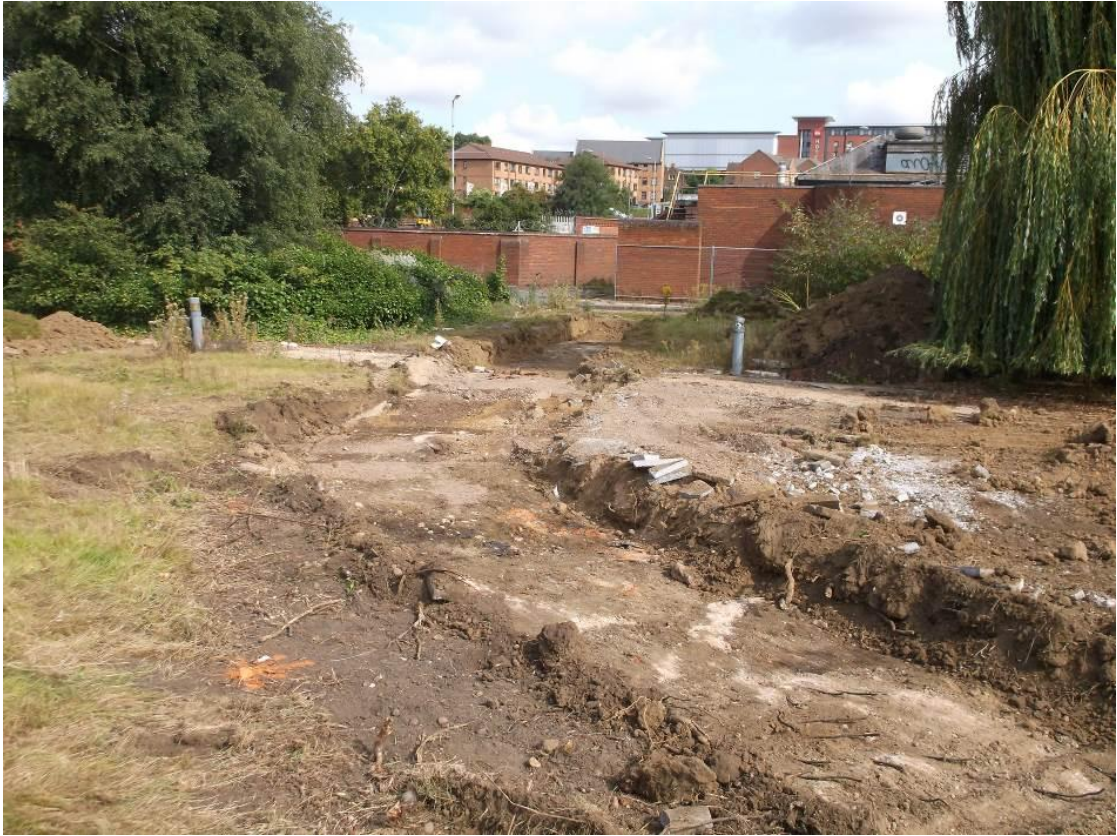
Curved exploration trench, looking north-west Fig 10

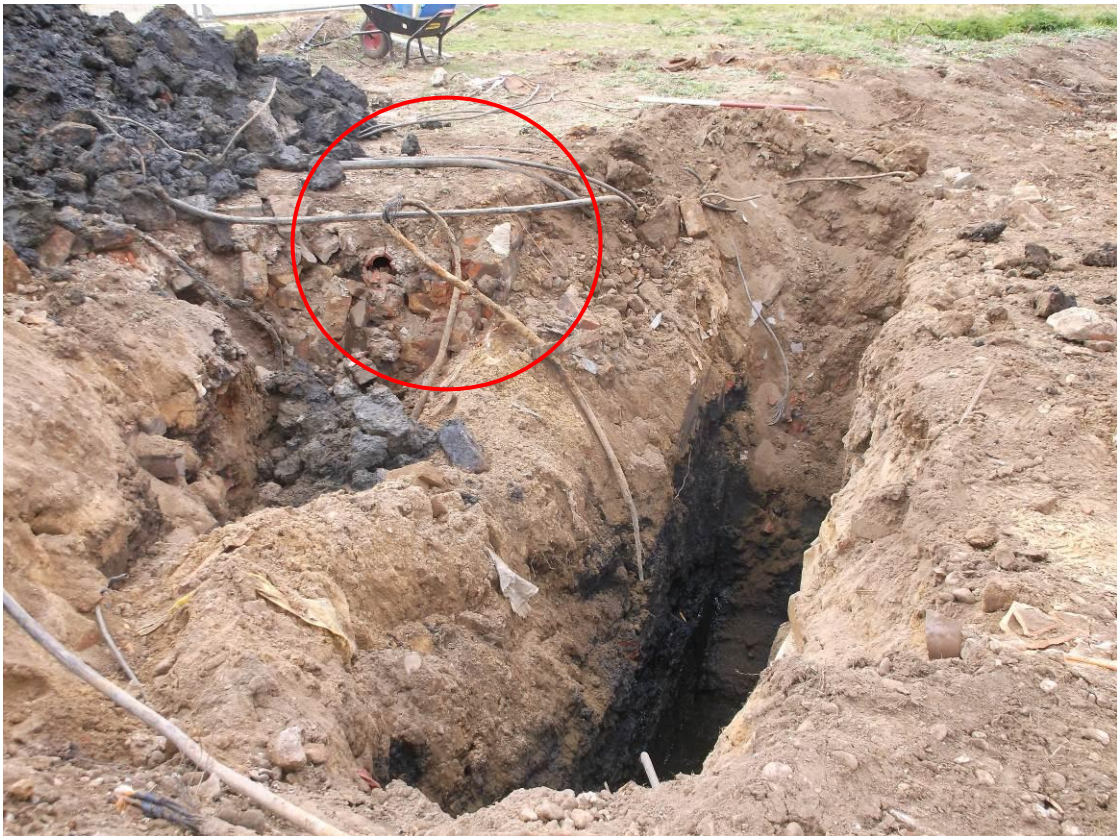
TP5, a brick corner foundation, looking west Fig 11

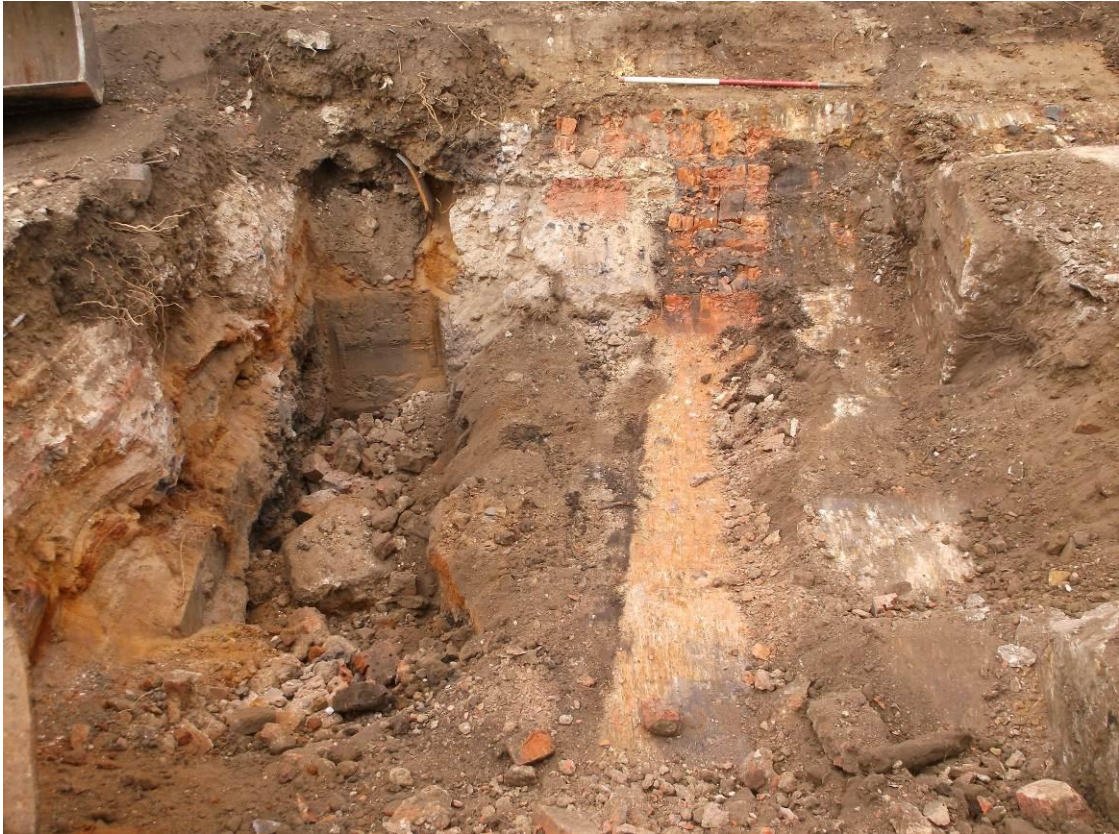
TP9, brick wall aligned north-south, looking north Fig 12

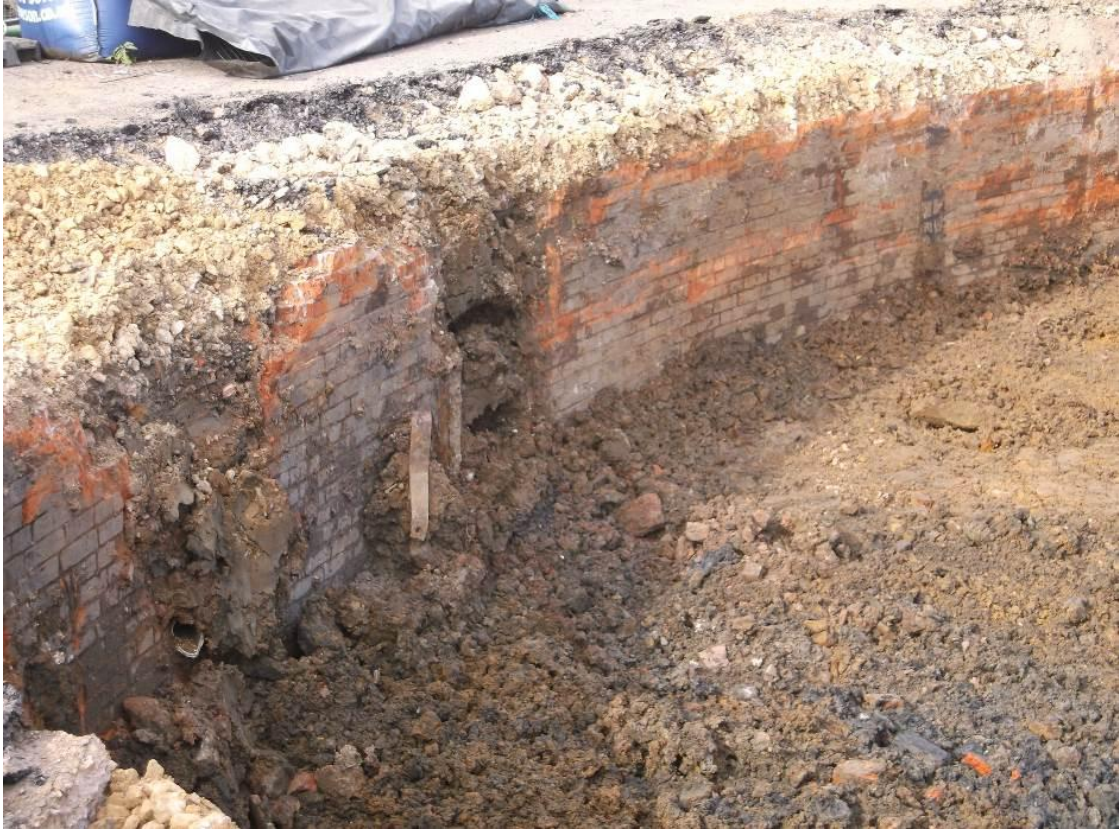
To the north of the River Nene was the site of Gasholder 2, the earliest plan of which is the 1884 Ordnance Survey (Fig 4). The interior of the brick gasholder were identified and recorded during remediation work. The red brick wall circumference was c30.0m in diameter and went deeper than the 5.0m that was exposed (Fig 13). The width of the wall was c0.57m or two bricks lengthways across the wall.

Gasholder 2, interior brickwork, looking north Fig 13

The wall was constructed of flat red brick with 18 round holes, using a variation on an English Cross Bond with cement. Faint lines on the interior of the brickwork suggest the positions of vertical metal pipes at regular intervals, which brought the gas into the gasholder during use.

The base of the gasholder was not exposed; however, black tar deposits were present c3.0m below the ground surface. Various modern services and the concrete slab had truncated the foundation wall.

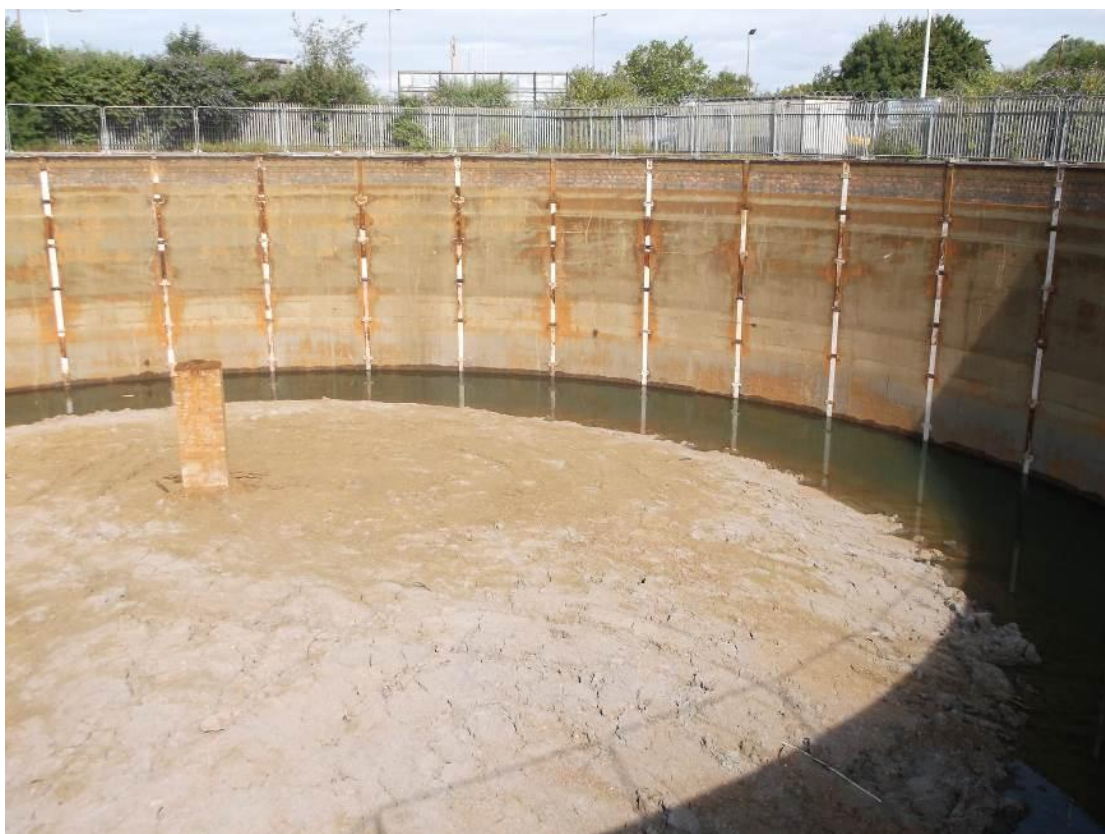
The main gasholder on the site was demolished immediately prior to the remediation work. The gasholder stood as a notable landmark in the centre of Northampton, immediately adjacent to Towcester Road. At the time of recording the whole of the superstructure had been removed and the tank below ground level had been fenced (Fig 14). The gasholder was 45.0m in diameter and a little over 6.0m deep. The base of the tank had been lined with clay to provide an impermeable seal. The sides of the tank were constructed of red brick using a variation on the English Cross Bond, held together with coarse grey cement mortar. The marks left behind by the steel frame of the superstructure could still be seen. The tank has now been backfilled.

Gasholder 5 interior, looking north-west Fig 14
