**Heritage Asset Assessment at
8 Halls Lane, Brackley
Northamptonshire
November 2014**

Report No. 14/234

MOLA carried out a heritage assessment at 8 Halls Lane, Brackley as part of pre-planning requirements ahead of a proposed re-development of buildings on the site. The survey area comprised three adjoining structures of a mid-18th century origin which were historically associated with the Crown Inn, formerly serving as stabling, coach houses or barns. For much of the 20th century, the site has functioned as a greengrocers with the first floors having latterly been converted into flats.

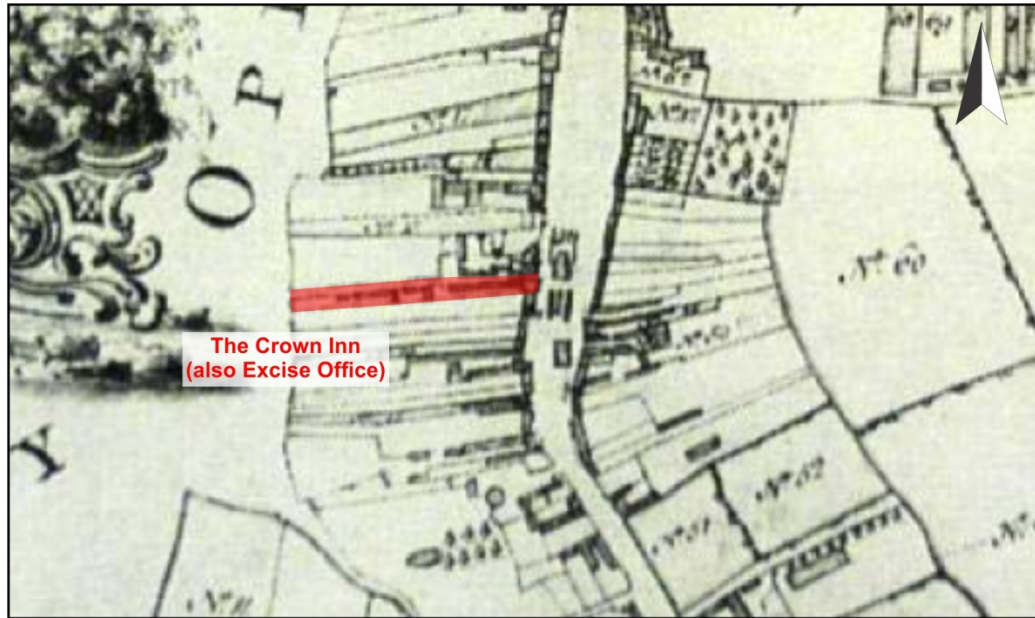
Plan of the estates belonging to Magdalen College, 1760 Fig 2

One of the earliest available maps of Brackley obtained during this assessment is a map of 1760 showing the *Estates belonging to Magdalen College at Brackley* (Fig 2). This map shows the full extent of the town of Brackley at this time as well as assigning ownership to the various parcels of land. The Crown Inn / Hotel and its associated outbuildings can be seen, contained within the narrow Burgage plot of the property. Unfortunately, a high resolution version of this map could not be obtained so it was not possible to make out the detail of the buildings, however, it can be seen that a long row of small structures mark the north edge of the property with a lane running adjacent to the them. A mid-18th century date of construction does appear to be likely for these structures and similar arrangements of buildings within the long, narrow Burgage plots can be seen within the historic core of Brackley. It is likely that at this time, the row of buildings of which 8 Halls Lane are a part, were in use as coach houses and stabling for the Inn. Another map of Brackley dating to 1760

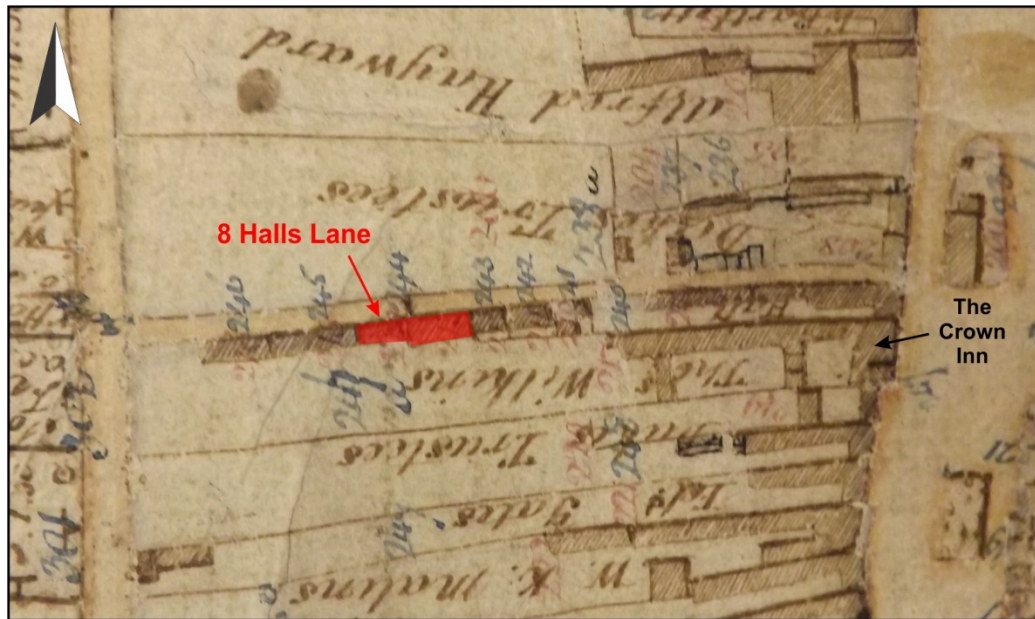
Draft Inclosure map of Brackley, 1830 Fig 4

The draft Inclosure map of 1830 shows the Crown Inn and associated structures, including 8 Halls Lane, to still be part of the same property, under the ownership of Thomas Wilkins (Fig 4).

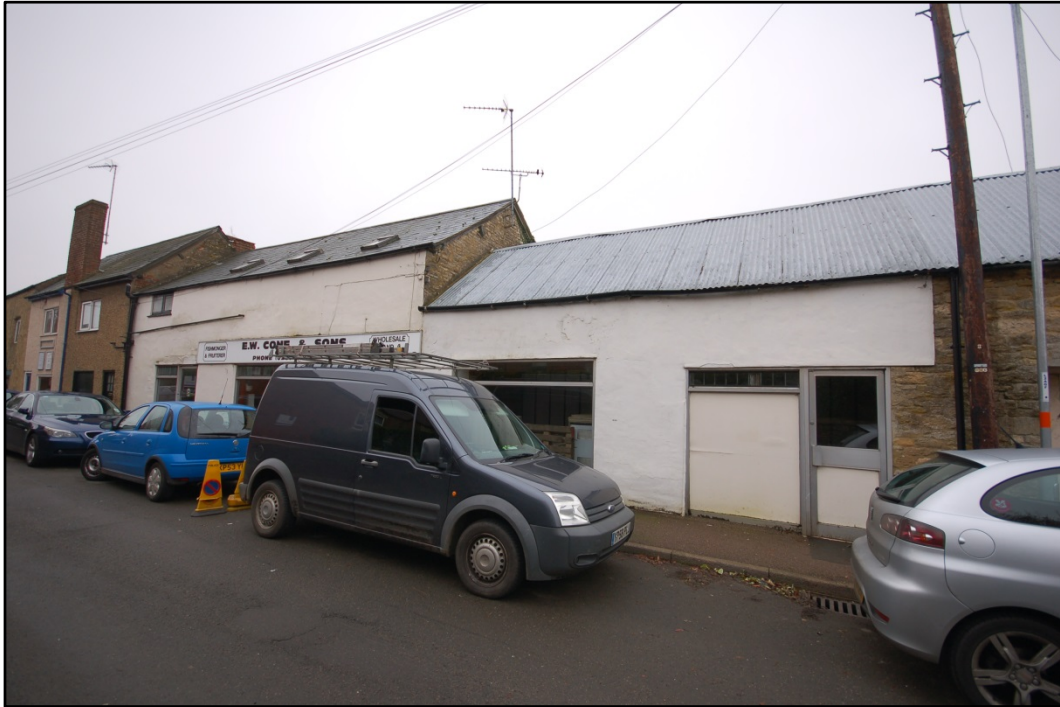
The western and central buildings of the site, looking south Fig 10

The site comprises three adjoining structures, the westernmost being a single storey structure constructed of coursed limestone rubble (Fig 10). It is a subdivision of a continuous range of buildings that run from the site to Manor Road at the west (Fig 13). These buildings likely formerly served as coach houses and stabling for the Crown Inn until the mid – late 19th century when they were sold and converted into other functions including workshops, blacksmith, stores and retail. The whole range was re-roofed with corrugated iron sheets which have subsequently been re-clad in places as the original sheets rusted or corroded. The surveyed building has been entirely re-roofed with modern corrugated sheeting. It is likely that this form of roof has been in place since the mid – late 19th century, perhaps contemporary with the selling of the buildings from the Crown Hotel. Latterly, this building functioned as an office for the grocery and housed a staff toilet, welfare facilities and store room (Fig 9). Internally, the original stone wall is hidden behind light stud partitions and the roof is obscured by a ceiling of suspended panels hung from the ceiling joists (Fig 19). Above the suspended ceiling, it can be seen that the roof structure is of machine sawn pine trusses. A large portion of the original north wall including the original door and window openings have been lost with the insertion of new door and window openings and the wall has been rendered externally. No fixtures or fittings relating to an earlier function of the building are evident.

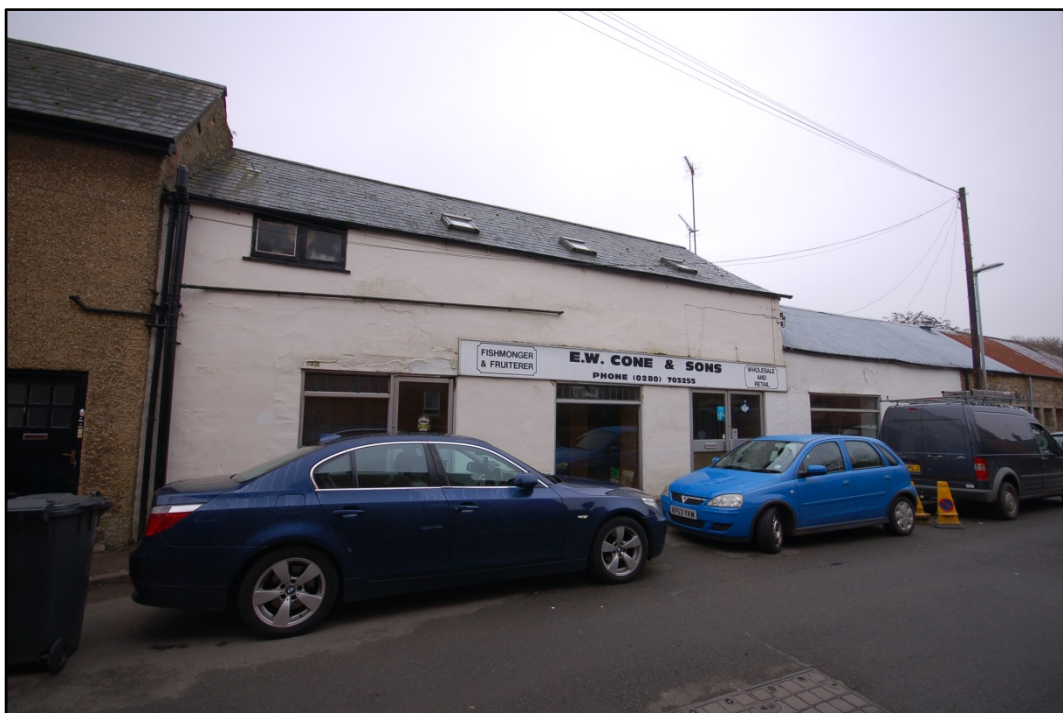
The central building, looking south-west Fig 11

The central building housed the former retail unit at ground floor and is a two storey structure with gabled roof aligned east-west, fronting onto Halls Lane (Fig 11). It too is rendered externally at the north and is constructed of coursed limestone rubble. Two large window openings and a double doorway are present at ground floor level in the north wall and a small two light casement with obscure glass is at first floor, looking north. The south facing wall is plain with no door or window openings and no obvious blockings. Internally, at ground floor, modern stud partitions hide the original walls and there is a ceiling of suspended panels (Fig 20). The floor is of modern PVC tiles over concrete. No original fixtures or fittings were evident within this room. At first floor the space is entirely of a modern date with stud partitions separating the various rooms including bathroom, kitchen, bedroom and living room (Figs 9 & 23). A modern lath and plaster ceiling hides a roof structure of machine sawn pine, a replacement of an earlier roof structure. Externally, the roof is of modern slate tiles and has three small roof lights opening into the first floor rooms (Fig 11). Access to the first floor is via the adjacent, eastern building (Fig 9). It is possible that this structure was originally a single storey barn, open to the roof which later had a floor inserted.

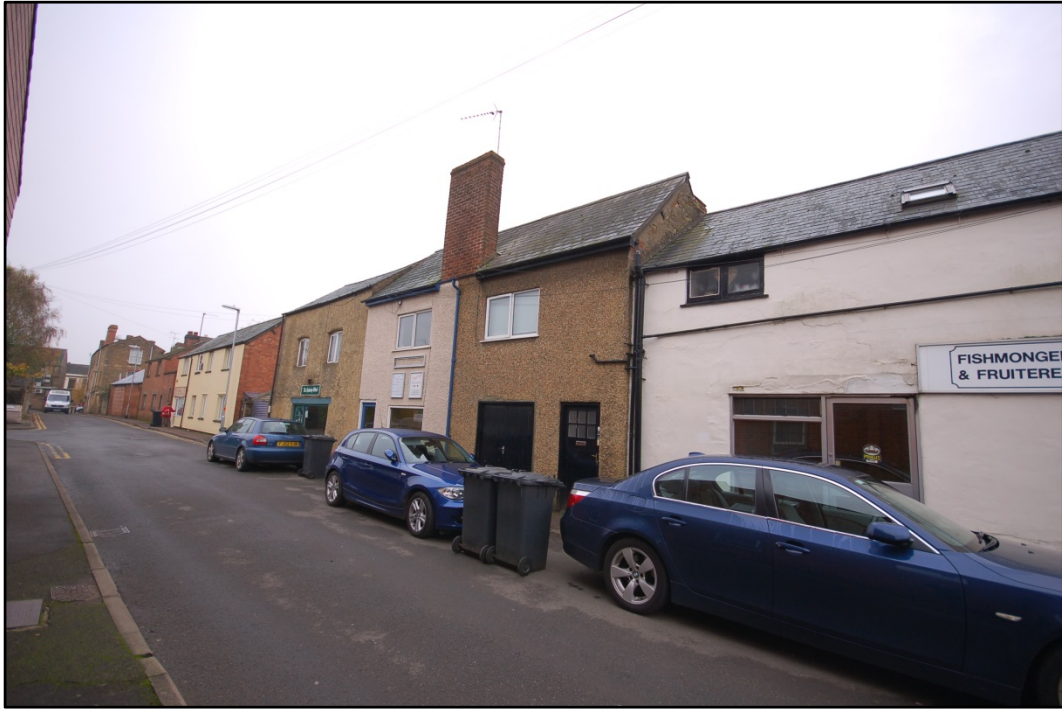
The central and eastern buildings, looking south Fig 12

Farthest east, the property incorporates the western half of a single building which has been divided centrally (Figs 9 & 12). The external, north elevation has modern pebble dash render. The west gable shows that the original fabric of the building is coursed limestone rubble. A patch of modern red brick can be seen in the space between the roof line and the roof of the adjacent building. Central to the building, a chimney breast rises above the roof line, flush with the north wall. At ground floor, a modern door is flanked by a double door and above these is a single modern double glazed window. It is unclear if these occupy original openings or if they are later insertions. The door opens into a hall with stair which allows access to flat over the adjacent greengrocers and also a small first floor flat with a single bedroom with en-suite bathroom and a combined living room and kitchen. The living room is located north of the bedroom and is within the original footprint of the building whilst the bedroom and bathroom is within a modern extension to the rear of the building. A black painted, chamfered timber beam is aligned north-south and spans the living room, off centre to the room (Fig 22). It is likely that this is an original beam and

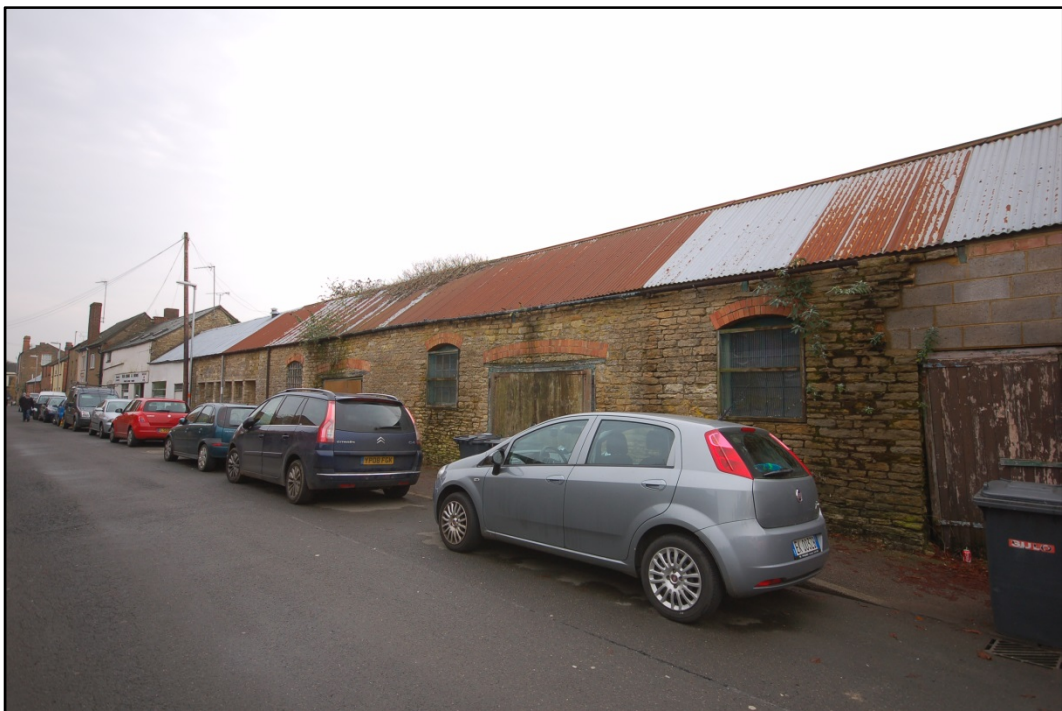
The linear range of 18th-century former coach houses and stables, looking south
Fig 13

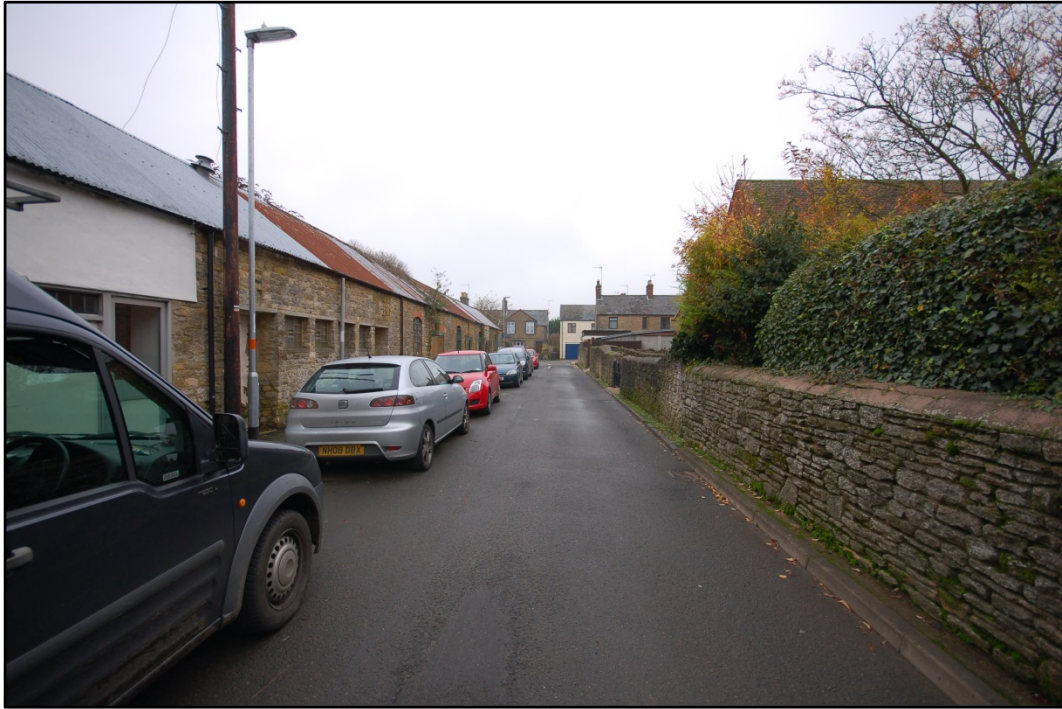
General view along Halls Lane, looking west Fig 14

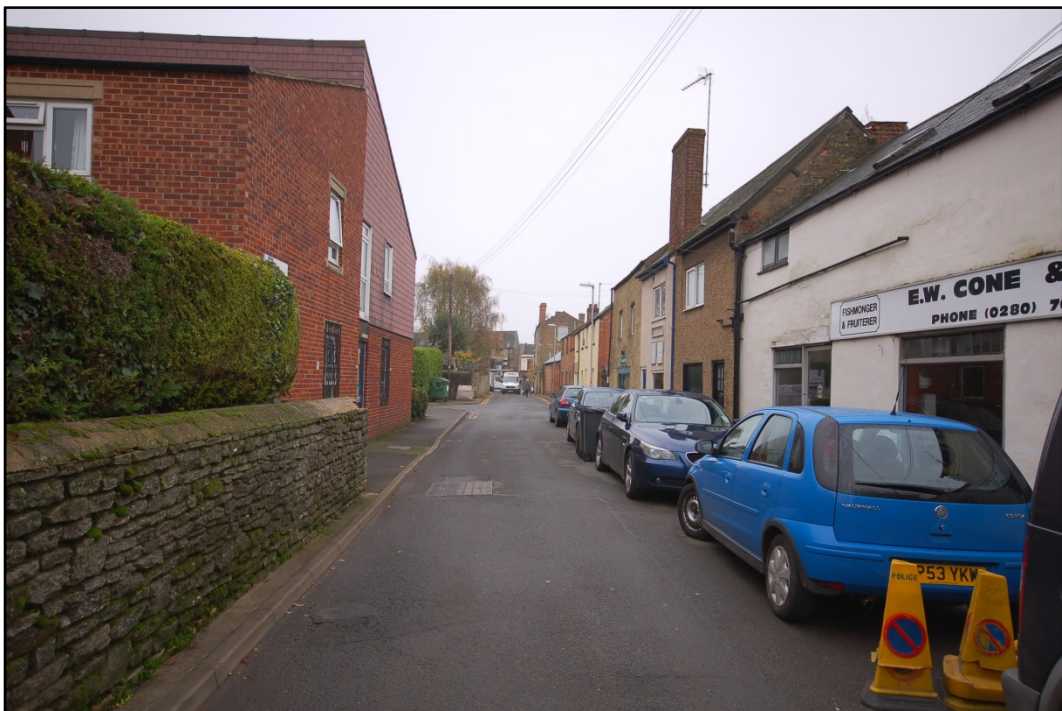
General view along Halls Lane, looking east Fig 15

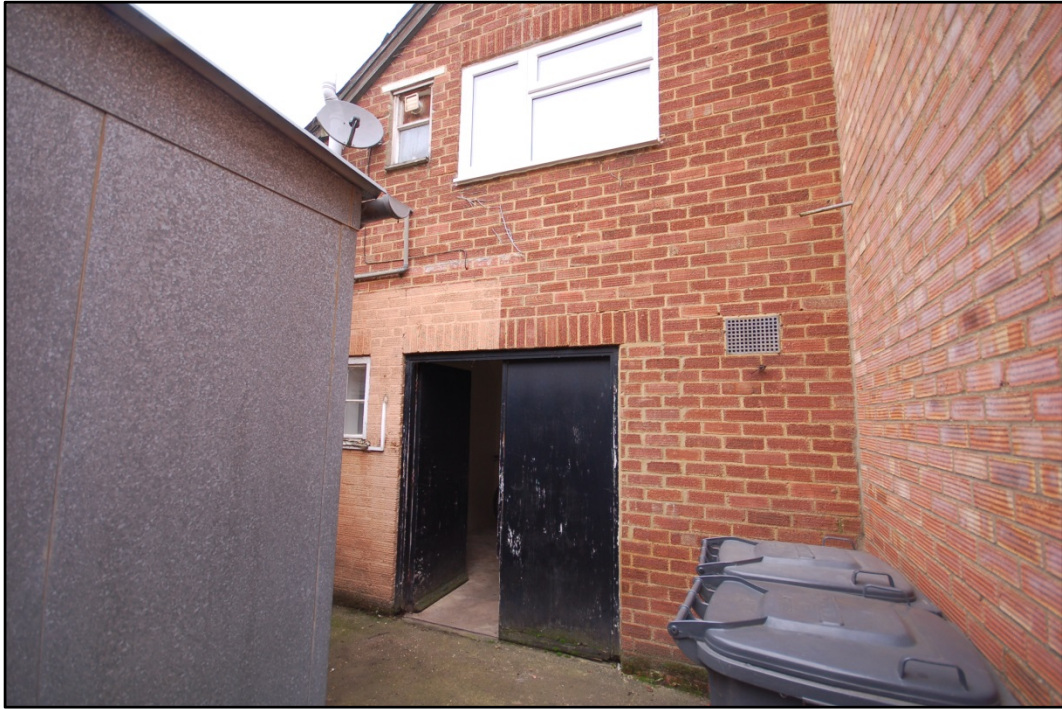
The modern brick extension and yard to the rear of the site Fig 16

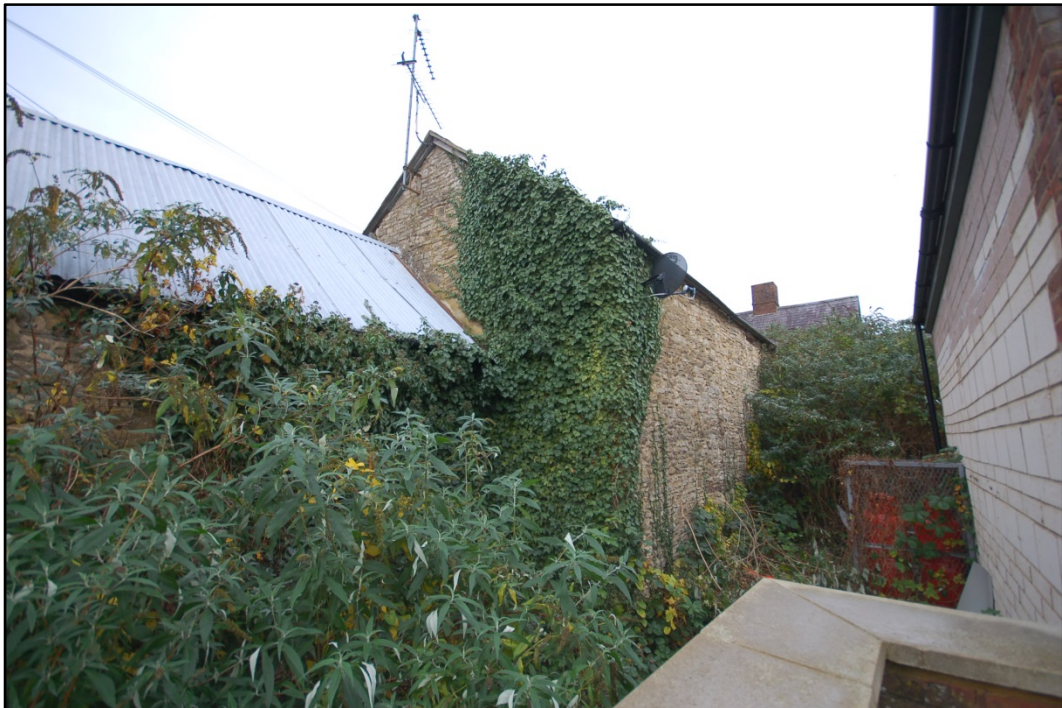
The western and central buildings, looking north-east Fig 17

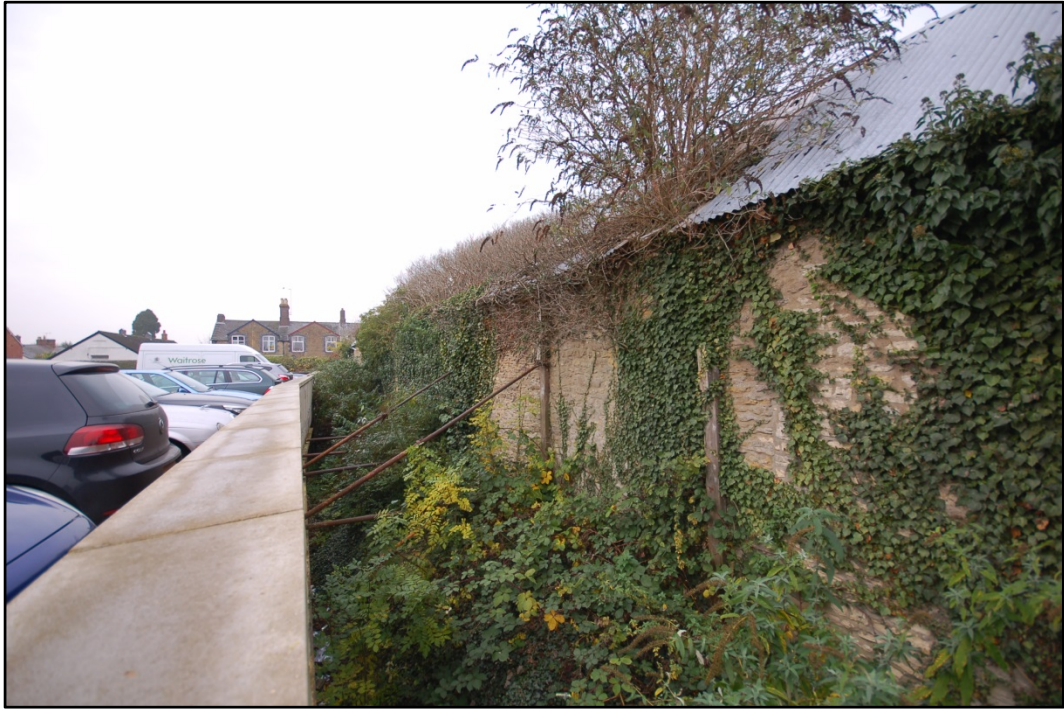
The rear of the linear range, showing modern steel props and the damage caused by vegetation Fig 18

When using the above criteria for assessing the condition of the site, it is clear that the condition of the buildings can be described as good or fair. The south of the site is most at risk where a narrow strip of ground, below the car park ground level is becoming increasingly overgrown with vegetation which is affecting the structure of the buildings (Figs 17 & 18). In some cases, the vegetation can be seen protruding through the corrugated roofs of the buildings. Steel props have been utilised to stabilise the south wall of one the buildings in the range further west of the site (Fig 18). As the buildings here share a common south wall, this deterioration of the range may eventually impact upon the site.

The buildings can be considered to be of medium significance within their wider context, in which they form part of the character of the area. The site has already been subject to conversion away from its former use and does not appear to retain any fixtures or fittings of historic value. The buildings would benefit from the clearance of vegetation to the south of the site to mitigate future damage to the historic fabric of the structures.

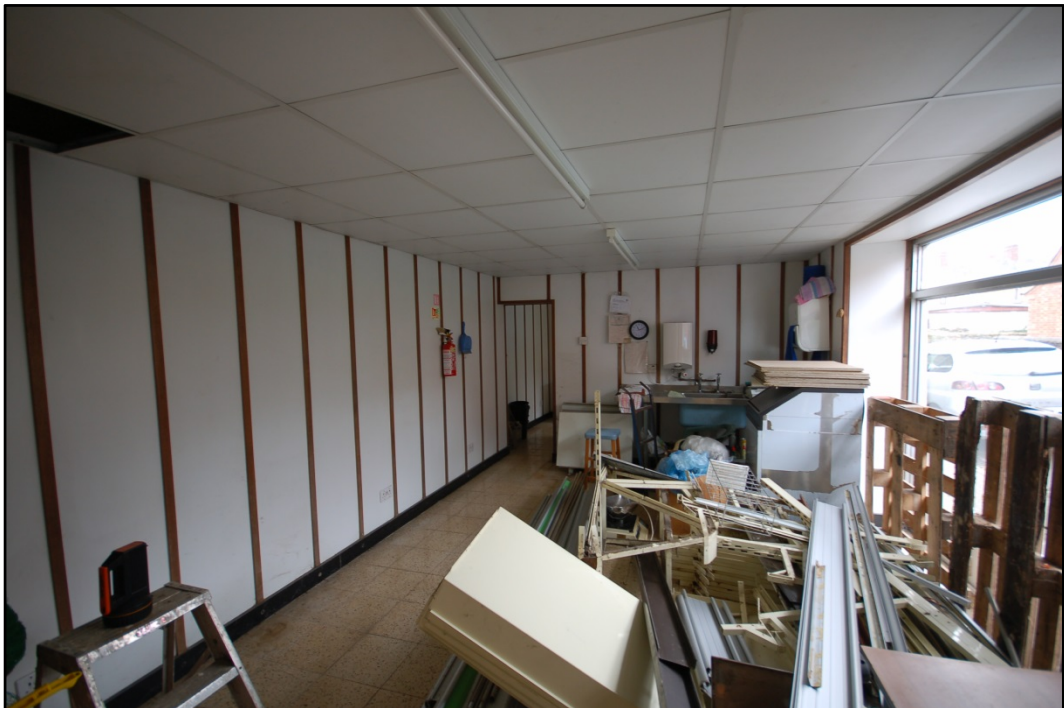
Interior of the western building, looking west Fig 19

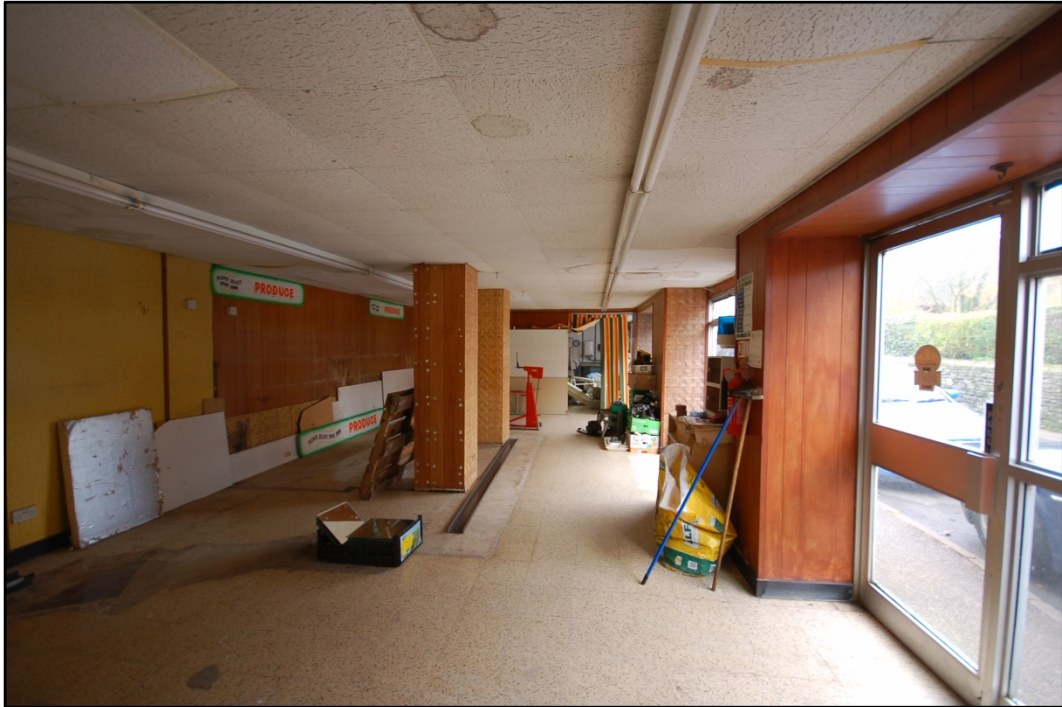
Interior of the central building, the former greengrocers, looking west Fig 20

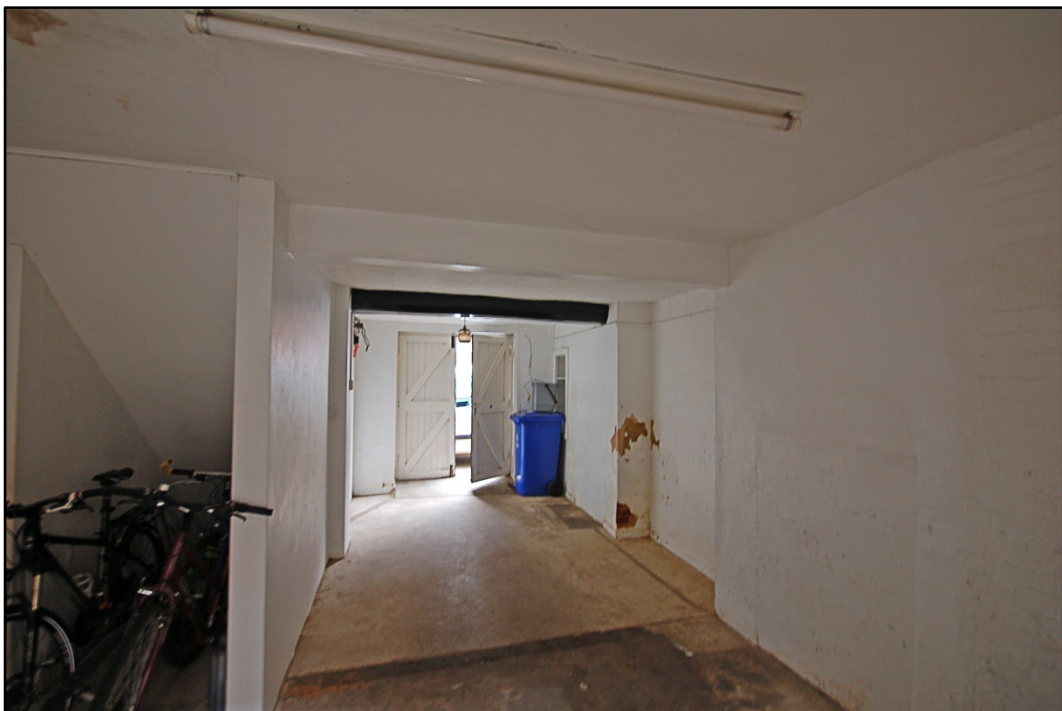
At ground floor, double doors allow entry into an open store room which widens beyond the stairs (Figs 9 & 21). A hearth can be seen in front of a blocked fire opening in a chimney breast in the east wall of the store. A small cupboard has been built into the space between the chimney breast and the north wall. A black painted beam, aligned east – west, is supported at its east end by the chimney and a pilaster adjoining the stair partition. It was unclear whether this is a genuine timber beam or an RSJ boxed in with plaster, designed to feel old. To the south, double doors allow entry from the store to a small yard at the south of the building.

Interior of the store, looking north Fig 21

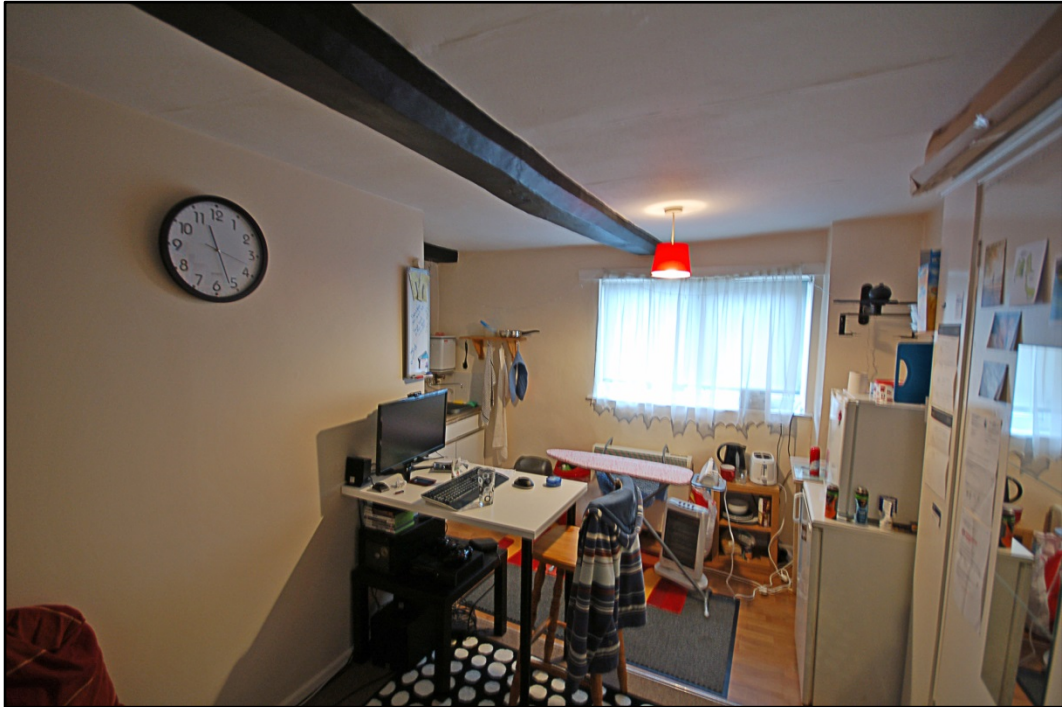
forms the bottom chord of a truss, though the roof space could not be accessed to confirm this.

First floor Living Room / Kitchen with timber beam over, looking north Fig 22

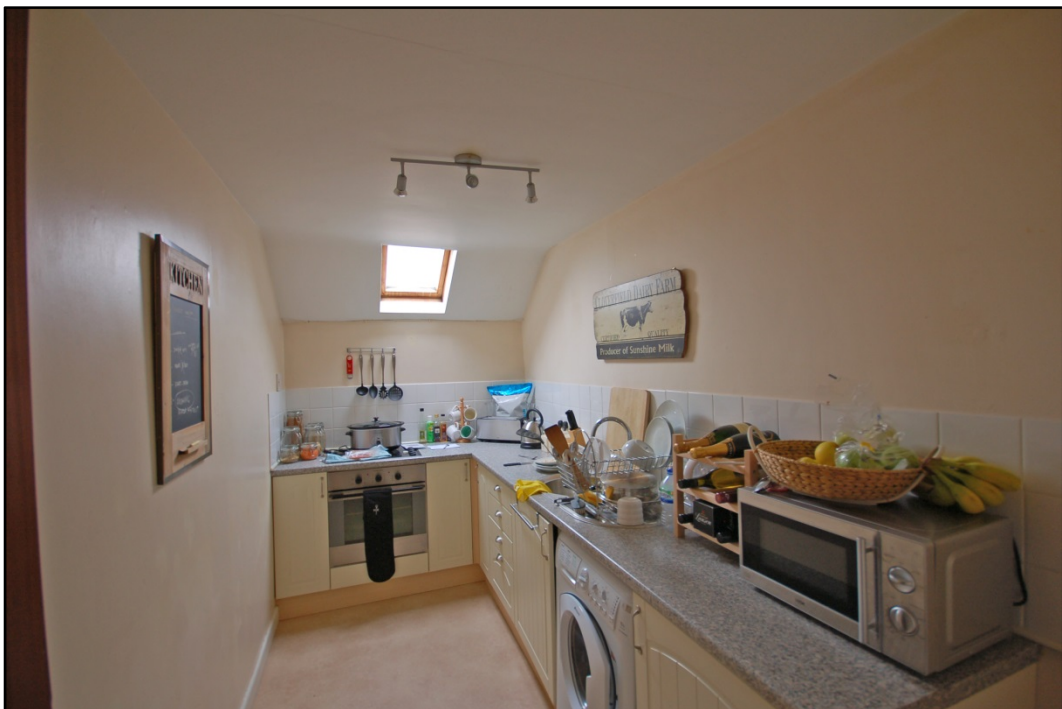
Interior of the flat over the former greengrocers, showing modern fittings Fig 23
