**Archaeological trial trench evaluation on land at
A605, Kings Dyke Crossing, Whittlesey,
Cambridgeshire
October 2014**

Report No. 14/227

Accession number: ECB 4193

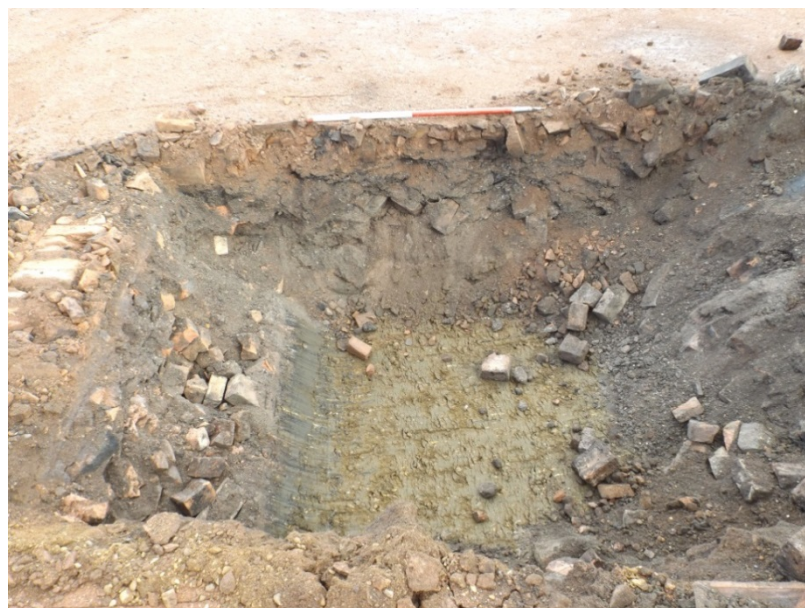
Trench 2, looking south-east Fig 4

Trench 2 was located within an old brick storage yard at the eastern side of the development area. Due to the compaction of the surface only the south-western end of the trench was excavated (Fig 4).

The trench was excavated to a depth of 0.92m and at the base exposed compacted redeposited clay-gravel containing occasional fragments of brick. This was overlain by three make up layers of brick mixed with sandy gravels and clinker. The bricks were all stamped with 'LBC' (London Brick Company) within the 'frog'. The bricks were laid directly on top of each other, with no bonding, in alternating directions. Below this fine ash was mixed with fused and broken brick, probably from one of the local brick kilns. The trench was not excavated further due to the very compacted layers.

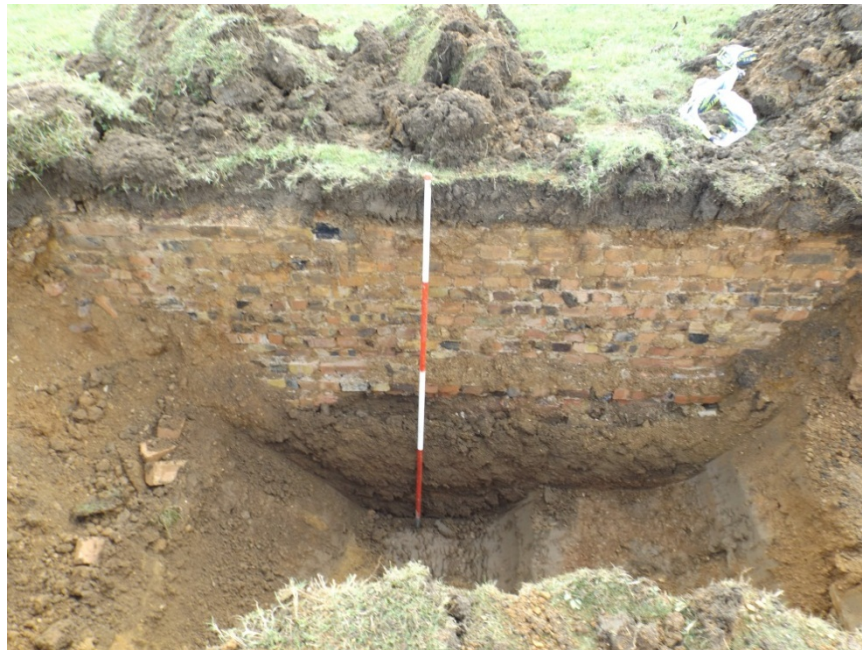
Trench 6, looking south Fig 5

Trenches 3, 4 and 6 were excavated to a depth of 0.90m. The natural clay was encountered at a depth of 2m in a sondage in Trench 6 (Fig 5). It was overlain by re-deposited clay mixed with brick fragments.

The wall foundations in trenches 4 and 6 were built directly on top of the re-deposited clays. The foundations were aligned north-west to south-east and north-east to south-west. The wall was two bricks wide and bonded with a coarse yellow sandy mortar. Trench 4 had an associated salt-glazed drainage and sewerage pipe that were linked to two man-hole inspection chambers. The gaps between the walls were filled with redeposited sands and gravels containing brick fragments, most likely forming a levelling layer.

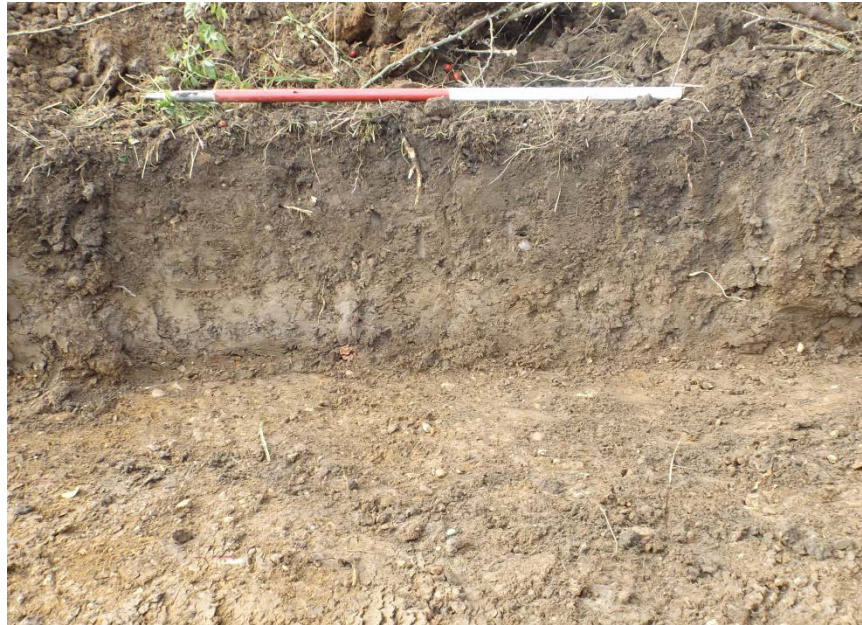
Trench 9, section, looking north Fig 6

Trench 9 was excavated in the south-east of the development, near to the former quarry. The natural substrate was encountered at 0.50m below the modern ground surface and comprised yellow-grey clay with bands of gravels. It was overlain by 0.30m of yellow brown clay-silt subsoil. The topsoil was dark grey-black silty sand (Fig 6). No archaeological features were present.

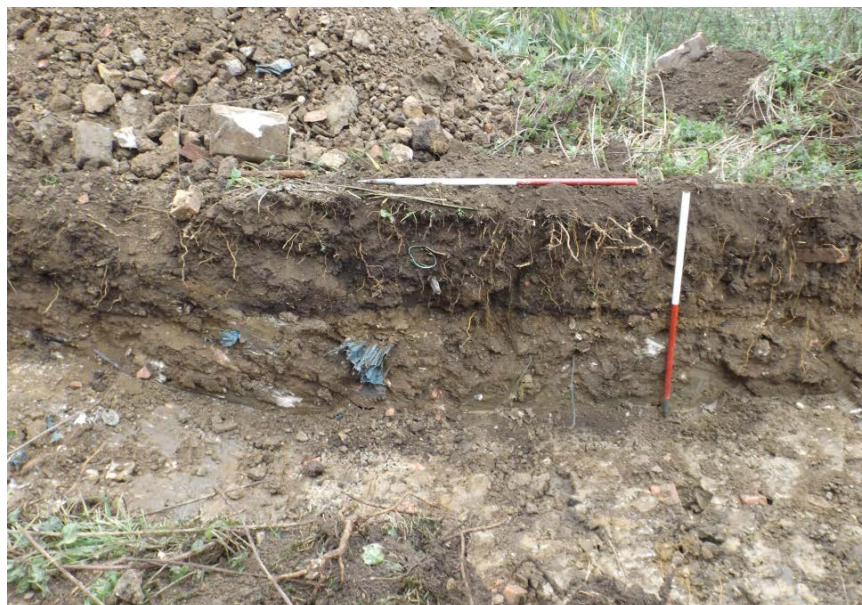
Trench 13, looking north Fig 7

Trenches 10, 13, 14 and 15 were excavated to a depth of 1.00m, except for a sondage in trench 15. The yellow-brown clay and gravel natural was only encountered in trench 14. It was overlain by modern make up layers which contained large amounts of corrugated and pipe lagging asbestos. Due to the presence of the asbestos these trenches were not fully excavated (Fig 7), although it was possible to excavate a sondage at the north-west end of Trench 15.

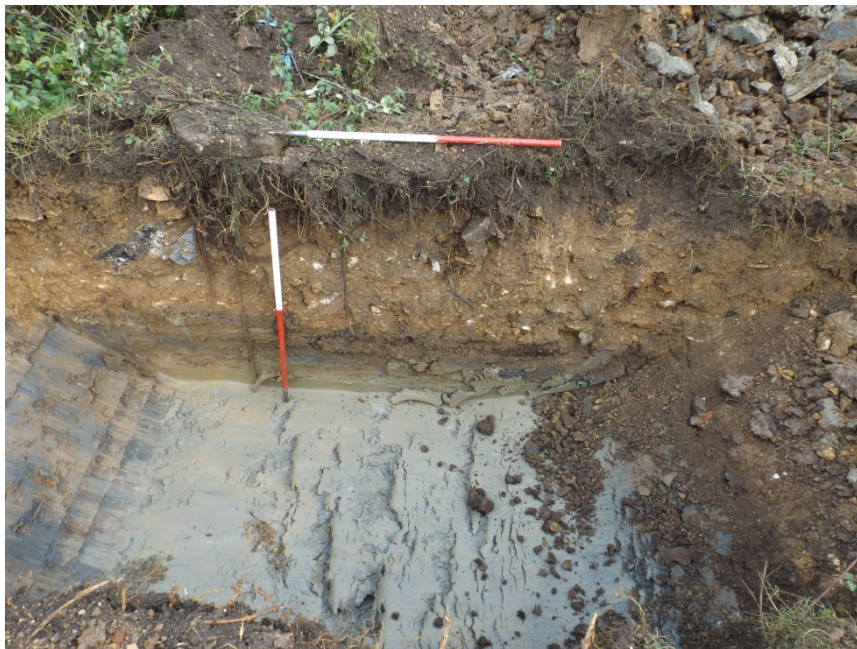
Trench 15, looking north Fig 8

The sondage was excavated as close to the A605 as possible in an attempt to be clear of any contaminated ground to establish the depth of the natural horizon. The natural substrate was encountered at a depth of 1.35m and appeared as clean blue-grey clay (Fig 8).

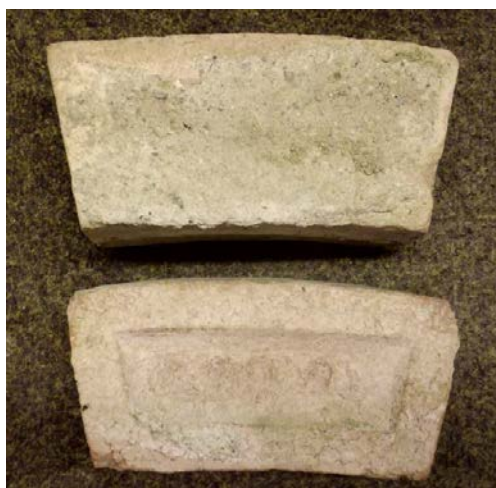
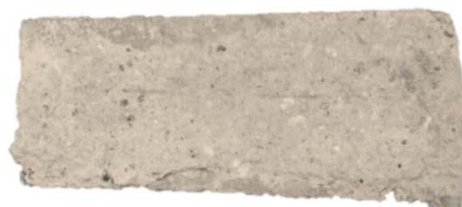
convex header brick, right Fig 9

Four slightly curved bricks are chimney or well stretchers, one with a stamp too damaged to decipher, and there is one convex header which also used in chimney construction (Fig 9; Frost and Boughton 1954, 15, figs 38 and 40). One frog is arrow-headed. These bricks are the remnants from old housing.

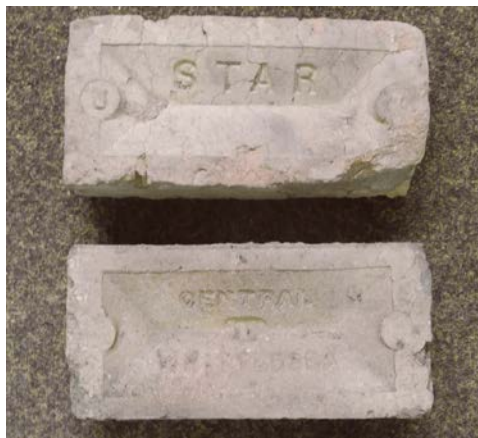
Star and Central Whittlesea bricks Fig 10

Around Dogsthorpe there were two sites, one being the Star Pressed Brick Company which traded from 1899-1914, until it was sold to the Dogsthorpe Star company in 1915 (Fig 10). In 1898 the Whittlesea Central Brick Company was formed and remained an independent company until the 1960s when it was bought by the National Coal Board, then sold in 1973 to the London Brick Company (Fig 10).

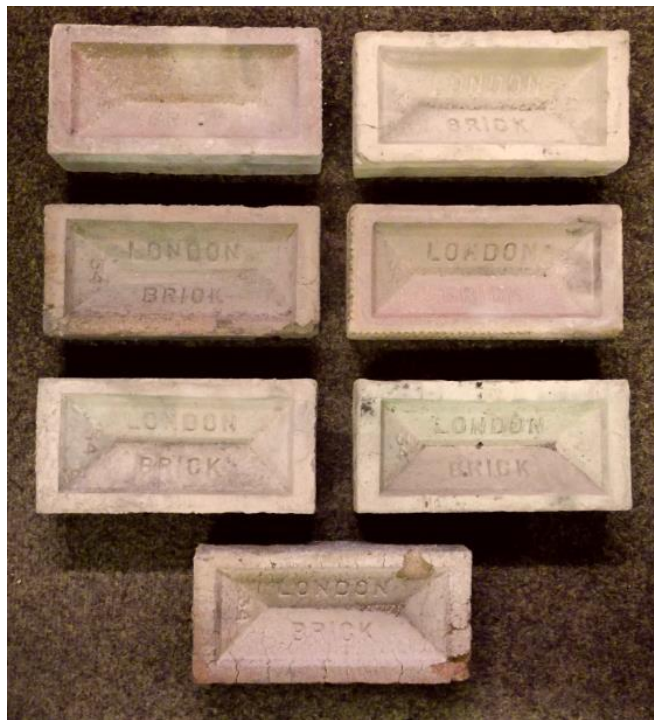
The London bricks Fig 11

The seven bricks with the LONDON BRICK stamp also include reference numbers in the frog; they all have 34 at one end and five have various numbers at the other (see Table 3; Figs 11 and 12). One facing brick has a zigzag rusticated stretcher and header designed in 1923, a type still in use today, another is dimpled on three sides.

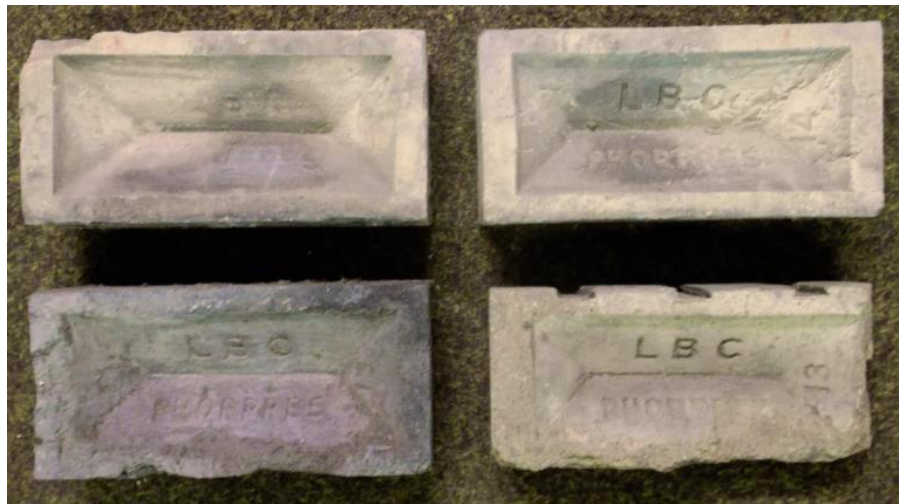
L B C PHORPRES bricks Fig 13

The trade-name Phorpres came about because fletton bricks made in Bedfordshire are pressed twice in each direction so that they are literally 'four pressed', PHORPRES, hence the stamp (www.penmorfa.com/bricks). The four bricks of this type are all

damaged and blackened, three have a stamped number at one end of the frog (Fig 13). These were the London Brick Stewartby works in Bedfordshire. The name is registered in 1926 as a trademark (uk.trademarkdirect.co.uk).

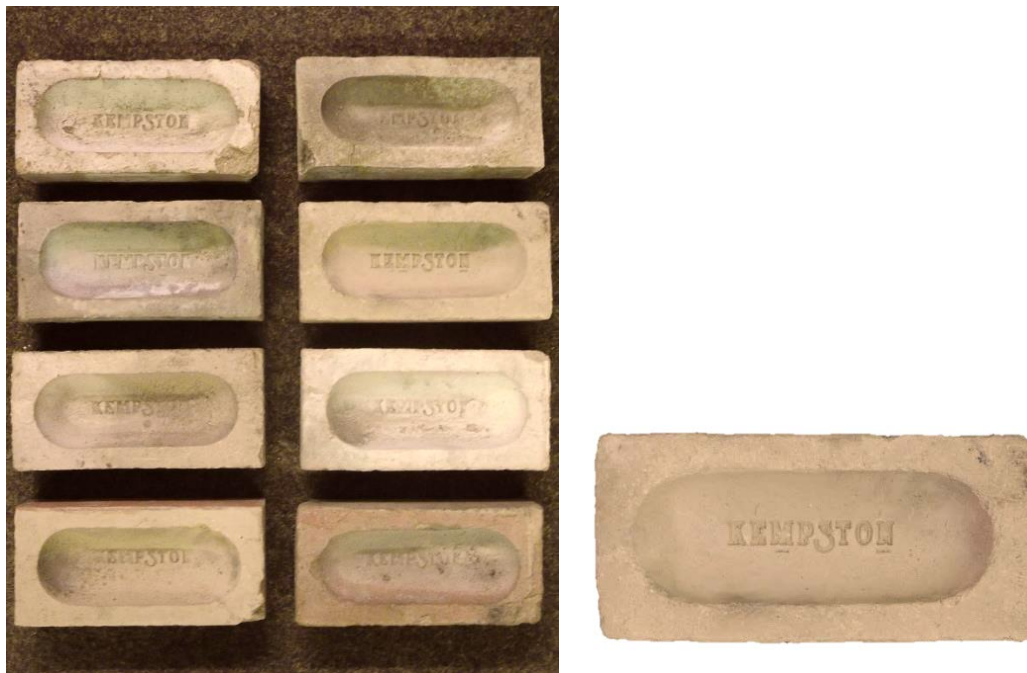
Kempston bricks Fig 14

Kempston in Bedfordshire was another of the early fletton brickworks. When these works were closed some of the bricks were collected and stacked locally near Kings Dyke in case they were required (Fig 14).
