**Archaeological observation, investigation
recording and analysis of land at
Burnham Bungalow, Hemington
Northamptonshire
December 2014**

Report No 14/264

An archaeological observation, investigation, recording and analysis was carried out by MOLA Northampton, during construction works at Burnham Bungalow (formerly Squirrel Cottage), Hemington, Northamptonshire. The one archaeological feature present was a shallow ditch likely to be post-medieval in date.

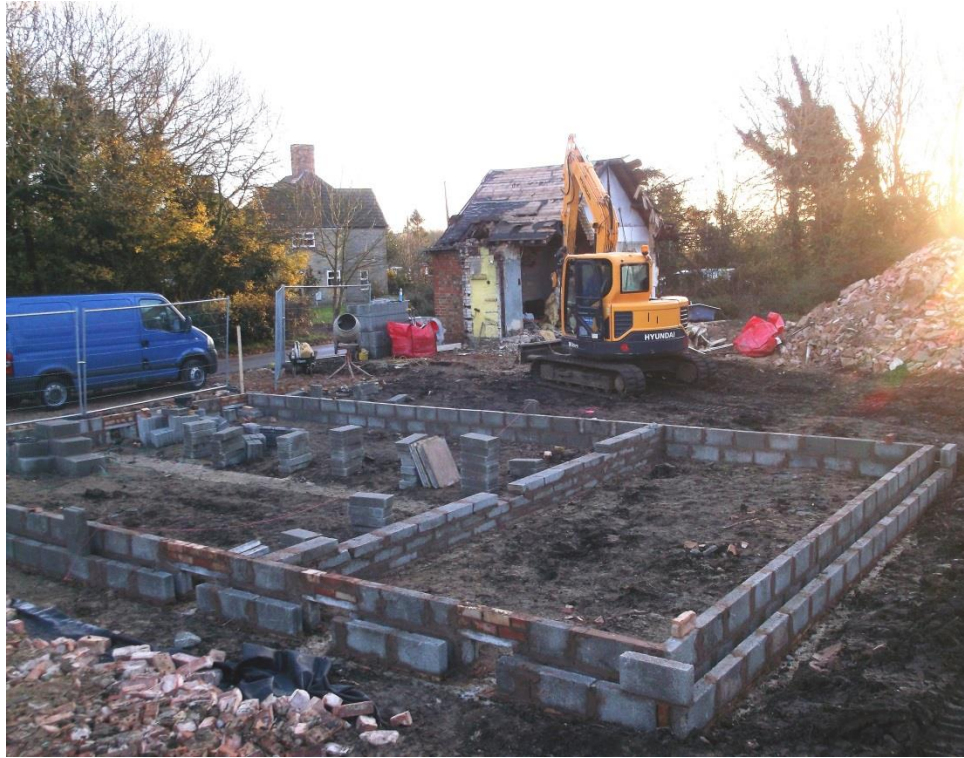
New building foundations with partly-demolished Squirrel Cottage in background looking south-east

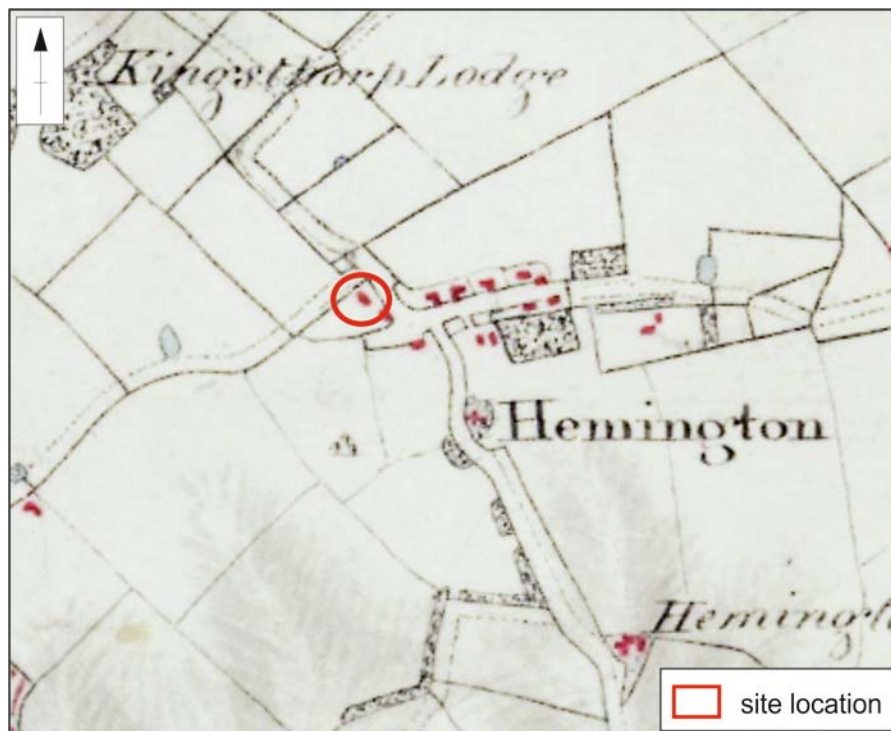
Excerpt from 1810 Ordnance Surveyors map Fig 3

The now-demolished Squirrel Cottage which formed part of the area of investigation was at one time the site of the village smithy. The Ordnance Surveyors map dating from 1810 shows the location of a building within the development area. A later map, the first edition Ordnance Survey, shows a building labelled 'Smithy'. Architectural evidence appeared to demonstrate that originally the building did not have a residential use and at some time, possibly in the early part of the 20th century, it was converted to a bungalow and named Squirrel Cottage.

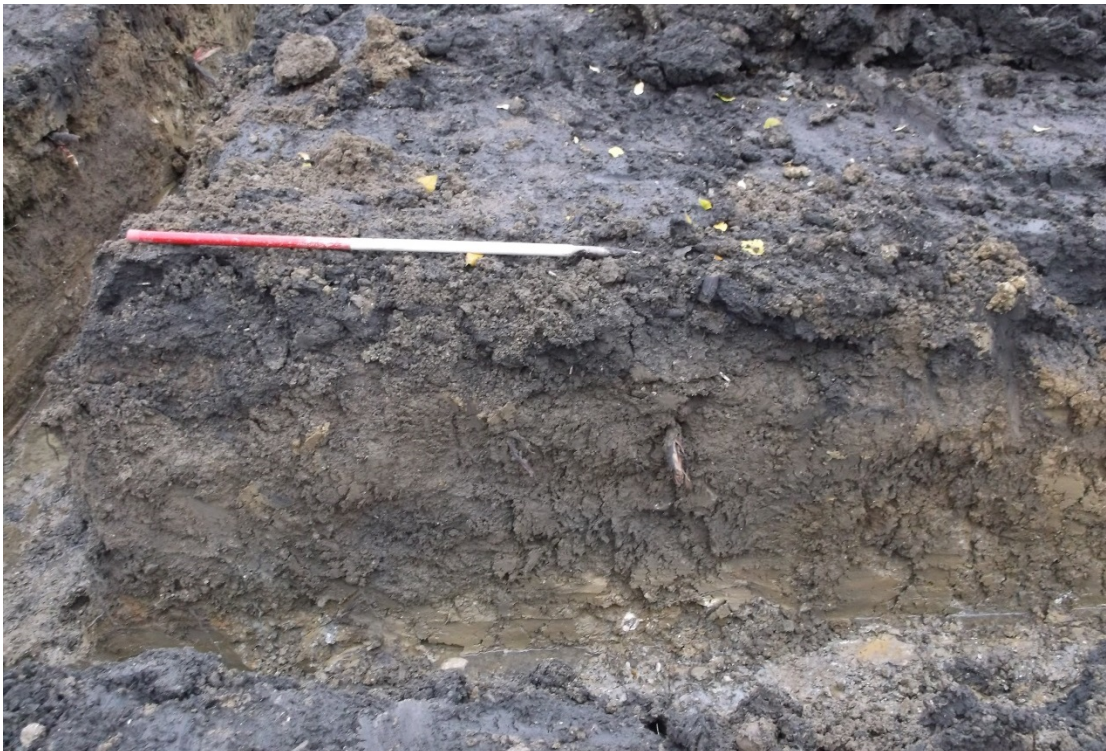
Trench 2, ditch (204), looking south-east Fig 6

A linear ditch [204, 304, 504, 904], likely to be of post-medieval date, was identified during the monitoring of the footings trenches (Figs 4, 5, section 1 and Fig 6). The length of ditch exposed was 12m, aligned north-west to south-east, and approximately 2m wide by 0.50m deep. The ditch contained a fill of grey-brown sandy clay loam with a few small fragments of limestone and coal (203, 303, 503, & 903). Three fragments of clay tobacco-pipe stem were recovered from the fill of this ditch in three separate locations (203, 503 & 903).

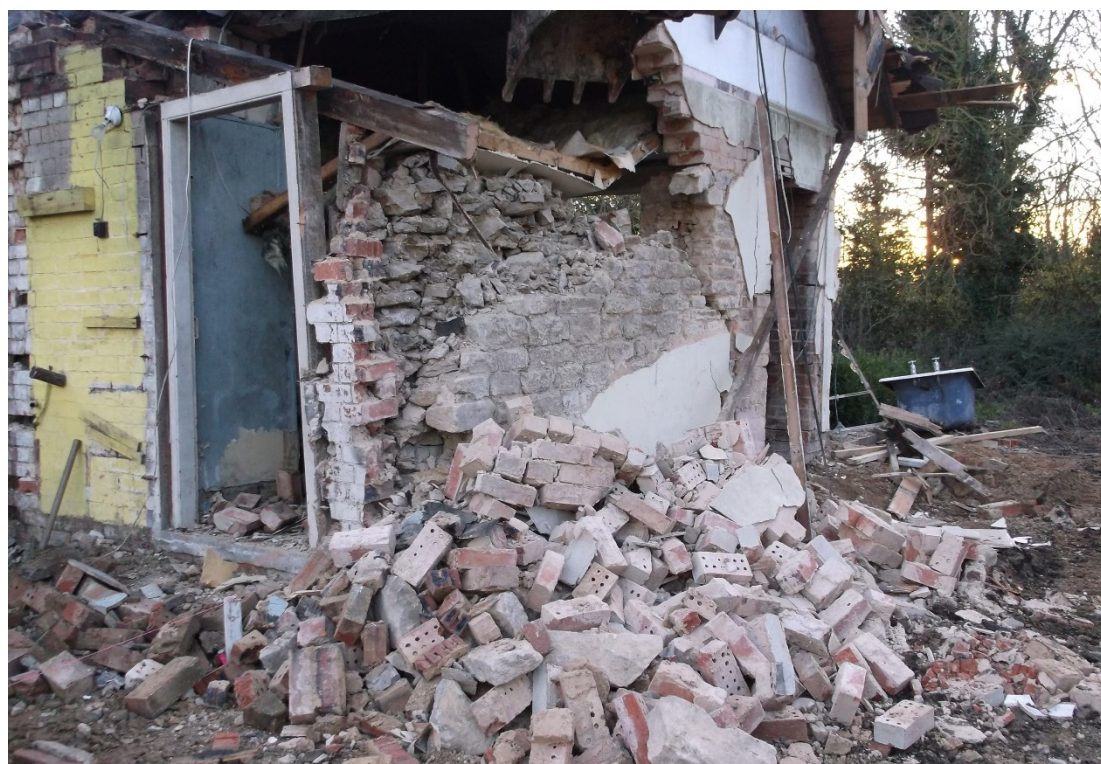
Squirrel Cottage, former external stone wall, looking south-east Fig 9

Following the demolition of the greater part of Squirrel Cottage, the opportunity was taken to examine the structure of the remainder of this building. It was noted that the core of the building consisted a small rectangular structure, approximately 6m long by 4m wide, with mortared limestone rubble walls (Fig 7). The original doorways and windows were edged with bull-nosed bricks which were concealed at a later date when the building was remodelled and extended during its conversion to a bungalow at some time, possibly in the early 20th century (Fig 8).

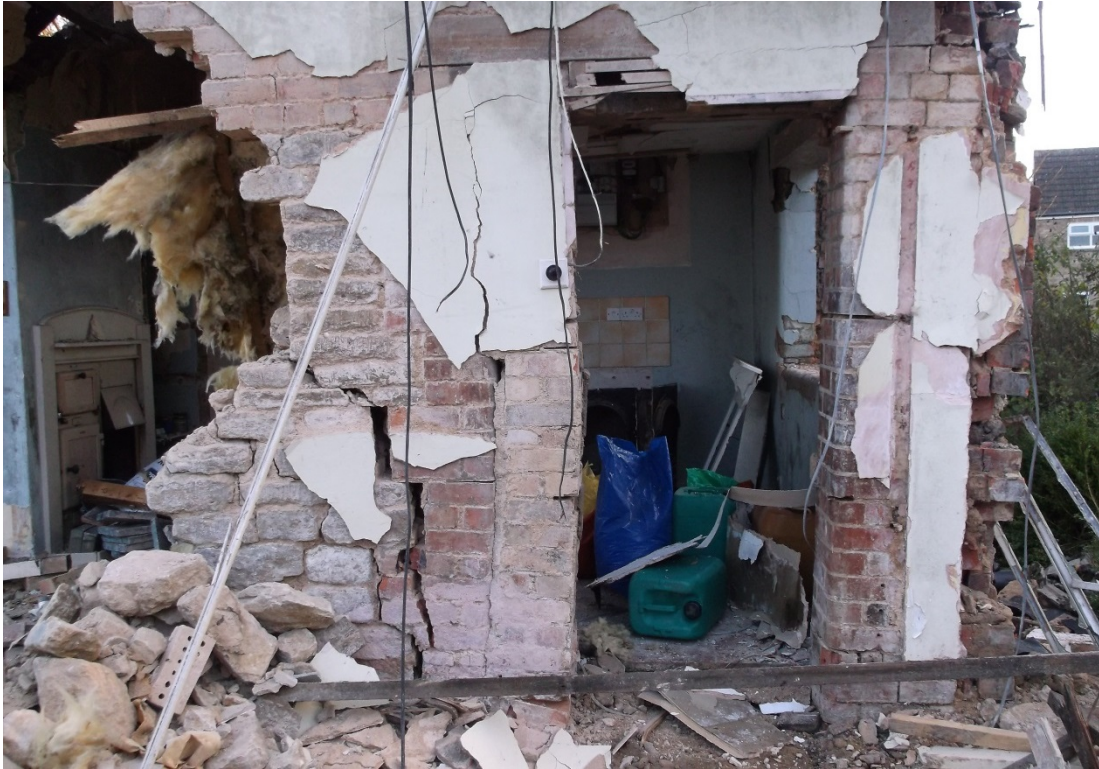
Squirrel Cottage, showing bull-nosed bricks on former doorway, looking east Fig 10

Evidence for a non-residential use for the earliest structure on the site of Squirrel Cottage was confirmed by the presence of bull-nosed bricks on the door jambs and window ledges. Such bricks were normally found in an agricultural or industrial context.
